## CONVENTIONAL AND NONCONVENTIONAL REPAIR OF CURTAIN WALL SYSTEMS

KAMRAN FARAHMANDPOUR,  
FRCI, RRC, RWC, REWC, RBEC, PE, CCS, CCCA, FNAFE

*BUILDING TECHNOLOGY CONSULTANTS, PC*

# Building Envelope Technology Symposium

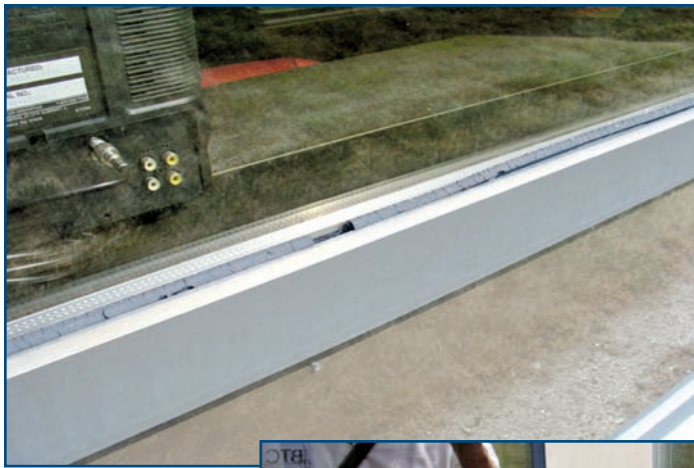
**Photo 1 – Crazing of glazing gaskets in a curtain wall system.**

Depending on gasket type, prolonged exposure to UV can result in hardening, shrinkage, and crazing (cracking) of the gasket material (*Photos 1 and 2*). In some cases, gasket shrinkage is significant enough that the gaskets shrink away from glass corners, resulting in loss of watertightness. Molded gaskets can pull out of their retaining grooves due to shrinkage, and extruded gaskets can simply shrink away from the corners, leaving the corners with no waterproofing protection (*Photo 3*). Although most curtain wall systems

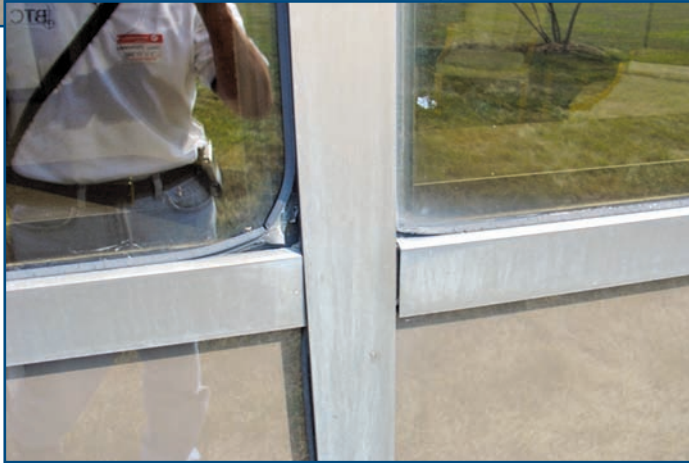
**Photo 2 – Shrinkage of glazing gaskets.**

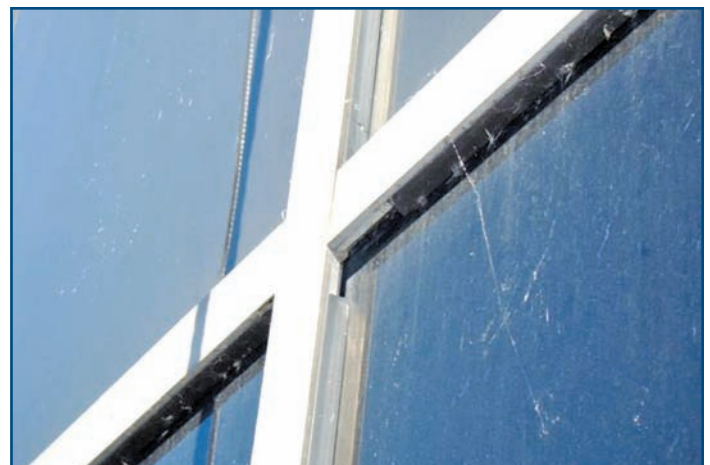
**Photo 3 – Extruded glazing gasket shrinkage.**

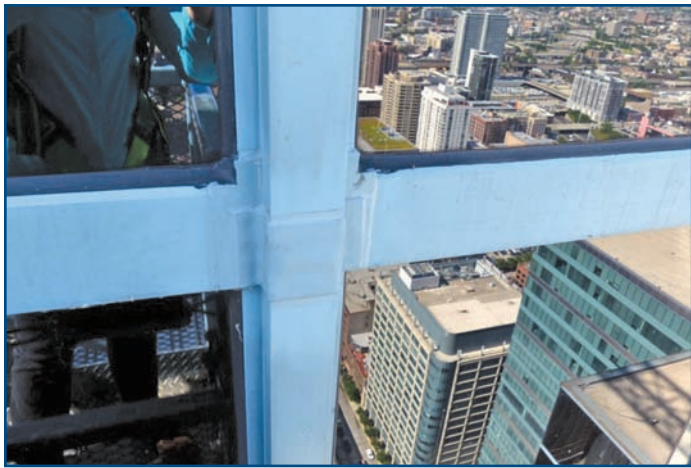
**Photo 4 – Premolded silicone boots used to seal framing joints.**

One of the most common and least expensive repair approaches to address curtain wall water infiltration issues is to seal all exposed glazing and frame joinery with sealant. This approach is typically referred to as "wet-sealing." Wet-sealing involves application of sealant over glazing gaskets and at all other locations where water infiltration into the system can occur. Although sealing of exposed frame joinery need not necessarily be included in a wet-sealing project, it often is. Wet-sealing of glazing typically consists of cutting and removing the exterior portion of the glazing gaskets and applying a cap bead of sealant around the glazing. In addition, frame joinery can be sealed. However, in most cases, decorative mullion caps are not removed to seal frame joinery. Instead, sealant is applied at all mullion cap interfaces. Some wet-sealing projects involve the use of silicone strips or premolded silicone shapes to seal mullion and frame joinery (Photo 4).

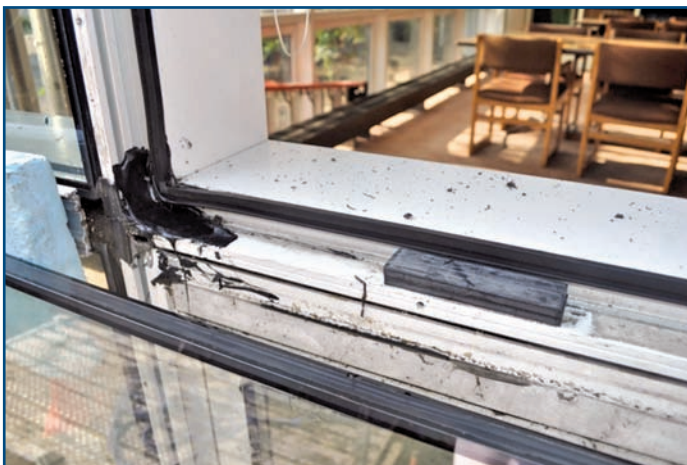
**Photo 5 – Repair of internal seals by deglazing.**

Repair of internal seals is not performed on a routine basis. Such replacement will necessarily require deglazing to expose the internal seals (*Photo 5*). In some cases, repair of internal seals may be possible by removing exterior pressure bars to expose glazing pockets. However, such repairs are difficult and not as reliable as those made where glazing is removed from the system.

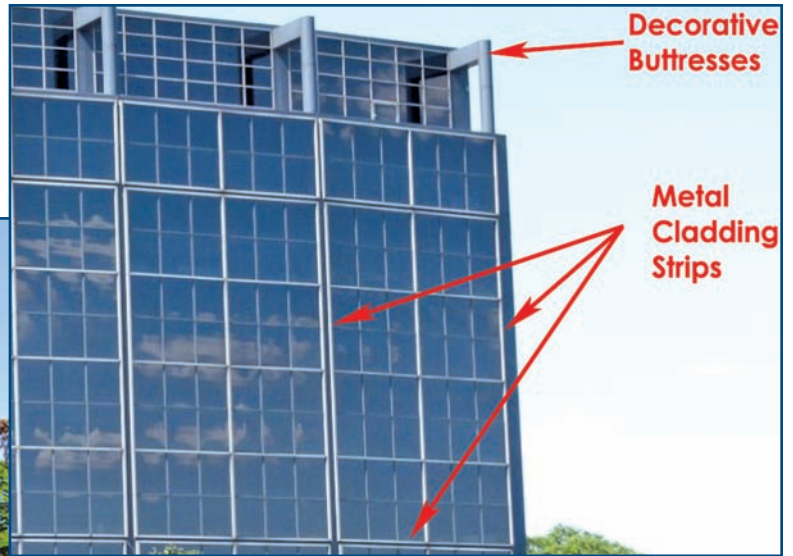
**Photo 6 – Overall view of the south and west elevations of the building.**

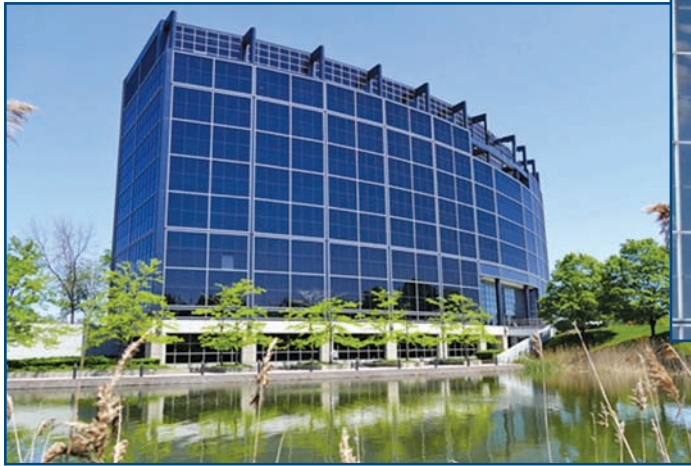
**Photo 7 – Barrier-type metal cladding strips between curtain wall sections.**

decorative metal cladding system separating the curtain wall panels (*Photo 7*). The joints in the barrier metal cladding are sealed with field-applied liquid sealant. On the east and west elevations of the penthouse level, large aluminum louvers serving the HVAC equipment have been integrated into the curtain wall system (*Photo 8*).

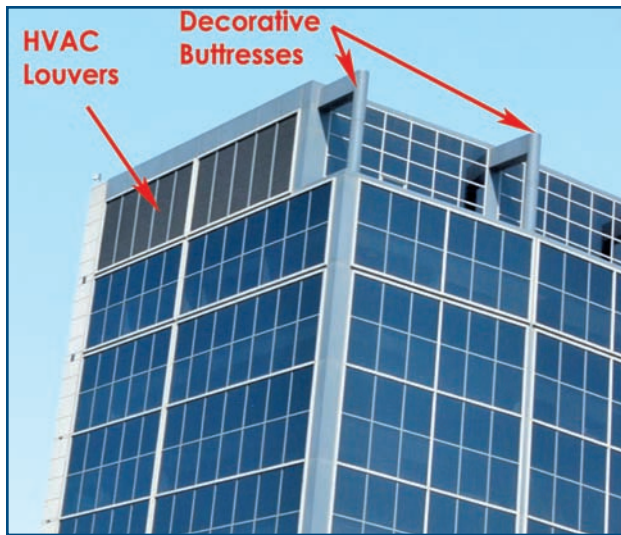
**Photo 8 – Large HVAC louvers installed within the curtain wall framing.**

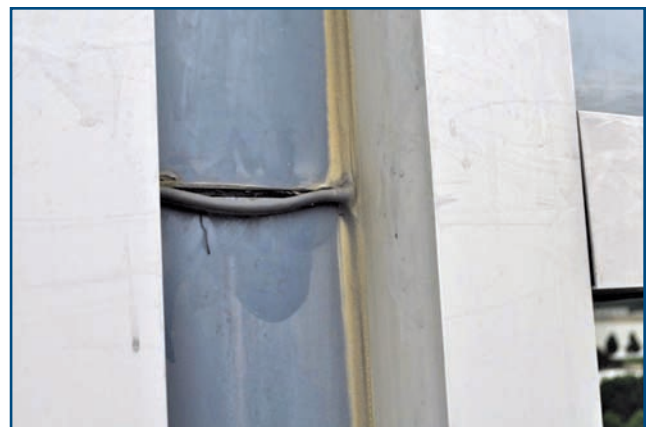
deteriorated glazing gaskets, deteriorated or open sealant joints at barrier metal cladding (*Photo 9*), inadequate internal seals, open-frame joinery, displaced or rotated mullions, and extensive water leakage issues below the louver assemblies. In addition, dislodged and loose mullion caps were observed at several locations. Extensive water leakage below the louvers was also confirmed through water testing.

**Photo 9 – Failed sealant joint at decorative metal cladding joint.**

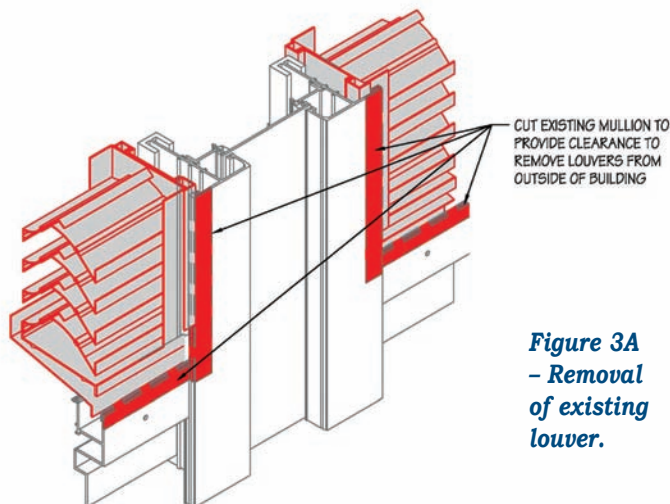
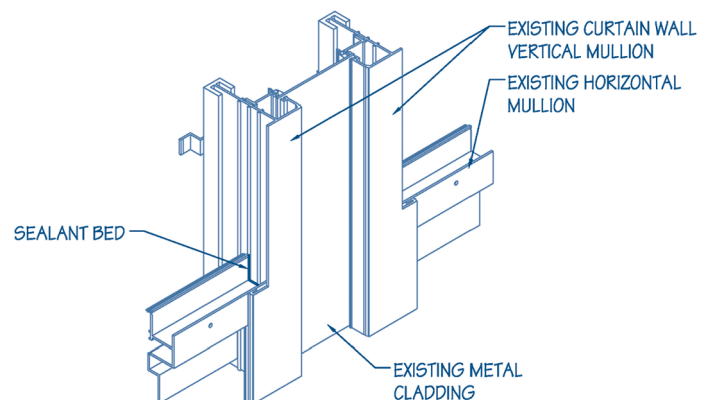
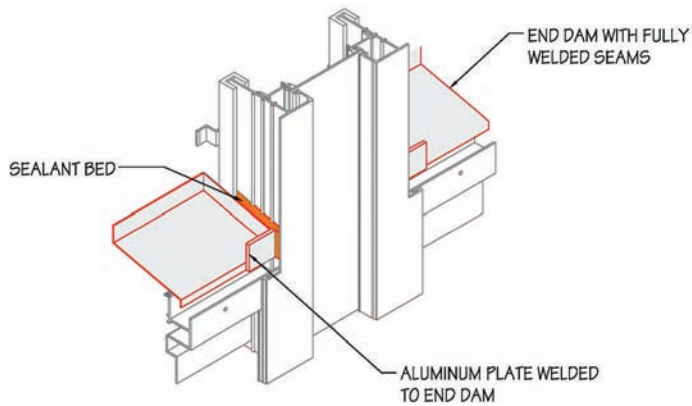
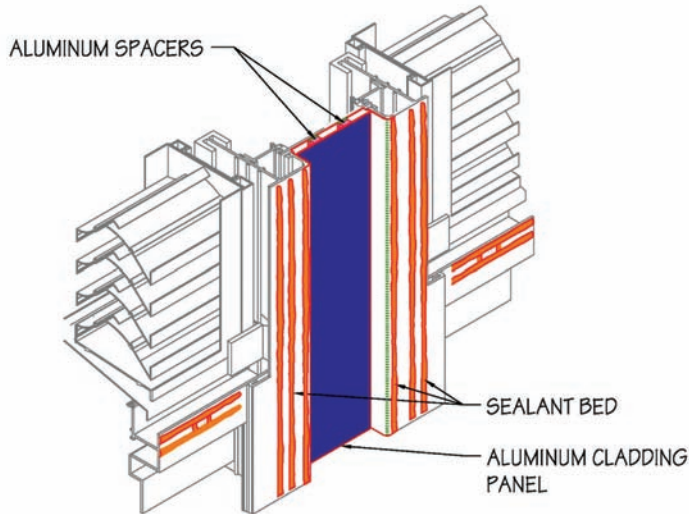
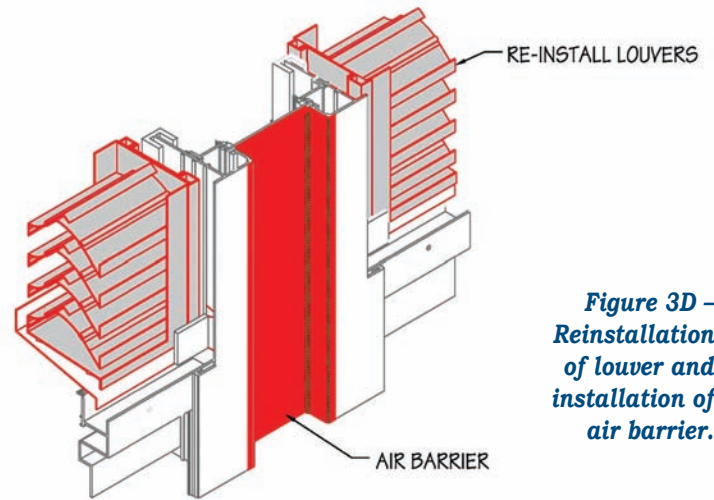
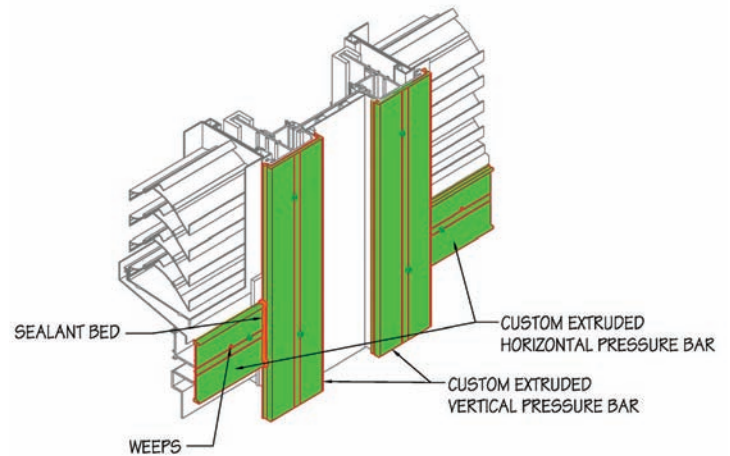
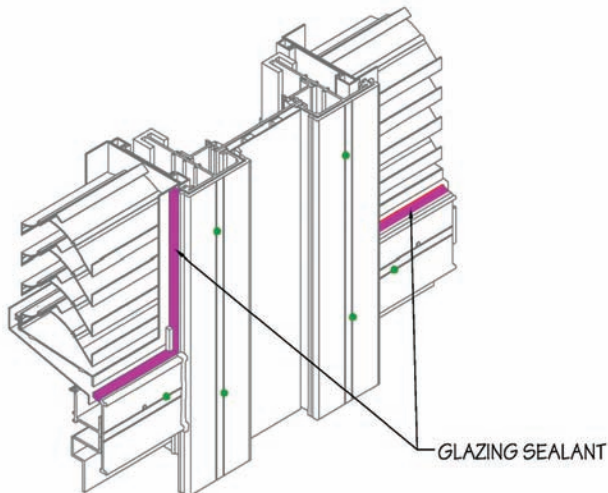
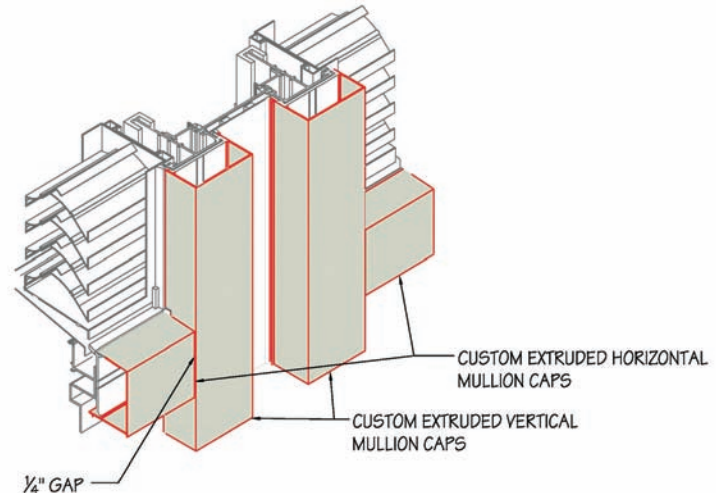
Another challenge for the design team was the configuration of the HVAC louvers. Field-testing has indicated extensive water leakage below the louvers. The interiors of the louvers were either blanked off or directly connected to large ductwork. In order to

ensure water management below the louvers, the louvers would have to be removed so that a pan flashing could be installed below them. The louvers had originally been installed from the interior. However, removal of the louvers would require removal of the interior ductwork that was deemed

impractical. As such, the design team opted to trim the exterior flanges of the vertical mullions to allow removal of the louvers from the exterior of the building. Once the flanges were trimmed, the louvers could be disconnected from the interior ductwork and removed. The design documents included an alternate to replace the louvers with new high-performance louvers.
