## PLAYING AGAINST A STACKED DECK: RESTORATION OF A STONE FIN FAÇADE

**MATTHEW C. FARMER, PE,  
AND  
FREDERICK W. PETERS**

*WISS, JANNEY, ELSTNER ASSOCIATES, INC.*

# PLAYING AGAINST A STACKED DECK: RESTORATION OF A STONE FIN FAÇADE

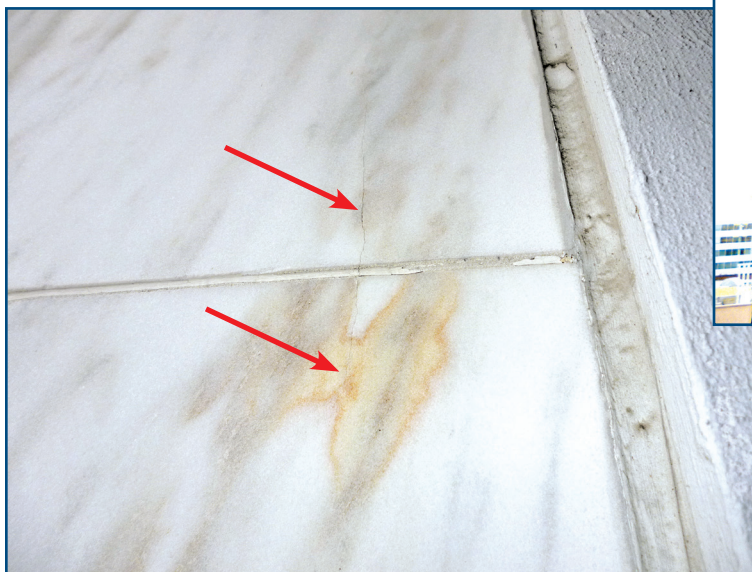
The façade fins were evaluated using a combination of high-power optics from the ground, roof, terraces, suspended scaffolds, and mobile personnel lifts. Cracks were observed in the marble fin panels at the ninth and tenth floors, typically emanating from the intermediate joints (see *Figure 7*). These cracks aligned with the locations of the dowels that connected the fin panels at the intermediate joints, suggesting that the

**Figure 7 – Vertical crack approximately 4-5 inches in length, emanating from the intermediate marble panel joint at the ninth-floor marble fin panel.**

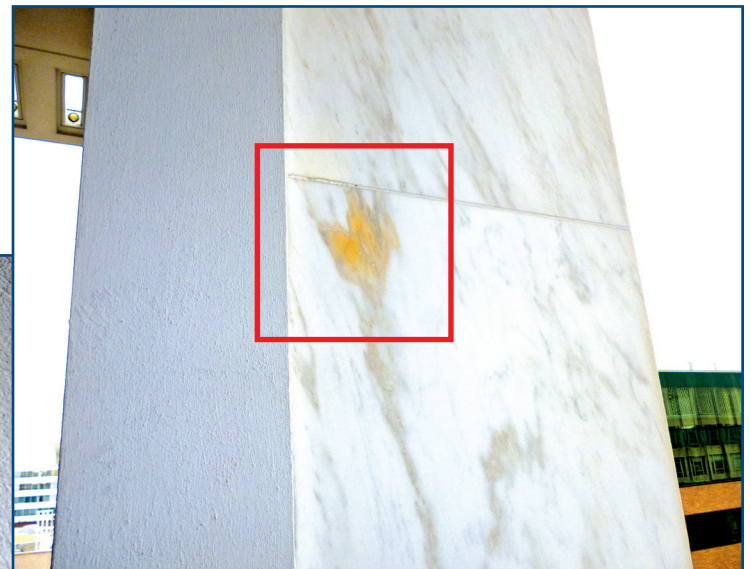
**Figure 8 – Rust-colored staining observed at the ninth-floor intermediate joints.**

dowels were inducing stress in the stone. Also common at the ninth and tenth floors were rust-colored stains above or below the intermediate joints (see *Figure 8*). The staining indicated corrosion of the embedded dowels that could be compromising their capacity. But more importantly, the staining also indicated that the corrosion was present in the space between the dowel and the stone, potentially exerting pressure on the surrounding stone that would lead to cracking, connection failure, and eventual instability of the marble fin panels (see *Figure 9*). The fin panels adjacent to the intermediate joints at the lower floors (eighth floor and below) were largely undamaged, because the dowels used at these connections were composed of a noncorrosive material.

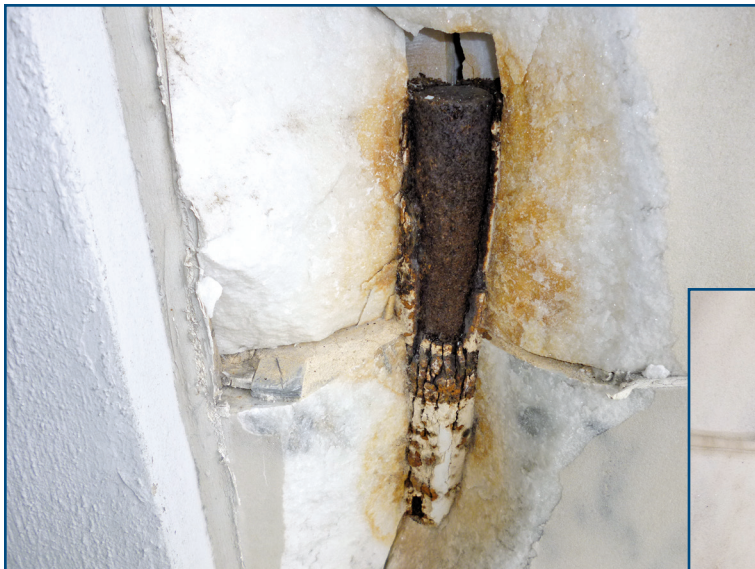
**Figure 9 – Corroded dowel exposed by removal of a spall at ninth-floor intermediate joint.**

A similar repair approach was performed at the intermediate joints. Once the panels above were supported, the damaged sections of marble fin panels were removed above and below the intermediate joints, along with the corroded or otherwise damaged dowels. A new single piece of stone cut to match the existing void

was installed using new stainless steel dowels to connect the new stone panel section to the remaining sections above and below (see *Figure 18*). The new stone joints were filled with mortar, raked back, and filled with sealant to reduce stress on the outer edges of the panels.

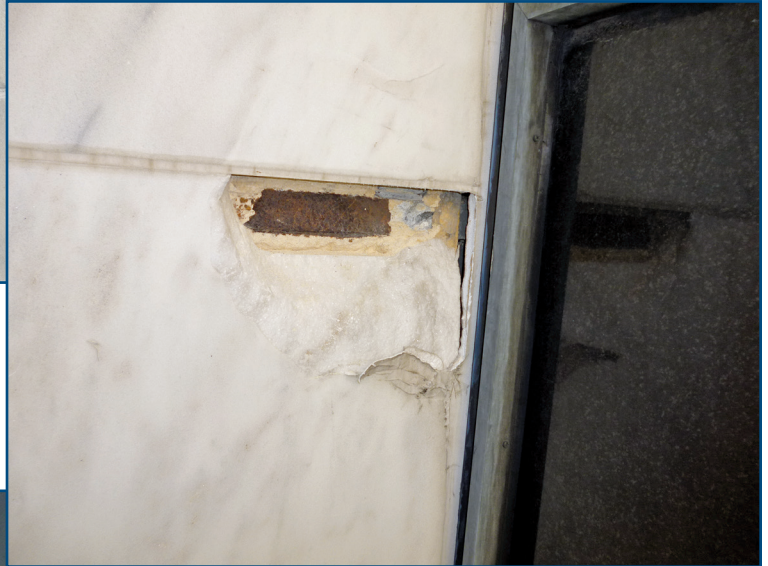
**Figure 10 – Removed incipient spall at marble fin panel below the floorline gravity support. The steel bar of the panel support is corroded.**

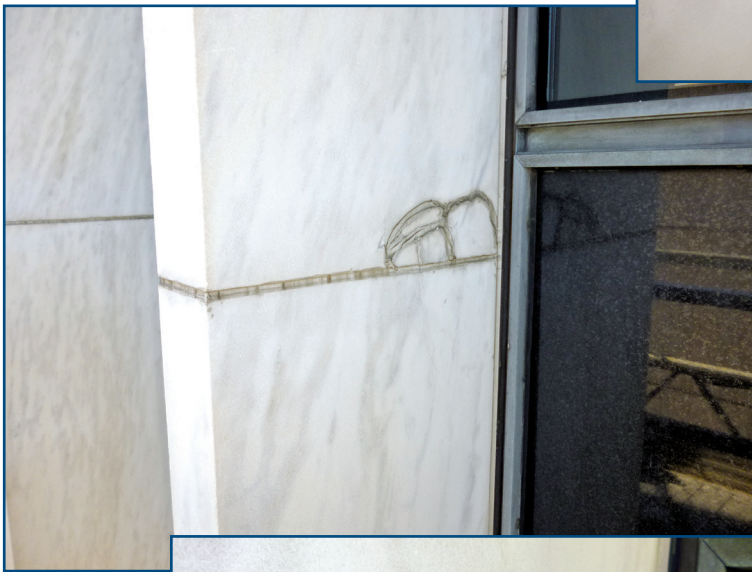
**Figure 11 – Cracks and an incipient spall in a marble fin panel above a floorline joint previously repaired with sealant.**

Also of concern was the discovery of significant cracks associated with incipient spalls near the floorline joints between panels at numerous façade fins, particularly at the panels directly below the floorlines (see *Figure 10*). Further close-range inspection was performed at several of these locations, revealing the gravity support connection was corroding. The corrosion was exerting pressure on the side of the rabbet in the stone, causing it to fracture. After identifying this condition, it was discovered that numerous repairs were completed prior to the earthquake, using sealant (see *Figure 11*). Upon further examination, these repairs were also unstable.

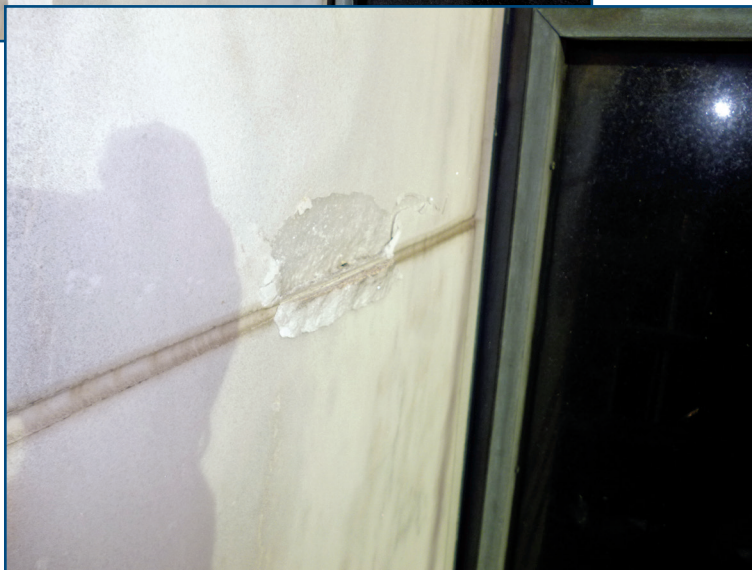
**Figure 12 – Typical shallow spall observed at the edges of the marble fin panel joints.**

Because the joints between the stone panels were solidly filled with mortar, the joints could not accommodate volume change of the panels over time, due to thermal cycling or hysteresis of the marble<sup>1</sup>. The mortar enabled load to transfer between fin panels due to the accumulation of gravity load (stacking pressure), which increased the stress at the edges of the stone where the stone panel was rabbeted and slotted to accommodate the gravity support connection. The increased stress at these edges often led to shallow spalls in the stone near the joints (see *Figure 12*).

The mortar and sealant from all fin panel joints was removed to a depth of 3/4 in. and then filled with sealant to reduce stress at the panel edges and to limit the potential for water to reach the concealed steel elements within the stone.

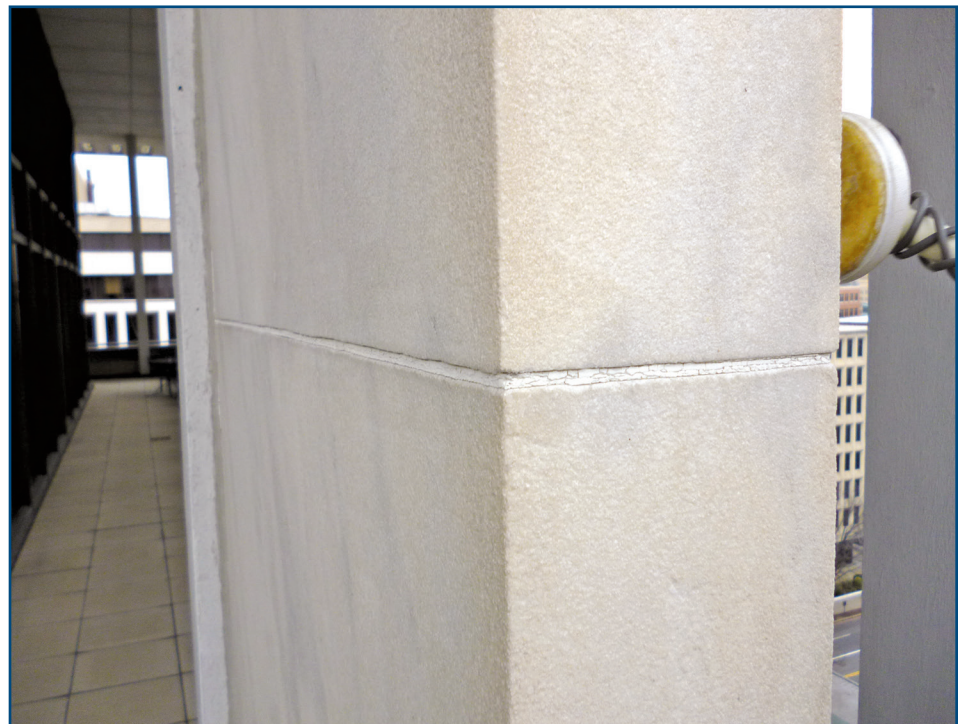
The mortar between marble fin panels had undergone multiple repair efforts. At some point in the past, the original mortar was removed from the joints to varying depths and replaced with a new, harder mortar used to fill the void or “point” the joints. When a hard mortar (in relation to that of the original mortar) is used as a repointing mortar, the harder mortar can cause stress concentrations at the face of the adjacent stone, causing them to chip or spall. Subsequent to the installation of the new mortar, sealant was applied in a thin layer over the mortar. This material is in poor condition, with frequent separations from the stone panels and severe oxidation of the surface (see *Figure 13*). Despite the application of sealant over the mortar, water could continue to reach the underlying steel (either the gravity supports at the floor line joints, or the dowels at the intermediate joints of the ninth and tenth floors), enabling corrosion to develop. It was clear from the condition of the mortar and

**Figure 13** – Typical example of deteriorated sealant at a marble fin panel joint. The sealant was thinly applied over the existing mortar.

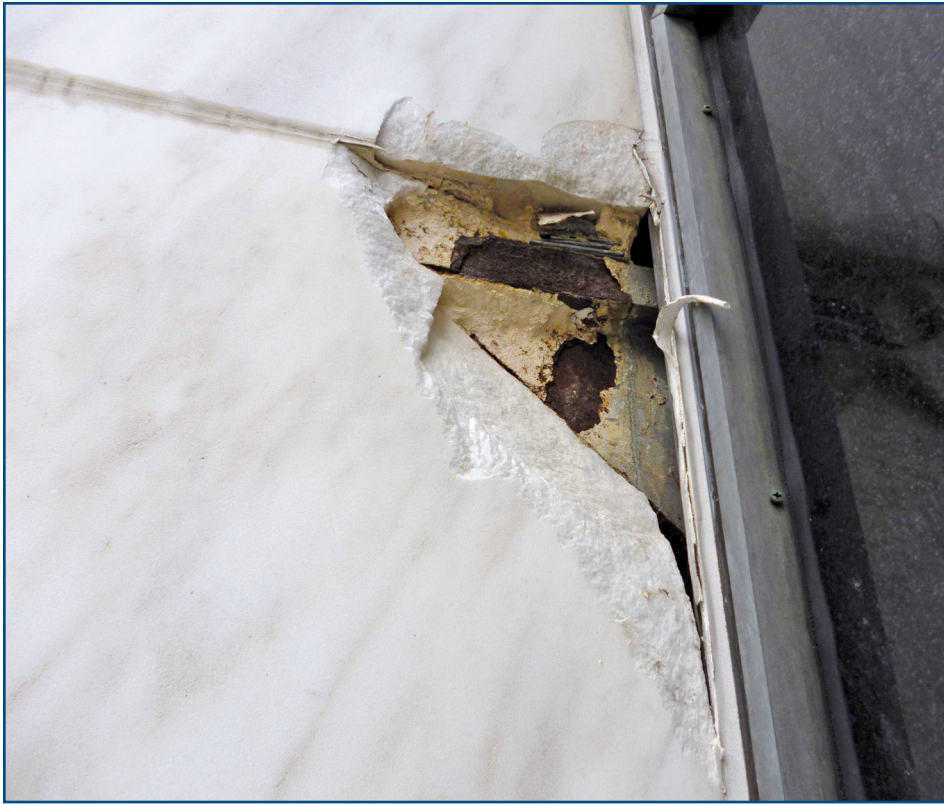
**Figure 14 – Substantial corrosion observed on the steel bar and stiffener plate at the location of a removed incipient spall.**

The corrosion observed was initiated by exposure of the steel elements to water and oxygen during prolonged periods of wetting and drying, attacking the steel at defects in the galvanizing. The alkalinity of the mortar used in the slot also provides some protection against corrosion; however, over time, the mortar is exposed to atmospheric carbon dioxide (the process of carbonation),

As time passes, the corrosion of the steel increases, leading to further degradation of the galvanizing and conversion of the base metal to iron oxide. Iron oxide (commonly referred to as rust scale) can occupy many times the volume of the deteriorated base metal. When confined, the iron oxide formation exerts expansive stress on the surrounding material, causing it to spall or crack. At the NGS building, moisture had reached the stone panel gravity support elements through failure of the joint mortar between the marble panels at each floorline. Water was absorbed and retained in the cementitious mortar that fills the rabbet cut into the lower panels to accommodate the steel bar and plate, then was held against the steel with no provisions for drying. Iron oxide that formed on the steel bar and stiffener plate had exerted expansive forces against the portions of the marble that form the rabbet and slot that conceal the steel elements (see *Figure 14*). Once the force exceeded the tensile capacity of the marble, it cracked or spalled, leading to more ingress of moisture and oxygen, thereby accelerating the corrosion process. There was no marble distress evident beyond the

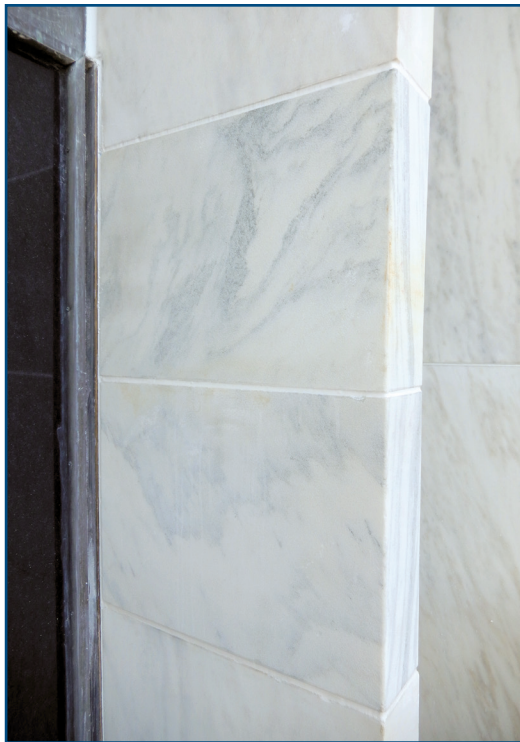
**Figure 19 – Completed repair of damaged marble fin panels at a floorline joint (gravity support).**

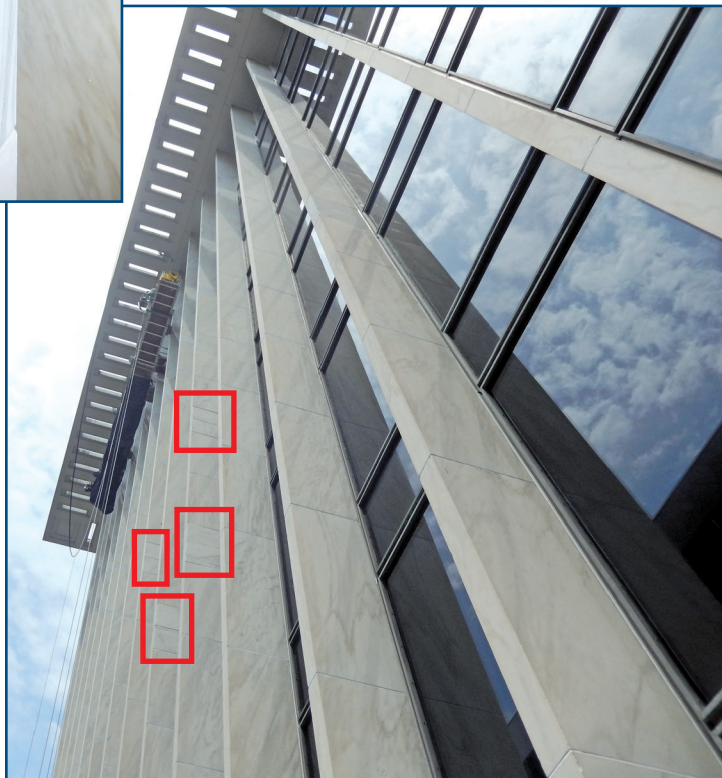
**Figure 20 – Completed repairs of damaged marble fin panels at floorline and intermediate joints.**
