REPAIR STRATEGIES FOR METAL ROOFING

JAMES W. RIPLEY, NCARB, RRC, RWC, RRO, REWC, RBEC

A/R/C Associates, Inc.

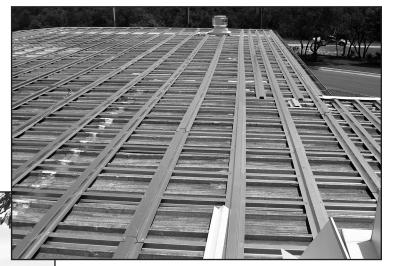
Photo 1 – Replacement of an architectural roof panel over a solid substrate.

We have worked with multiple metal roofing projects over the years and many have simply been removal and replacement of an existing metal roof "in-kind," which is most easily accomplished for an architectural roof panel over a solid substrate (as shown in *Photo 1*). But many of our roofing projects involve an existing and occupied building that must remain functional during the course of the work. Under these conditions, removal and replacement is much less feasible with a structural metal panel roof system over open purlins. Removal of the roof panels would expose the interior of the building to weather and damage, endanger the safety of the occupants, and eliminate any working platform for the laborers and installers. Installation of a furring system over which the new metal roof is installed becomes a viable option that allows the existing metal roof system to remain in place and avoids the cost of removal and disposal of the existing metal roof system, provided the structural system has adequate capacity to support the additional dead load.

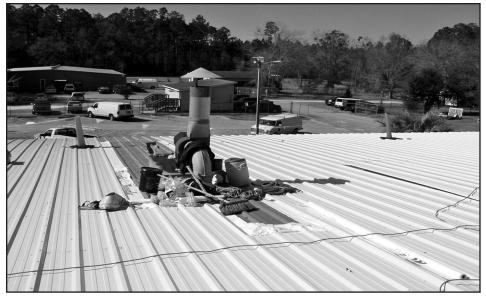
Photo 3 - A replacement system that seems to be unique to utility panels with exposed fasteners is overlaying an existing metal roof system with a nesting panel system.

A replacement system that seems to be unique to utility panels with exposed fasteners is overlaying an existing metal roof system with a nesting panel system (as shown in *Photo 3*). Although very little guidance is available from the roof panel manufacturers with regard to this panel installation method, it can be very cost-effective. Initially, all the existing exposed fasteners at several roof panels are removed, a separator sheet is applied, a new utility roof panel is nested over the existing panel, and new exposed fasteners with neoprenebacked washers are then driven through both roof panels into the underlying steel purlins. The difficulty we have sometimes encountered with this replacement method is finding a new roof panel that will properly nest within the existing roof panel.

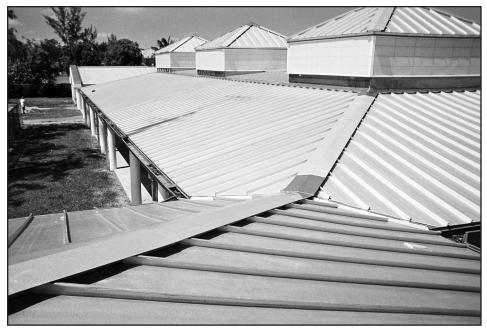
Photo 4 – New roof at Broward County school.

In Broward County, FL, we were involved with five sister schools that were all constructed within a few years of each other; three were even built by the same contractor. (See example of new roof in Photo 4.) These mill-finish Galvalume steel roof systems were approximately 12 years old, so they were nowhere near the end of their service lives based on the weathering capabilities of the metal itself. These schools had all been plagued with leaks since their initial construction, so the owner had tried several different repair options over the years. All repair attempts-including bituminous roofing cement, elastomeric coating, and sealant-had been unsuccessful.

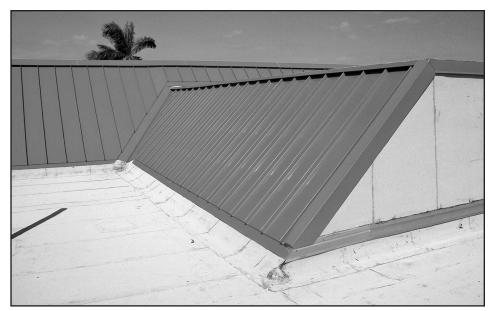
Photo 5 - Roof at Imperial Point Library.

This library in Broward County incurred storm damage from a hurricane in 2006. Attempts to perform temporary repairs to secure the metal roof system caused permanent damage to the system to the extent that repairs were no longer feasible. (See example of roof in *Photo 5.*) Exposed fasteners were used to secure metal roofing and flashing that had been dislodged by the high winds, which made metal roof replacement necessary. This project involved the straightforward replacement of both the architectural metal roofing in "like kind" and a modified-bitumen roofing system over a structural deck.

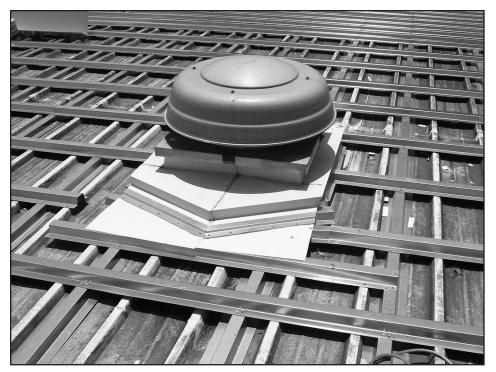
Photo 6 – This pre-engineered structural metal roof system over purlins incurred storm damage during Hurricane Charlie.

This building is a pre-engineered metal building with a structural metal roof system over purlins, which incurred substantial storm damage during Hurricane Charlie in 2004. (See *Photo 6.*) Significant portions of the perimeter and corner zones were lost during the hurricane, which made roof replacement necessary.

In this case, the obvious choice was to reinstall a new structural metal roof panel system because of the building type, building use, and the minimal roof slope. Due to the lack of an intermediate purlin at $2\frac{1}{2}$ ft. from the roof edge, which is needed in our area to adequately resist wind uplift, it was advantageous to leave the existing metal roof in place as a working surface and to install a double metal furring system. A single furring system, cut to fit the existing metal roof panels, was not feasible because additional uplift resistance was needed in the perimeter and corner roof zones; therefore, the first layer of furring was run vertically and anchored directly to existing purlins. The second layer of furring is run across the slope and attached to the first

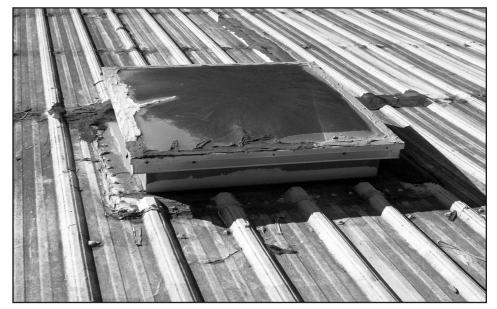
This was a pre-engineered metal building with an exposed-fastener metal utility roofing panel. The building had ongoing water intrusion problems at the exposed fasteners and the head laps and various other conditions throughout the roof. Our initial analysis indicated the roof system had followed the typical evolution in this type of panel: The sealants and neoprene gaskets at the fasteners had broken down over time, which had caused minor widespread leaks. As a response to those problems, the owner had previously applied elastomeric coatings at selected areas, fasteners, and head laps, which had also deteriorated with age. This was allowing the widespread water intrusion to recur as shown in Photo 7.

Photo 7 - Deteriorated elastomeric coatings allowed widespread water intrusion.

As a result, we designed a typical metal roof refurbishment project that included replacement of sealants, flashing boots, fasteners with neoprene washers, and isolated treatment of surface corrosion. Corrosion treatment consisted of abrasive cleaning, treatment with a corrosion neutralizer (such as "Ospho"), then priming and painting with a corrosion-resistant finish to match the existing roof panels.

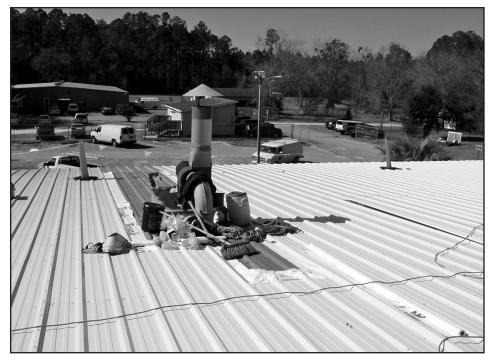
Photo 8 – The darker existing metal roof panel can be seen downslope of the exhaust fan; some building wrap is seen along the edge of the new white roof panel that has been installed.

panels had to be created; therefore, a building/house wrap was used as a separator sheet. The construction process was to remove all the existing fasteners at several roof panels, apply the separator sheet, lay down the new utility roof panel, and install new exposed fasteners with neoprenebacked washers through both roof panels into the underlying purlins (*Photo 8*).

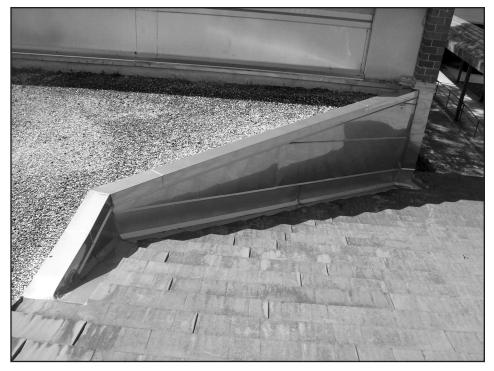
The roof system at this school consisted of Bermuda-style metal shingles installed on felt underlayment over gypsum board and rigid insulation on a sloped metal deck that was experiencing ongoing water intrusion problems. (See *Photo 9.*) Roof leaks were widespread throughout the field of the roof, but primarily at some angle walls, against and along which several roof areas drained. The owner elected to remove the

Photo 9 – Roof leaks were widespread throughout the field of the roof, but primarily at some angle walls, against and along which several roof areas drained.

metal shingles and correct the flashing problems, install a modified-bitumen underlayment over a new nail board sheathing secured to the underlying metal deck, and install an asphalt shingle roof system.

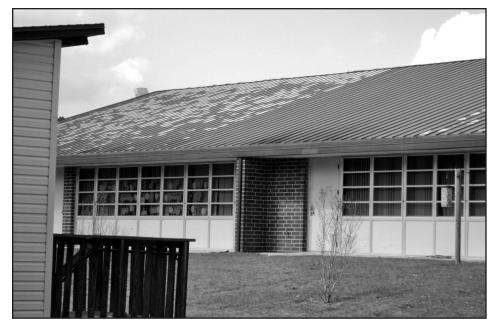
Photo 10 – This architectural standing-seam metal roof with a snap-on seam cap was experiencing water intrusion problems, primarily along an angled wall flashing.

At this sister school to Wiles Elementary, the architectural standing-seam metal roof with a snap-on seam cap was experiencing water intrusion problems, primarily along the same angled wall flashing as the other school. (See example of conditions in Photo 10.) But at this school, it was decided that the roof areas associated with the problem areas would be removed, which would allow us to correct the transition wall flashing conditions. At these seven roof areas, a modified-bitumen underlayment was installed over the gypsum board on metal roof deck, followed by the unusual approach of reinstalling the existing metal roof panel system. This was determined to be possible due to several unique characteristics: The roof panels were simple pans with a friction-fit seam cap that was easily removed, there were no sealants in the seams or the field of the roof, the roof panels were the full length of the slope with no head laps, and the roof panels were "fixed" at the ridge. Also during reinstallation, gutters were replaced, and the drip edge and ridge cap configurations were revised to

require a shorter roof-panel length to avoid existing holes and sealant along the top of the roof panels. At the remaining metal roof areas, seals and flashings were refurbished, and the leaking gutters were replaced to correct all of the roofing functional concerns as to the roofing at this campus.

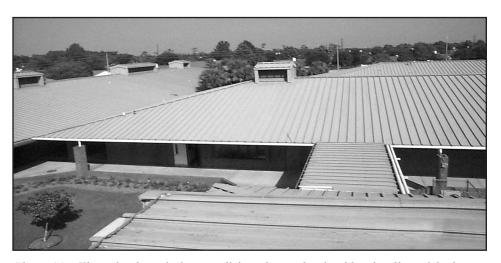
Photo 11 – The school s existing condition shows the dead-level valley with the internal gutter and several ventilation cupolas.

As mentioned earlier, metal roofs are more appropriate when used with simple roof configurations; therefore, we elected to remove the existing cupolas and extend the existing roof planes to the ridge of the building to greatly simplify the roof configuration of the buildings. The campus had two dead-level valleys be-

tween buildings with internal gutters that had had ongoing water intrusion problems ever since the construction of the school. All previous repair attempts had been unsuccessful. We elected to change the configuration of the roof system. Additional metal framing and metal roof panels were installed over the existing structure prior to the application of elastomeric coating to extend existing roof planes and eliminate the dead-level valleys. Three very-low-roofslope areas with numerous pieces of rooftop equipment were also converted to thermoplastic single-ply roof membrane, which was more appropriate for those specific roof conditions.

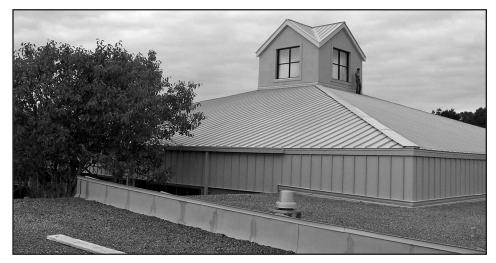
Media Center (Photo 15) was deemed necessary due to a long history of leakage problems at the central cupola, which affected the entire roof system. The waterproofing problems exposed at this building involved the cupola wall construction, the clerestory windows in the cupola, and the metal roof flashing at the cupola. For this limited roof area, it made more sense to disassemble the roof and cupola, perform the proper waterproofing (including removal and replacement of cupola windows and their sill flashing), reapply the EIFS, and reinstall the metal roof. The remaining metal roofs on campus were refurbished, which included replacement of pipe flashing boots; sealing the ridge, rake, and hip conditions; correction of flashing problems; securement of loose rake and drip edges; and repairing of seams at gutters. All of the existing metal roof areas and the newly installed Media

Photo 15 – A portion of the media center s refurbished roof.

Center roof system were prepared by highpressure washing and priming as recommended, then inspected and accepted by the manufacturer's technical representative. After adhesion testing, all the metal roofs (new and existing) were field-painted with a high-performance, automotive-grade polyurethane enamel coating. This mixture of tasks within the scope of work of these projects was recognition of what problems could be repaired and addressed and what problems needed to be disassembled and corrected by replacement.

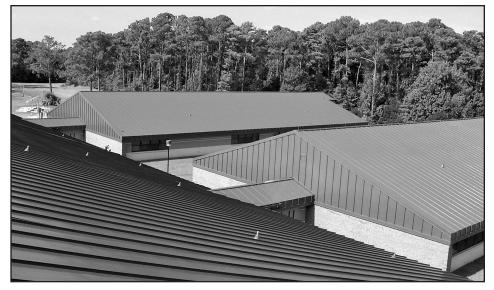
Photo 16 – Portion of completed roof.

with high-performance industrial paint /coating. Use of a field-applied PVDF-"Kynar" coating system was considered, but due to budget constraints, a high-performance, automotive-grade polyurethane enamel was selected for application at all four campuses, which were refurbished over the course of four years (*Photo 16*).

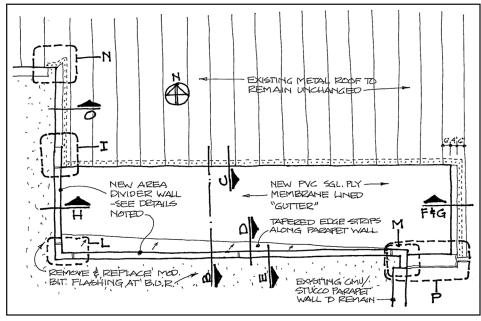
Figure 1 – Plan of the problem roof area.

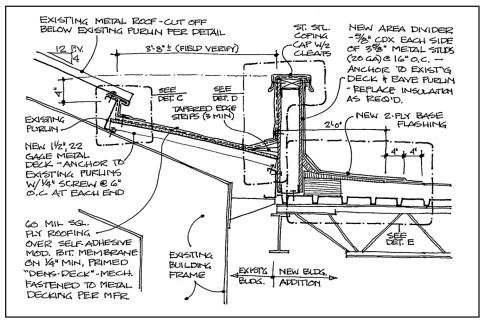
Figure 2 – This section through the roof repair area illustrates the basic concept.

ing-seam panel that is mechanically seamed as a single piece for the entire roof width. The 80 feet from the ridge was draining into a concealed internal gutter at the top of the wall that was 4 in. wide and 6 in. deep. Considering that the design rainfall in central Florida is 4¹/₂ inches an hour, this gutter size was inadequate. During heavy rains, the gutter would fill, but because the outside edge of the gutter was higher than the drip edge of the panels, water was being forced back through the panel seams above the edge metal and entering the building. The solution was not to replace the roof but to create a larger gutter. This was accomplished by removing the wall extension that concealed the gutter by utilizing the additional width of that parapet wall. A 14-in.wide, 4-in.-deep gutter that could adequately handle the amount of rainfall was created. This gutter depth allowed the outer edge of the gutter to be an inch lower than the drip edge of the roof system. The aluminum roof panels remained unchanged. The gutters were fabricated from heavy-gauge aluminum to avoid corrosion problems, minimize brackets and straps, and allow all components of the gutter system to be welded.

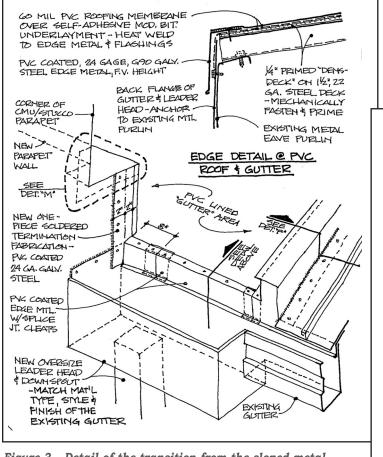
Figure 3 – Detail of the transition from the sloped metal roof to the newly created, single-ply lined gutter.

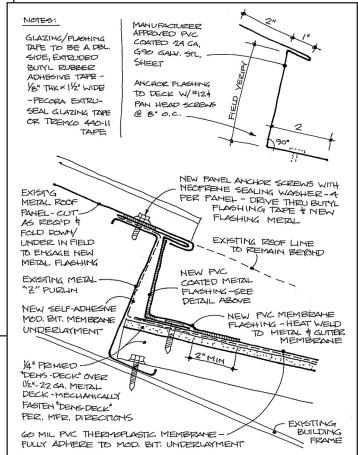
Figure 4 – Detail of discharge from the "gutter at the roof edge.
