30th RCI International Convention and Trade Show

INNOVATIVE REPAIRS TO TERRA COTTA PARAPETS AND CORNICES

STEVEN P. BENTZ, RBEC, PE, AND MICHAEL PAYNE, EIT

FACILITY ENGINEERING ASSOCIATES, P.C.

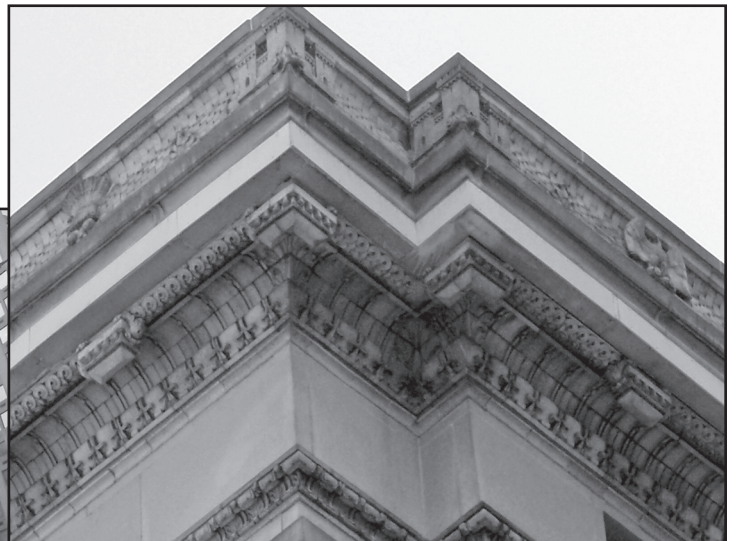
Photo 2 – Ornate terra cotta cornice and parapet wall.

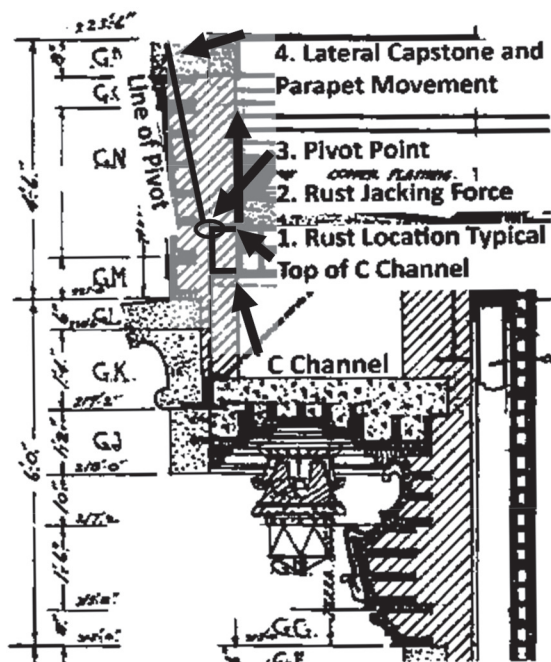
Figure 1 – Diagram indicating initial failure mode and pivot point of the parapet wall and terra cotta cornice.

Along with falling pieces of cornice, the parapet wall was believed to be leaning towards the street. Initial thoughts pointed towards rotation of the wall due to rust-jacking, omission of terra cotta anchorages and grouted terra cotta cavities during construction that were specified in the original design drawing, aging of the exterior components, and excessive corrosion of structural framing and masonry fasteners as the potential reasons for these failures. It was believed that a pivot action failure (rotation of the wall due to uneven uplift forces) was occurring at the bottom of the parapet wall, causing the entire wall (coping included) to lean as a single element. This was presumed to be partly due to issues with the terra cotta hangers (shown on the original details but not observed in the construction), along with rust jacking of steel framing, pushing the wall up and outward. This assessment summary can be observed in the diagram in *Figure 1*.

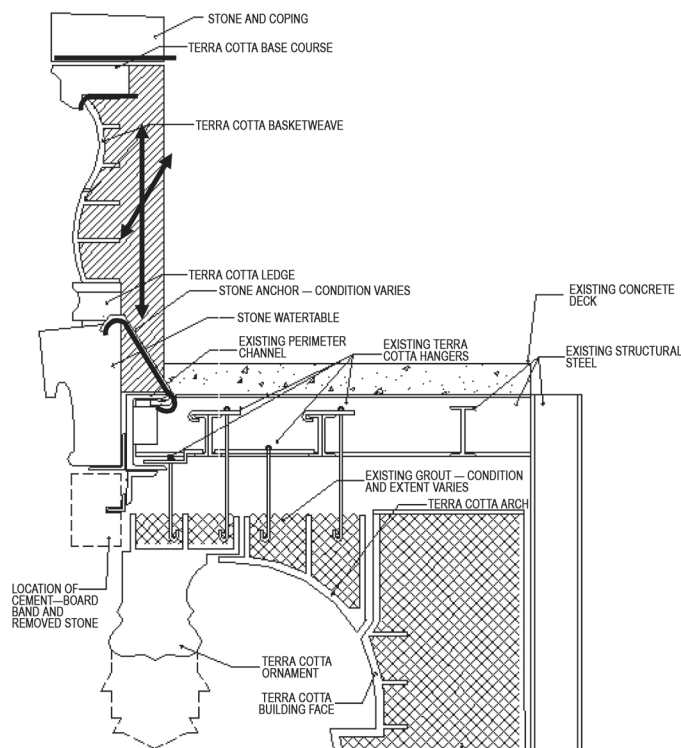
Figure 2 – Diagram indicating revised failure mode of the parapet wall and cornice. Thick black lines at the coping indicate erosion of mortar joints that result in rotation of the terra cotta base and coping. The black arrows along the parapet wall represent the irreversible expansion of the masonry due to the absorption of moisture. The stone anchor highlighted at the water table was typically failed due to corrosive section loss of the anchor and resulted in rotation of the water table ledge.

The second team of consultants focused on the idea that pivot action failure was not occurring at a single location. Based on the observed movement and deterioration, the team concluded that various failure modes were occurring at specific elements of the parapet wall and cornice simultaneously, causing the misconception that the entire wall was leaning from a single point. In this second opinion, it was believed that the cornice and parapet were failing due to expansive forces of the adjacent parapet walls, expansive forces within each wall, and movement and deterioration of the cornice elements below, as indicated in *Figure 2*.

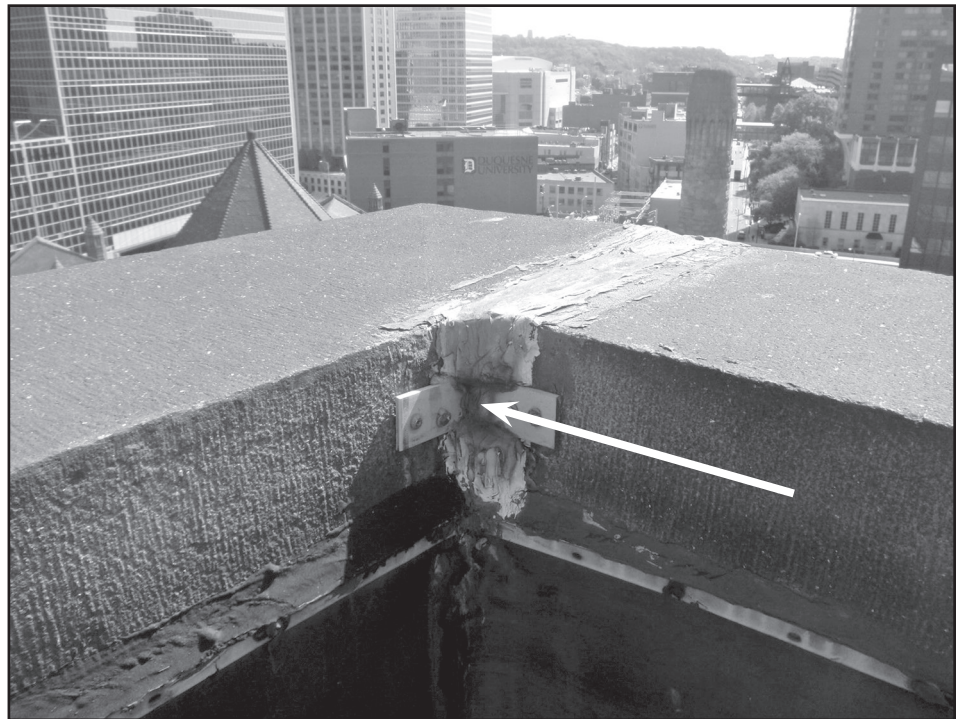
In the case of the leaning parapet wall, it was found that the original parapet wall design did not account for enough thermal and moisture expansion of each perimeter edge. The corners of the roof did not include any type of joint to take the movement caused by an increase in temperature and swell at the long-axis parapet walls. This created a force at the adjacent parapet wall perpendicular to it, pushing the wall outward (see *Photo 3*).

Photo 3 – Thermal and moisture expansion within the brick and granite parapet wall elements caused a pushing motion to occur at the corners of the perimeter wall.

expansion (3 inches of total expansion from initial length). Or, assuming no movement is accommodated at the corners, where perpendicular parapet walls abut the long walls, a stress of over 1,700 psi is developed pushing on the adjacent wall. The force is substantial, and the movement that is occurring must go somewhere, with the end result being that the perpendicular walls must be forced outward. When the thermal movement relaxes, the long wall returns to its original position, but the perpendicular wall is left displaced. Over time, this cycle results in cracks at the corners (*Photo 3*).

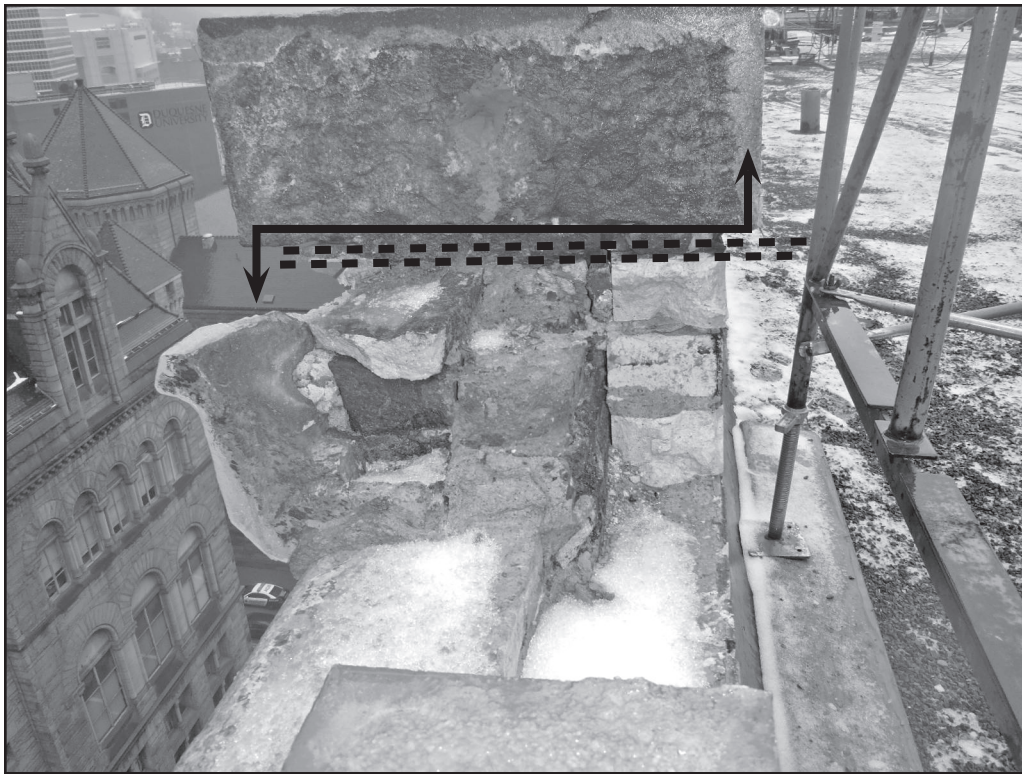
Photo 4 – Cross-section of parapet coping. Arrows indicate rotation of coping. Solid line is approximately level to show amount of rotation. Dashed lines indicate differential amount of heave in back-up masonry due to irreversible moisture expansion.

Swelling of individual brick caused height expansion within the brick courses. This expansion slowly created stresses within the brick-layers and began to push the wall slightly upward. Because expansion was unequal among the different layers of the wall, a differential lift was created, causing the coping-stone atop the wall to rock toward

the street. The amount of lift caused by irreversible moisture expansion in the brick can be seen in *Photo 4*.

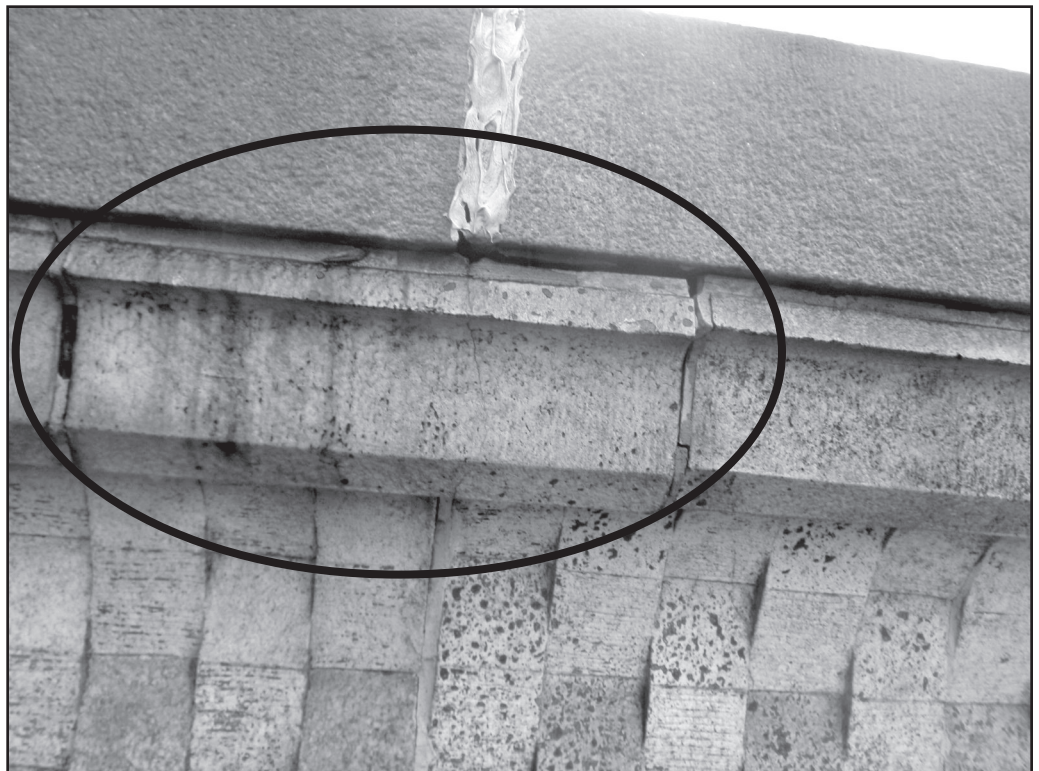
Photo 5 – Mortar deterioration at joints below coping stone.

It seems that the lift was not the only action occurring at the parapet wall. The rocking of the coping was intensified by the erosion of mortar joints along the front face of the coping stone between the coping and terra cotta base course, as well as the joint between the terra cotta base course and decorative terra cotta weave (as seen in *Photo 5*). Mortar joint deterioration was widespread throughout the parapet and cornice, however, not just at these joints.

Moisture intrusion and freeze/thaw cycles had caused the mortar within these joints to severely deteriorate. Among other outcomes, this allowed cornice and wall elements, such as the terra cotta base course and coping stone above, to settle at the outside face, while the brick backup and steel framing remained intact to support the remaining sections, thus creating the appearance of an outward-leaning parapet wall.

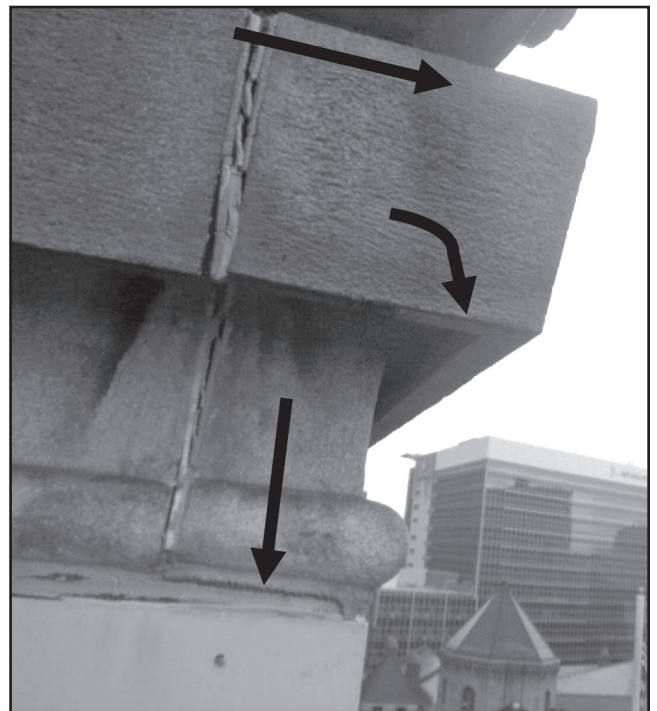
Granite water tables were found to be leaning down and outward, as depicted in *Photo 6*. The most severe areas were at the corners of the building, although stability was questionable for the entire length. Therefore, the question arose as to why the granite water table pieces had started to move. Initial thoughts pointed to possible failed or missing anchors. However, it turned out that it was caused by several different reasons.

prevent lateral movement had severely corroded and failed in numerous locations, but the shelf angle supporting the water table was intact. This allowed the water table to rotate down and outward from the top.

It was observed that the anchor rods, which were hooked steel bars that were intended to prevent water table rotation, had corroded. The rods, connected to a steel c-channel, went through back-up masonry and attached to the top edge of the granite piece to the steel framing. The rods had corroded due to being packed tightly against the masonry, which had been subjected to water infiltration from above. As deterioration of joint materials continued through the years, open joints within the granite, masonry, and terra cotta allowed water to enter into the wall and continue to corrode the steel anchors. This condition was most notable at the corners, where the previously discussed irreversible movement had opened cracks and allowed even more water into the assembly.

Photo 6 – Granite water table at the corner of the cornice was noted to be rotating down and out from the corner

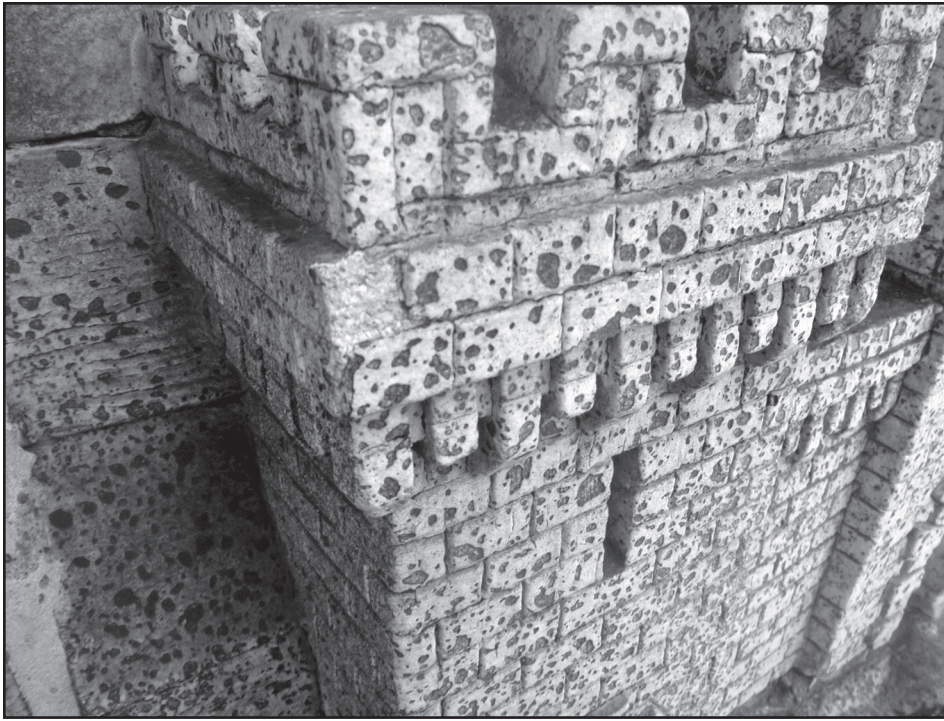
Photo 7 – Glazing degradation failure at terra cotta parapet, as well as areas of cracked and spalled terra cotta.

Although the above conditions were present and were assumed to be contributing factors to terra cotta failure, there was a more general issue that was occurring at the entirety of the terra cotta pieces at the parapet, cornice, and soffit. The terra cotta elements had been subject to widespread glaze failure. What was initially thought to be a “speckled” finish in the glaze (see *Photo 7*) was found, upon close-up inspection, to be defects in the glaze. The exact cause of the glaze degradation failure was not determined, but it was suspected that it was related to atmospheric conditions (possibly acid rain) or a very aggressive prior cleaning of the building (anecdotal evidence suggests that the building may have been sand-blasted in the late 1960s). Regardless of the cause, glaze failure was allowing water into

within. Second, to prevent the porous surface of the terra cotta where glazing failure had occurred from absorbing water from the surface in the future, a breathable protective elastomeric coating was applied to the surfaces of all the terra cotta elements within the parapet, cornice, and soffit. This process sealed the terra cotta system (but allows it to breath or release trapped moisture vapor) and had the added benefit of creating a uniform, clean look to the entire ornate cornice (see *Photo 10*). The repairs to the parapet above were intended to limit water entering the cornice.

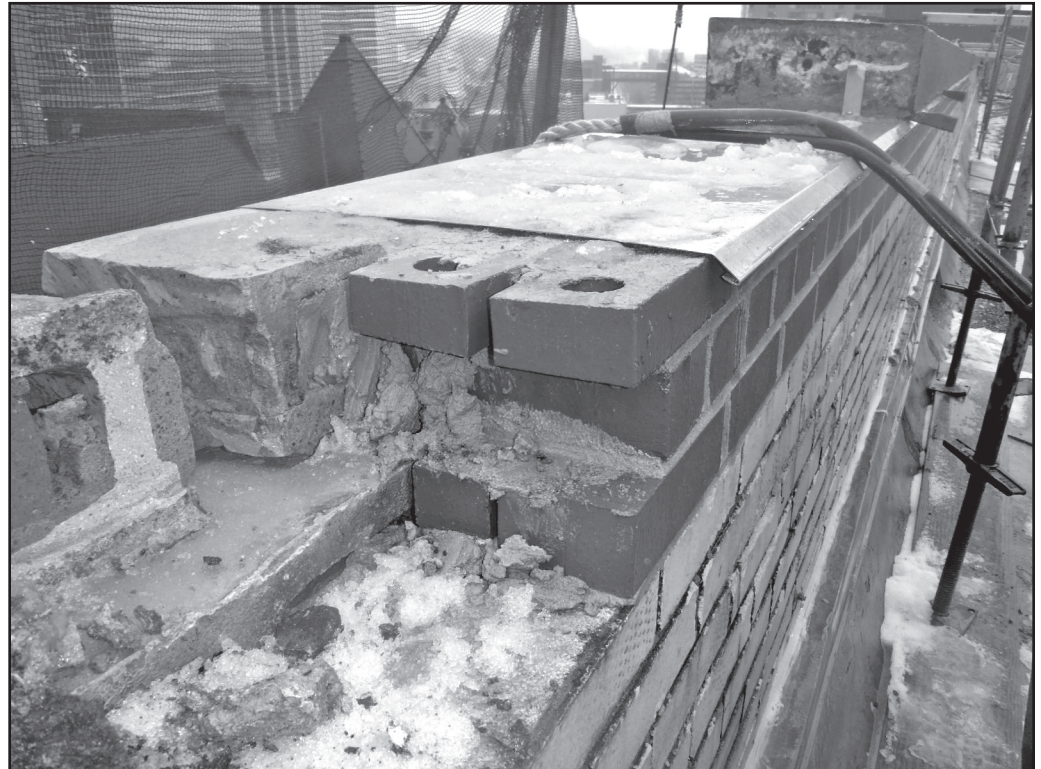
Photo 8 – Limited rebuild of masonry parapet wall and installation of metal through-wall flashing. Note half brick (approximately 2 in. high) used at top of wall; this represents the amount of swell in the remainder of the wall due to irreversible expansion of the masonry.

The first two repairs focused on the parapet wall. To ensure that thermal and moisture expansion did not create further stresses on adjacent parapet walls, it was recommended that masonry expansion joints be installed at all four of the building's main corners to allow for movement. To correct the heaving motion caused by moisture expansion within the parapet walls itself, the coping stones, brick backup, and terra cotta base course were removed and rebuilt to reestablish the back-slope profile of the coping as shown in the original drawings (see *Photo 8*). Additionally, the EPDM membrane was removed from the back wall to allow for proper drying, and a metal through-wall flashing was installed under the copingstones to prevent additional moisture from accessing the backup wall. The coping stones were secured with stainless steel dovetail anchors in slotted holes to allow for movement. The skyward-facing joints in the coping were sealed with caulking. A rain-screen cladding on the interior face of the wall is recommended for future installation.

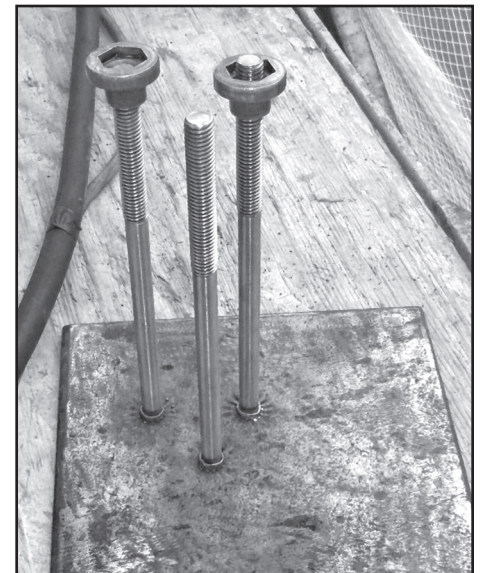
Photo 9 – Mock-up example of Nelson stud used for repairs.

stud-welding two ½-in.-diameter Nelson studs with washers and nuts at the end through each granite piece onto the steel channel (see stud mock-up in *Photo 9*). The holes were covered with a stone patch repair mortar material, and the granite water table was stabilized without the removal of any stone or adjacent component.

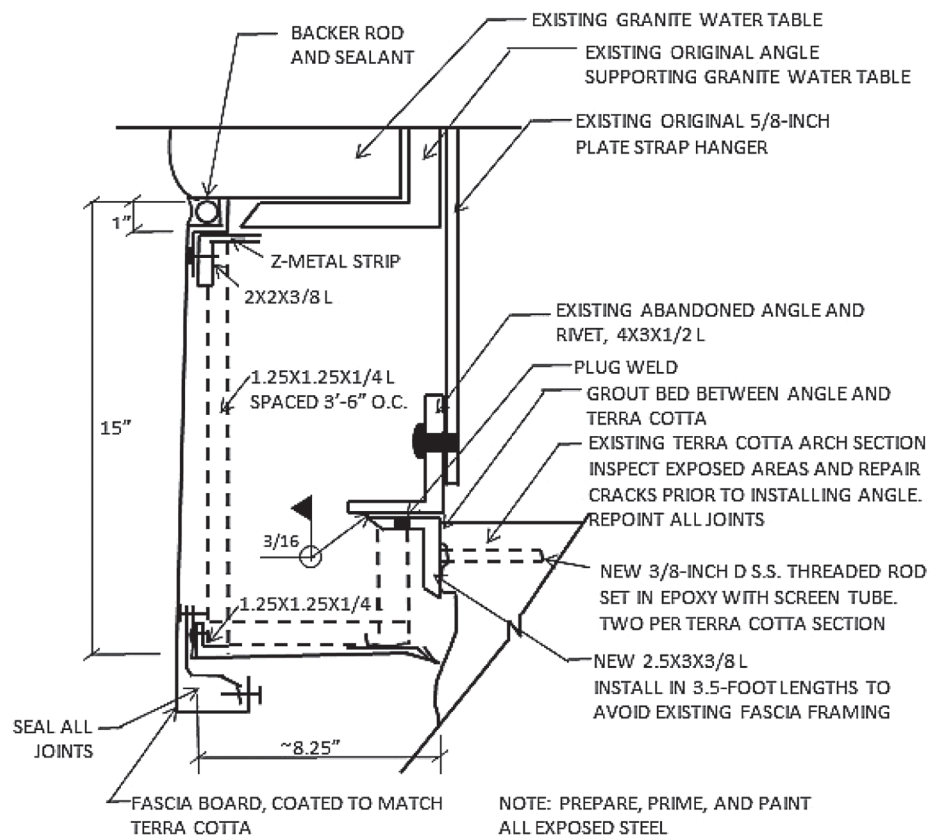
Figure 4 – Repair detail for new fascia board and fascia support angle.

Another issue that arose concerned the fascia board repairs. The missing granite fascia stone was causing confinement issues with the arched terra cotta soffit and other adjoining elements of the cornice. It would have been monetarily unrealistic to replace the existing coverboard with a new granite band to match the existing one, but stabilization was required in some way. To accomplish this, a new steel angle

was welded to the bottom leg of the then-abandoned granite fascia support angle, and a stainless steel threaded rod was drilled into the existing terra cotta at the top of the soffit arch and epoxied into place (see *Figure 4*). This replaced the lost confinement from the removed granite band and helped to restore stability in the entire cornice system. The new angle was then covered by a new painted galvanized steel fascia panel that matched the adjacent stone pieces. Similarly, the granite and terra cotta base courses were reinstalled with new, stainless steel masonry anchors to tie them to the backup material. This helped to stabilize the parapet level.

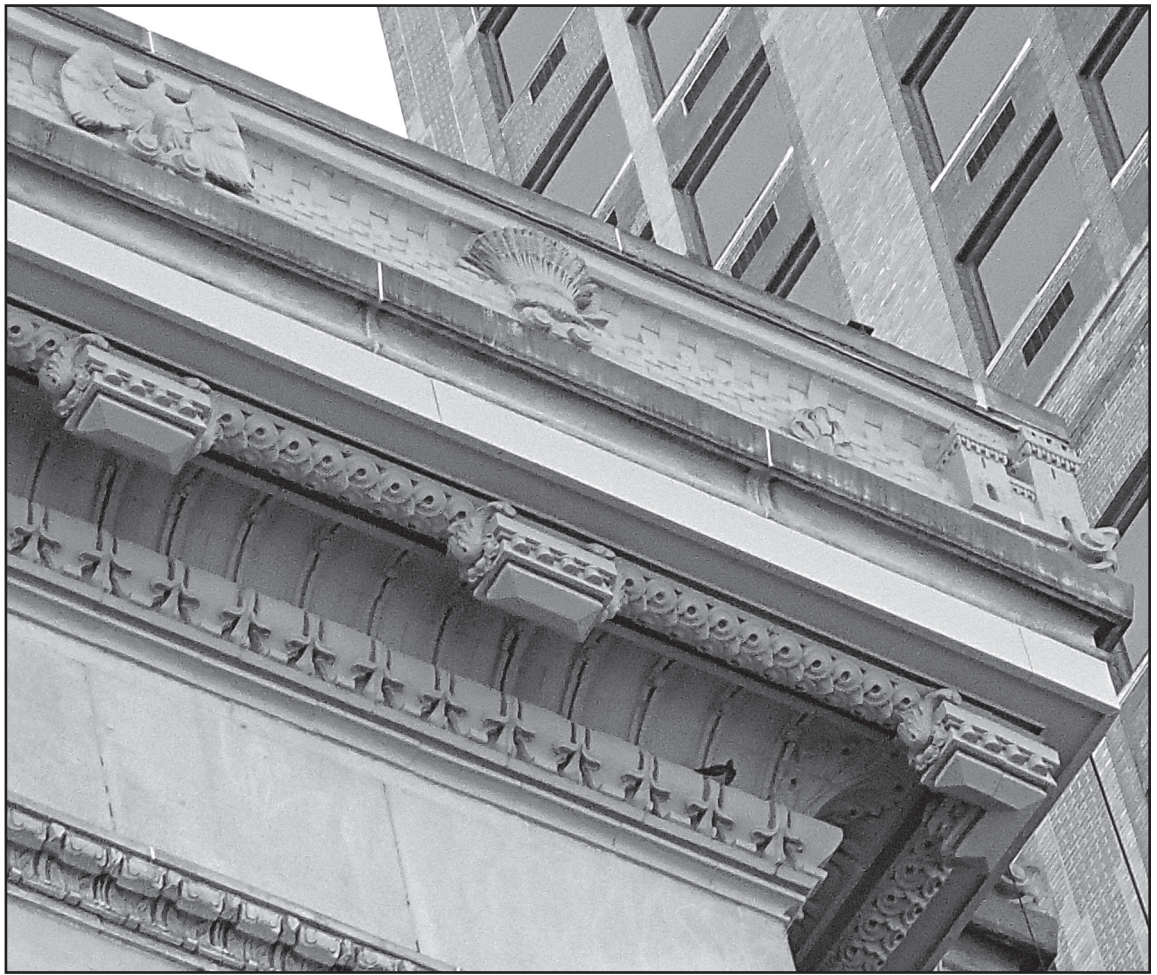
Photo 10 – Completed repairs at terra cotta cornice and parapet.

The final repair area was focused on closing the gaps and sealing the cornice system from water infiltration. To do this, two methods were employed. First, joint sealants and mortar joints that had deteriorated previously, causing open joints into granite and terra cotta, were pointed and sealed. Cracks that were found within terra cotta pieces were routed and sealed to close the cracks and prevent water infiltration
