# ACCESSING THE ARCH

By Remo Capolino, RRC, PE;  
and Christine Freisinger, SE, PE

**Location:** St. Louis, Missouri  
**Client:** National Park Service

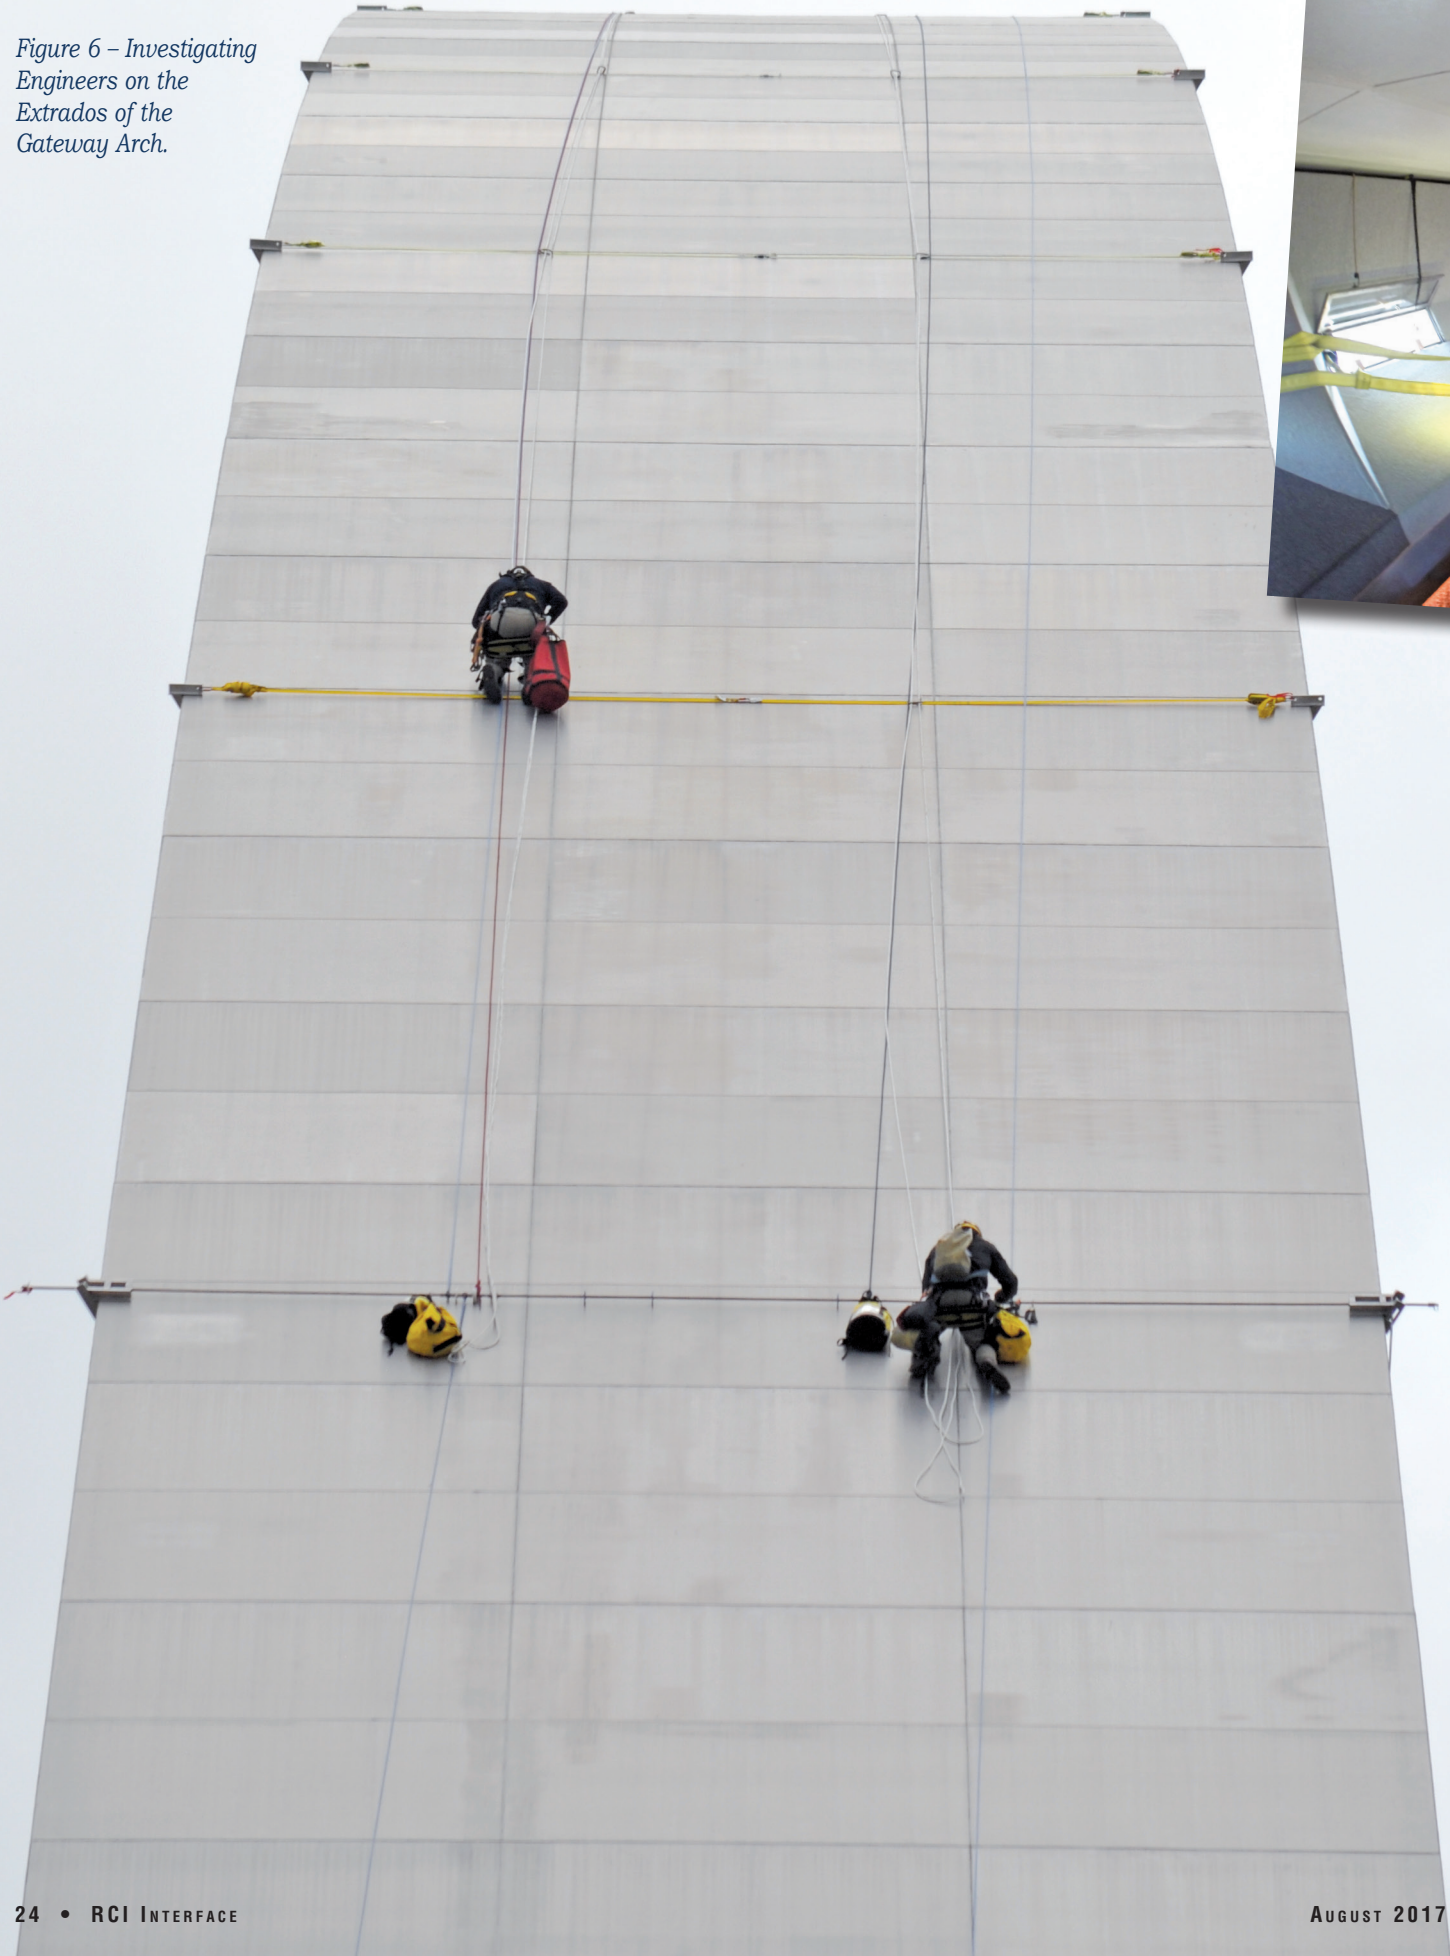
*Figure 6 – Investigating Engineers on the Extrados of the Gateway Arch.*

Accessing the exterior of this structure was truly a monumental task (Figure 6). While the goals of the investigation were

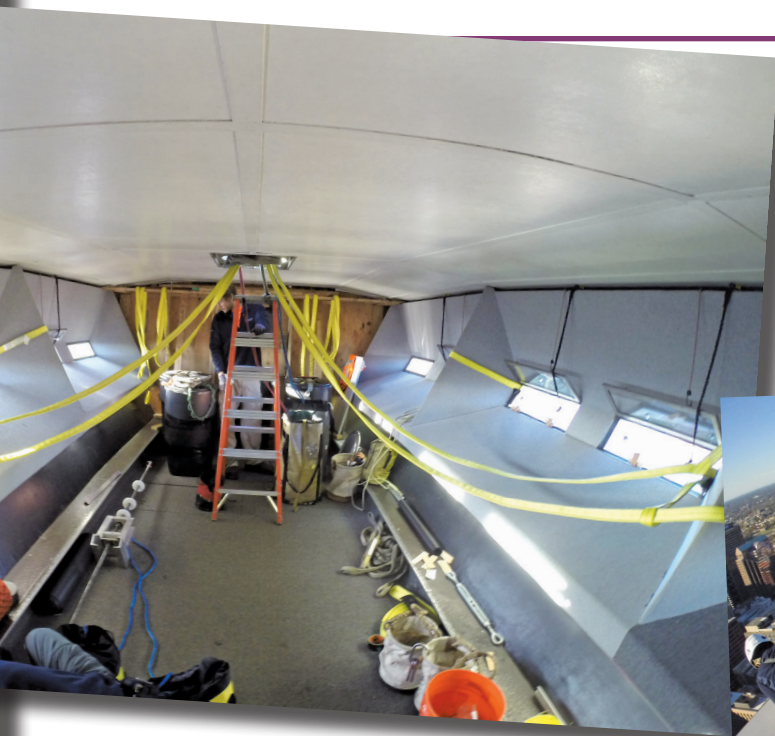
Figure 4 – Rigging at interior of hatch at apex.

Once it was determined the rigging was possible, custom fabrication of the system components was completed and transported to the site. From the small hatch at the apex of the Gateway Arch, the custom-designed and fabricated system was installed along the north leg (Figure 4).

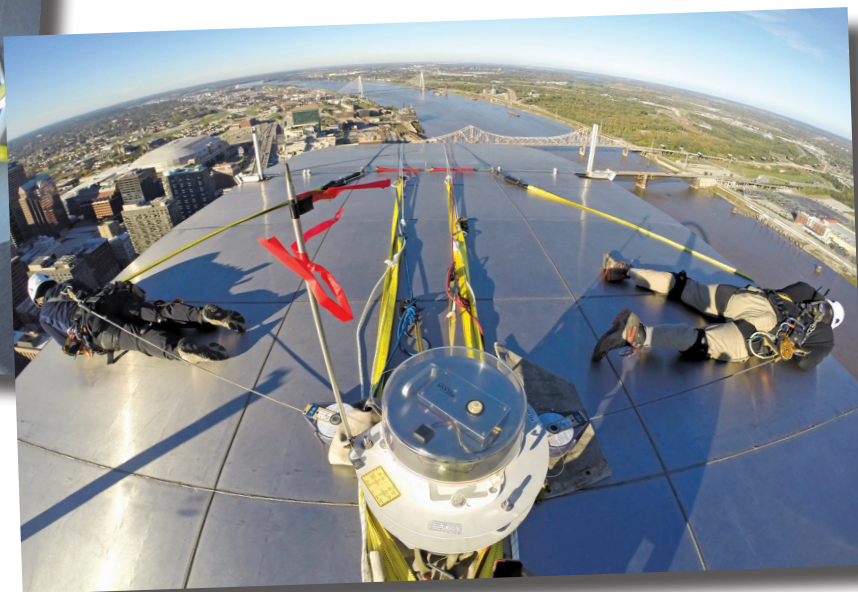
Figure 5 – Custom IRA system at the top of the Gateway Arch.

system that was tensioned from the top of the Gateway Arch down the extrados of the north leg to the base of the structure (Figure 5). Two-rope systems were used along the bridle system in order to reach areas of work. No intrusive or permanent connections were made to the exterior stainless steel skin or interior structural components. Metal components of the rope access system were separated from direct contact with the stainless steel skin at all times to avoid contamination of, and/or potential damage to, the stainless steel. Additionally, investigative staff used work boots, knee pads, and other equipment that would not leave any marks on the stainless steel skin as they traversed from the hatch to the ground. Use of the IRA system was contingent on weather and wind speed. The investigation was halted multiple times due to unfavorable conditions, extending the total time on site from five to 11 days.
