# FLASHING OF CURTAINWALL AND STOREFRONT SYSTEMS IN COMMERCIAL APPLICATIONS

*NELSON FORENSICS, LLC*

## BUILDING ENVELOPE TECHNOLOGY SYMPOSIUM

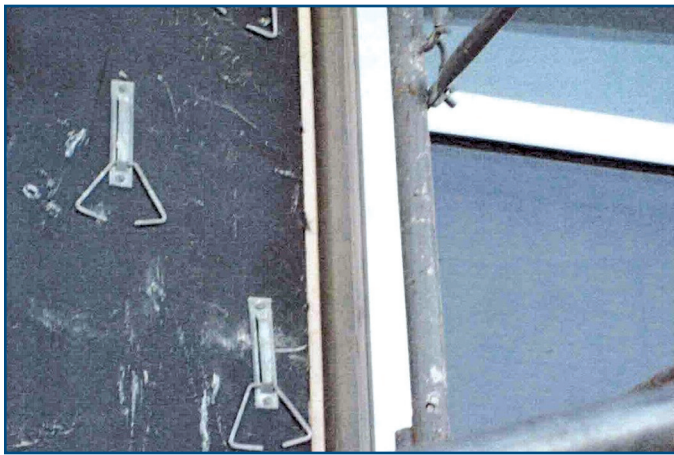
**Figure 8 – Missing membrane flashing at curtainwall jamb (photo provided by client).**

due to widespread moisture intrusion. Flashing issues at the curtainwalls included improperly installed or unadhered membrane flashing at multiple locations (Figure 8). In addition, there were large gaps between the sheathing and the curtainwall jambs with no membrane flashing installed at several curtainwalls to integrate the WRB with the curtainwalls for a watertight drainage plane.

While several of the curtainwalls had been water-tested and spot-repaired during the remediation attempts, water intrusion at or around the curtainwalls continued to be an ongoing problem. Therefore, new curtainwall flashing was required to be installed around the perimeter of all curtainwall locations, and the curtainwall components were repaired and water-tested.

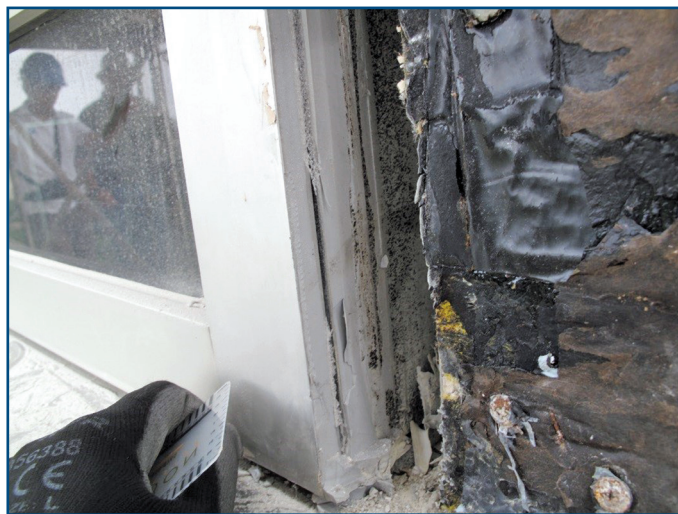
**Figure 9 – Large gap at curtainwall jamb and no WRB or flashing wrapped in rough opening.**

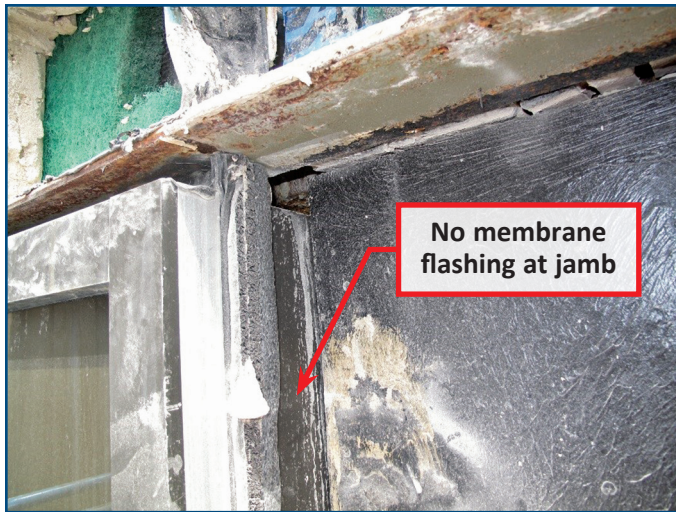
**Figure 10 – No flashing integration of curtainwall jamb and WRB.**

Deficient or missing flashing was observed around several curtainwall and storefront systems (Figure 10). At these locations, the building envelope relied solely on sealant joints to prevent water penetra-

tion into the wall cavity. These areas should have been flashed in a shingle-lapped manner and properly integrated with the vertical wall WRB.

It was recommended that all curtainwalls, storefront windows, and parapet caps abutting curtainwalls be inspected for proper flashing and integration with the WRB. All deficient window wall systems were water-tested once new flashing had been installed to integrate the WRB and window systems for a watertight drainage plane.

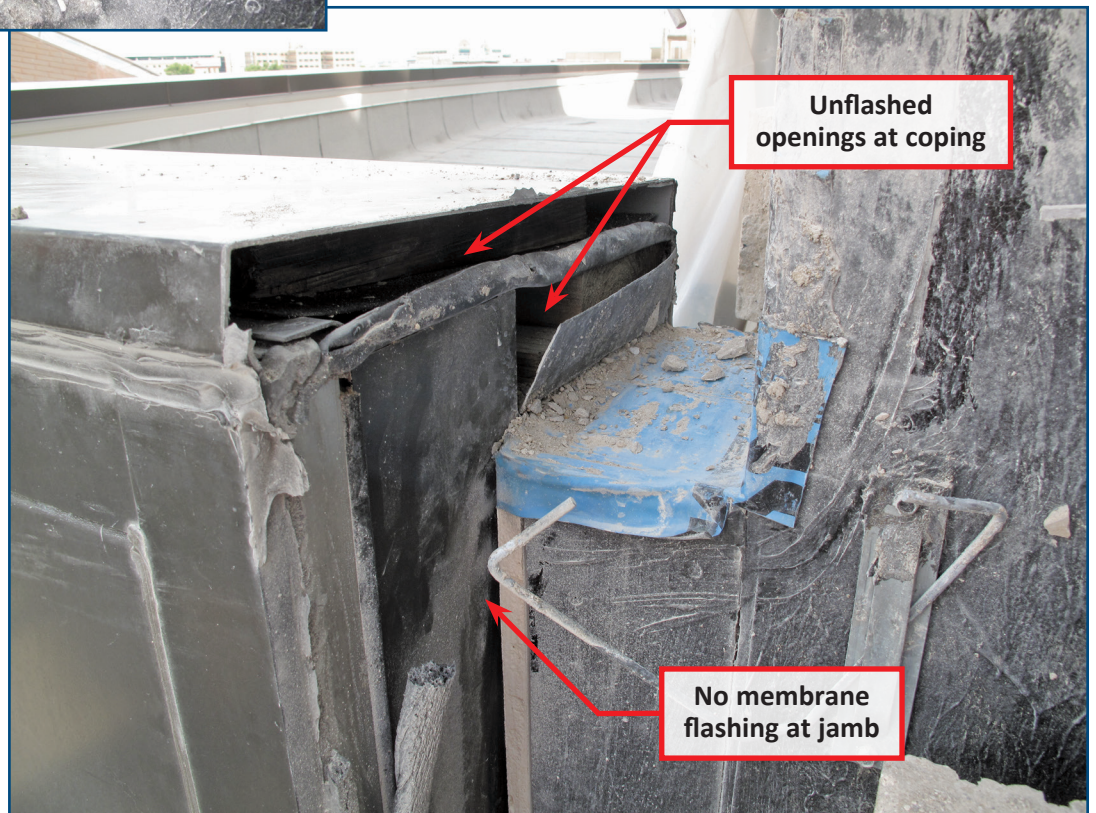
**Figure 11 – Lack of flashing integration at head and jamb of curtainwall.**

Along the front of the building, the head of a curtainwall system at the interface of the top of a parapet wall intersected multiple components. The head of the curtainwall abutted a coping cap and an adjacent exterior brick cavity wall. Through removal of the brick veneer and adjacent coping cap, the lack of integration between the coping cap, WRB, curtainwall, and adjacent brick wall was observed (Figure 11). No membrane flashing was integrated with the curtainwall jamb and the WRB. Additionally, the weep holes in the brick

veneer terminated below the top of the parapet wall, allowing water within the cavity wall to migrate into the unsealed edge of the coping cap and curtainwall interface. Substantial moisture intrusion, including blistered paint and stained ceiling tiles, was observed at the interior of this location. At several other locations throughout the building, blistered and moisture-stained interior finishes were observed adjacent to curtainwall jambs, attributable to the lack of a continuous building envelope and an integrated WRB and flashing system. In this case study, poor construction coordination by the contractor and deficient installation of the WRB, flashing, and weeping systems were the primary factors that lead to the

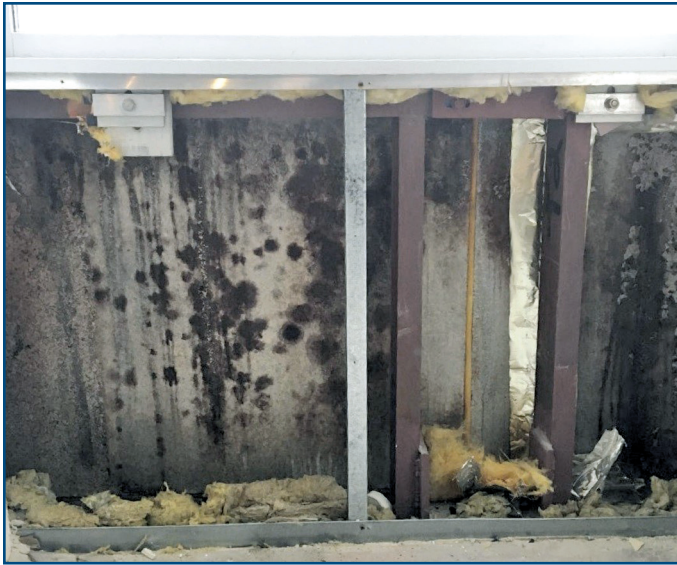
**Figure 12 – Suspected fungal growth at back of granite panels. Exposed backer rod (yellow in color) for exterior sealant between granite joints (photo provided by client).**

During tenant improvements at two of the upper floors, suspected fungal growth was observed at the interior side of the exterior granite panels (Figure 12). When the interior wall and insulation were removed, it was discovered that there was no sheathing, WRB, or curtainwall flashing. The sealant at the panel joints and windows was the only protection against moisture intrusion. Removal of the sealant revealed that many of the backer rods were wet, indicating that the sealant had failed.

With no maintenance program in place, over time the sealant had slowly disintegrated and created conditions conducive

to moisture intrusion and suspected fungal growth. The hidden nature of the suspected fungal growth (generally behind dry-wall) made the maintenance of the sealant all the more important; however, from the exterior, the separations in the sealant were difficult to distinguish. Without the protection of a secondary drainage plane providing a more secure method of flashing, the building envelope was inherently weak and challenging to maintain.

Due to the expense of adding new sheathing, WRB, and flashing to the existing granite cladding system, it was decided to maintain the barrier system and remove and replace all the sealant and backer rods. However, these components will continue to be high-maintenance areas that are exposed to the weather and will require a great deal of monitoring by the building owner to maintain their performance.

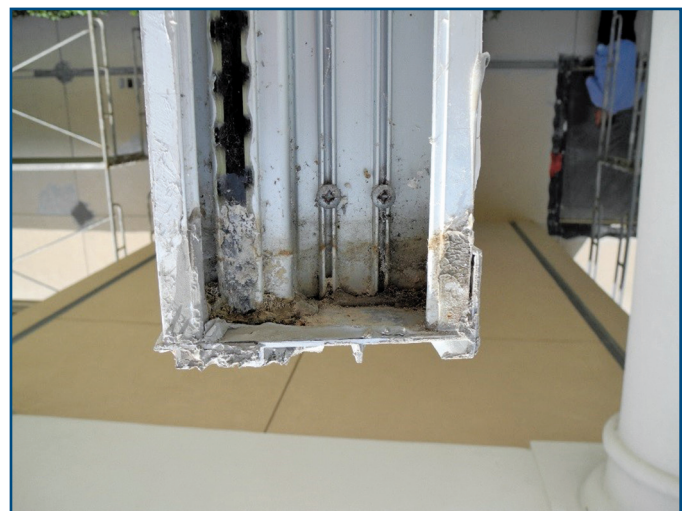
When the storefront frame was removed from these windows, it was noted that the sill pan was not fastened to the rough opening framing, but remained attached to the storefront frame (Figure 13). Further observation of the sill pan indicated that the intersection between the pan and the storefront vertical edge mullion had been sealed shut, damming water from being able to flow from the interior of the mullion to the weep slot between the sill pan and storefront frame along the sill of the window. A waterline was visible, indicating dammed-up water had accumulated up to approximately 1 inch above the bottom of the sill pan. The end dams had been directly attached to the rough opening and remained intact when the storefront frame and sill pan were removed (Figure 14). The WRB had also been terminated at the vertical face of the exterior sheathing and had not been extended into the window opening. Additionally, there were no backer rods installed behind the perimeter sealant joints, no end dams or weeps, and neither flashing nor vertical mullion cap flashings at the window heads.

**Figure 13 – Sill pan attached to storefront frame after removal from rough opening. Note sealant-damming intersection to vertical mullion and waterline approximately 1 in. above the bottom of the sill pan.**

It was concluded that the damage at the interior was due to a number of factors. First, the improper head flashing was allowing an excessive amount of water to enter and travel down the vertical edge mullion where it was dammed up at the sill pan/vertical mullion intersection. This water leaked through gaps in the poorly sealed sill pan/end dam connection and spilled into the wall's exposed interior components with no flashing or WRB on the interior surfaces of the rough opening to stop it. This condition was exacerbated by water entering through the improperly installed and failing sealant joints. As mentioned in the previous case studies, poor construction coordination by the contractor and deficient installation of the WRB, flashing, end dams, and weeping systems were the primary factors that lead to the problems encountered during the original construction of this building.

To remedy this situation, it was recommended to reconfigure the head flashing, cut back the surrounding stucco, add inboard flashing around the perimeter of the opening, and add a new custom-designed sill pan with integrated end dams. Once this new sill pan (Figure 15) was installed, shingle lap flashing was added connecting the inboard flashing to the end dams in order to maintain the integrity of the building envelope. The edges of the stucco were then reinstalled with perimeter ½-in. sealant joints with backer rods in the proper 2:1 configuration.

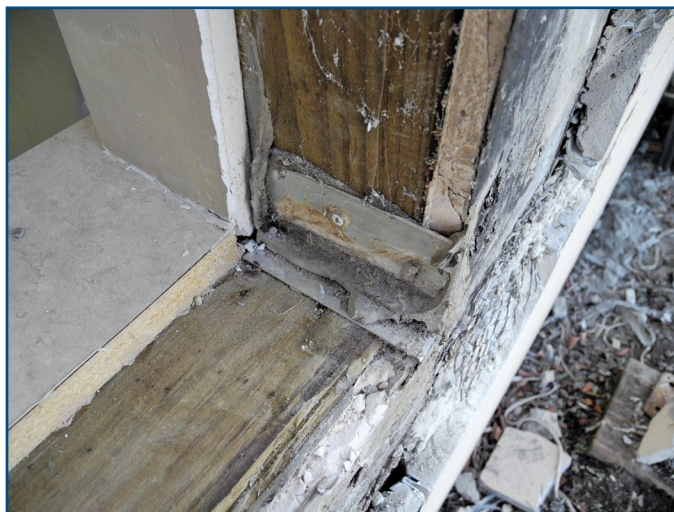
**Figure 14 – End dams directly connected to rough opening rather than sill pan. Note the WRB terminating at vertical face of sheathing and not wrapped into rough opening.**

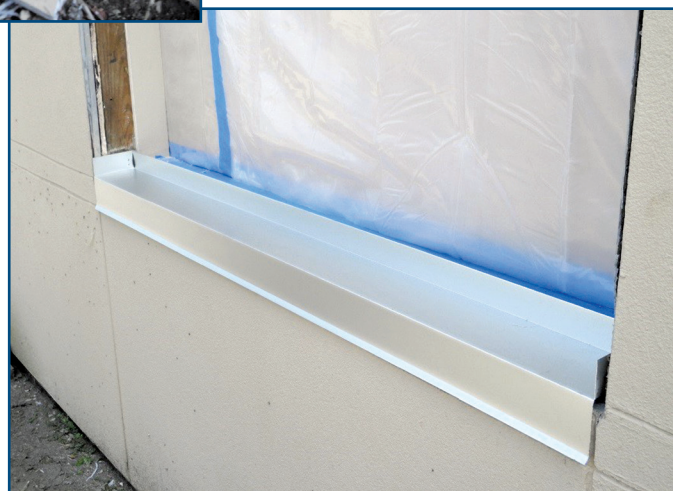
**Figure 15 – New custom-built sill pan with integrated end dams.**
