Journal of the Roof Consultants Institute

Interface

November 2000
Vol. XVIII, No 11
\$7.00

**INSIDE: EIFS,
CURTAIN WALLS,
&
MASONRY**

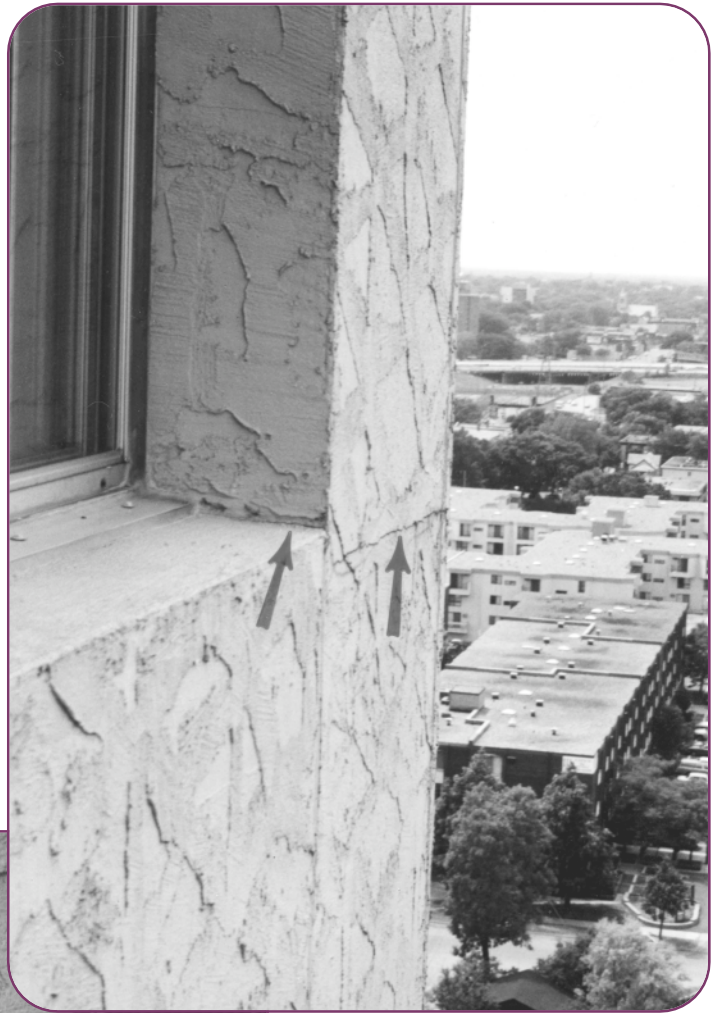
Above. Figure 1—Inadequate slope at original sill.

Improper Steel Framing—As previously stated, adequate slope at the window sills was effectively non-existent, because the steel framing below each opening had been fabricated perpendicular to the plane of the wall. See *Figures 1, 2, 3 and 9*. This condition could not be effectively remedied without extensive modification to the original framing. In view of the potential costs for this aspect of the renovation, this work was bid as an alternate to the base bid. Fortunately, the costs from the successful bidder were not out of line and the owner recognized the need for this modification. The alternate was incorporated into the construction contract. See *Figures 4, 5, 6, 7 and 10*. In addition, selective demolition during the renovation revealed a number of areas throughout the existing steel wall framing that were inadequately fastened to the principal structure. In addition, the wall framing consisted of excessively long metal studs that had been installed continuously across expansion joints of the building envelope.

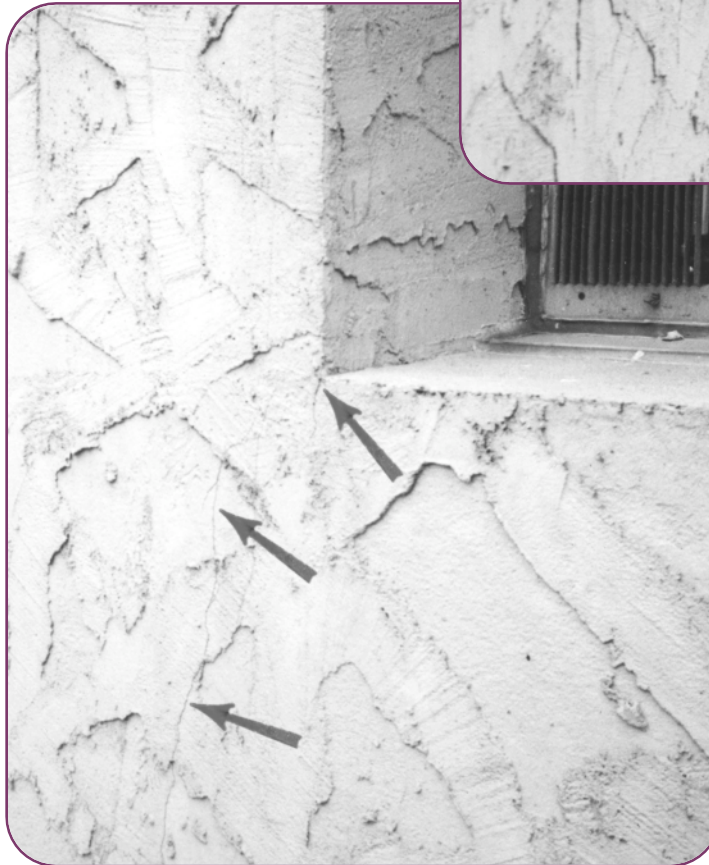
Left. Figure 2—Typical sill and A/C opening.

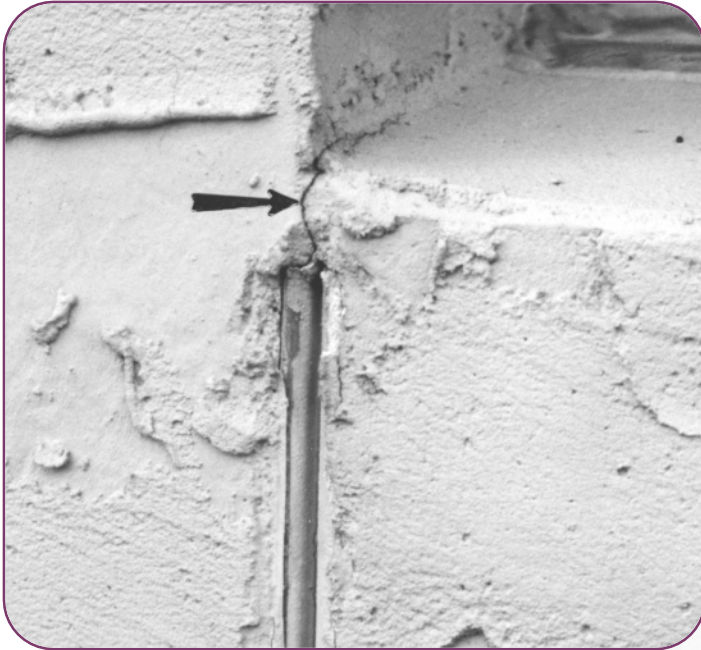
Above: Figure 3—Control joint termination.

Plastering Accessories—Improper installation of plastering accessories was common and widespread throughout the EIFS applications of this project. Installation problems included variations in the field fabrication, assembly, and securement of these accessories not in accordance with recognized industry standards. Corners of the control joints were found to be improperly mitered and fitted in numerous locations, particularly around window openings but also at standard outside corners. In addition, joint accessories were terminated improperly at window recesses at all locations throughout this building. Typically, these joints did not extend into the recess, resulting in a plaster bridge subject to cracking at the end of the metal termination. See Figure 3.

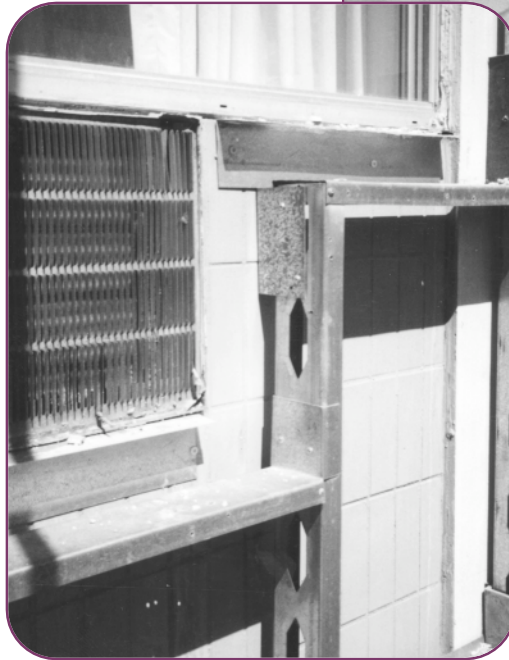
Left: Figure 9—Original framing at sill.

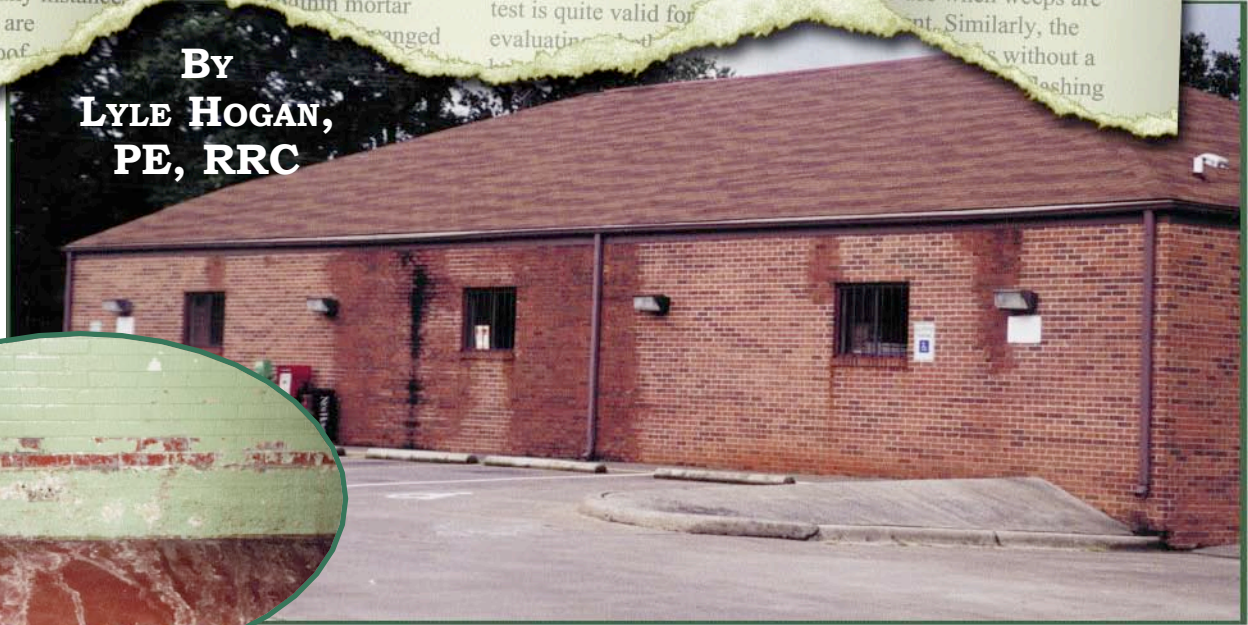
*Inset:
Figure 1
—Many instances of water invasion are unrelated to the roof. Investigation may reveal that the brick masonry veneer is the culprit.*

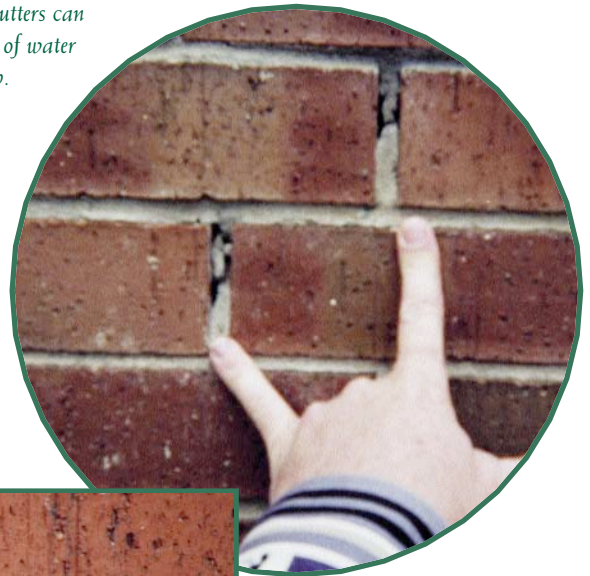
Improperly tooled joints will admit significant amounts of water (Figure 3). Inadequately filled head joints are a common observation. Wire reinforcing within mortar joints is sometimes arranged too close to the outside face (Figure 4). This causes the thin mortar cover to break away, resulting in yet

Above: Figure 3—Improperly filled mortar joints will admit significant amounts of water.

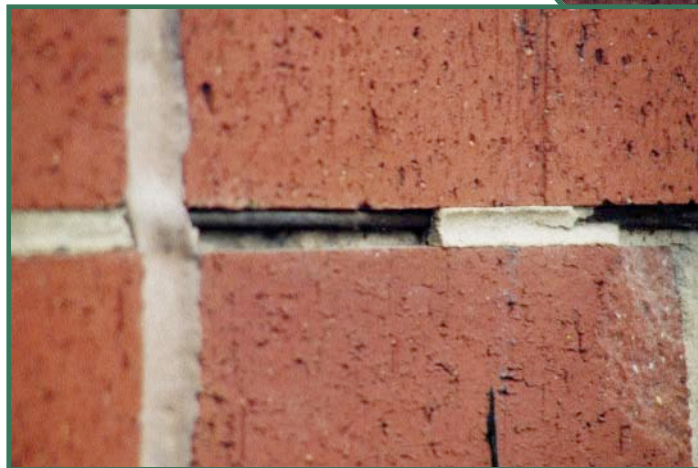
Left: Figure 4—Wire reinforcing within mortar joints is sometimes arranged too close to the outside face. This causes the thin mortar cover to break away, resulting in still more avenues for water entry.

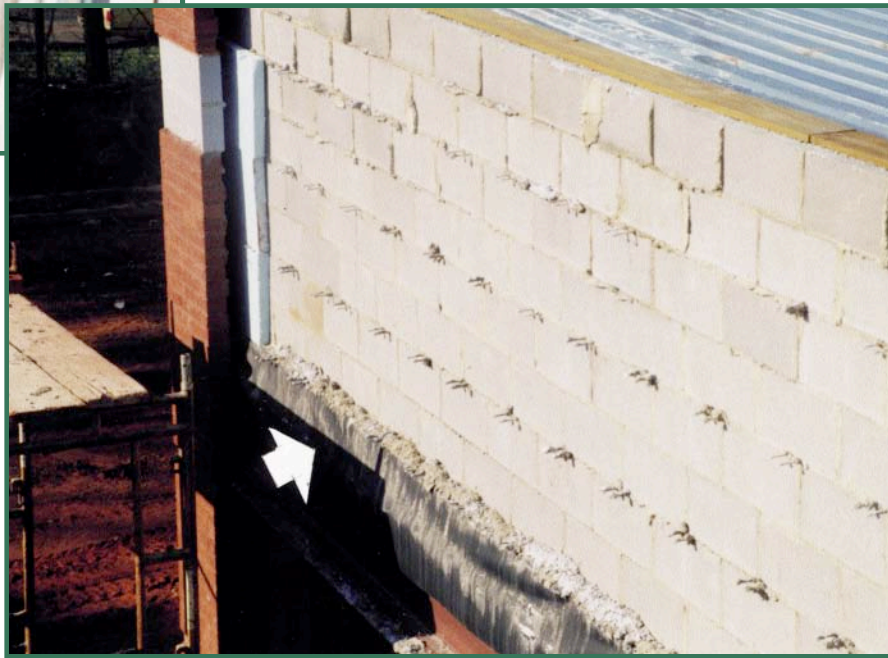
Brick masonry should be considered a “drainage wall,” anticipating that water will enter. Traditional claddings such as wood, brick, and stucco contemplate water penetration and incorporate secondary water barriers³. The water absorbed is of no great consequence if thru-wall flashing has been provided along with avenues for draining the wall cavity. Cavities clogged with mortar are not functional avenues for water removal (Figure 6).

Figure 6—Cavities clogged with mortar are not functional avenues for water removal.

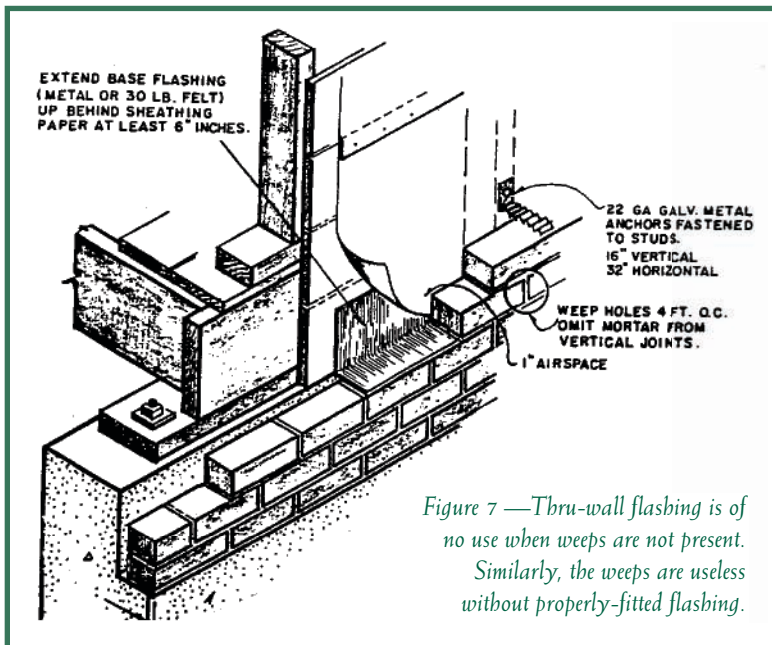
Figure 7—Thru-wall flashing is of no use when weeps are not present. Similarly, the weeps are useless without properly-fitted flashing.

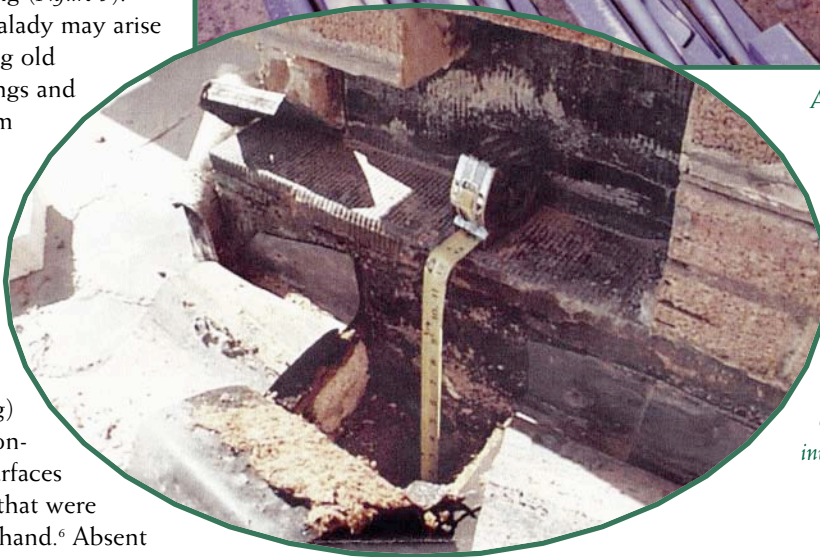
Left: Figure 9—Re-roofing in a manner that causes masonry flashing features to be covered will invite water behind, below, or into new roof flashing. Photo courtesy of Don Kilpatrick.
