FRT PLYWOOD CORRODES METAL DECK

BY JOHANN (JOHN) L. WILLERS, PE, RRC, FRCI

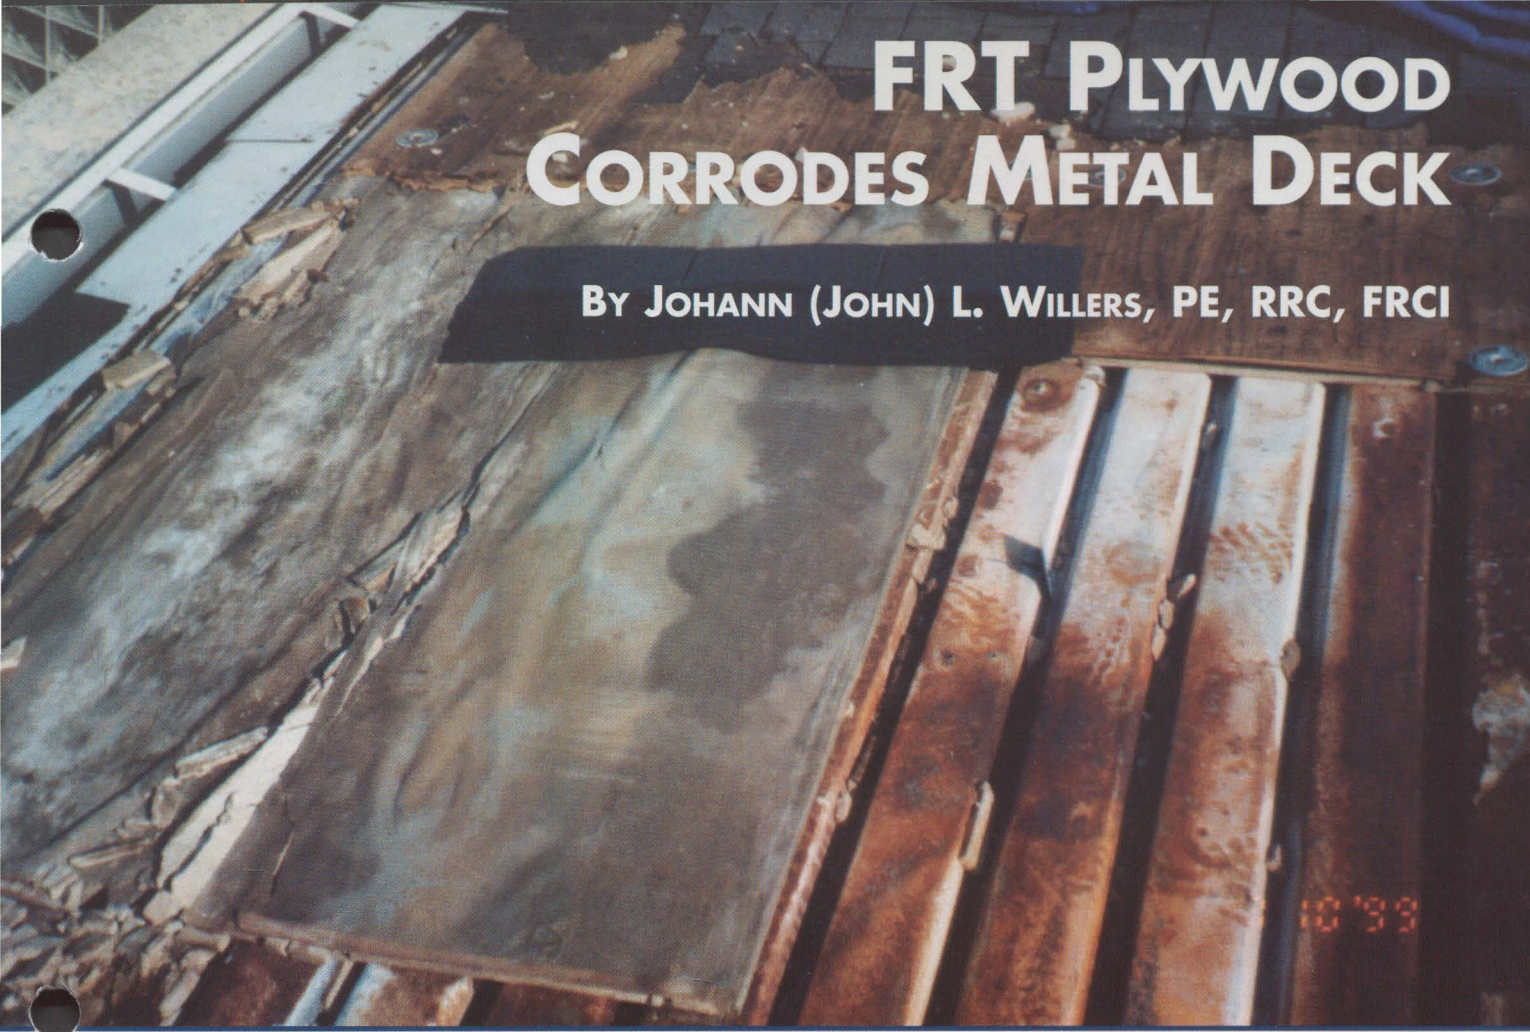
Solar heating destroyed the FRT plywood. The acids in the activated FRT plywood and moisture entry from split shingles destroyed the metal roof deck. Moisture destroyed the gypsum board.

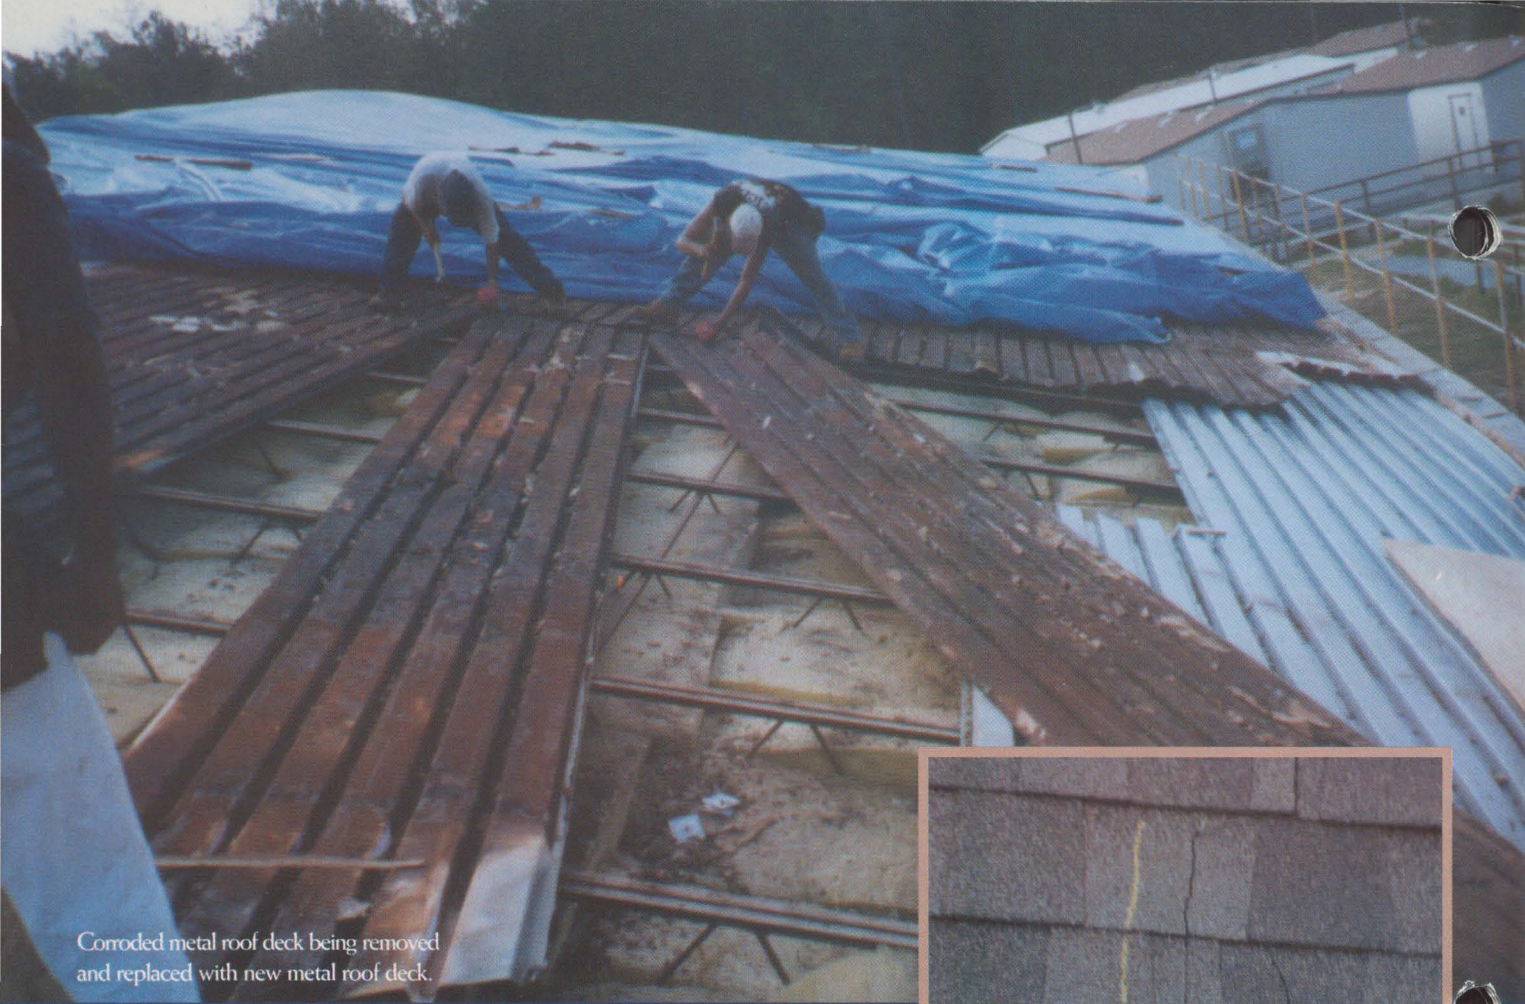
Corroded metal roof deck being removed and replaced with new metal roof deck.

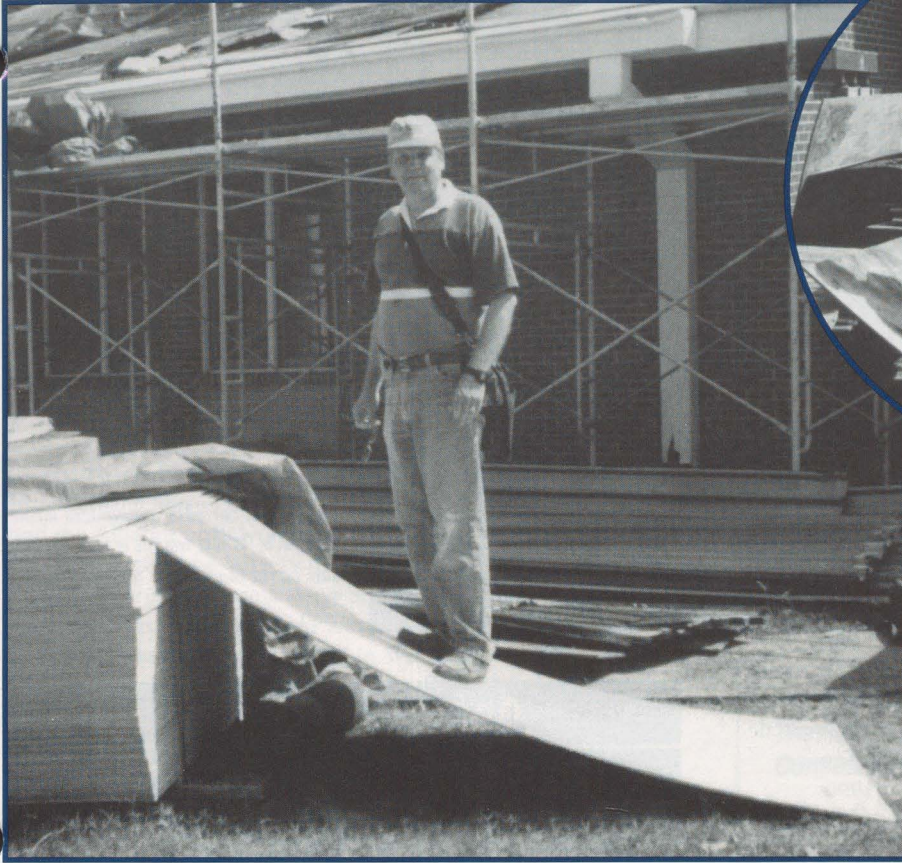
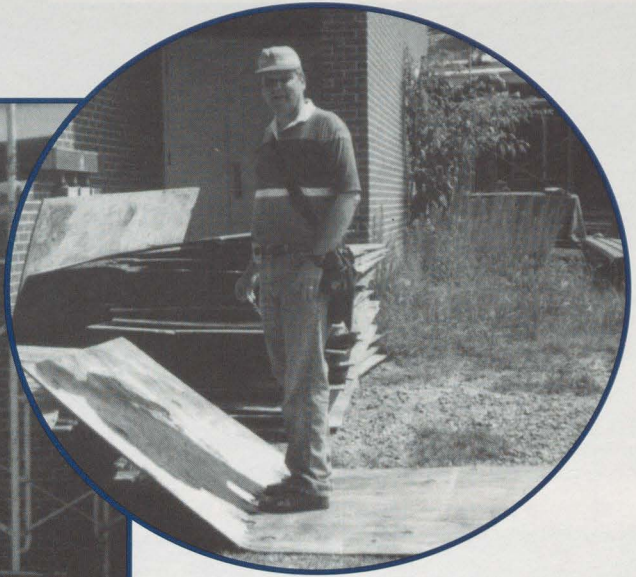
Salvaged FRT plywood failed the field test.

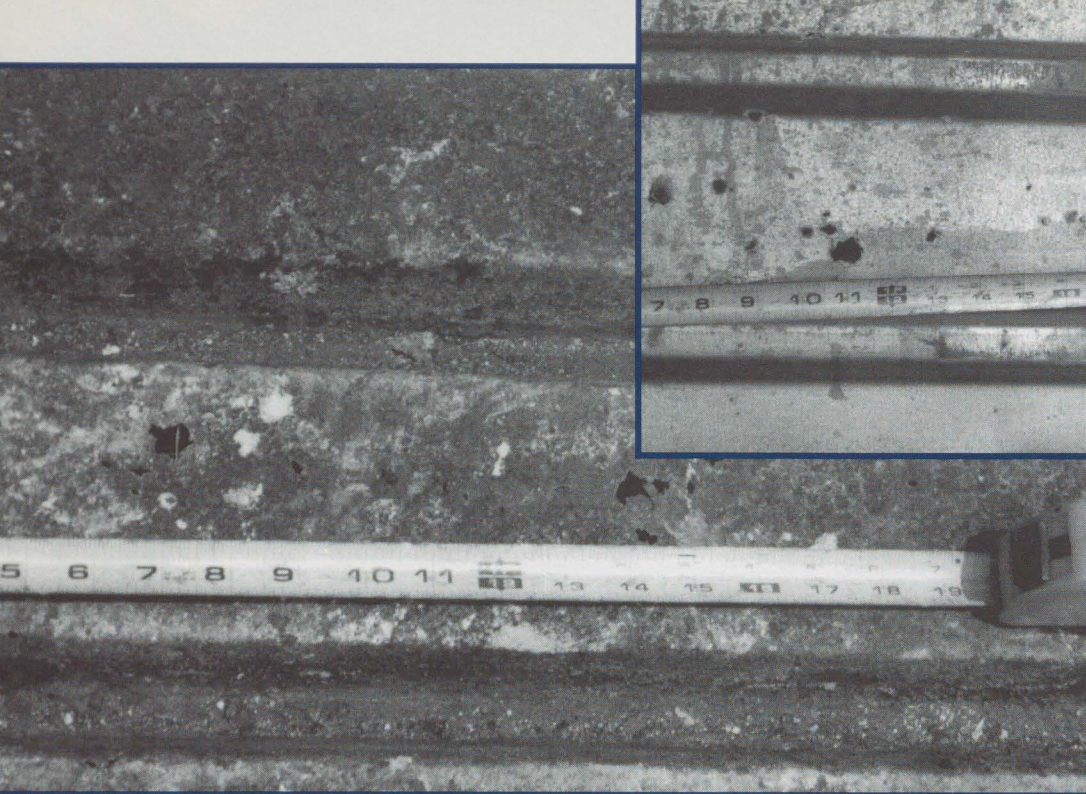
Bottom face of corroded, galvanized metal roof deck.
