# MOISTURE ENTRAPMENT IN BUILDINGS WITH EIFS AND STUCCO FACADES IN THE STATE OF FLORIDA

BY KATHRYN M. BARKER AND MICHAEL G. KNETTEL

*(This article is reprinted with permission from the Proceedings of Thermosense XXI, Volume 3700, pp. 463-470, International Society for Optical Engineering (SPIE), Bellingham, WA., April 1999.)*

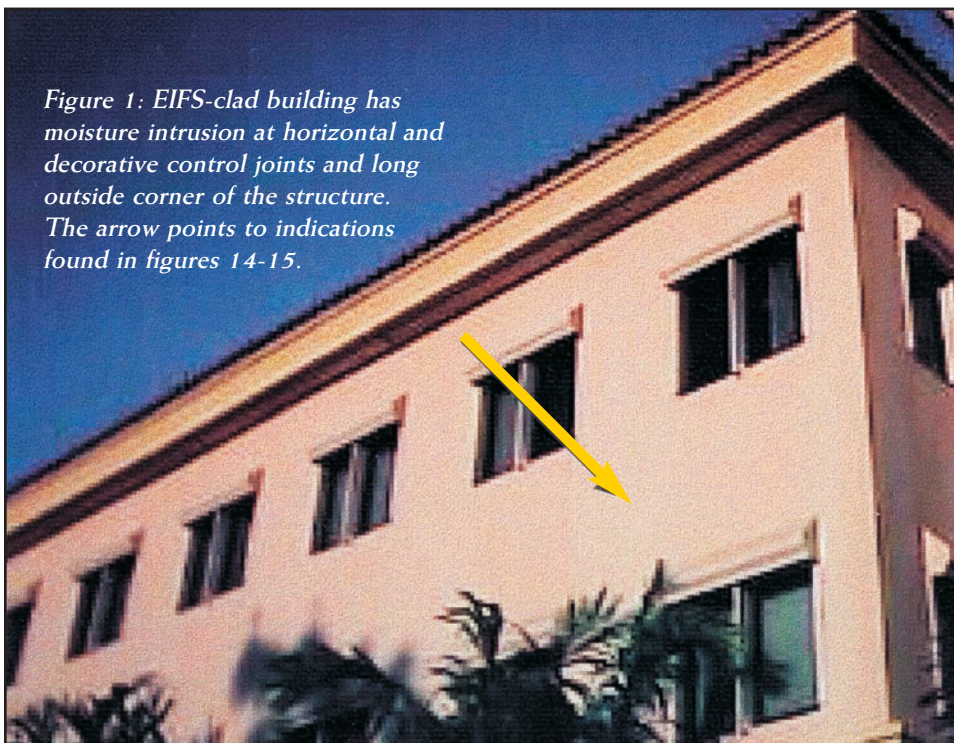
*Figure 1: EIFS-clad building has moisture intrusion at horizontal and decorative control joints and long outside corner of the structure. The arrow points to indications found in figures 14-15.*

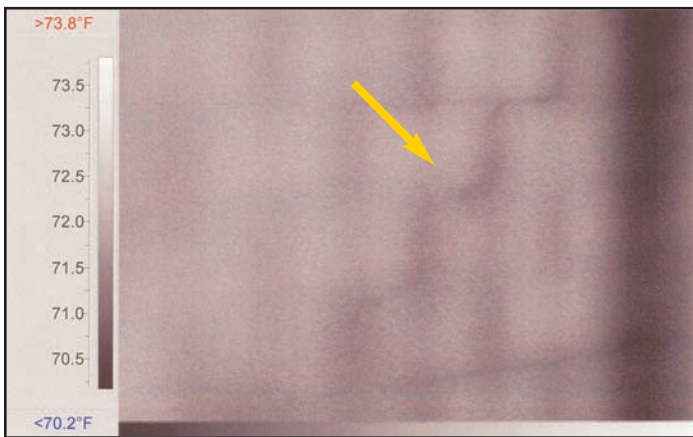
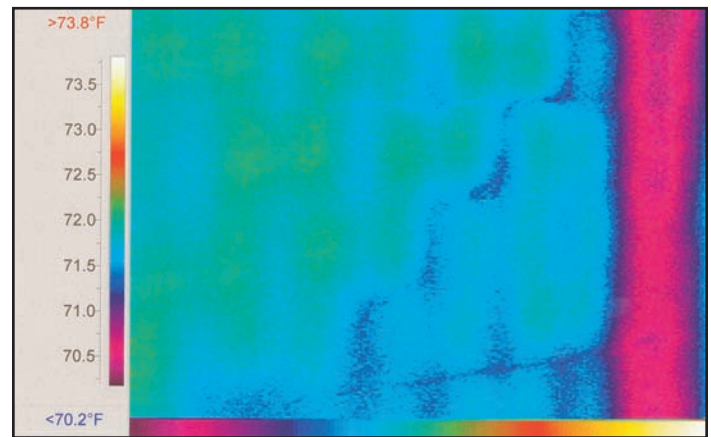
Figures 2 (left) and 3 (right) demonstrate stair-step cracking typical of common cement-based stucco failure found in Florida. The stair-step cracking is found in corner conditions such as shown in the thermograms of Figures 2 and 3 and is due to lateral movement in the concrete frame caused by thermal expansion. This causes cracks in the stucco, opening a gap for the transmission of water to the building interior. The failure mechanism in this case was the lack of proper bond separation between the concrete block and poured concrete frame. At the time of construction, there was a failure to provide a control joint in this location.

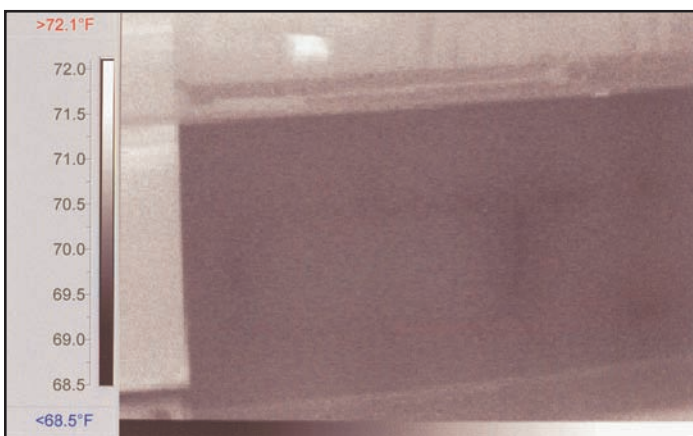
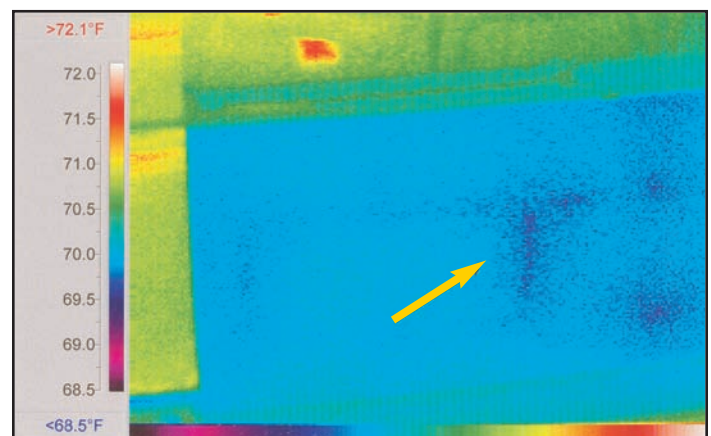
Figures 4 (left) and 5 (right) are thermograms showing water intrusion and are the interior wall of Figures 2 and 3. Water intrusion was extensive at this facility. The anticipated repair procedures and cost will exceed \$1.2 million.

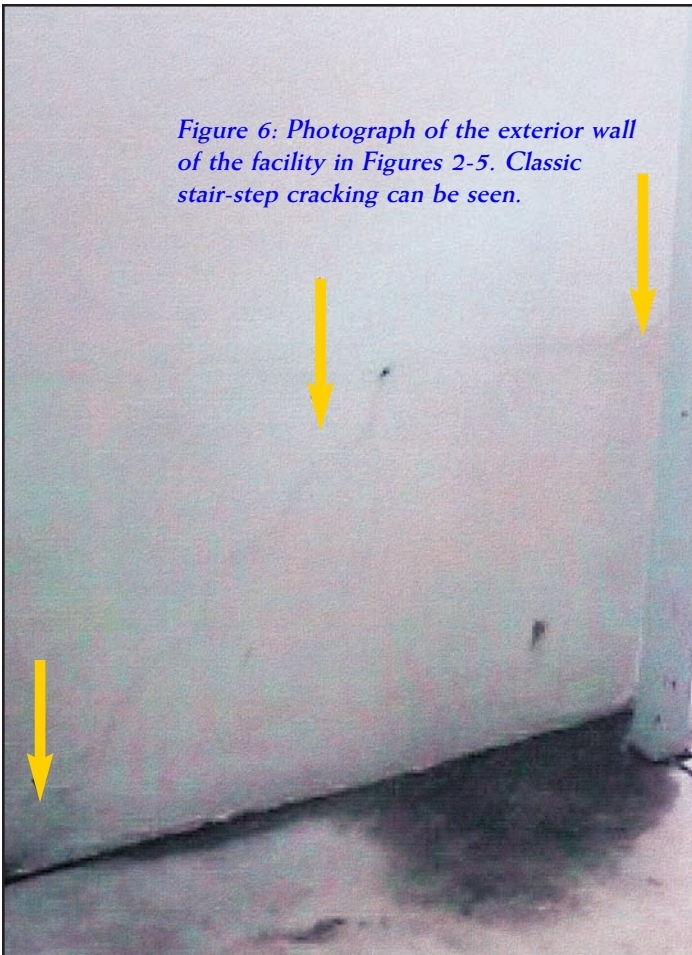
Figure 6: Photograph of the exterior wall of the facility in Figures 2-5. Classic stair-step cracking can be seen.

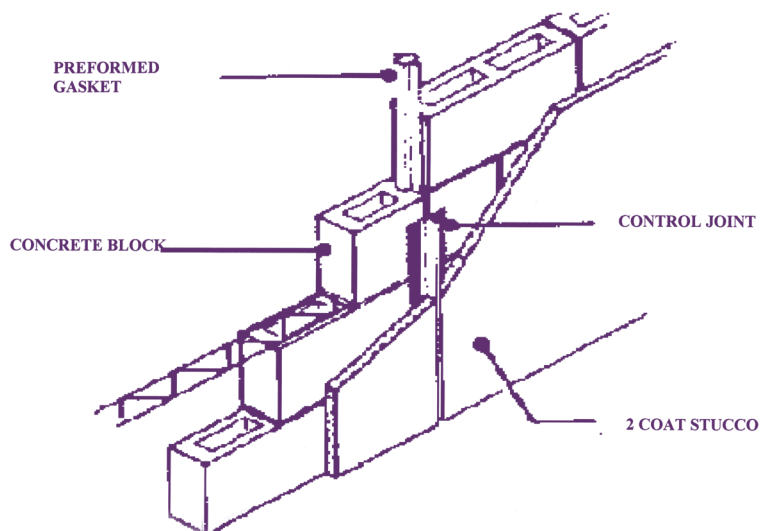
Figure 7: Rough drawing of the wall mechanism demonstrated in figures 8-11.

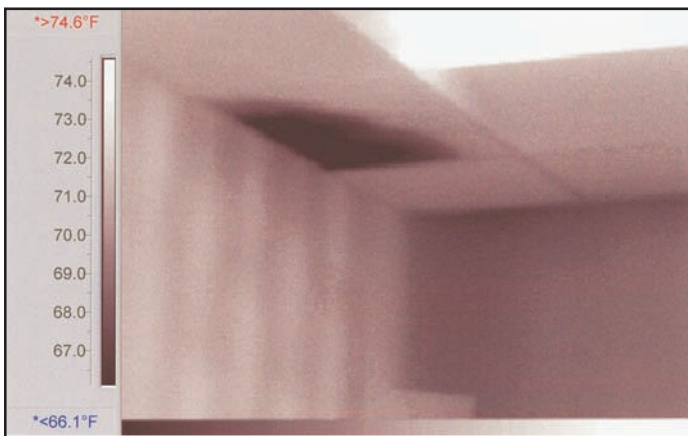
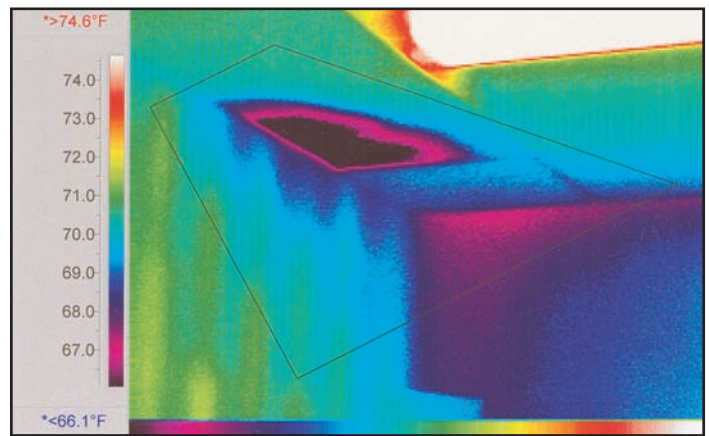
Figures 10 (left) and 11 (right) are thermograms of the interior wall of Figures 8 and 9.

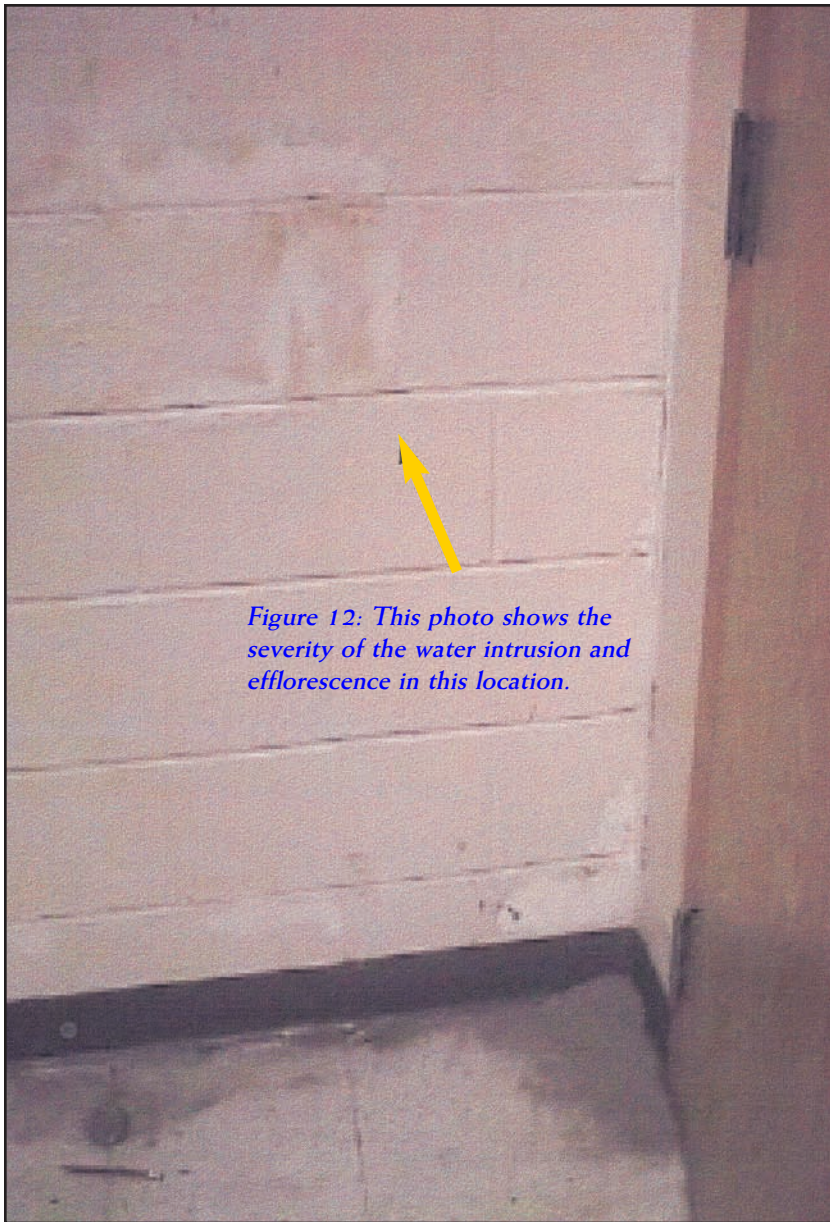
*Figure 12: This photo shows the severity of the water intrusion and efflorescence in this location.*

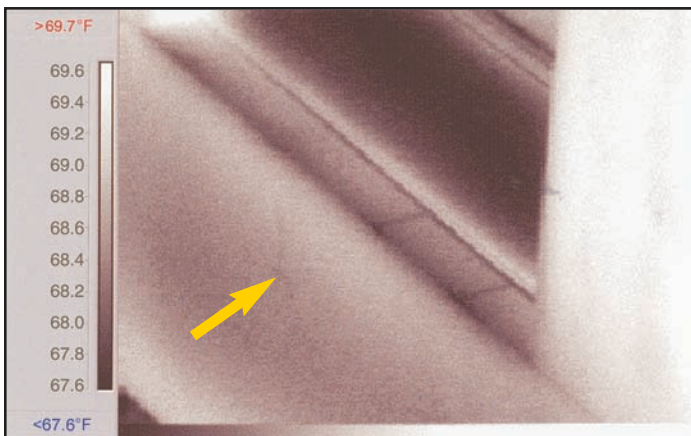
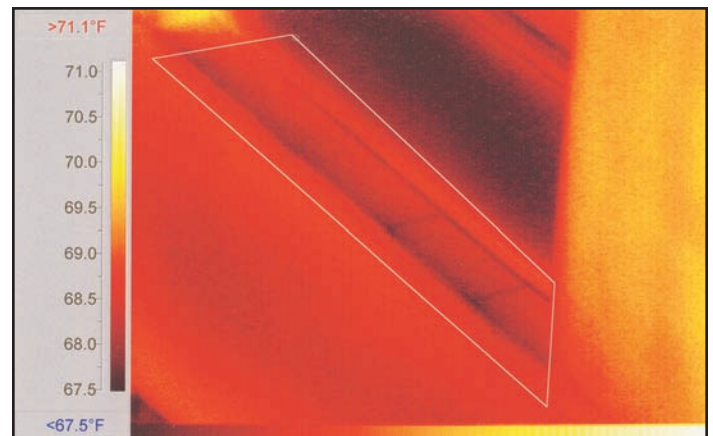
*Figures 13 (left) and 14 (right) are thermograms of water intrusion at a window ledge. Moisture intrusion was caused by lack of caulking and caulking bond failure.*

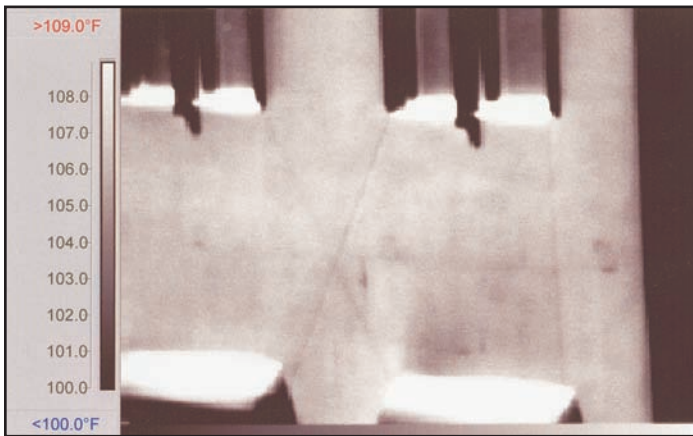
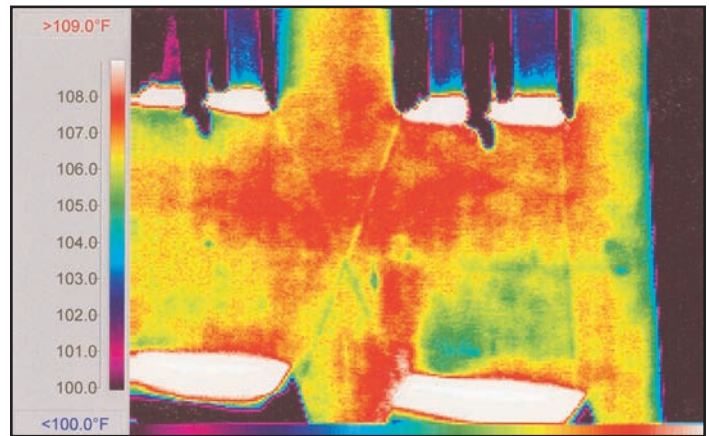
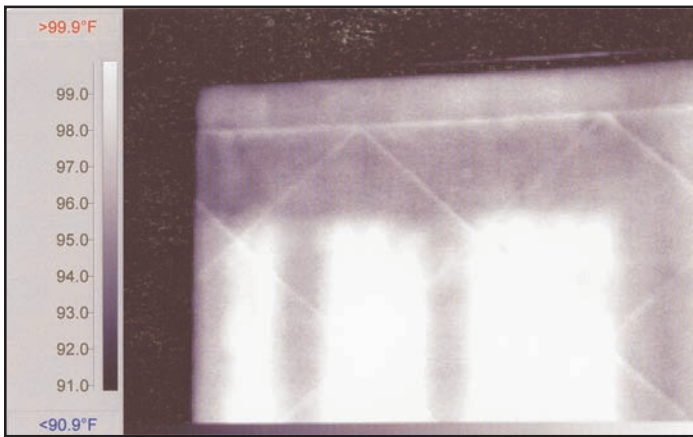
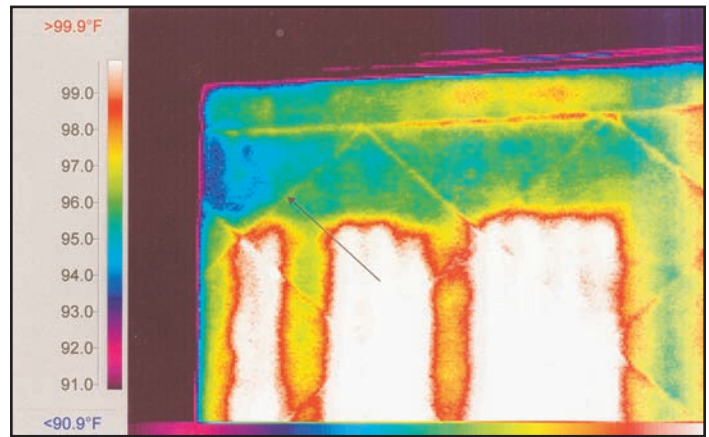
Figures 15-18 (above) demonstrate moisture intrusion at horizontal and decorative control joints and along the outside corner of an EIFS-clad structure in Central Florida. The failure mechanism was a combination of poor installation technique and lack of attention to detail. Please note the water intrusion indications in Figure 16 (blue and green on top right graphic). These are typical of non-drainable EIFS veneer.

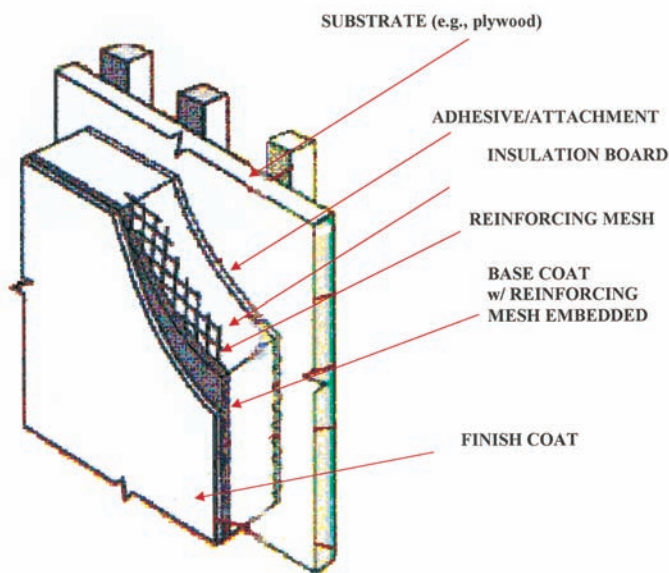
Figure 19 is a rough drawing of the wall mechanism demonstrated herein.

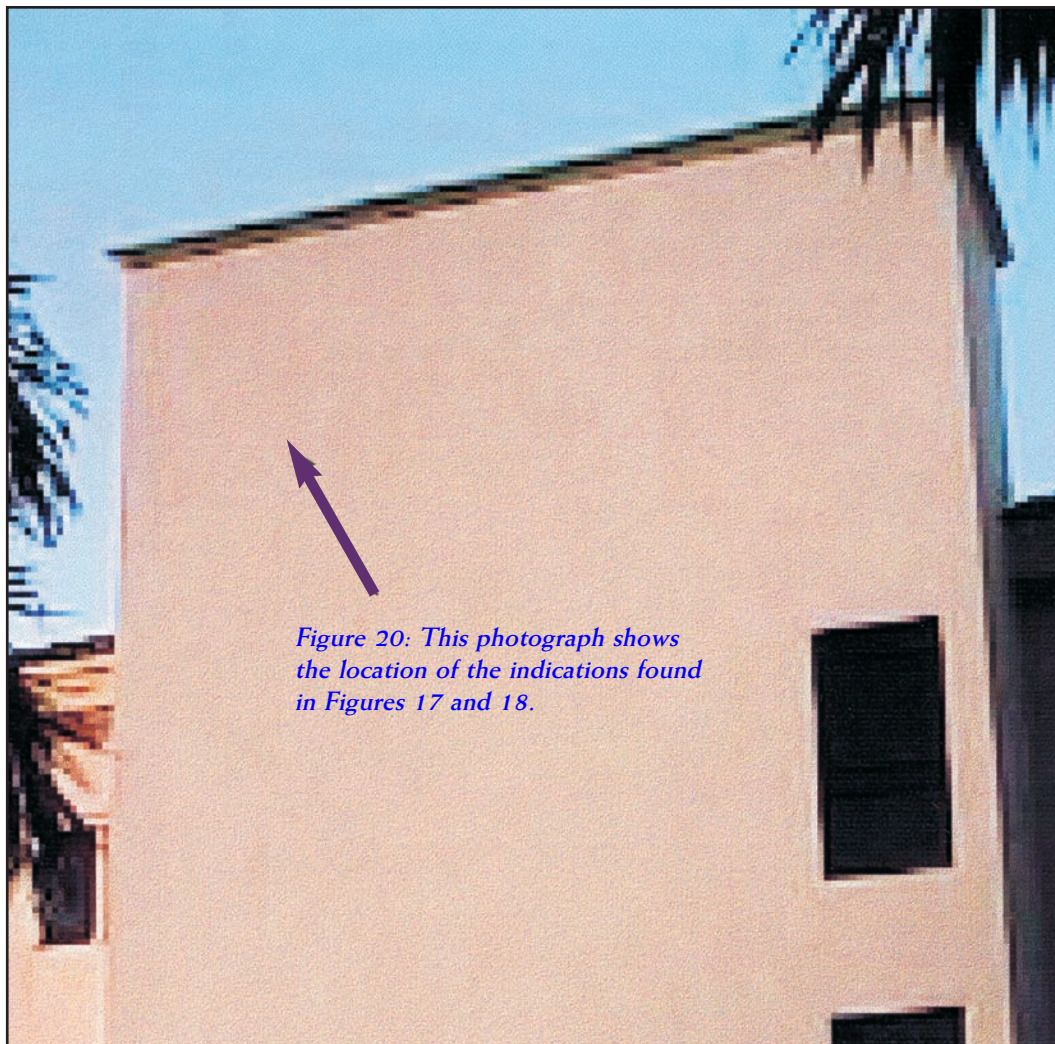
*Figure 20: This photograph shows the location of the indications found in Figures 17 and 18.*
