DESIGN & RENOVATION OF A HIGH-RISE RETROFIT EIFS CLADDING

A C A S E S T U D Y

BY WARREN R. FRENCH, PE, RRC, CCS

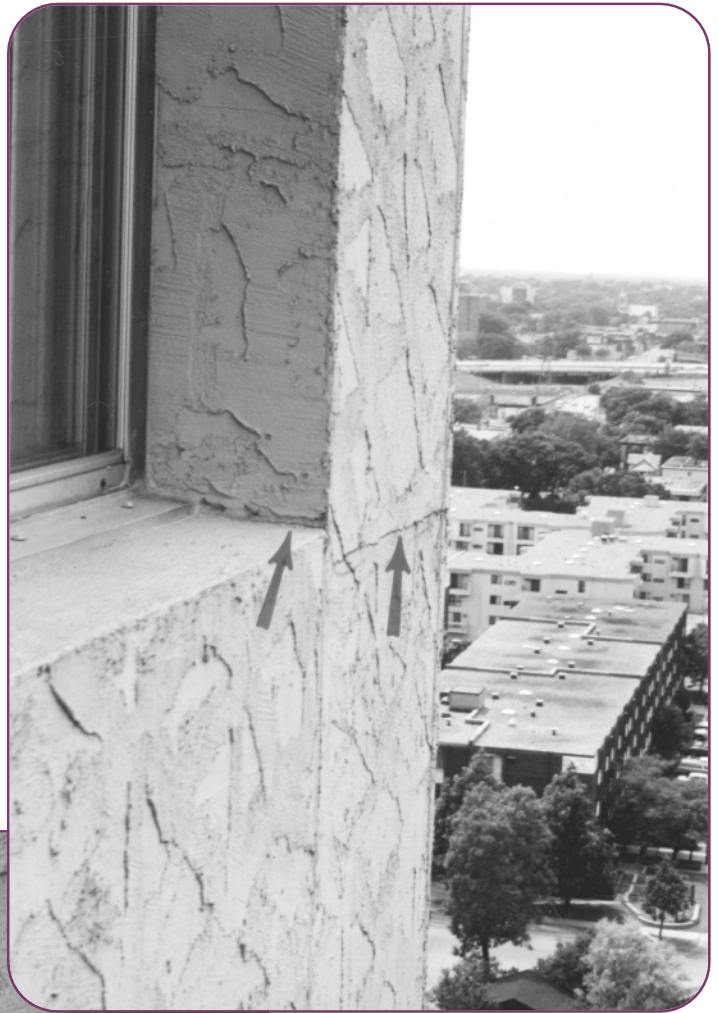
Above. Figure 1—Inadequate slope at original sill.

Improper Steel Framing—As previously stated, adequate slope at the window sills was effectively non-existent, because the steel framing below each opening had been fabricated perpendicular to the plane of the wall. See *Figures 1, 2, 3 and 9*. This condition could not be effectively remedied without extensive modification to the original framing. In view of the potential costs for this aspect of the renovation, this work was bid as an alternate to the base bid. Fortunately, the costs from the successful bidder were not out of line and the owner recognized the need for this modification. The alternate was incorporated into the construction contract. See *Figures 4, 5, 6, 7 and 10*. In addition, selective demolition during the renovation revealed a number of areas throughout the existing steel wall framing that were inadequately fastened to the principal structure. In addition, the wall framing consisted of excessively long metal studs that had been installed continuously across expansion joints of the building envelope.

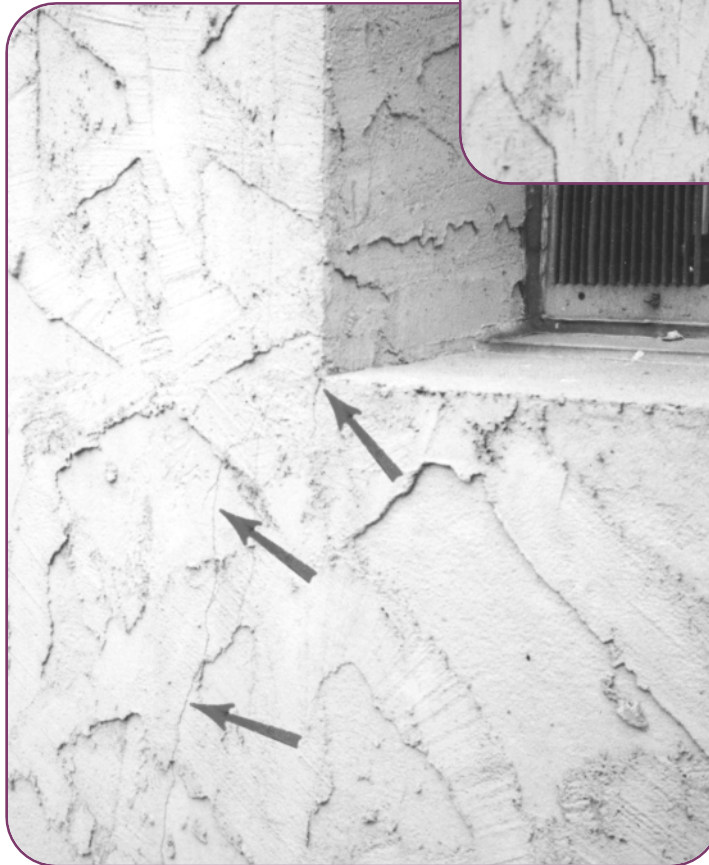
Left. Figure 2—Typical sill and A/C opening.

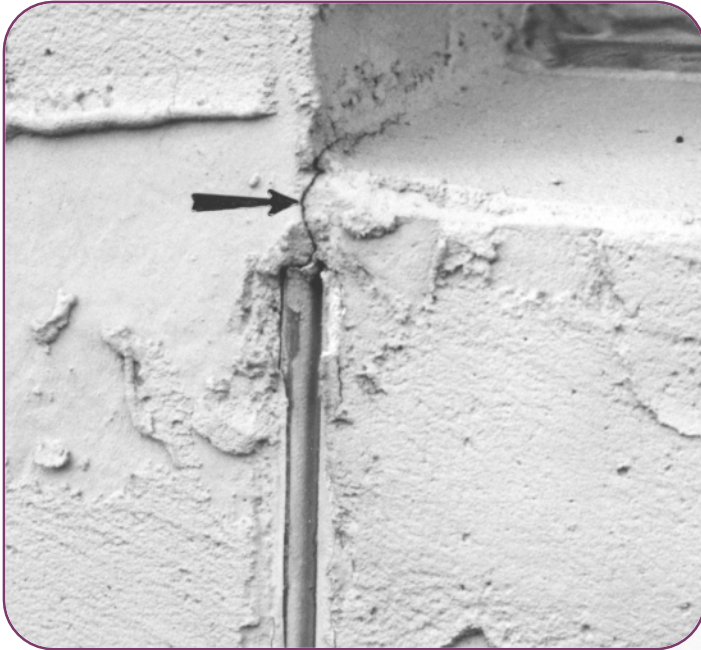
Above: Figure 3—Control joint termination.

Plastering Accessories—Improper installation of plastering accessories was common and widespread throughout the EIFS applications of this project. Installation problems included variations in the field fabrication, assembly, and securement of these accessories not in accordance with recognized industry standards. Corners of the control joints were found to be improperly mitered and fitted in numerous locations, particularly around window openings but also at standard outside corners. In addition, joint accessories were terminated improperly at window recesses at all locations throughout this building. Typically, these joints did not extend into the recess, resulting in a plaster bridge subject to cracking at the end of the metal termination. See Figure 3.

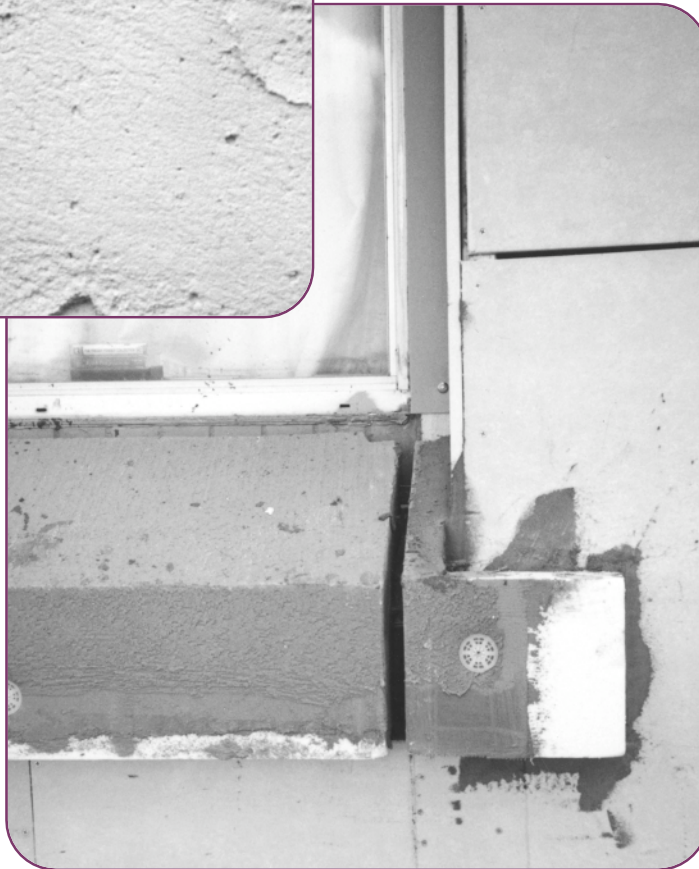
Patterned cracking of the EIFS lamina was observed at regular intervals that appeared to correspond to the location of butt

joints within the insulation boards. Possible causes of this patterned cracking at insulation board joints are (a) dimensional instability of the insulation foam product, or (b) improper fastening of the insulation resulting in a "loose" substrate.

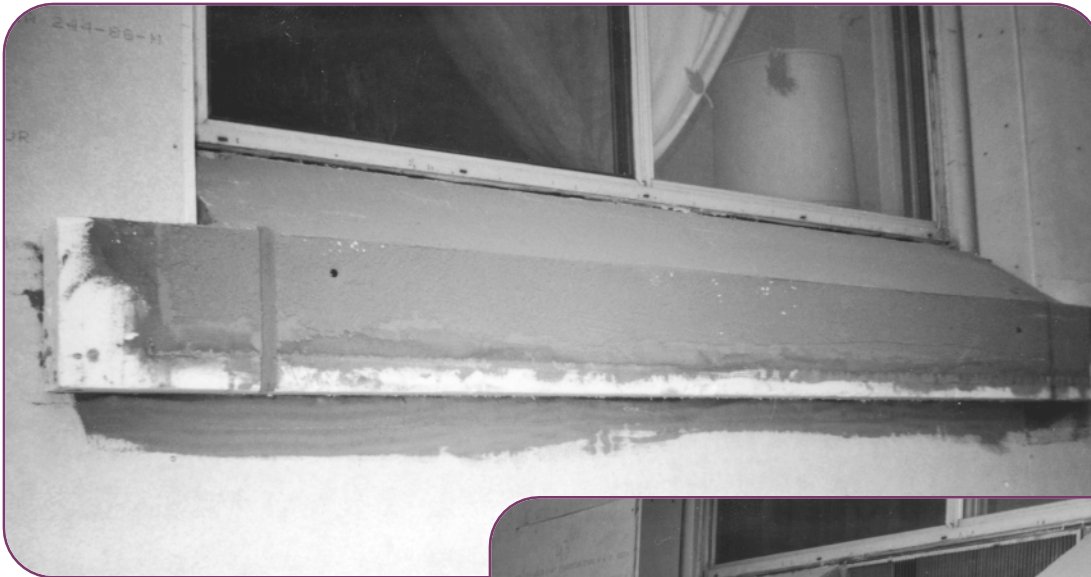
Left: Figure 5—Prefabricated straight sill.

Prefabricated EIFS Sloped Window Sills—Due to a specific construction sequencing that we specified for the window sills and sheet metal sill flashings, the contractor developed and submitted for approval a pre-fabricated assembly comprised of foam that had been properly shaped, covered with the base coat and finish, then incorporated into the wall at the bottom of each window opening. Realizing the importance of achieving a completely base-coated foam installation (in conjunction with a sheet metal sill flashing that was to be incorporated into the wall behind the EIFS assembly at the window jambs), the contractor struck upon the idea to prefabricate the sloped portions of the sill as a method to achieve the required sequencing while allowing an acceptable production rate. See *Figures 4, 5 and 6*.

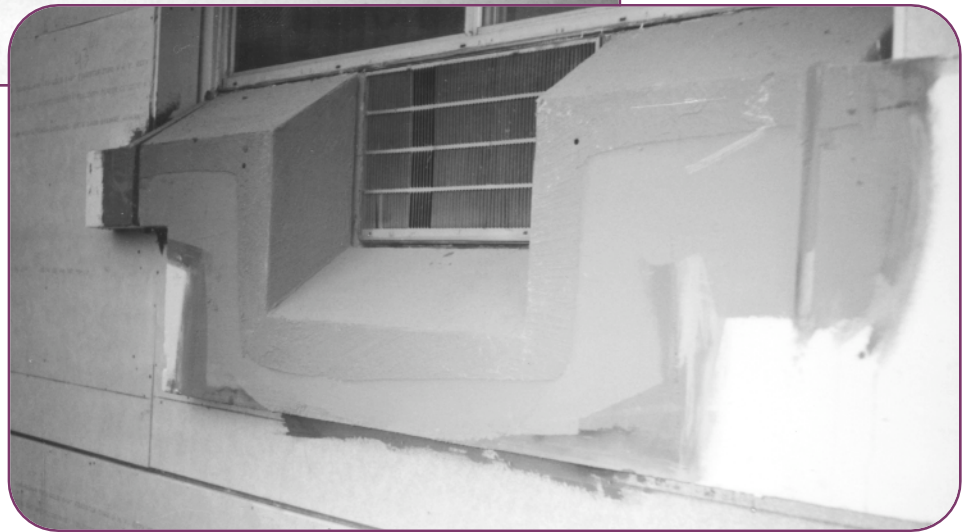
Below: Figure 6—Prefabricated sill on window with A/C opening.

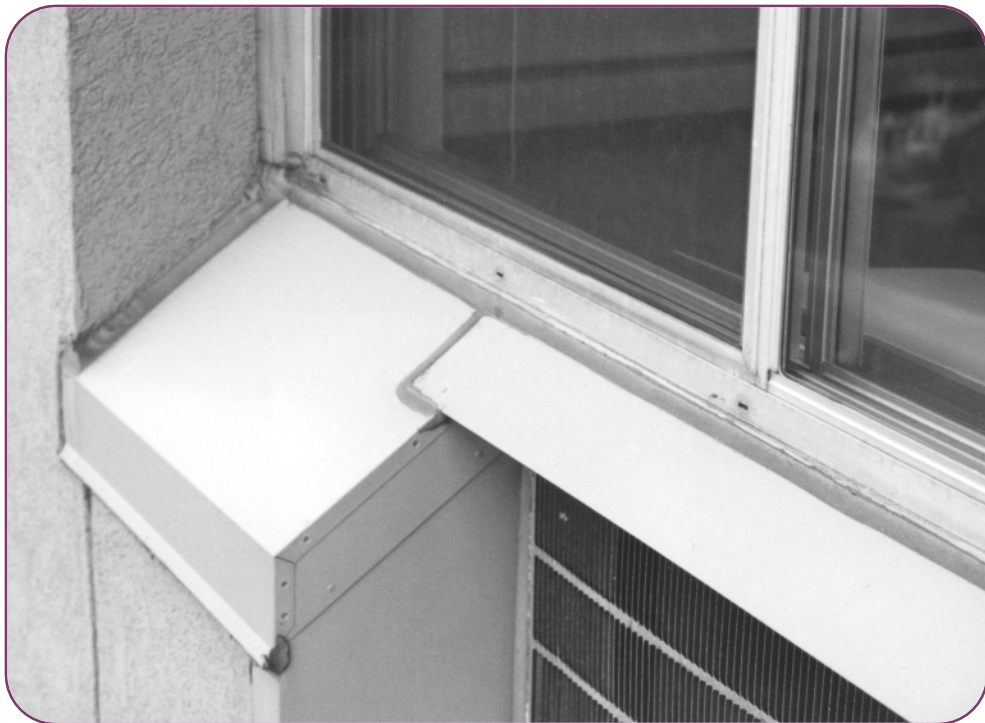
Figure 7—Sill and A/C opening with new sheet metal flashing.

Sill Flashing Integral with EIFS at Jambs—Once the sloped sill of the window opening was fully finished, a special sheet metal sill flashing was installed in a bed of non-curing butyl sealant. Upturned end dams at each end were fastened directly to the sheathing at the recessed edges of the window opening, with the EPS foam board and finished surfaces extending down over the sheet metal at these jamb locations. The EIFS finish at the recessed jambs was incorporated into exposed front surface of the main wall systems. See *Figure 7*.

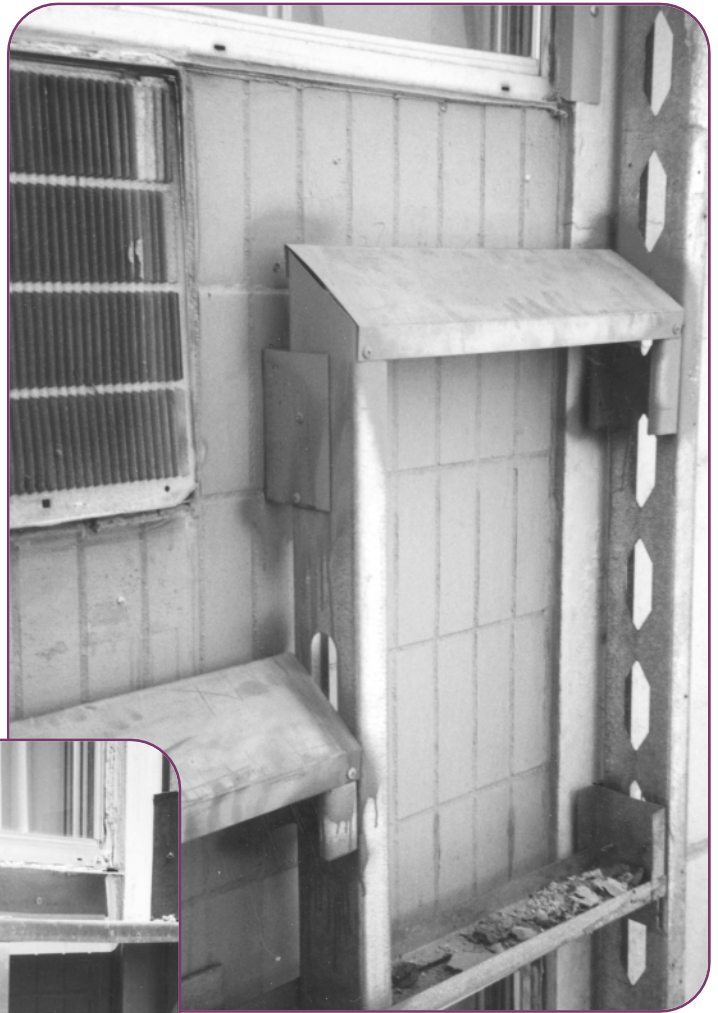
Above: *Figure 10*—Modified framing at sill.

the window sills. Original sill framing had improperly created virtually flat surfaces at each window sill, resulting in inadequate drainage at these surfaces. See *Figure 9*. The renovation design was meant to correct this condition by cutting the original steel studs at a sharp angle and installing a bent plate to cap these framing members as a sloped track member. See *Figure 10*.

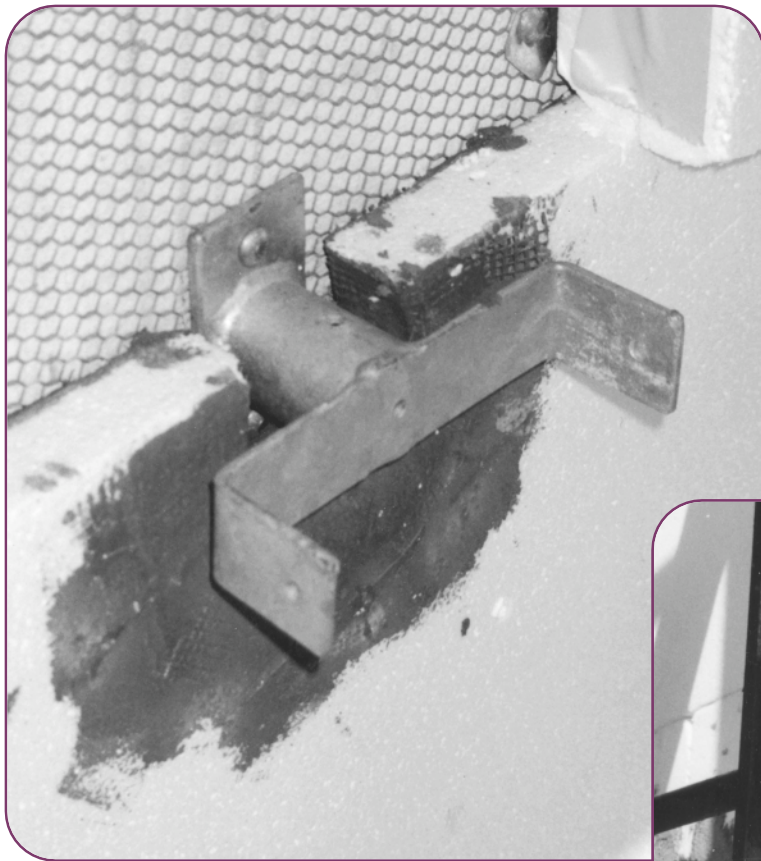
Figure 11—Stand-off downspout bracket.

Stand-off Mounting Hardware for Appurtenances—Based upon numerous investigations of buildings having distressed EIFS applications, an attempt was made to provide specific details to support and mount various appurtenances through the EIFS assembly and onto the building structure. These appurtenances included fixed ladder brackets, sheet metal downspouts, and communication antennae. Each of these items could produce an undesirable penetration or opening through the new EIFS lamina if not detailed properly. Accordingly, special fabrications were utilized to create stand-off mounting hardware that secured the appurtenance with minimum disturbance of the EIFS lamina. See *Figures 11 and 12*.

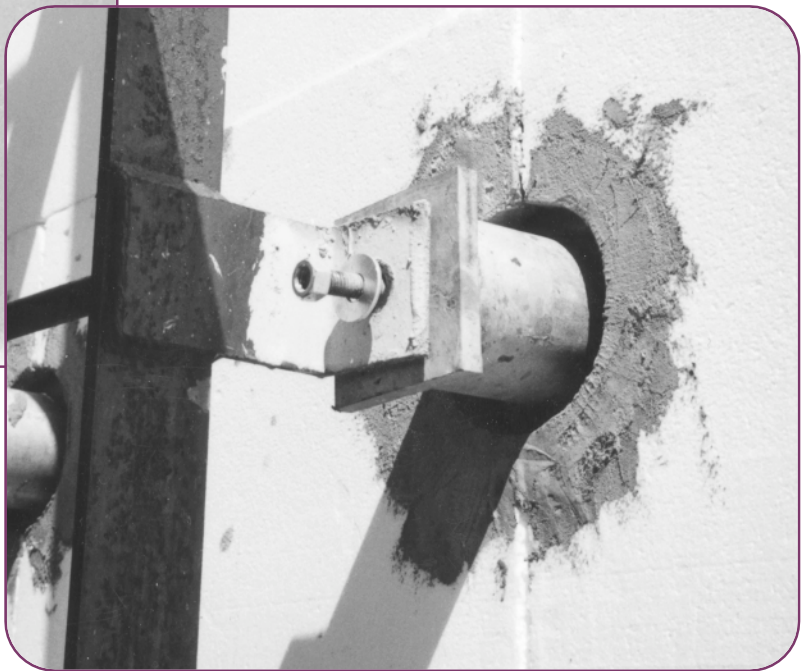
Figure 12—Stand-off ladder bracket.
