# PROBLEMS WITH FIRE-RETARDANT-TREATED (FRT) WOOD EXTEND BELOW THE ROOF DECK

BY DEREK A. HODGIN, PE, RRO

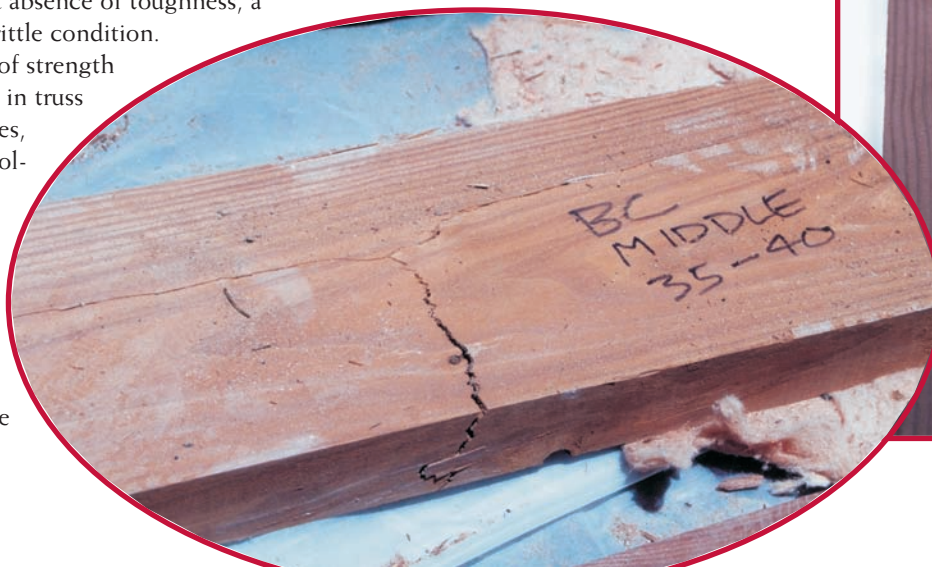
*Below: Figure 2: Splitting parallel and perpendicular to grain.*

While FRT can be applied to stick-built framing, it is most commonly used on engineered trusses to span large buildings. In recent years, it has been observed that certain chemicals used in the FRT have resulted in significant compromise to structural members. The loss of strength can cause premature failure of the trusses. The modes of failure include heavy checking parallel and perpendicular to the grain, splitting, and full cross-grain breaks (Figures 1, 2, and 3).

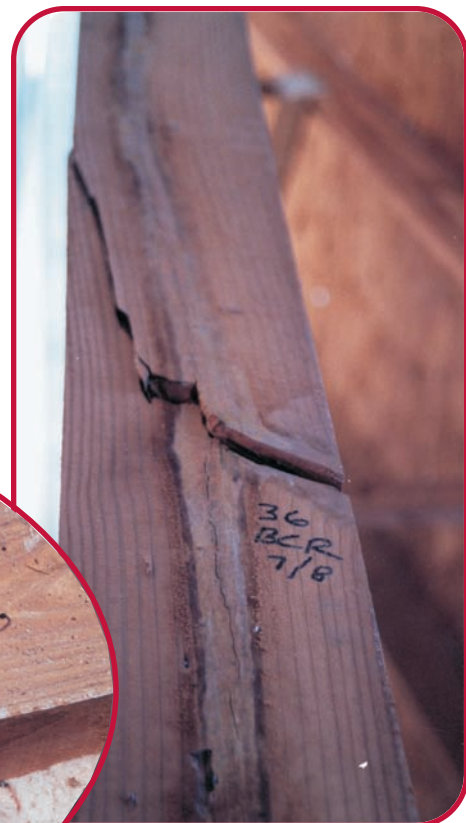
*Right: Figure 3: Full break.*

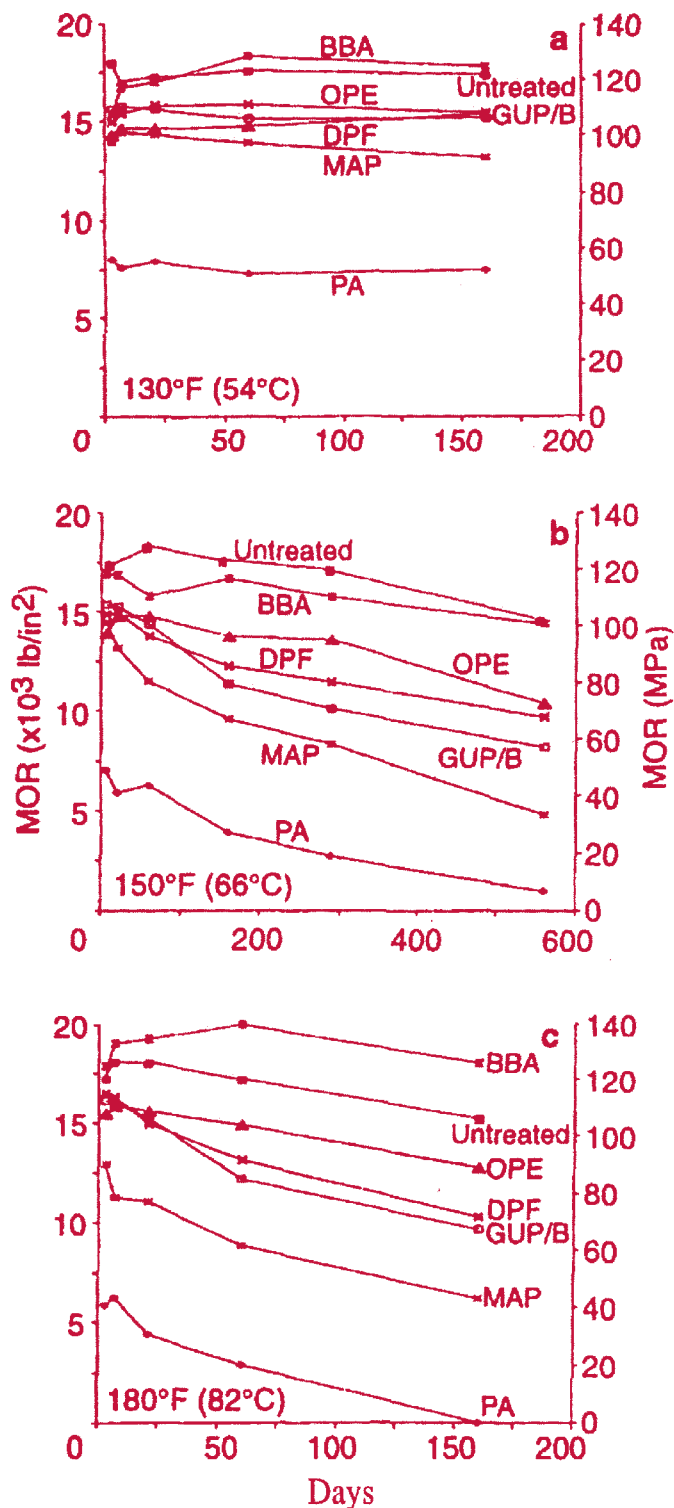
Figure 4: Effect of extended exposure to elevated steady-state temperatures on bending strength for untreated and fire-retardant-treated wood. (a) 130°F (54°C). (b) 150°F (66°C). (c) 180°F (82°C). BBA is borax-boric acid, DPF, dicyandiamide-formaldehyde-phosphoric acid, GUP/B, guanylurea phosphate/boric acid, MAP, monoammonium phosphate, OPE, diethyl-N, N-bis (2-hydroxyethyl) aminomethyl phosphonate, and PA, phosphoric acid. MOR is modulus of rupture, 1 lbs/in.<sup>2</sup> = 6.894 kPa. (Note differences in scale of x-axis.) Reprinted with permission. © Wood and Fiber Science, United States Department of Agriculture, Forest Products Laboratory.

Based on a review of available literature, the fire retardant chemicals phosphoric acid (PA) and monoammonium phosphate (MAP) appear to result in the most significant affects in terms of wood degradation (*Figure 4*).<sup>10</sup> Specifically, the FRT chemicals lower the pH of the wood, which results in the acid-catalyzed dehydration process. The PA treatment has the lowest pH, and it has the greatest effect on mechanical properties.<sup>6</sup> As inorganic salts, PA and MAP diffuse through the wood with moisture during cycles of temperature change as described above. This diffusion process allows the wood to continually degrade as the acidic salt makes it way through the wood. In a roof environment, changes in temperature and humidity cause shifts in the equilibrium moisture content of the wood. As the moisture moves, so do the inorganic salts. At each new site, the acidic salts can cause further degradation.<sup>7</sup>

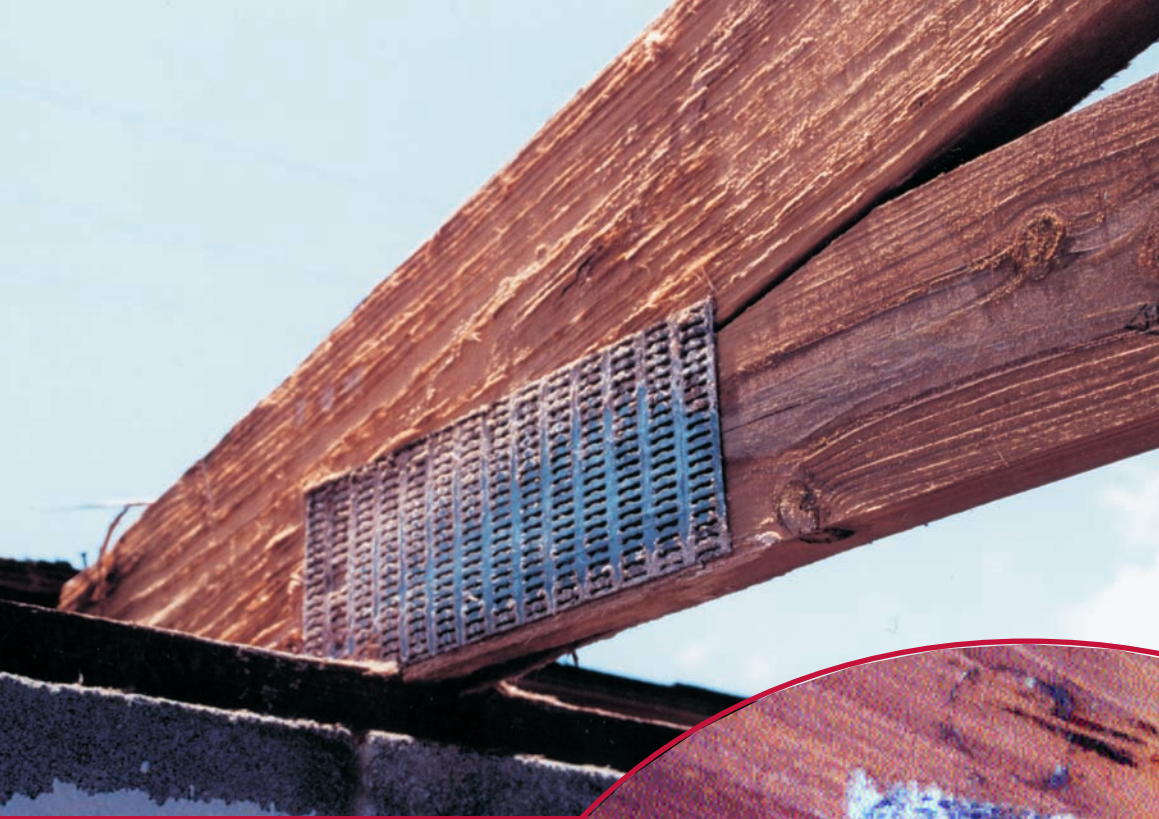
Left: Figure 5: "Fuzzy" surface on FRT truss due to elevated moisture conditions.

- Look at the surface of the plywood. FRT plywood sometimes degrades and causes the surface to be "fuzzy" in appearance (Figure 5). This particular mode of degradation is related to elevated moisture conditions. Therefore, this condition is most often located near the eave or at roof penetrations where water intrusion may occur.

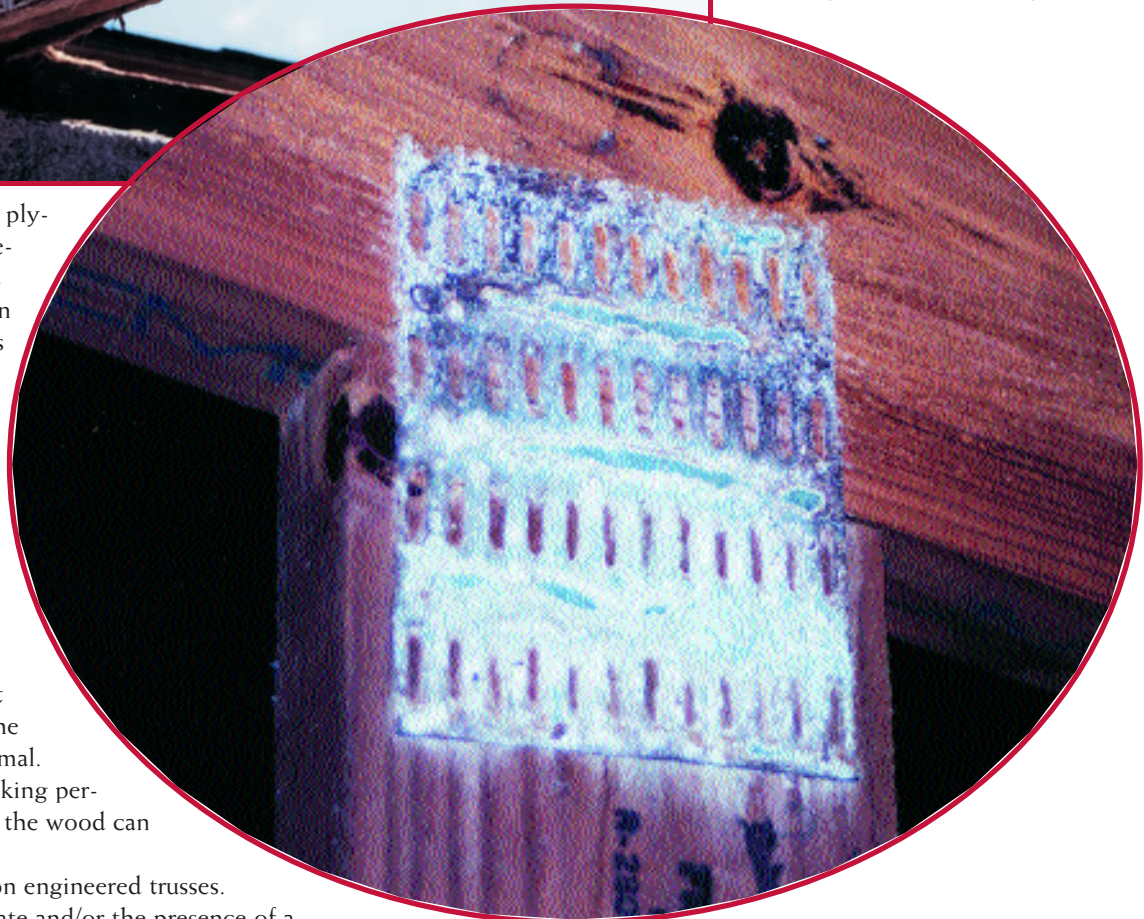
Below: Figure 6: Corrosion and salt deposits on a metal truss plate.

- Look at the metal plates on engineered trusses. Corrosion of the metal plate and/or the presence of a white residue may be associated with the salt from FRT chemicals (Figure 6).

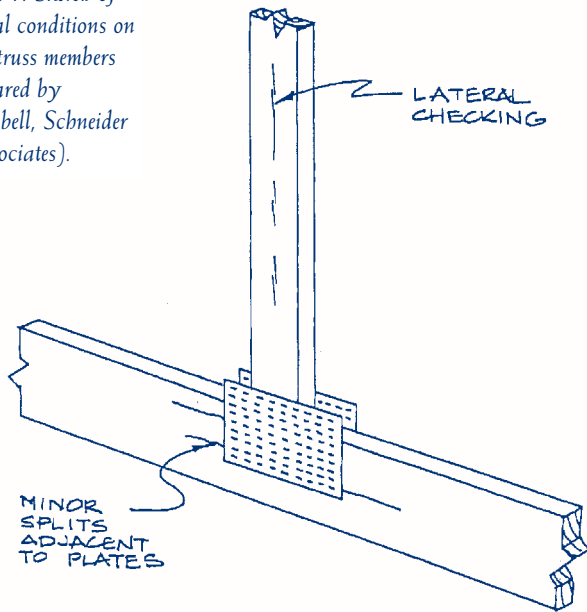
Figure 7: Sketch of typical conditions on good truss members (prepared by Campbell, Schneider & Associates).

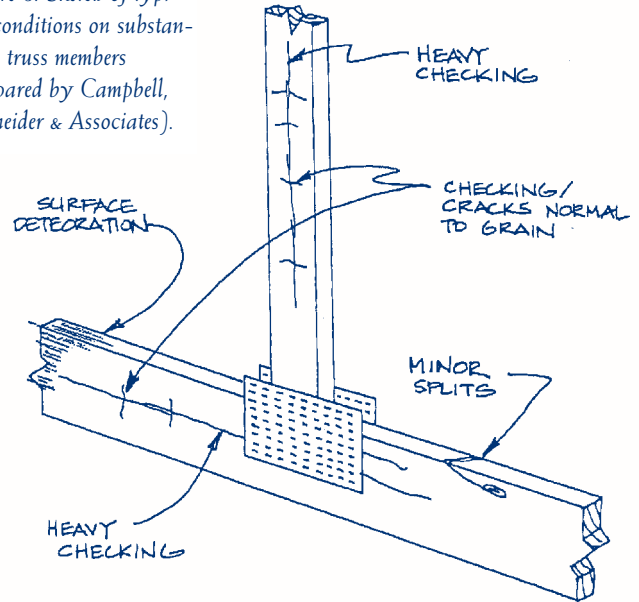
Figure 8: Sketch of typical conditions on substandard truss members (prepared by Campbell, Schneider & Associates).

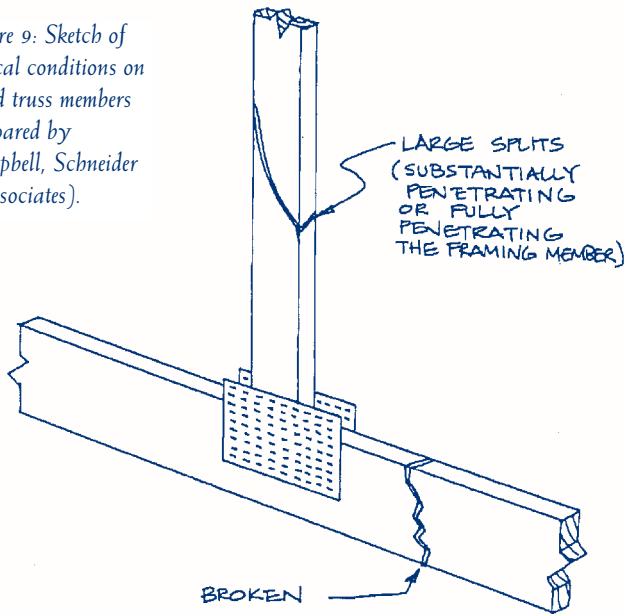
Figure 9: Sketch of typical conditions on failed truss members (prepared by Campbell, Schneider & Associates).
