# REROOFING OVER FAILED ROOFS CONTAINING MOISTURE

*An ORNL/RCI/SPRI Collaborative Demonstration Project*

BY A.O. DESJARLAIS, J.P. SHEAHAN, AND P.C. GARRIGUS

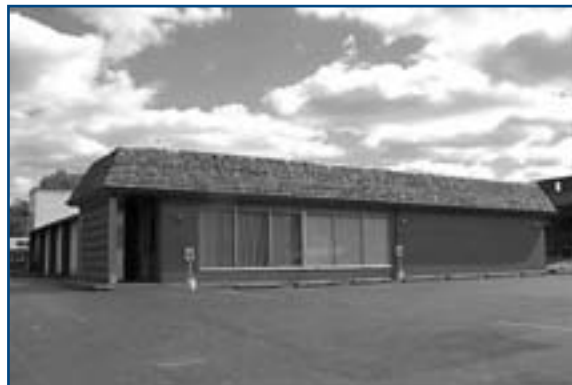
*Figure 1. The New Bethel Fellowship Church in Rossville, IL*

In 1997, SPRI identified a building, the New Bethel Fellowship Church in Rossville, IL (approximately 100 miles or 160 km south of Chicago), that satisfied most of the criteria developed by SPRI for a satisfactory demonstration site. The building is pictured in *Figure 1*. It was a one-story structure that originally served as the town's market. The building had two roof planes and a total roof area of 11,000 ft<sup>2</sup> (1020 m<sup>2</sup>). The main roof plane made up 95% of the entire roof area. The second roof plane covered a small service elevator at the rear of the building.

The existing roof was comprised of an 18 gauge metal deck with 18 gauge metal panels welded to the underside, 39 mm or 1.5 inches of perlite insulation spot-mopped with asphalt to the deck, and an aggregate-surfaced, four-ply organic felt and asphalt BUR. In addition, an asphalt base sheet with a liquid-applied aluminum coating had been applied over the BUR in what appears to be a reroofing attempt. The roof had a 1:12 slope that peaked in the middle, equally dividing north and south on each side. The building owner informed us that the original roof was approximately 25 years old. The current owner had acquired the building in 1994, and it had been leaking since that time. The age of the attempted reroofing is unknown. Numerous ineffective temporary repairs were apparent, and the church was financially incapable of replacing the roof.

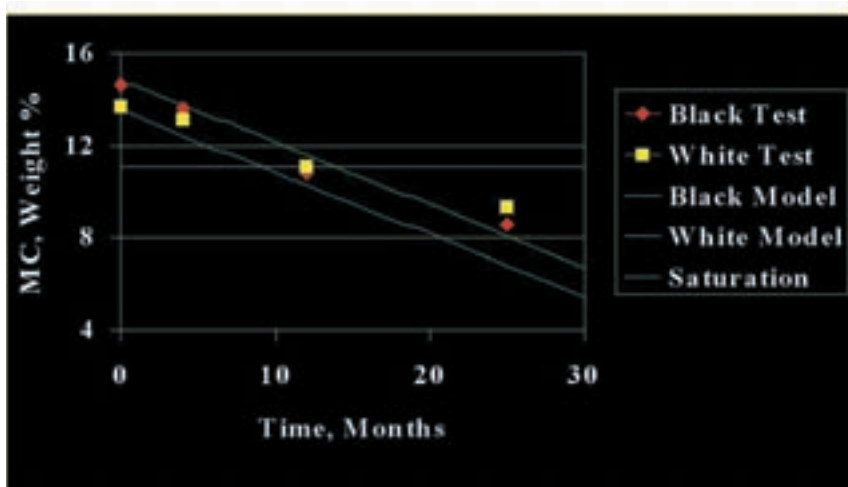
Figure 3. Comparison of measured and modeled moisture contents of perlite insulation.

A comparison of the measured drying data and model predictions for the perlite insulation re-covered with white and black membrane areas are presented in Figure 3. The model overpredicts the drying rate of the perlite insulation and does not appear to capture the impact of membrane color. Possible explanations for these variations include the lack of sensitivity of the nuclear densometer at lower levels of moisture content or the permeance of the metal deck. The fact that we are averaging a number of locations that range from relatively dry to saturated and the average is not similar to the sum of the range of moisture contents present certainly contributes to the differences noted. Areas that are already relatively dry will dry no further, and the

nuclear densometer will simply detect no change in moisture content for these locations. These areas, averaged with areas that are drying, will yield an average change in moisture content that is less than the situation where all of the locations contain the same (average) amount of moisture.

The model does not predict any significant seasonal variations in the drying rate of the perlite insulation. This result is consistent with our expectations because the wetted insulation layer is relatively protected from seasonal temperature fluctuations by the re-cover insulation. However, the model does a fair job at estimating how long the perlite insulation must be exposed to reach an average moisture content that was less than saturation. The model predicted times ranging from 9-13 months while the test data indicates that 12 months were needed.
