EVALUATION OF Liquid-Applied Waterproofing Systems:

CASE HISTORIES

By Kami Farahmandpour and Terry Willems

Case 1 - Cincinnati Museum Center Plaza Fountain

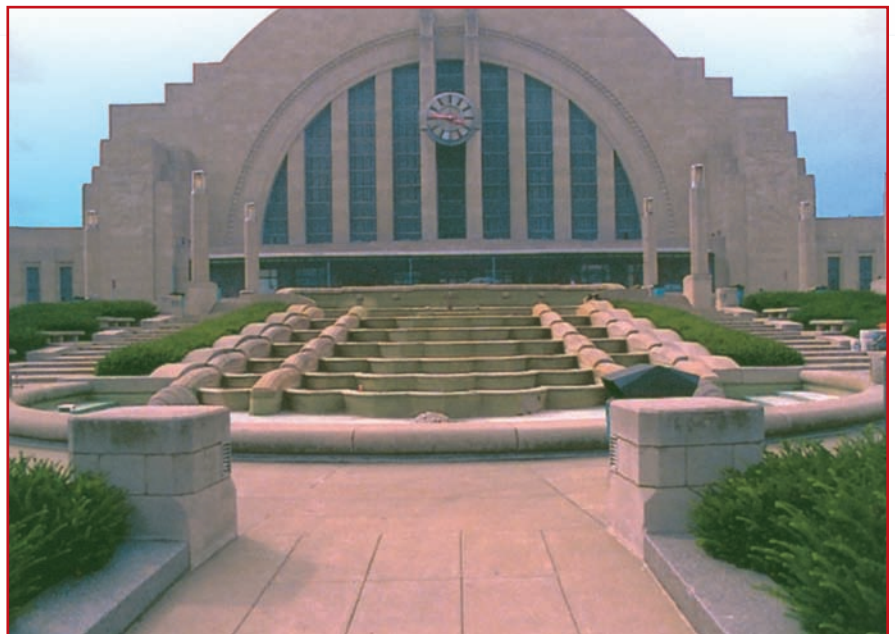
Photo 1 – Overall view of the Cincinnati Museum plaza fountain

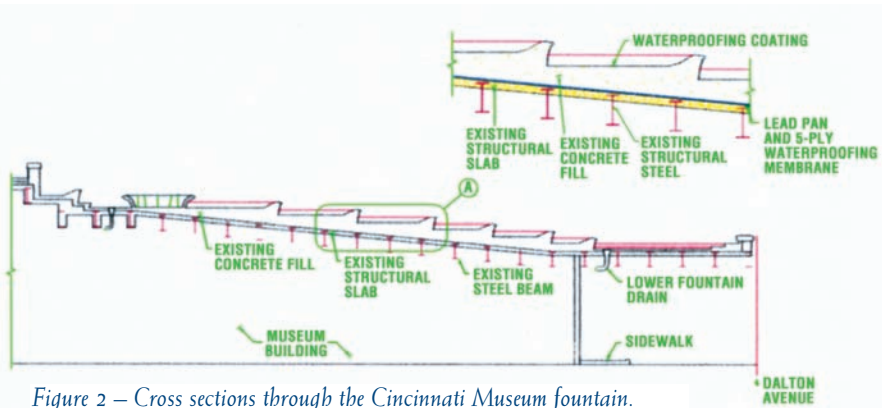
Figure 2 – Cross sections through the Cincinnati Museum fountain.

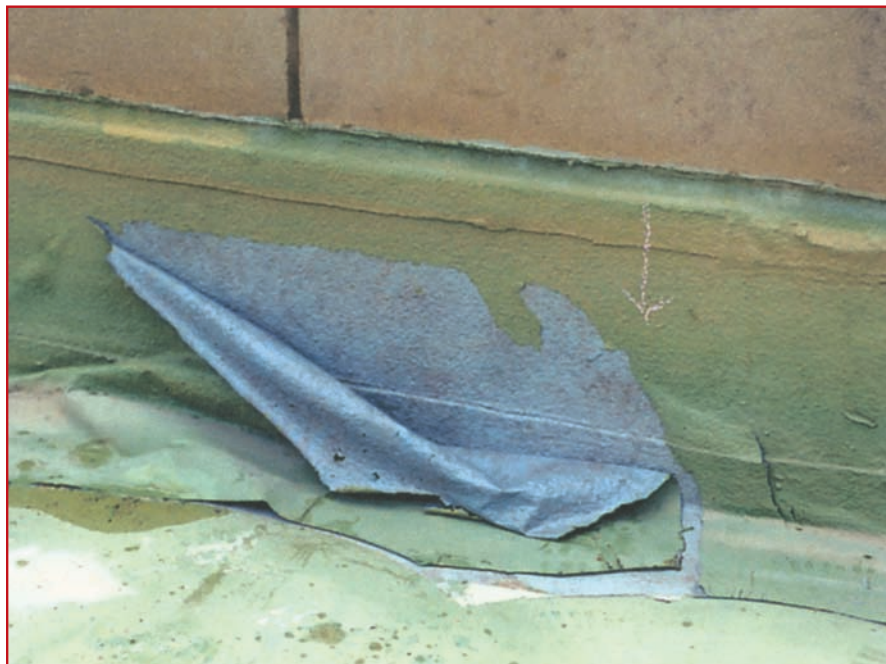
Figure 3 – Typical example of interlayer disbonding of the membrane between the green top coat and the gray base coat.

The coating had disbonded (separated from the substrate) and delaminated (separated from its underlying layers) in many areas of the fountain (Figures 3 and 4). Large sheets of membrane and color coat peeled away easily in some areas. In general, second and third applications of the

Re-application of the membrane had failed in numerous areas, primarily due to lack of proper bond between the first membrane application and subsequent applications. Bond failure was typically caused by inadequate surface preparation techniques. The lack of interlayer bond provided voids that collected water and created blisters. The water collecting in these voids penetrated through pinholes and other deficiencies in the membrane.

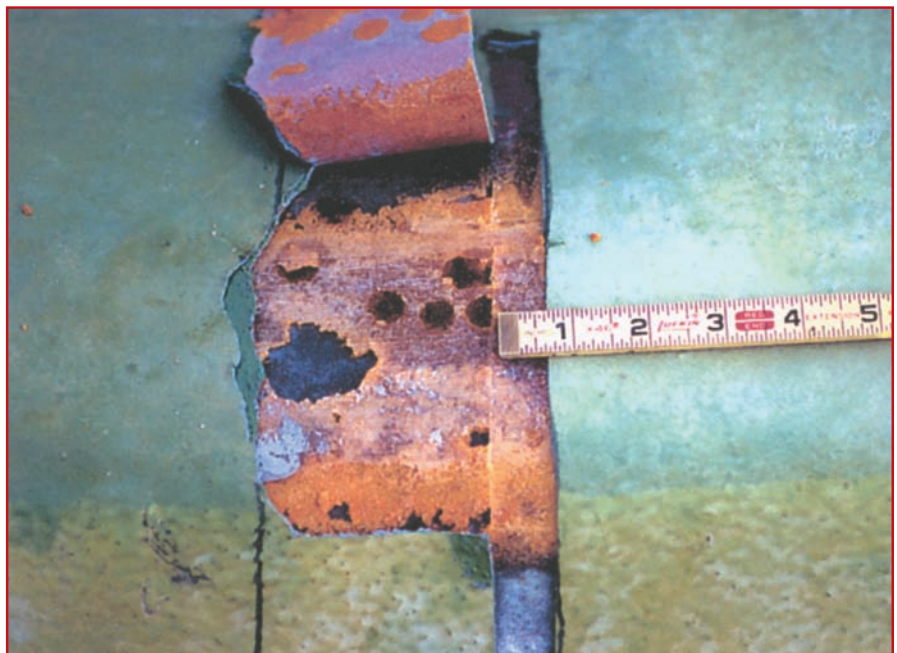
Figure 4 – Typical example of membrane disbonding from the epoxy patching material.

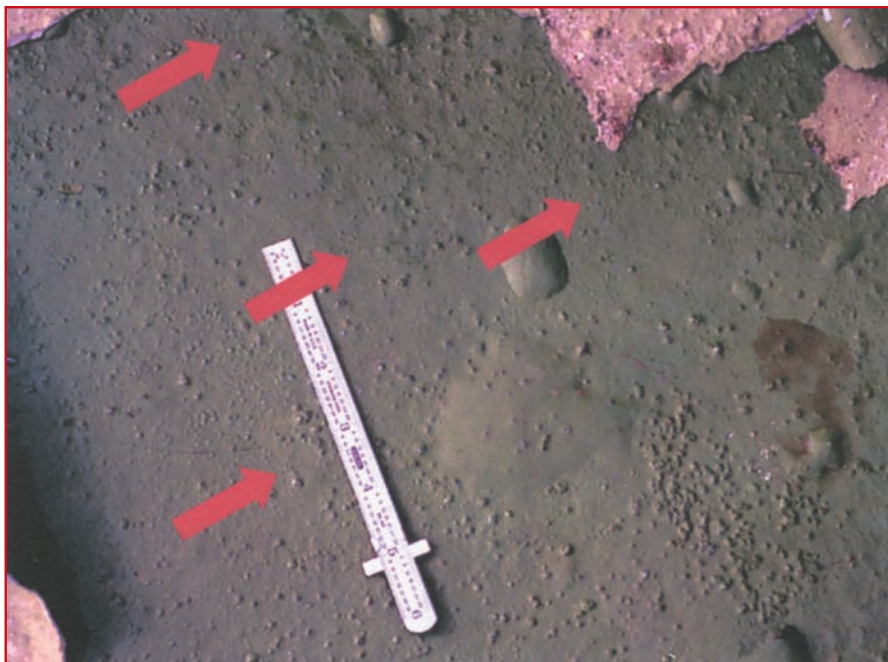
Numerous water-filled blisters, ranging in size from 1/4 inch to 4 inches in diameter, were observed (Figure 5). Several of these blisters were cut open to determine the location of the water layer within the coating system. The location of blistering varied, occurring between coats (layers) of the first application membrane, at the primer/membrane interface, at the color coat/membrane interface, or between layers of the color coat.

Figure 5 – Surface blisters in the membrane (red arrows).

Numerous small pinholes and blisters in the first application of the primer and membrane were observed. There was no record of water vapor emission tests having been performed prior to application of the liquid-applied membrane. Therefore, it was concluded that the concrete substrate was saturated and exhibited high water vapor emission rates during and immediately after application of the membrane system. This high water vapor pressure resulted in the formation of numerous pin-

holes in the primer. These pinholes provided a path for water vapor to penetrate the porous membrane from the substrate below, and fill air voids with water, producing blisters.

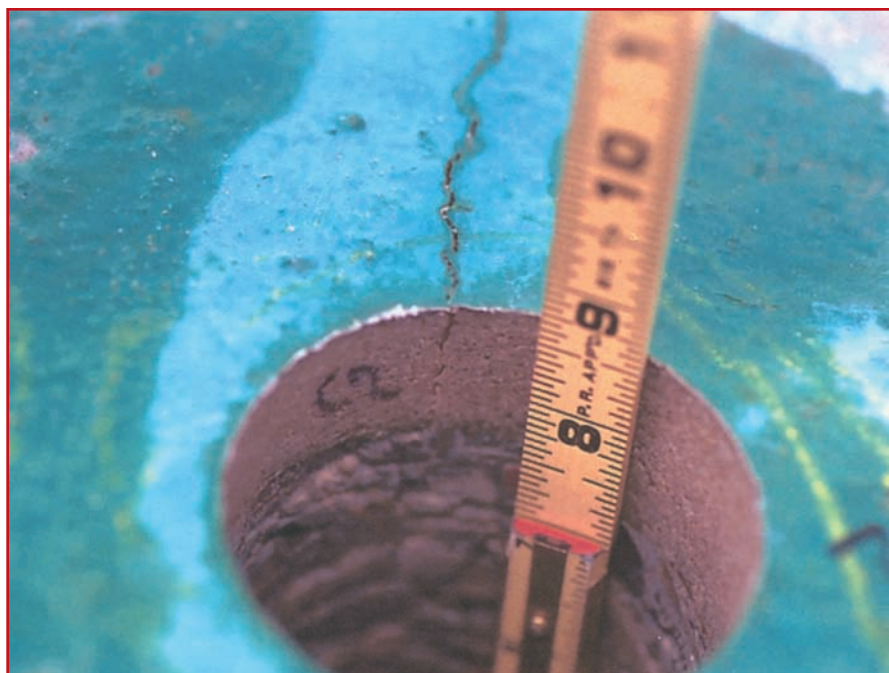
In several areas, cracking of the substrate concrete had reflected through the membrane directly over the crack (Figure 6).

Figure 6 – Substrate cracks reflecting through the membrane.

Cracks observed within the membrane lined up with cracks in the substrate. These cracks were attributed to deterioration of repair patches, as well as to cracking and deterioration of the original concrete within the fountain. Since the original fountain concrete was not air-entrained and did not have a topline waterproofing membrane for many years, it was susceptible to freeze-thaw deterioration. Also, a drainage layer was not provided at the level of the lead pan. Therefore, water penetrated and saturated the concrete above the lead pan. During winter months, the trapped water froze and cracked the saturated concrete. This deterioration likely began early after construction and had continued through the life of the fountain.

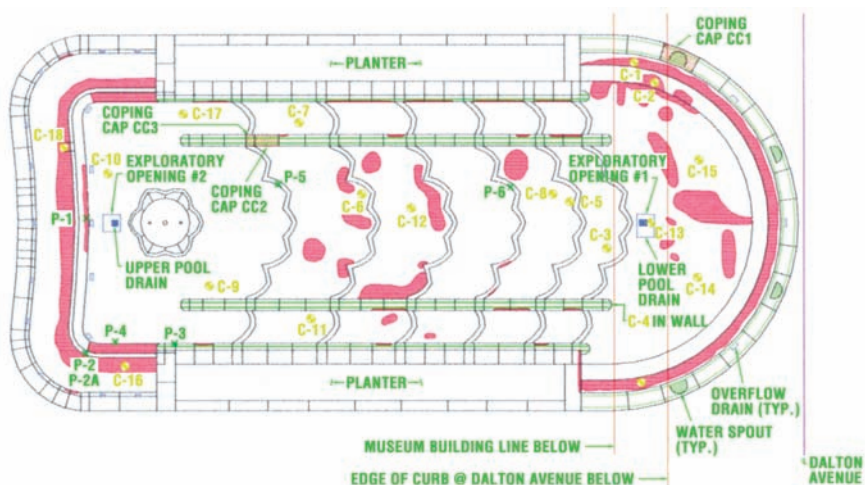
Approximately ten percent of the fountain surfaces exhibited sub-surface delaminations when sounded with a hammer (Figure 7). The delaminations were primarily in areas where previous repairs were performed using an epoxy repair mortar. Core sampling at these locations showed that the epoxy repair material had debonded from the substrate concrete.

Figure 7 – Above, delamination survey of fountain surfaces revealed significant areas of delamination concrete (red areas).

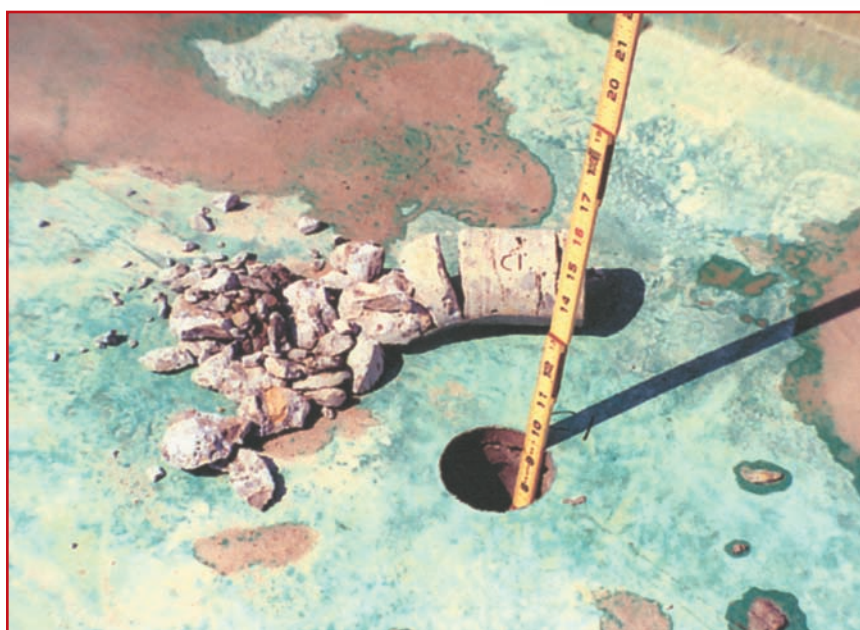
Examination of cores during sampling indicated widespread delaminations deep within the fountain concrete. Most of these areas containing deep delaminations were not detectable by hammer sounding (Figure 8).

Figure 8 – Coring of the substrate revealed extensive freeze-thaw deterioration.

In general, the epoxy repair mortar had delaminated from the cementitious substrate. The majority of the deterioration and cracking was found in the original concrete layer. The original concrete was not air-entrained. Therefore, it is susceptible to freeze-thaw damage when saturated with water. Extensive sub-

parallel cracking, typical of freeze-thaw damage, was present in the original concrete

Based on the findings of this investigation, it was concluded that the only viable long-term solution for rehabilitation was a complete reconstruction of the fountain above the lead pan.

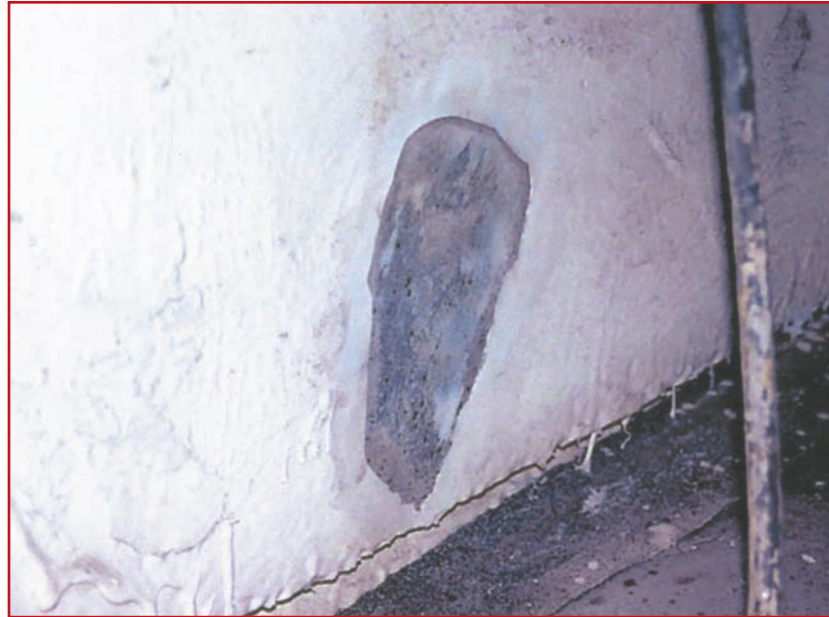
Figure 10 – Large blister at the base of a marine tank.

At the time of the first field visit, the waterproofing membrane had been removed from the tank floor. The majority of the blisters were reported to have occurred on the tank floor. Two blistered areas approximately 6 inches in diameter were also observed on the tank walls within 24 inches of the floor. No other blisters were observed on the tank walls, where the membrane had been left intact. Small delaminations in the membrane were observed at a limited number of locations. Subsequent conversations with the membrane manufacturer and research into the polyurea chemistry revealed that such deficiencies are likely due to reaction of isocyanates in the polyurea with moisture. This reaction results in formation of carbon dioxide that can cause small blisters to form within the membrane. This phenomenon is usually caused by improper mixing of the polyurea at the gun and can be alleviated through better mixing and application practices.

Based on the initial MVER measurements, it appeared that the blistering of the first membrane application in the first tank was due to high MVER through the floor of the tank. The high MVER was attributed to lack of an effective vapor retarder under the tank floor slab and flooding of the tank a few days prior to application of the membrane. These high moisture vapor emission rates were somewhat consistent throughout most of the tanks. At that time, the tanks were not protected from rain. Therefore, exposure to rain increased the moisture content of the slab resulting in a sustained high vapor emission rate.
