PROJECT PROFILE

WOOD SHINGLE REROOFING

Restoration of Chowan County Courthouse, Edenton, NC

By John L. Willers

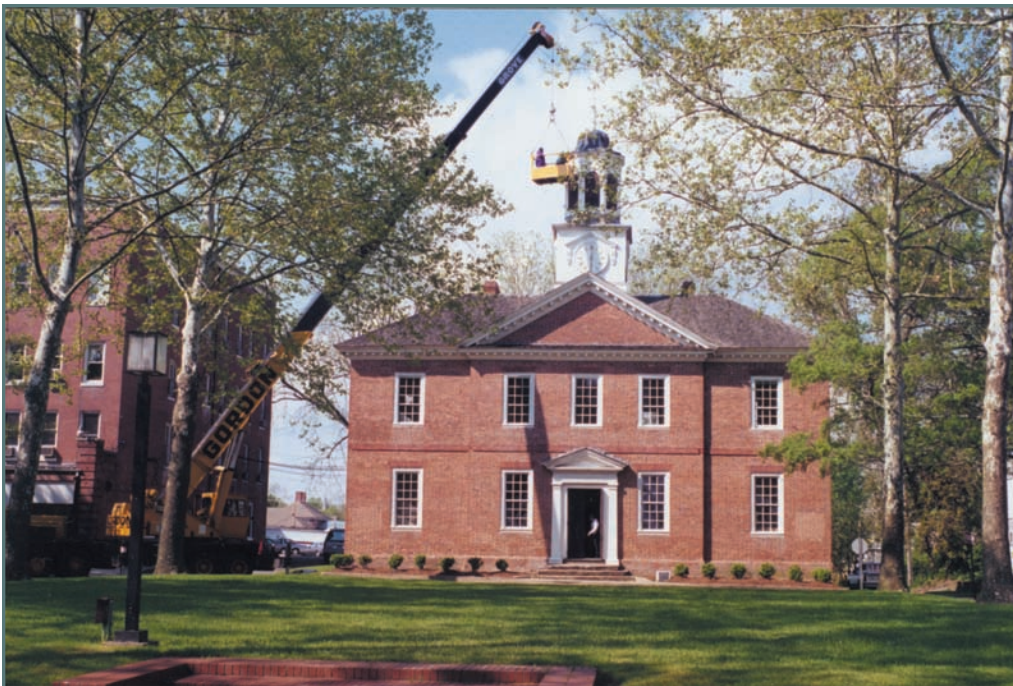
Photograph 1—Before renovation. Roof investigation in progress.

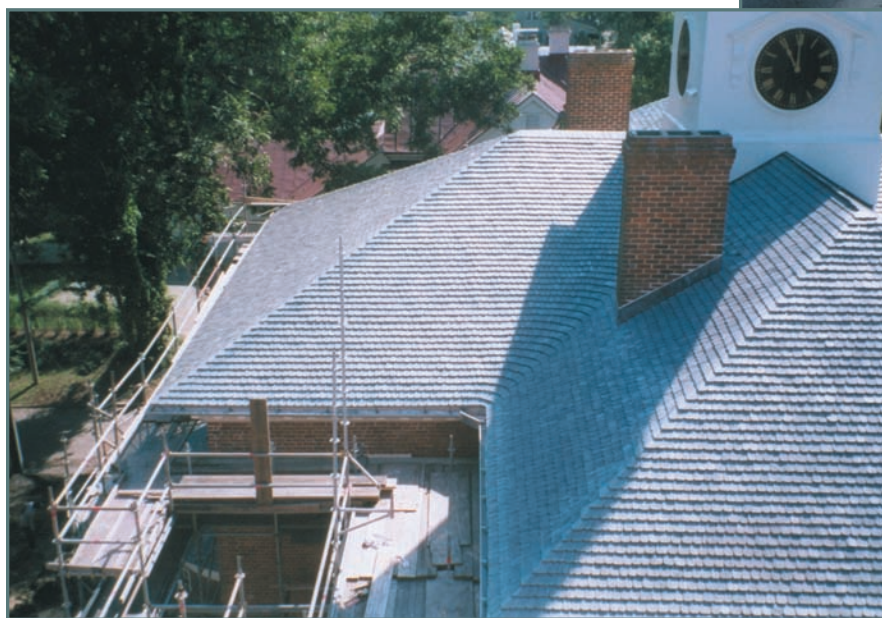
Photograph 2—New cypress shingle roof.

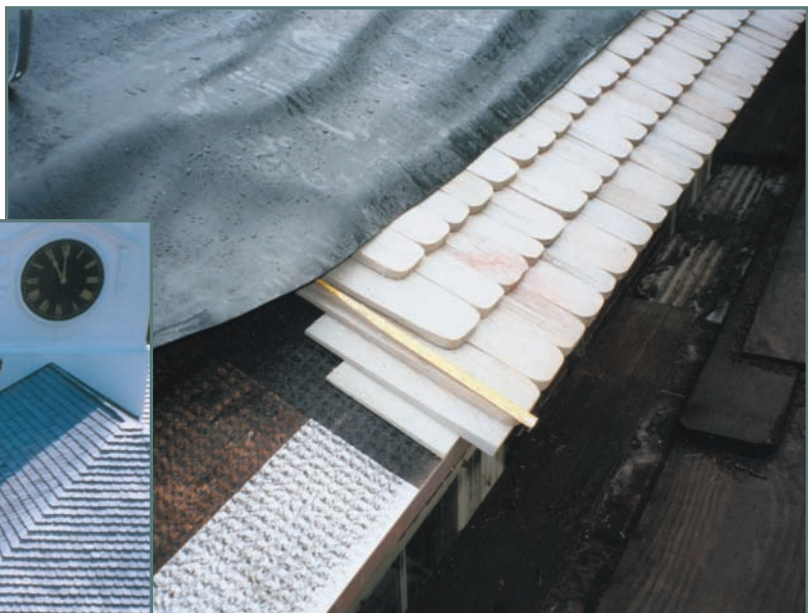
Photograph 3—Typical eave construction viewed from scaffolding during construction. Shows wood deck, edge metal, ice and water shield at eave only, Cedar Breather, two starter courses of wood shingles, and the new cypress shingles.

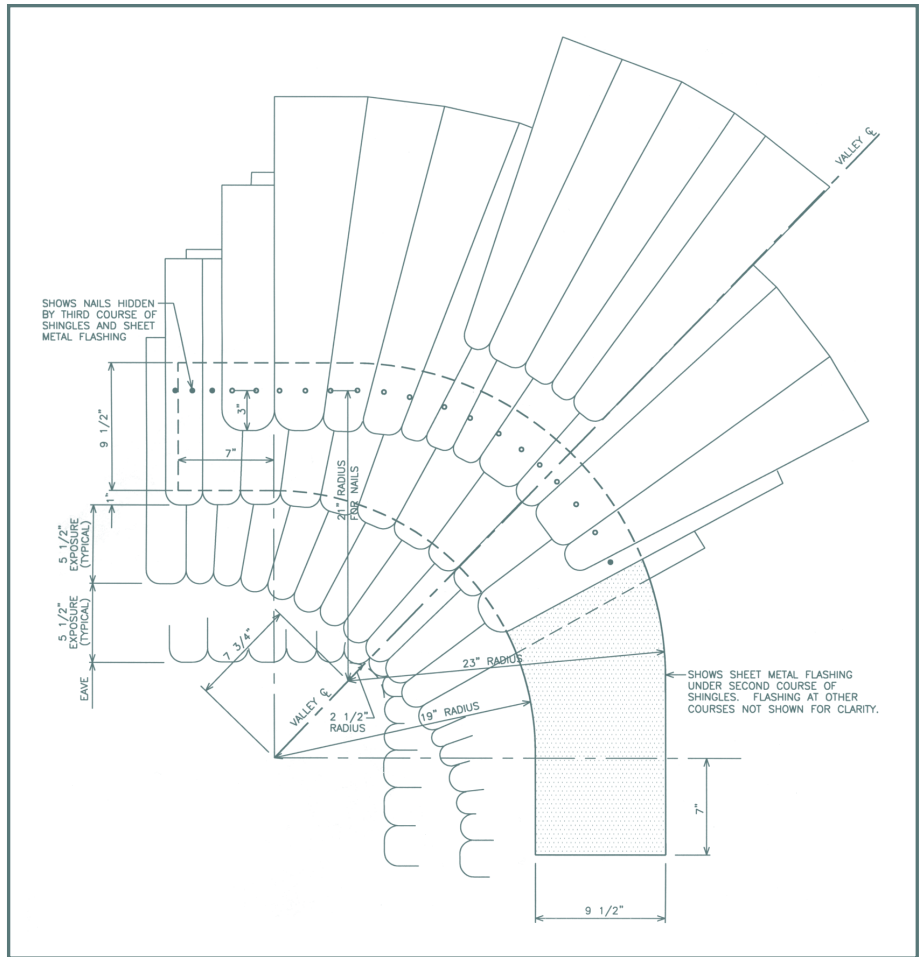
Figure 2—Swept valley shingle layout showing placement of sheet metal interlayment. Only one piece of interlayment is shown for clarity.

The use of shingles with a minimum butt width of 2" (1" radius on each corner) and with a length of 24" rather than 18" would be required within the swept area of the valley. This would satisfy the geometric requirements, but it would not be watertight (see Figure 1). The only way to achieve a watertight valley would be to install sheet metal interlayment as shown in Figure 2.

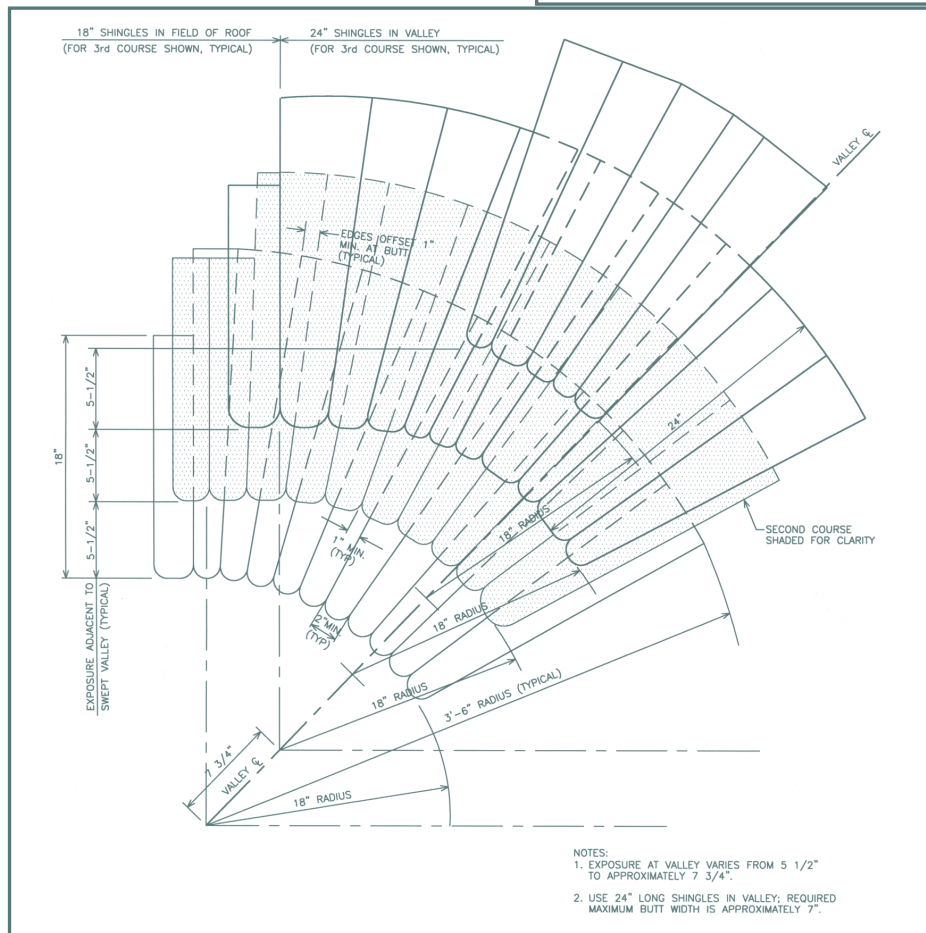
Figure 1—Partial swept valley shingle layout. Note the two different lengths of shingles and note that the exposure varies from 5-1/2" to a maximum of approximately 7-3/4". The second course of shingles has been shaded for clarity.

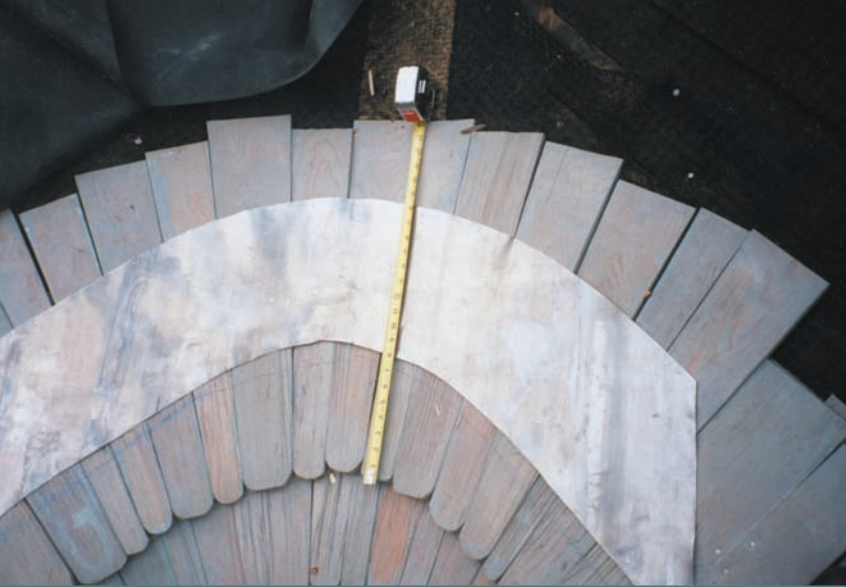
Photograph 4—Swept valley construction. Note the 24" valley shingles, which are tapered and have very narrow tips. Geometry of this construction does not permit the joints to be offset from one course to course below; therefore, the lead "step" flashing was installed. Also, note the adjacent 18" shingles. The longer shingles in the valley are necessary due to the increased exposure required within the sweep of the valley.

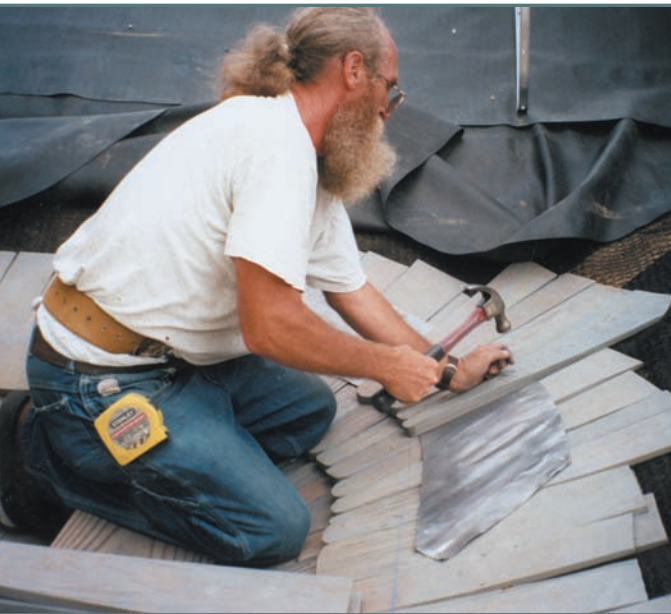
Photograph 5—Buddy Tate constructing a valley. Note the 18" shingles approaching the valley, the 24" shingles within the swept portion of the valley, and the lead flashing.

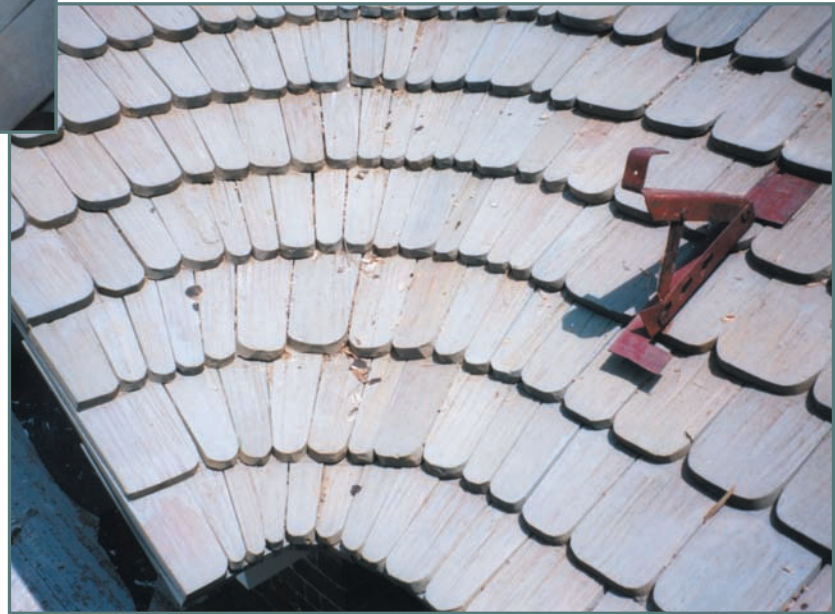
Photograph 6—View of completed swept valley.

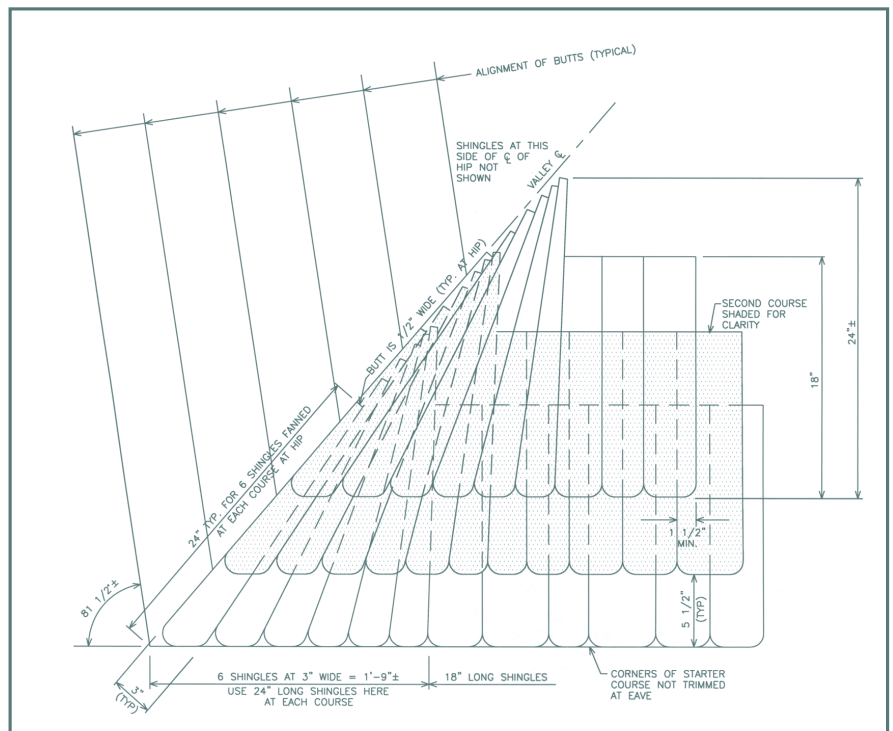
minimum butt width of 3" and with a length of 24". Again, this would satisfy the geometric requirements but would not be watertight (see Figure 3). The only way to achieve a watertight hip would be to install sheet metal interlayment as shown in Figure 4. Photographs 7, 8 and 9 show the actual construction.

Figure 3—Partial fanned hip shingle layout. Note the two different lengths of shingles. The second course of shingles has been shaded for clarity.

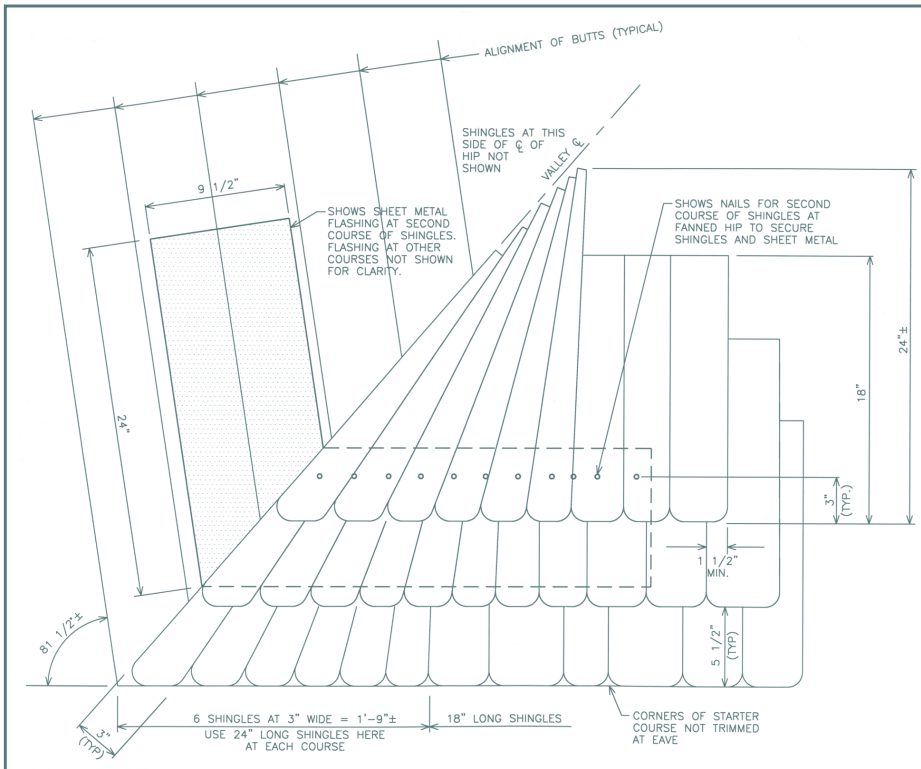
Figure 4—Fanned hip shingle layout showing placement of sheet metal interlayment. Only one piece of interlayment is shown for clarity.

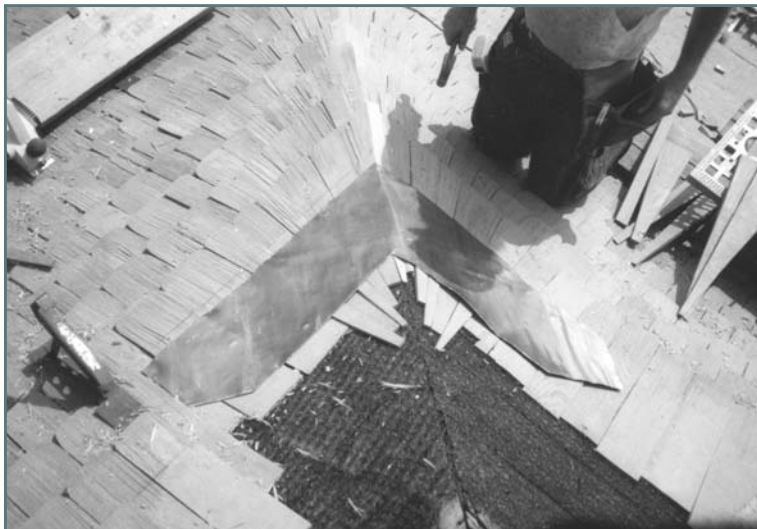
Photograph 7—Fanned hip construction. Note the 24" hip shingles, which are tapered and have very narrow tails. Geometry of this construction does not permit the joints to be offset from one course to course below, therefore, the lead "step" flashing was installed. Also, note the adjacent 18" shingles. The longer shingles at the hip are required due to the increasing distance as the shingles approach the hip in the wood deck.

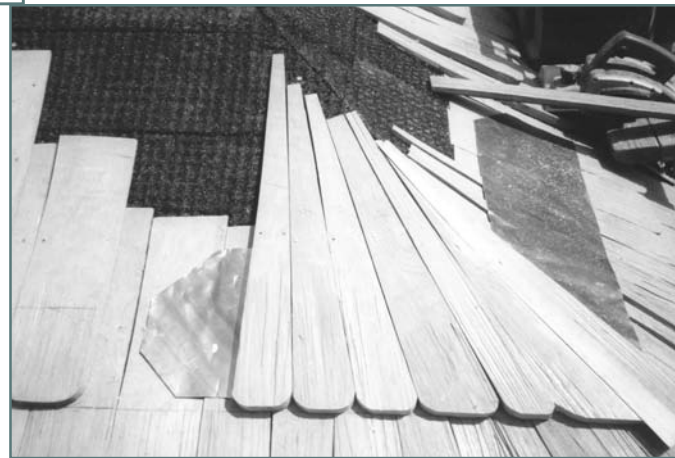
Photograph 8—Fanned hip construction. Shingle to right side of hip has been mitered and lapped; however, the butt remains to be trimmed.

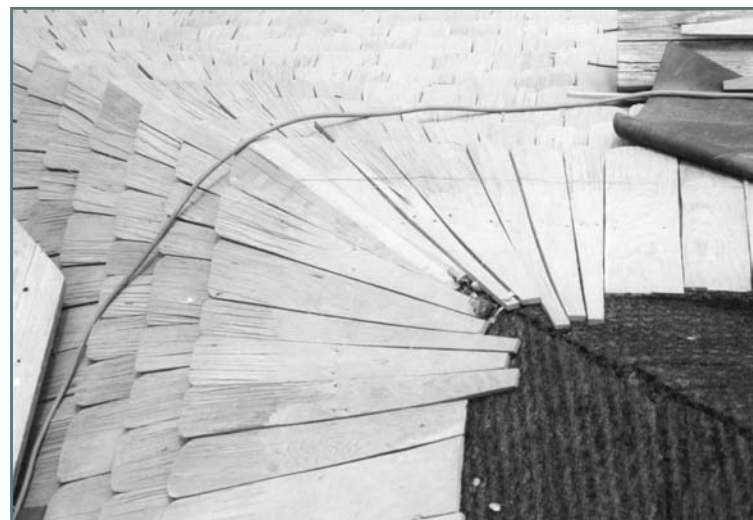
Photograph 9—Completed fanned hip construction.

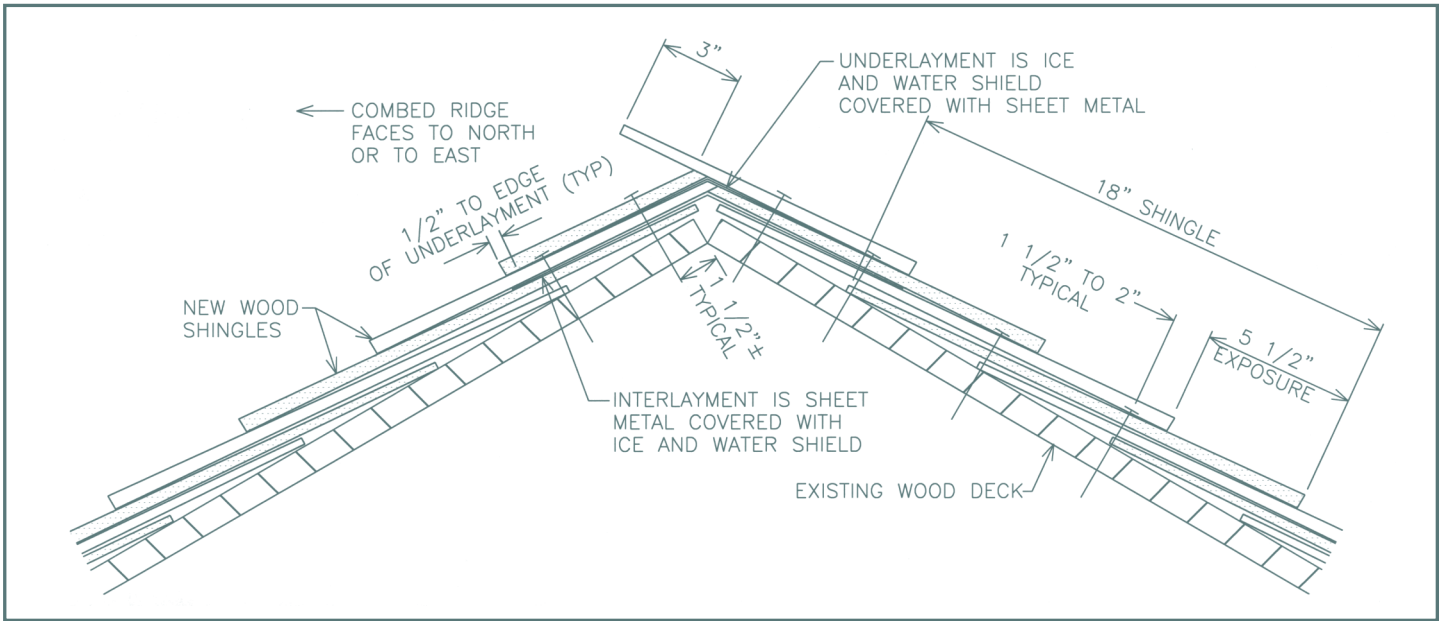
Figure 5—Combed ridge. Note the dual layers of interlayment.

shingles and due to the required exposed nails, these typical details were not considered satisfactory for this restoration project. Therefore, the typical detail was modified to incorporate two layers of interlayment.

The first layer of interlayment would be installed once the tails of the shingles reached the ridge line. The interlayment would be stainless steel sheet metal clad with ice and water

shield material. This would be fabricated to the maximum width possible without being exposed to view.

Next, the second-to-last course of shingles would be installed on each side of the ridge. Following this, the second layer of interlayment would be installed. This would be similar to the previously installed layer of interlayment, except that the ice and water shield material would be installed on the bottom face of the stainless steel sheet metal. This would avoid exposing the ice & water shield material to UV rays at the joints between shingles.

Finally, the last course of shingles would be installed to form the combed ridge. A single layer of interlayment would shed any water entering the joint between abutting shingles at the ridge; however, two layers were detailed to provide two opportunities to seal the shanks of the exposed nails.

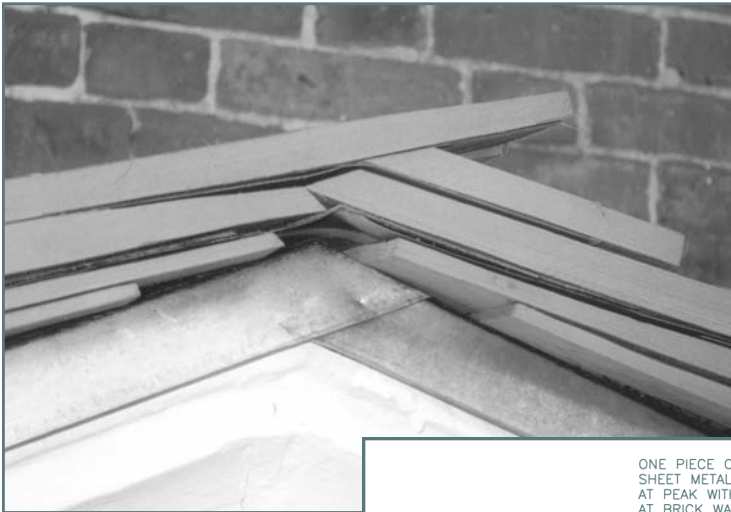
Photograph 10—Combed ridge. Due to the joints between adjacent shingles and the exposed nails, ice and watershield-clad stainless steel interlayment was installed at two locations within the ridge construction. Also, note the added layer of ice and water shield that was placed under the first layer of clad stainless steel.

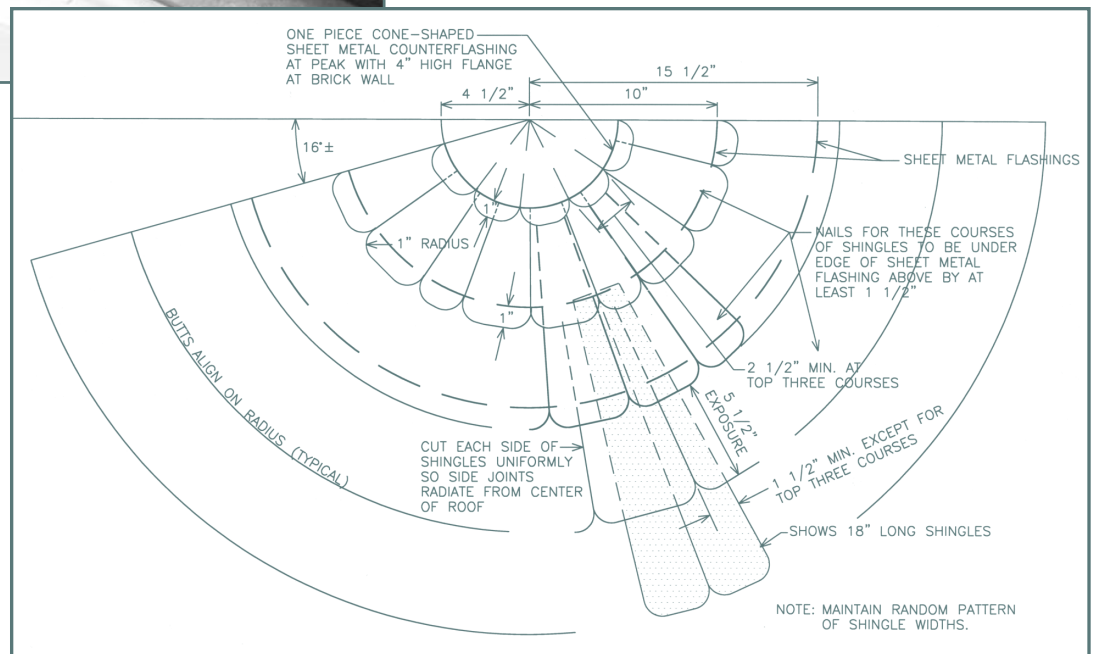
Designing this detail would involve addressing constraints similar to those encountered for the swept valleys and the fanned hips. *Figure 6* shows how the last three courses of shingles would be installed utilizing narrow, tapered shingles. As the construction approaches the peak, it becomes increasingly difficult to maintain the required offset at the joints between shingles, and the nails for the last course of shingles would be exposed.

Figure 6—Plane view of shingle construction at peak of apse roof showing shingle layout and location of sheet metal interlayment.

Therefore, sheet metal interlayment was detailed here as well. *Figure 6* shows one layer of sheet metal interlayment and a sheet metal cap that would be fabricated with a vertical flange.

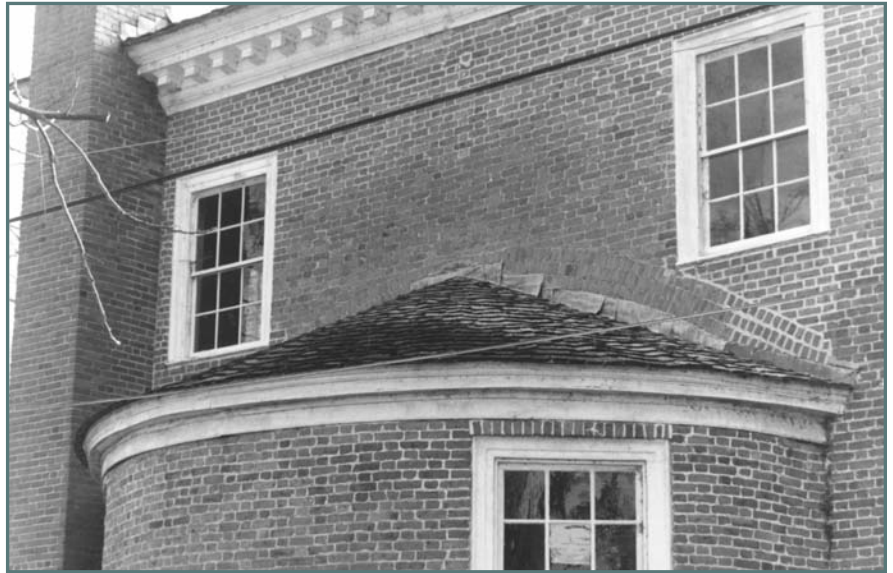
Photograph 11—Roof of apse before reroofing. Note that the geometry of this cone-shaped roof is not a portion of a true cone. The circular eave does not intersect the wall at a 90° angle; therefore, the apex would be located within the main building. This altered the geometry of the exposed roof such that the distance from the peak to the eave, as measured along the wall, is greater than the distance from the peak to the eave as measured in a plane perpendicular to the wall. This required that the exposure of the wood shingles be constantly changing along each course of shingles.

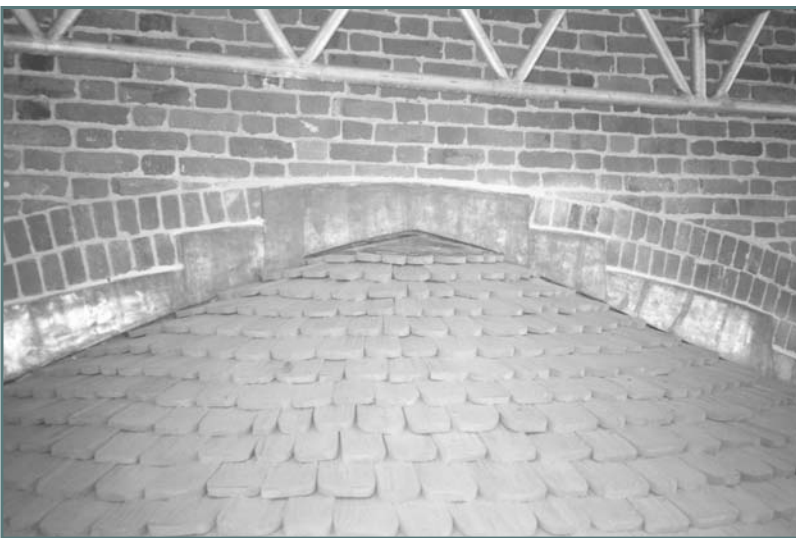
The actual construction is shown in *Photographs 12 and 13*. Note that the actual construction involved the installation of two pieces of concealed interlayment rather than a single layer of concealed interlayment as detailed.

Photograph 12—Fanned shingle installation at apse.

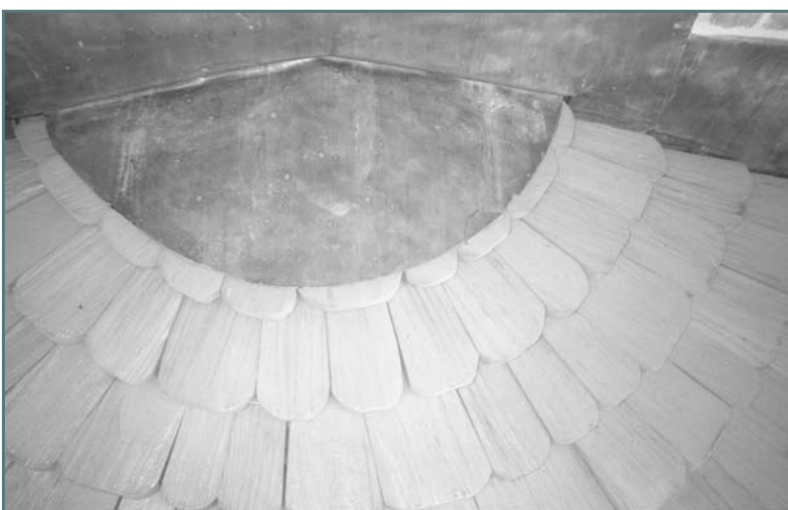
Photograph 13—Fanned shingle installation at apse roof. Note the lead cap at the peak of the apse shingles. Not visible is the lead interlayment under the course of wood shingles below the lead cap.
