# Blue-Green Algae and its Effect on Fiber-cement Roofing Within a Microclimate

## An Investigation of Biodeterioration of Fiber-Cement Roofing by Cyanobacteria and its Implications for the Roofing Industry in Hawaii

By Colin Murphy, RRC, FRGI

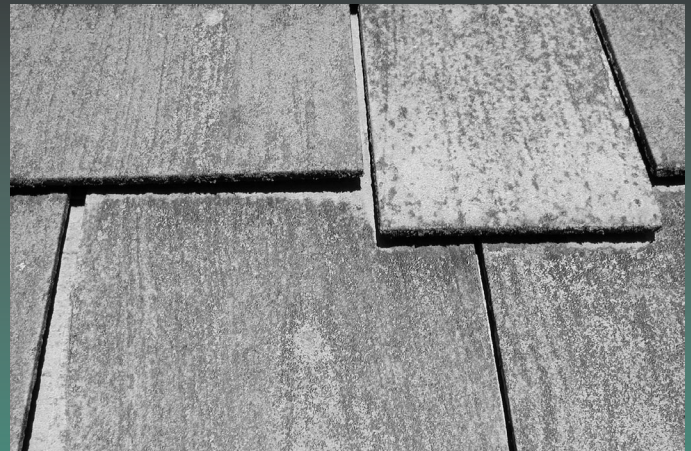
Inspections of fiber-cement roofing assemblies installed throughout Oahu revealed very extensive areas of blackish "algae" growth at all roofs. Only areas under cover (i.e., below overhangs and trees) were void of surface growth.

Photo 1 – Typical blackish algae growth observed throughout the project complex.

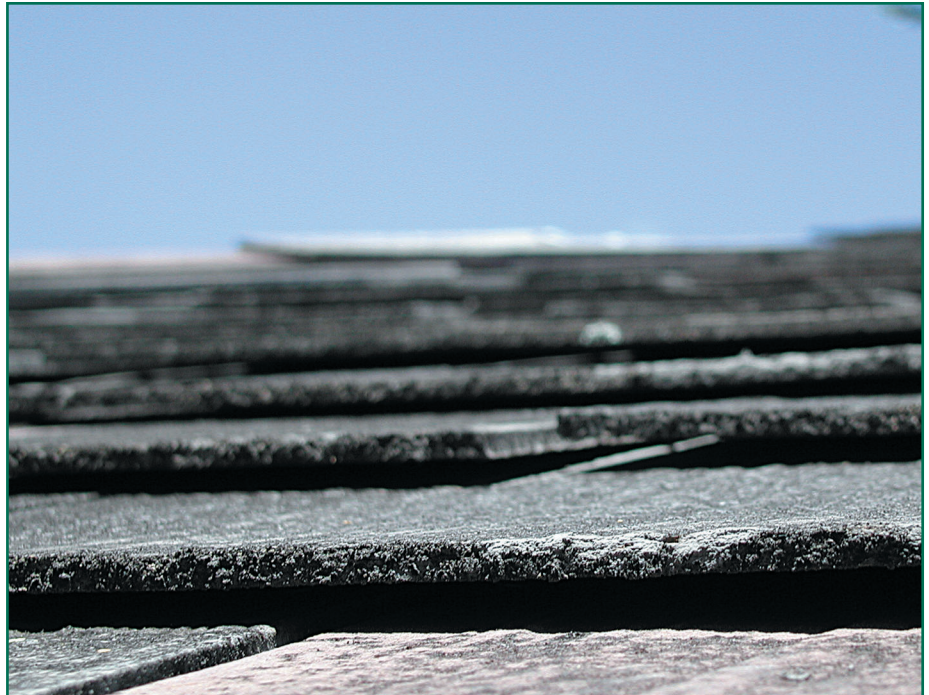
*Photo 3 – Crumbling deterioration at leading edge*

including cracking, crumbling and "leafing" at the leading edge, and delamination of the fiber-cement layers.

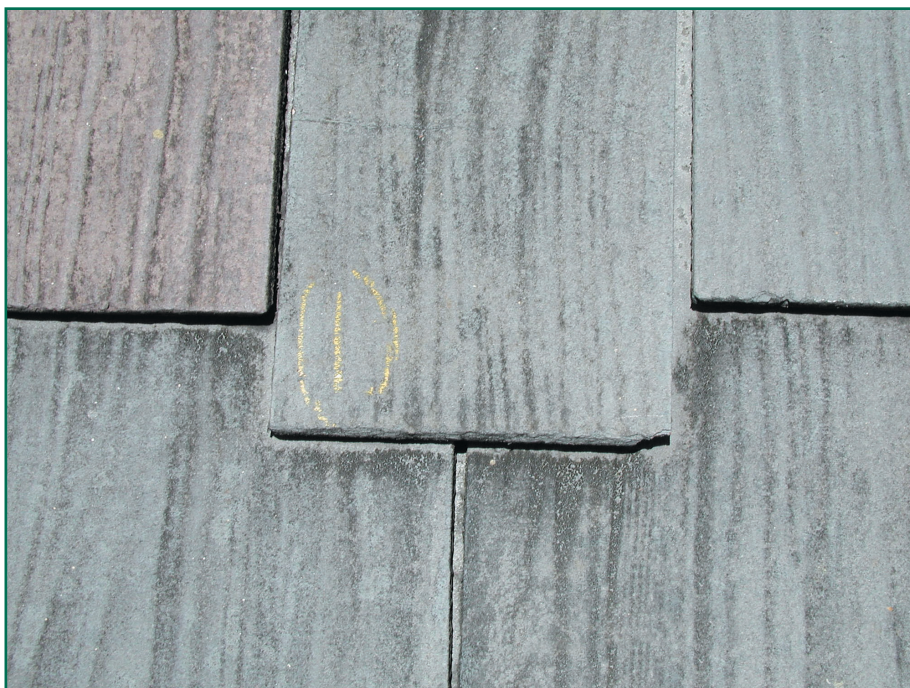
*Photo 2 – Typical blackish algae growth observed throughout the project complex*

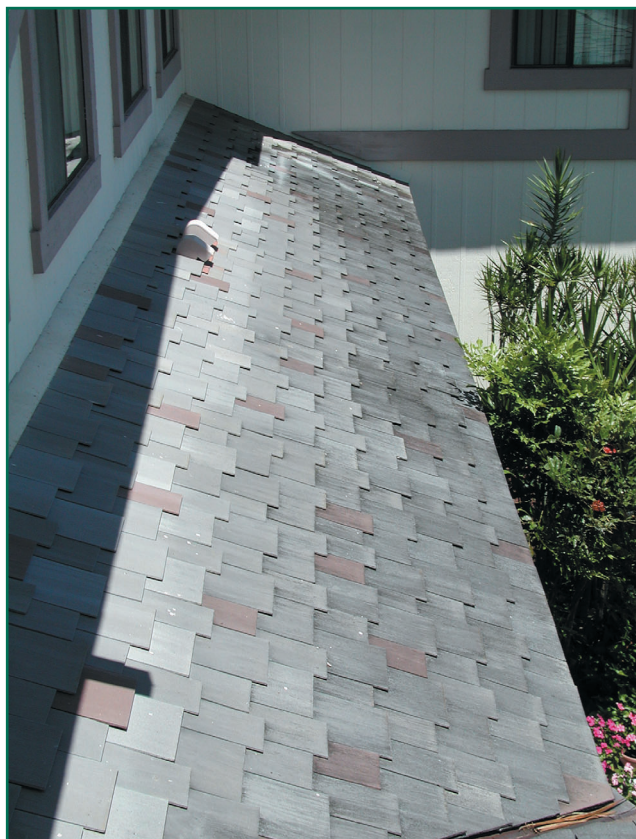
Photo 4 – Blackish algae growth begins below eave-protected, shaded area

With varying degrees of severity, areas of blackish "algae" growth on the shakes were observed throughout the Project complex. At some localized areas, e.g., under eaves and at locations swept clean by tree branches, minimal algae growth was observed on the fiber-cement shakes. Generally, inspection revealed significant deterioration of the shakes,

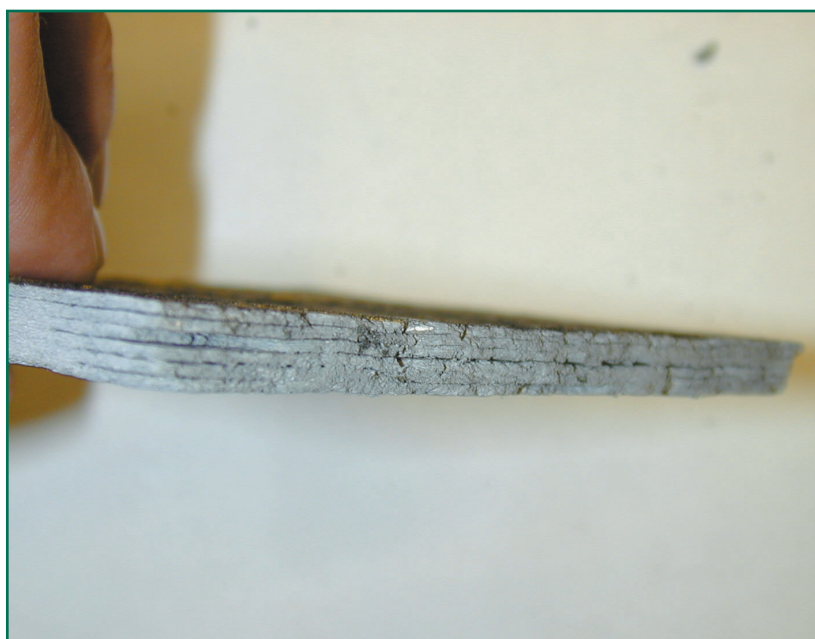
Photo 5 – Cohesive failure of the laminates

Cohesive failure (delamination) of the fiber-cement layers was observed on some samples. In several cases, the extent of the structural deterioration precluded testing of physical properties.

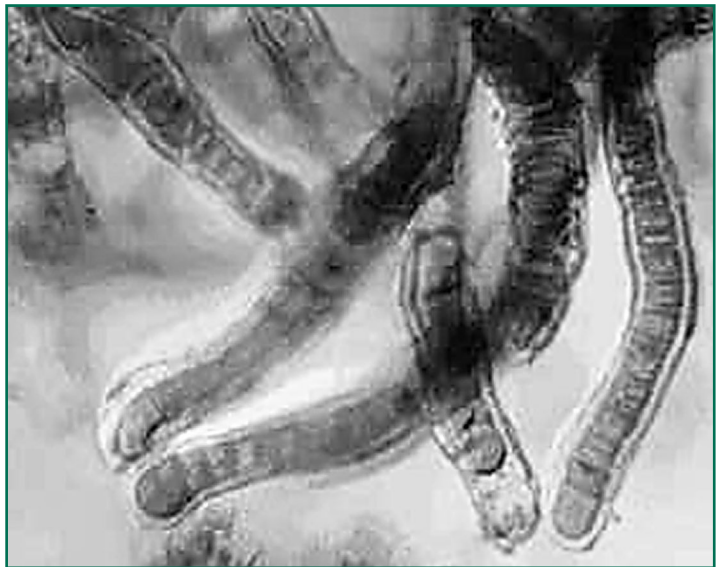
In addition, the *Scytonema* cyanobacteria have filaments that are surrounded by mucilaginous (moist and sticky) sheaths that are negatively charged and hydrophilic. The sheaths absorb and store water and associated nutrients during periods of rain and from moisture found within the substrate. If the conditions (inorganic nutrients, pH, UV, temperature, and water) are appropriate, the filaments will grow, form new sheaths, and extend over larger and deeper areas. The effects of the shrinking and swelling of the hydrophilic sheaths during arid conditions and periods of moisture intake will accelerate the biodeterioration process.

Photo 6 – Microscopic view of *Scytonema Endolithicum* – mucilaginous sheaths cover the growing filaments (<http://www.botany.hawaii.edu/faculty/webb/BOT341/Cyanobacteria/Cyanobacteria.htm>)

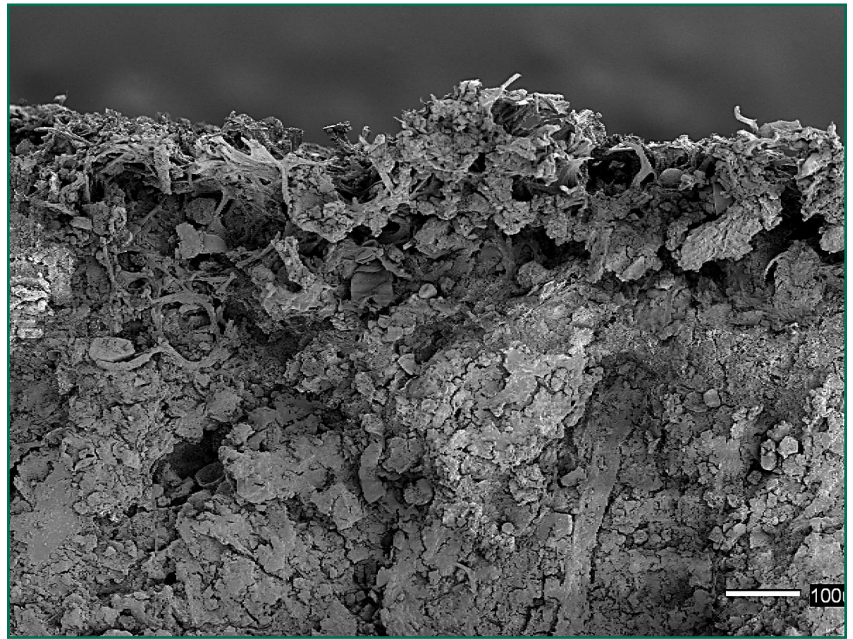
SEM (scanning electron microscope) images produced by Lab-Cor<sup>23</sup> dramatically depict the effects of the expansion of these mucilaginous sheaths into the fiber-cement elements. *Photos 7, 8, and 9* provide comparisons of a 150x cross-section of the surface of a fiber-cement sample (from below an eave) without algal growth and 100x and 1000x cross-sections of the biodegraded surface of a sample colonized by *Scytonema*.

*Photo 8 – SEM Image (original mag = x100) of cross-section of surface of fiber-cement sample taken from area colonized by Scytonema*

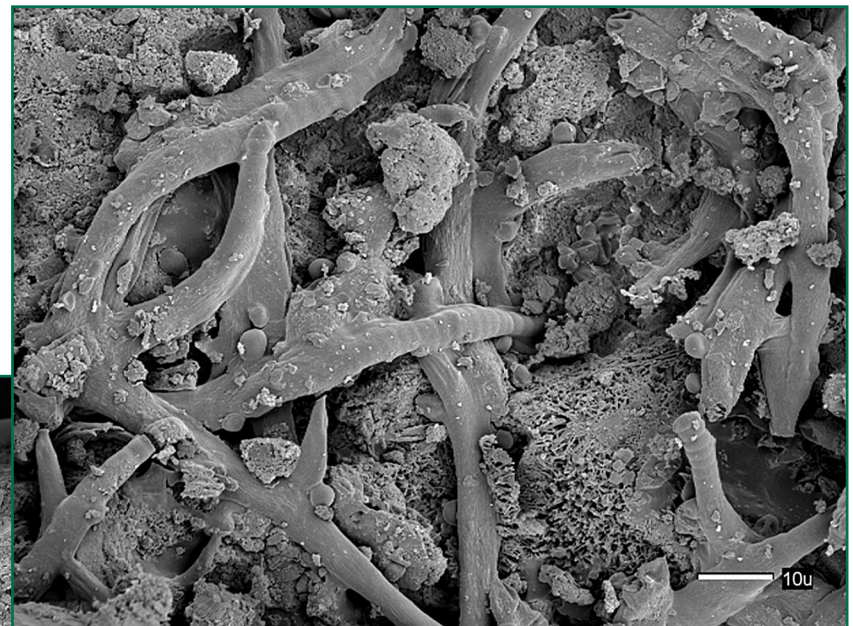
In summary, *Scytonema* is feeding upon the rich, moist fiber-cement matrix. Grains of fiber-cement are continually being loosened from the substrate and adhered to the sticky, slimy sheaths to provide essential nutrients to the feeding cyanobacteria.

The resulting corrosive secretions work to loosen more grains from the product matrix. The swelling sheaths apply stress to the shake surface and core, resulting in stratification and "leafing."

*Photo 9 – SEM image (original mag = x1000) of cross-section of surface of fiber-cement shake. Grains have "... become disassociated from the product matrix and become entangled with and adhered to the gelatinous sheaths of the filaments of the growing Scytonema sp."*

Remediation of the conditions observed in Hawaii may require similar full removal and replacement of fiber-cement roofing systems. ■

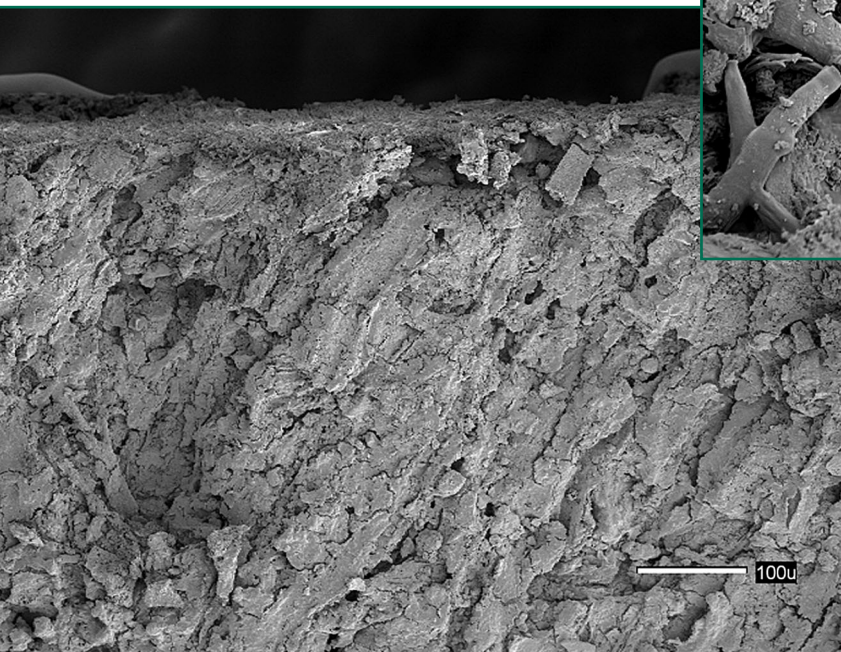
*Photo 7 – SEM image (original mag = x150) of cross-section of surface of fiber-cement sample taken from under eave where no algal or bacterial colonization had occurred*
