SMARF BUILDING CAPE CANAVERAL AIR FORCE STATION, FLORIDA

*Seven
Years
Later*

BY RICHARD (“DICK”) P. CANON, RRC, PE, FRCI
BLAKE S. JOPLIN, EIT
S. THOMAS WATSON, MSCE, EIT

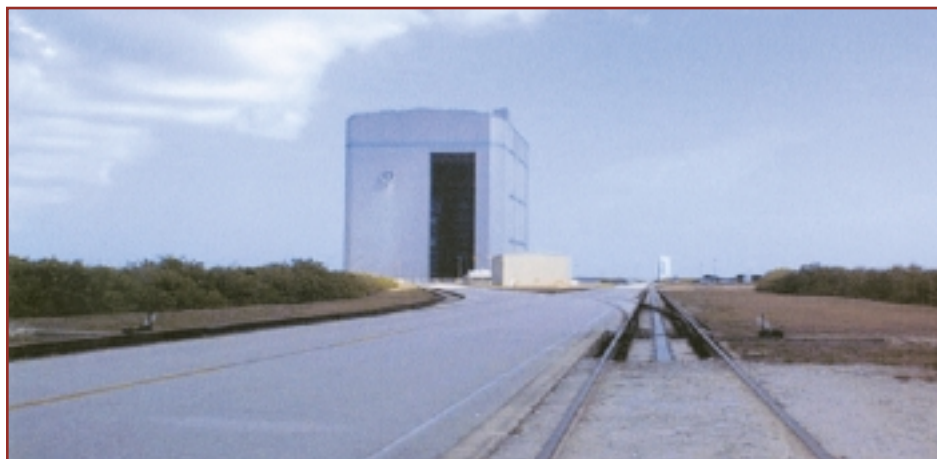
Photo 1: Exterior view of SMARF Building.

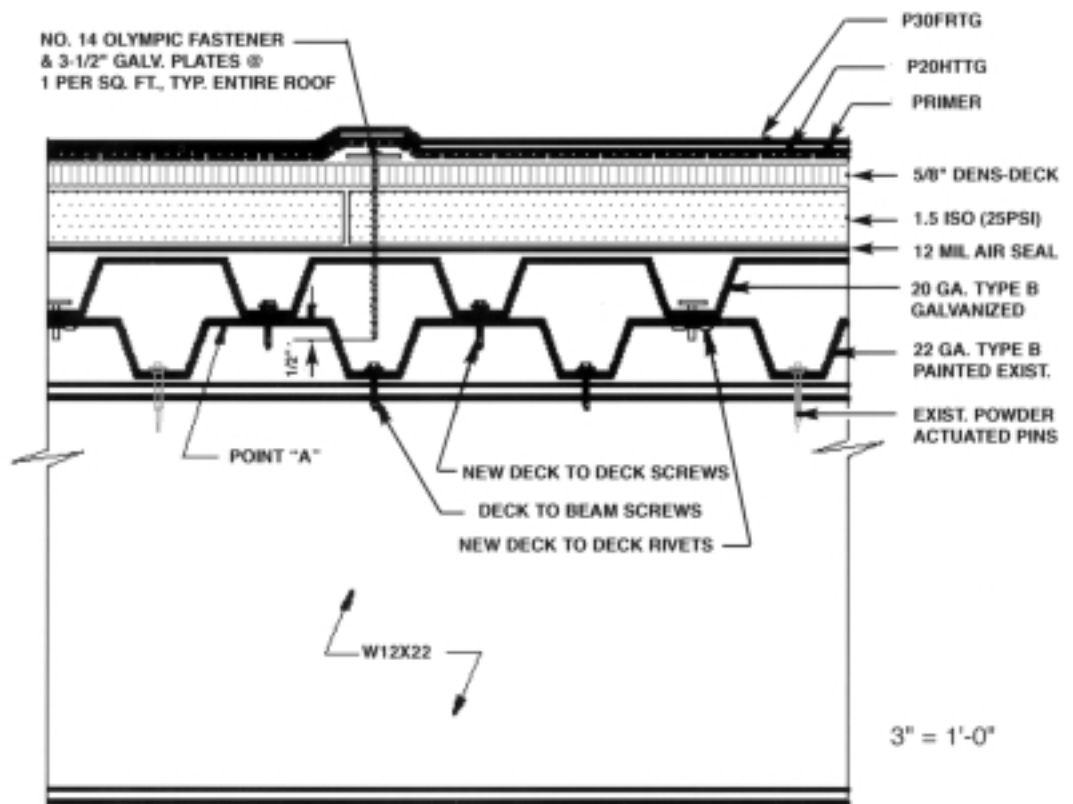
Figure 1: Roof cross-section.

The results of all twelve fastener tests exceeded the target value of 485 lbs. force as shown on *Table A*. The higher values of over 1,000 lbs. are probably because the screw penetrated both the over-lay deck and the original deck at point "A" on *Figure 1*.

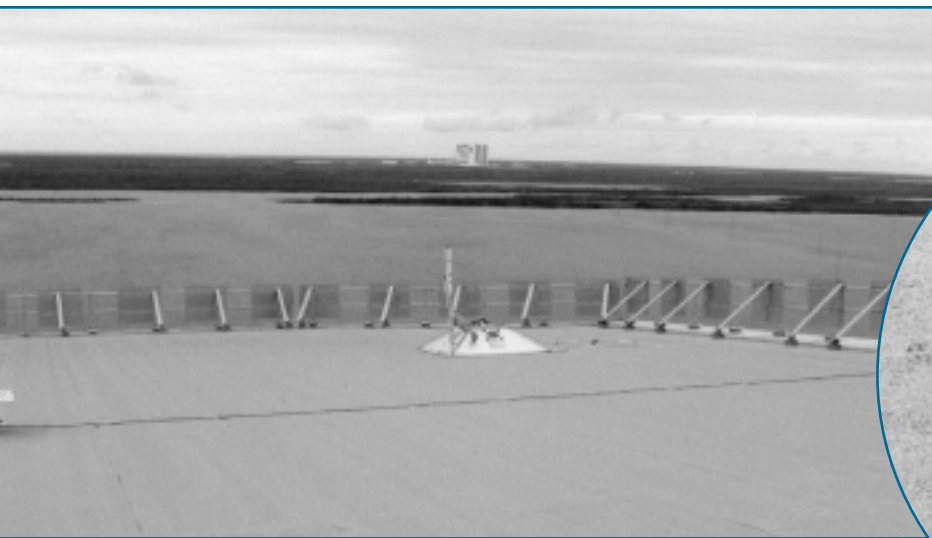
Above: *Photo 2: Wind diverter/spoiler system. Chamber in place at U-3.*

Richard Canon personally inspected the spoilers. No deficiencies of any kind were observed. The U-bolt-to-handrail connections observed were tight and double-nutted. There was no vibration of the panels checked when struck with the hand, indicating securement. The brace struts were tight. No unusual corrosion was observed. The penetration pockets need some attention relative to water resistance.

The system of spoilers mounted on the handrail is in good condition. The connections and bracing are sound and functional. No repairs to the spoiler components are needed, but Canon Consulting suggested that it would be prudent to have these inspected annually or at least on the 10th, 15th and 20th anniversaries of completion (2004, 2009, and 2014).

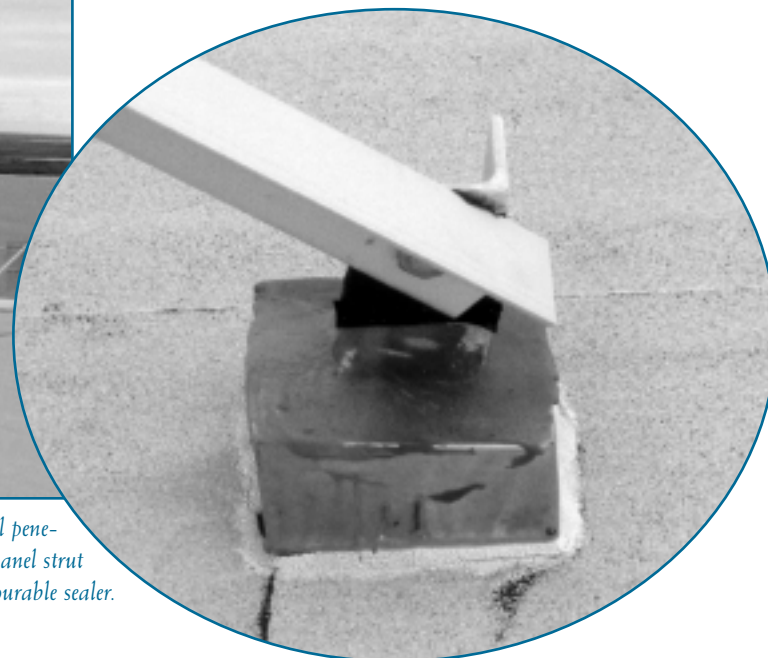
Right: *Photo 3: Typical penetration pocket at spoiler panel strut filled with two-part pourable sealer.*

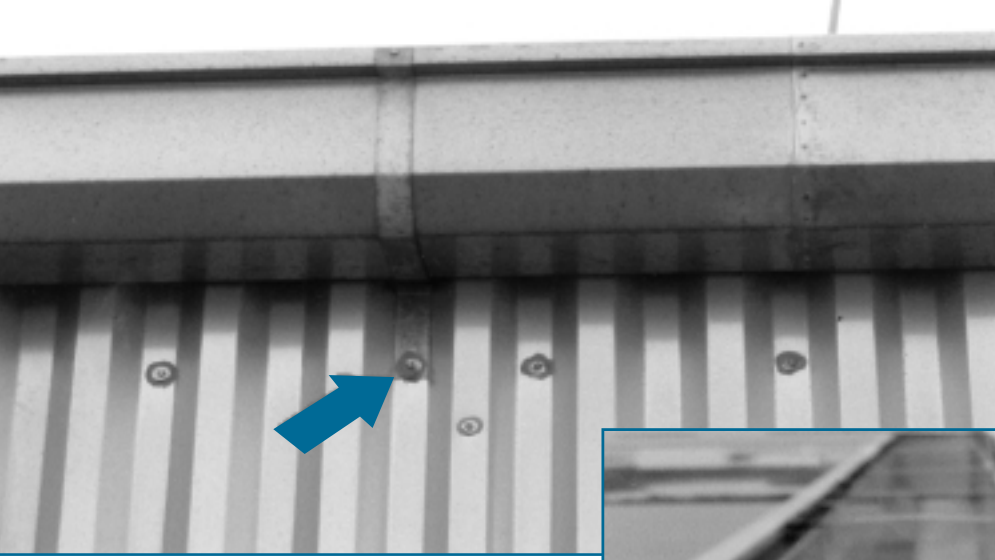
Left: Photo 4: Gutter with wrap-around bracket. Note back of bracket has an extension that is fastened to the wall girt for securement to resist rotation of the gutter in high wind conditions.

Donning a safety harness, Richard Canon inspected several locations on each face of the building to evaluate the attachment of the gutter and rake fascia assembly. Generally, the gutter is well secured with no displacement under heavy pulling on the hanger/strap assembly. At one point of observation on the west side, two adjacent lag screws into the edge nailer at the gutter bracket were not driven snugly. They were, however, tight, indicating they have not been withdrawn or backed out. It is believed that they were simply never snugged up. (For long-term performance, this and all other gutter brackets should be checked and snugged up if found deficient.)

The gutters are believed to be safe as they are, but since a random inspection identified several lag bolts that were never snugly driven, all should be checked and driven snug. The pri-

major concern prior to inspection was rotation of the gutter. It is now believed that securement is adequate for the original design, and no enhancements are needed.

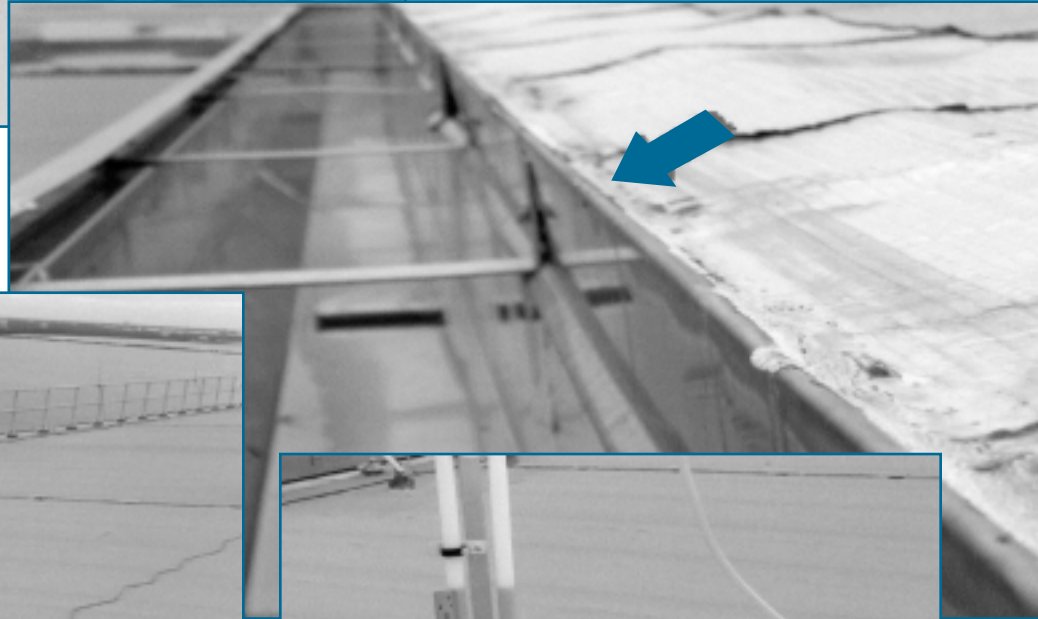
Below: Photo 5: View inside gutter. Several loose bolts noted.

As shown in Photo 5, as part of the firm's 1994 design, the gutter is secured with a wraparound cradle, a standoff support bracket, and a hanger bracket secured to the wall girt with a gasketed, self-drilling anchor. The inspection procedure was for the engineer (properly secured in safety harness equipment) to lean over the edge and physically tug or pull on the gutter assembly and check for any excessive movement or displacement.

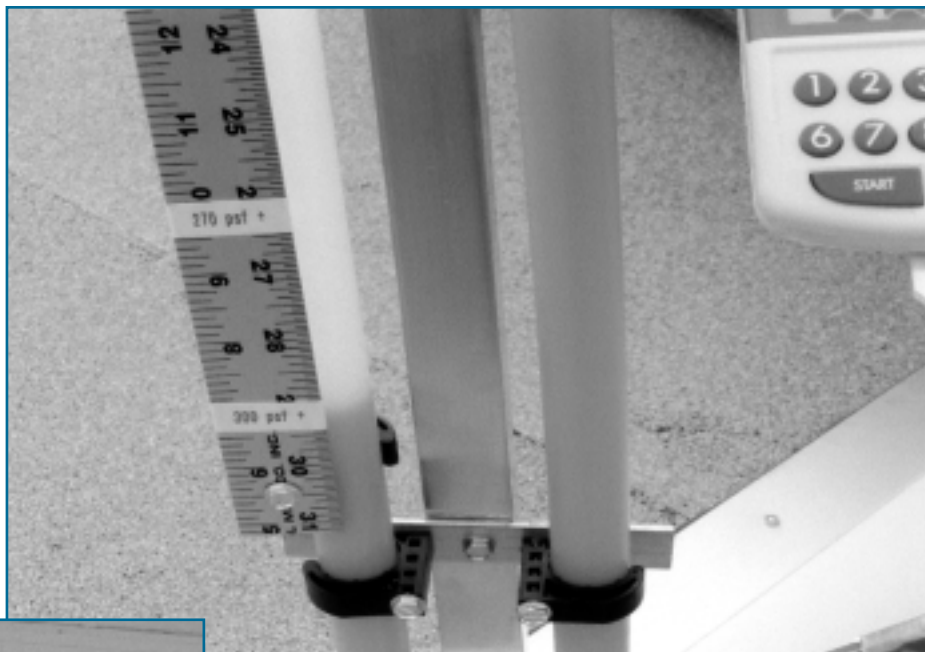
Above: Photo 8: Negative pressure capacity of chamber is in excess of 300 psf. Test pressures ranged from 150 psf to 270 psf.

The results of each of the seven negative pressure tests are summarized in *Table A*. At test sites where the field pressure did not achieve the target pressure of 240 psf, the plane of failure was between the P20 base sheet and the facer of the primed Dens-Deck. This is precisely where it was anticipated the failure plane would be. At test site U-1 (at test cut U-1B), there was separation in a small area between the P20 and the P30. This occurrence is probably an anomaly due to inadequate melt of the P30 to the P20 during application.

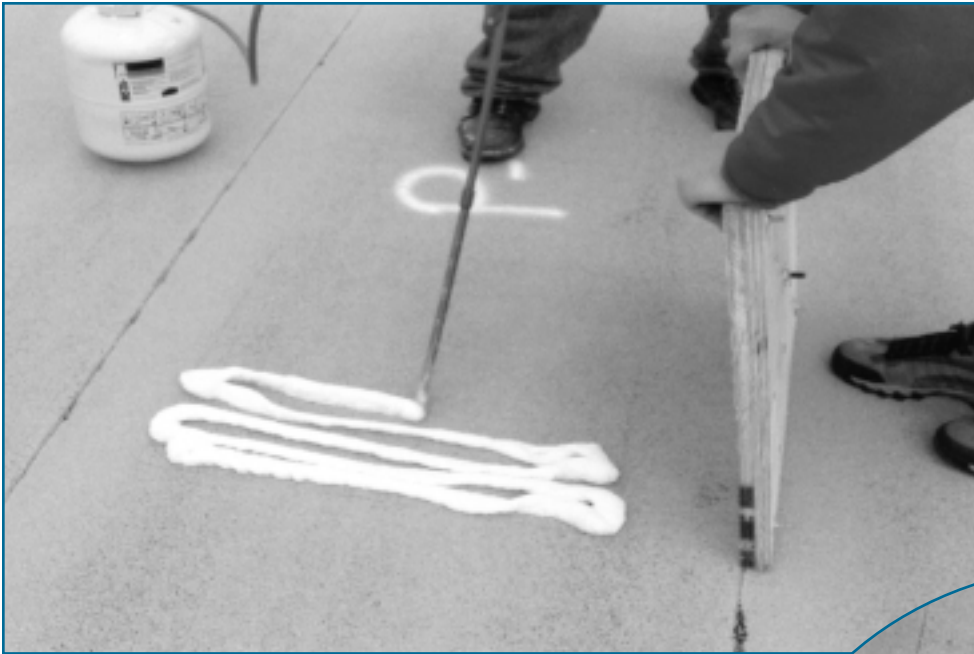
Left: Photo 11: Placement of "Insta-Stik" to secure plywood panels for the FM Global Mechanical Pull Test. Application rate was determined to be heavier than needed, resulting in the panel sliding until material cured.

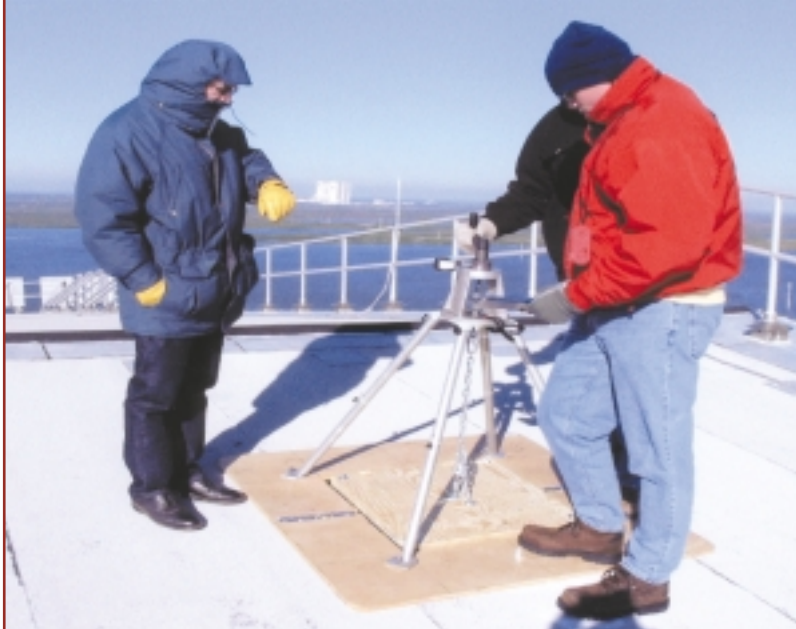
Photo 15: Test in progress. Test values ranged from 240 psf to 300 psf.

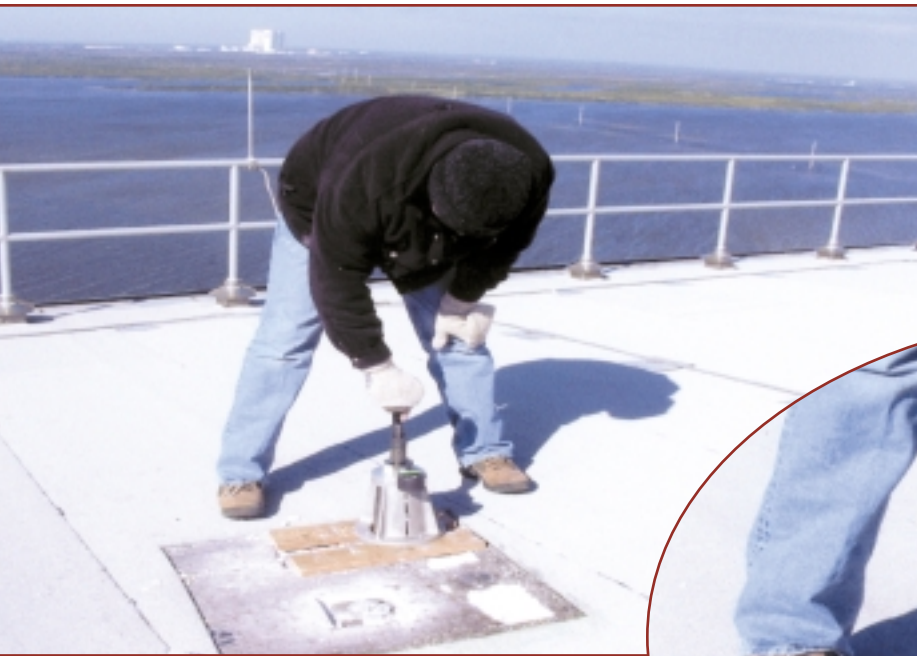
Left: Photo 16: Fastener Pull Out or Withdrawal Test conducted after removing the membrane and Dens-Deck, leaving the fasteners and 3" plates exposed.

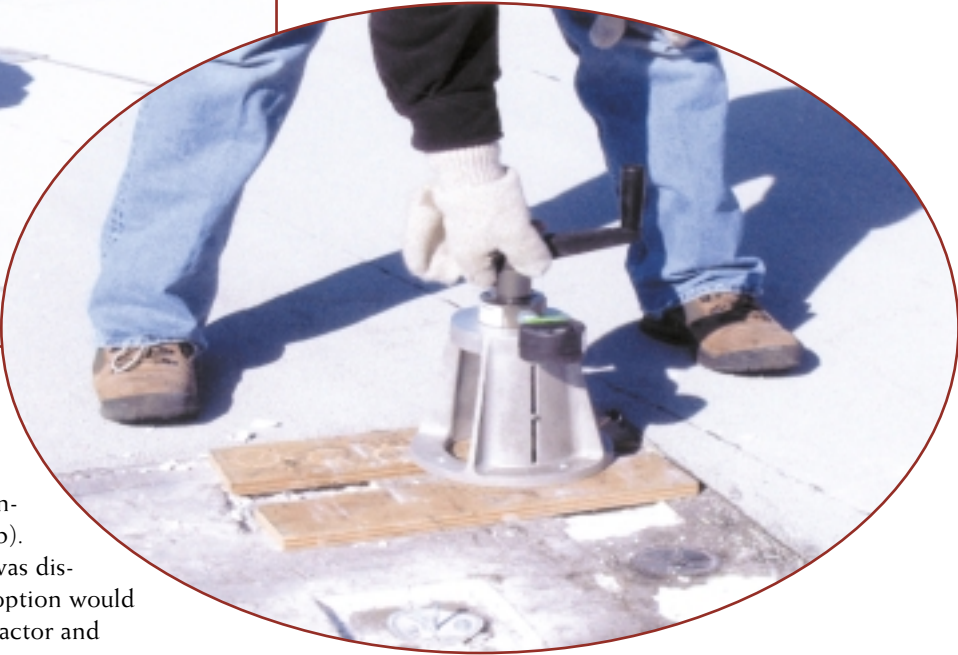
Below: Photo 17: Plywood panels placed on surface to distribute load during testing. Values ranged from 528 pounds to 1,274 pounds. Fasteners are spaced at approximately 1'-0" on centers.

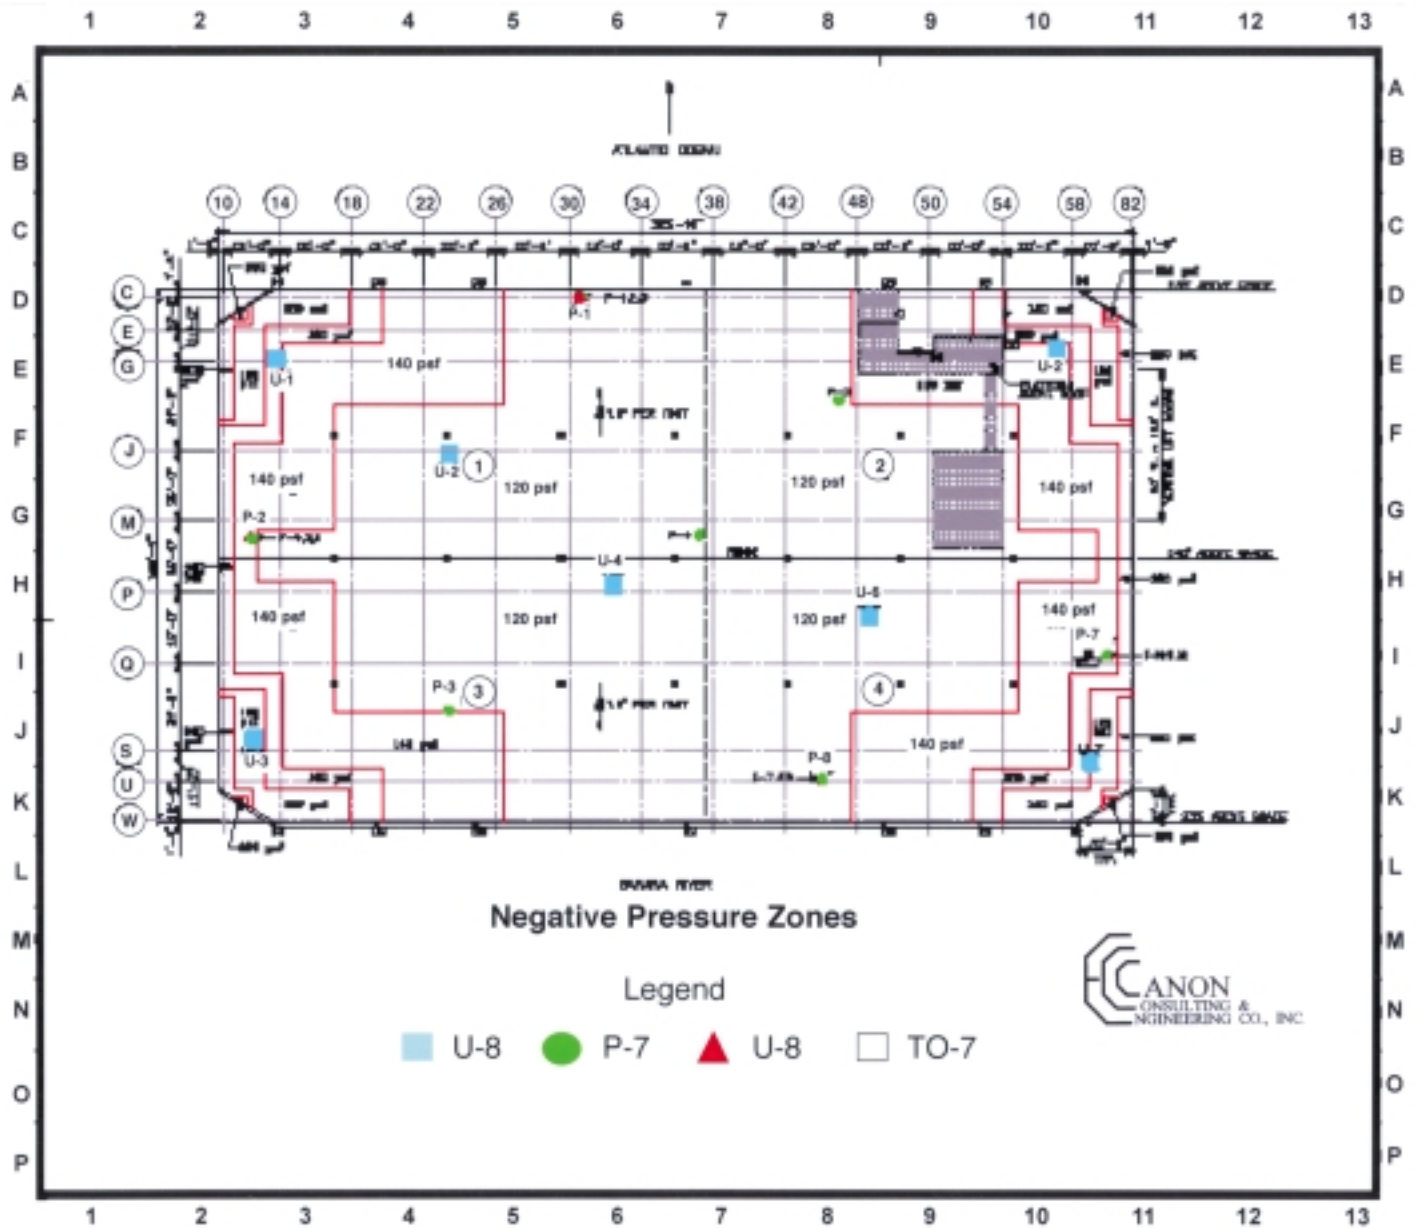
Drawing R-2: Negative pressure zones.

Note on *Drawing R-2* that from the wind tunnel study, the field of the roof and the long axis perimeters along the east and west sides have a maximum uplift value of 120 psf. The corner pressures range from 140 psf up to 220 psf with the 220 psf value applicable at only at a very small segment on the beveled corner of the building corners as shown on the drawing.

The authors believe that the Negative Pressure Test and the FM Pull Test are more representative of a test of the roof's failure mode under uplift. This is because if a single fastener is overloaded, its load will be redistributed to the four adjacent fasteners and thus resist the uplift. In summation, the probable safety factor on the SMARF roof is derived from the average of the Negative Pressure Tests and the FM Pull Tests. This value is 1.97.
