# Further Evaluation of a Pressure-Equalized Single-Ply Roofing System to Determine Drying Effects on a Moist Cementitious Roof Deck

By Warren R. French, PE, RRC, CCS, FRCI

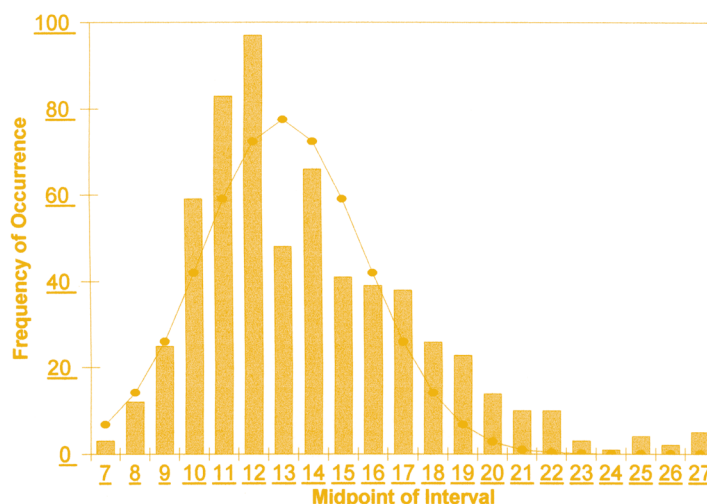
Figure 1

The 1998 moisture survey exhibited moisture content ranging between 4.7% and 33% of dry weight, with approximately 96% of the total area exhibiting moisture content that was less than 25% by dry weight. The most surprising result of a comparison between the two surveys was *not* that approximately half the data points on the 5' by 5' grid had decreased in moisture content, but that about half of the data points had *increased* in moisture content for no apparent reason. Even so, a large majority of the roof locations (about two-thirds of the total area) occurred in the 12% to 25% moisture content range. This represented an increase in the data points occurring in this range of about 65% over the previous study. Although the results of the previous study were considered to be "inconclusive" with respect to drying effects of the P.E. roof system, there was no doubt that the overall trend of

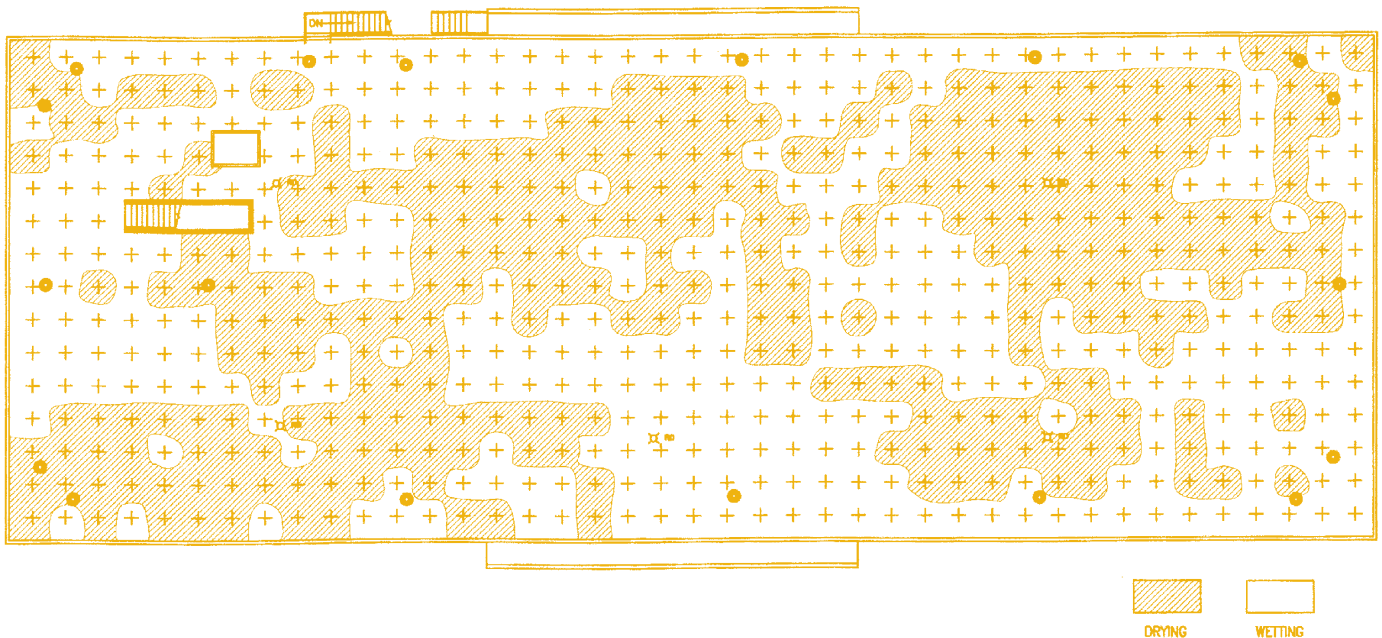
Figure 4

The 1998 moisture survey also consisted of 608 data points and indicated extremely consistent conditions within the gypsum sheathing layer of the new roof. Although the moisture content of these materials was slightly elevated, with moisture content ranging between 17.8% and 18.2% by weight, the integrity of the water-resistant sheathing had not been adversely affected. In addition, although no isocyanurate insulation samples were extracted, moisture probes using a Delmhorst meter indicated no significant moisture in that roofing layer either. However, the lightweight fill still exhibited moisture content ranging from 4.7% to 33%. The mean moisture content throughout the entire roof was 15%, with a standard deviation of 5.6%. Reference *Figures 1* through *3*. A comparison of the wetting and drying that had occurred as of 1998 has been presented herein as *Figure 4*.

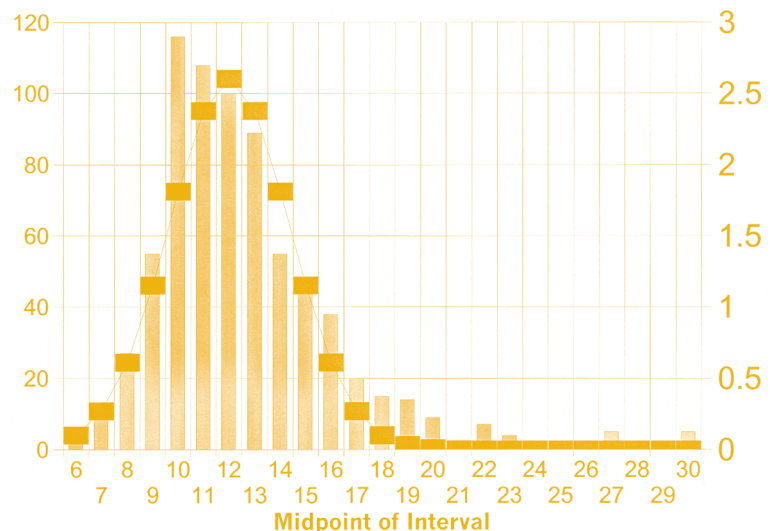
Figure 6

The 2003 moisture survey consisted of 667 data points and indicated consistent results, based on the statistical analysis. During the 2003 survey, samples of the isocyanurate insulation were extracted concurrent with the lightweight insulating fill. The isocyanurate exhibited moisture content ranging between 20.0% and 171.4% by weight, with the highest moisture absorption occurring at a location where an active roof leak was found. More importantly, the lightweight fill exhibited moisture content ranging from 5.4% to just 17.4%. The mean moisture content throughout the roof was down to 12.6%, with a standard deviation of only 2.8%. See Figures 5 through 8.
