# Employing the **SEALED FLOOR TECHNIQUE** to Resolve Underfloor Moisture Problems in Warm, Humid Climates

PART 2 OF 2  
By Larry Elkin, PE

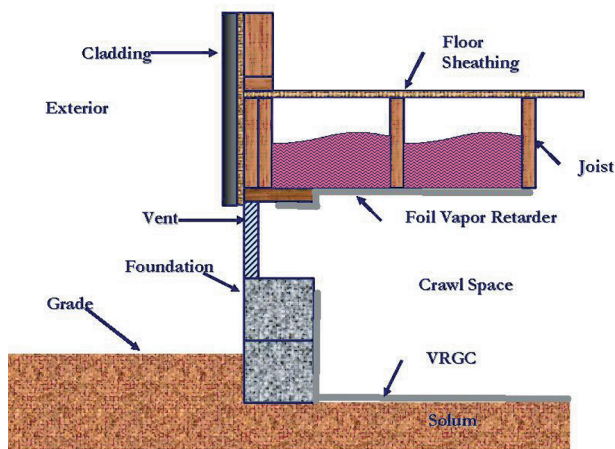
Figure 1: Example of a crawl space treated with the Sealed Floor Technique.

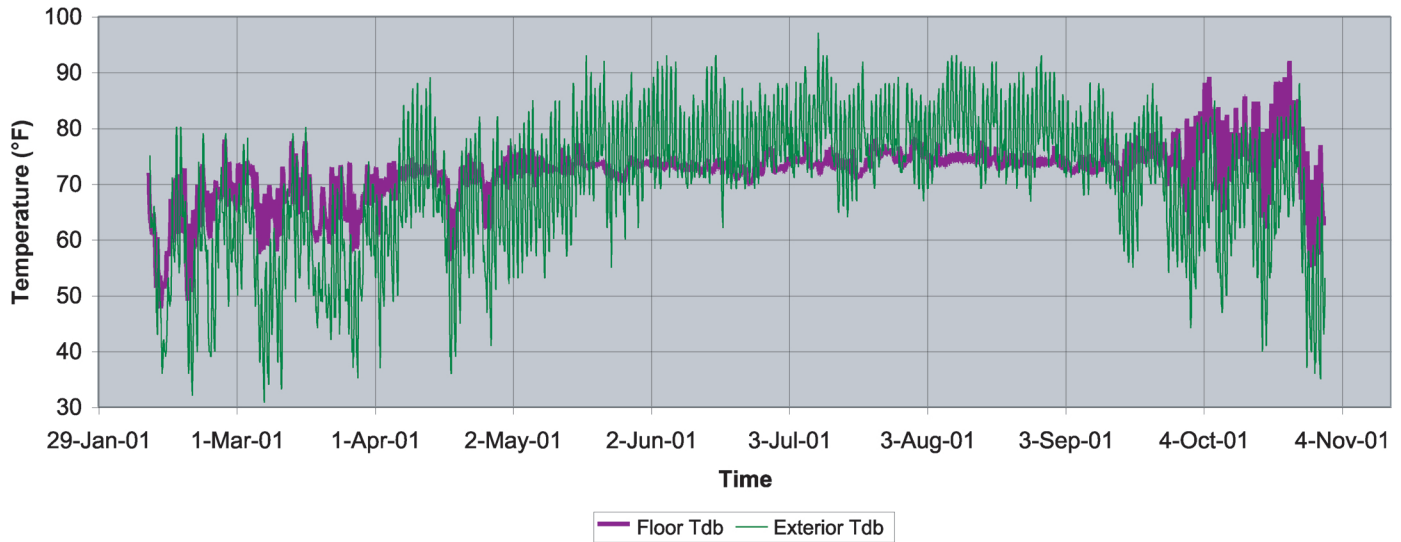
**Figure 2**  
**Edisto Beach Temperature Conditions**

Figure 2 shows a graph of the dry bulb temperatures for the exterior and floor conditions. Overall, the data show that the floor temperature was warmer than the exterior in the winter and cooler than the exterior in the summer. The floor's daily temperature range is larger in the spring and fall as compared to the summer. An examination of the spring and fall data shows that the daily peaks occurred between 3:00 p.m. and 4:00 p.m. The data logger had been installed several feet in from the west wall. The west wall above this location has several windows. It seems that the angle of the sun and the seasonal absence of tree foliage allowed the interior floor surface to warm during the spring and fall. The floor temperatures for several days at the beginning of the sampling period were logged prior to the installation of the floor insulation.

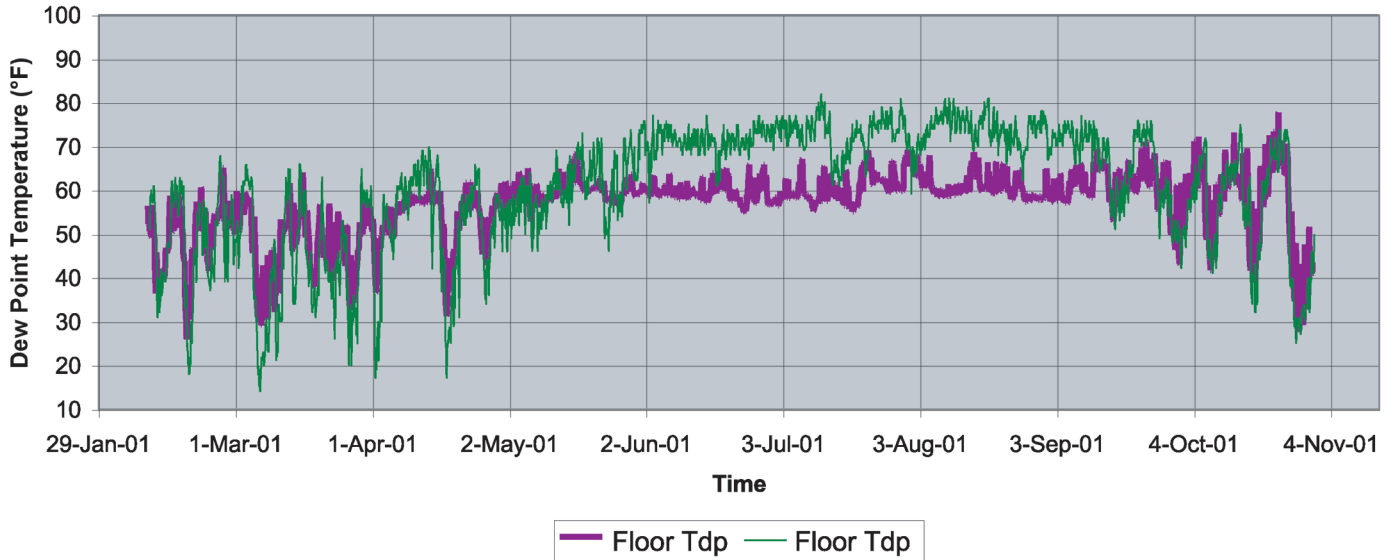
**Figure 3**  
**Edisto Beach Dew Point Conditions**

Figure 3 shows the dew point temperature data for the exterior and floor conditions. The floor's dew point conditions in the spring and fall appear to closely follow the exterior conditions. However, the exterior range is slightly larger than the floor's range. This may be attributable to open windows and doors during the more temperate seasons. The interior and exterior moisture conditions

would tend to equalize as a result of the communication between the interior and exterior. The floor's dew point is approximately 12 to 15 degrees less than the exterior dew point throughout the cooling season (June to September). Occasional cool fronts provided brief exceptions to this trend. This indicates that the floor assembly is effectively isolated from the warm and humid exterior air.

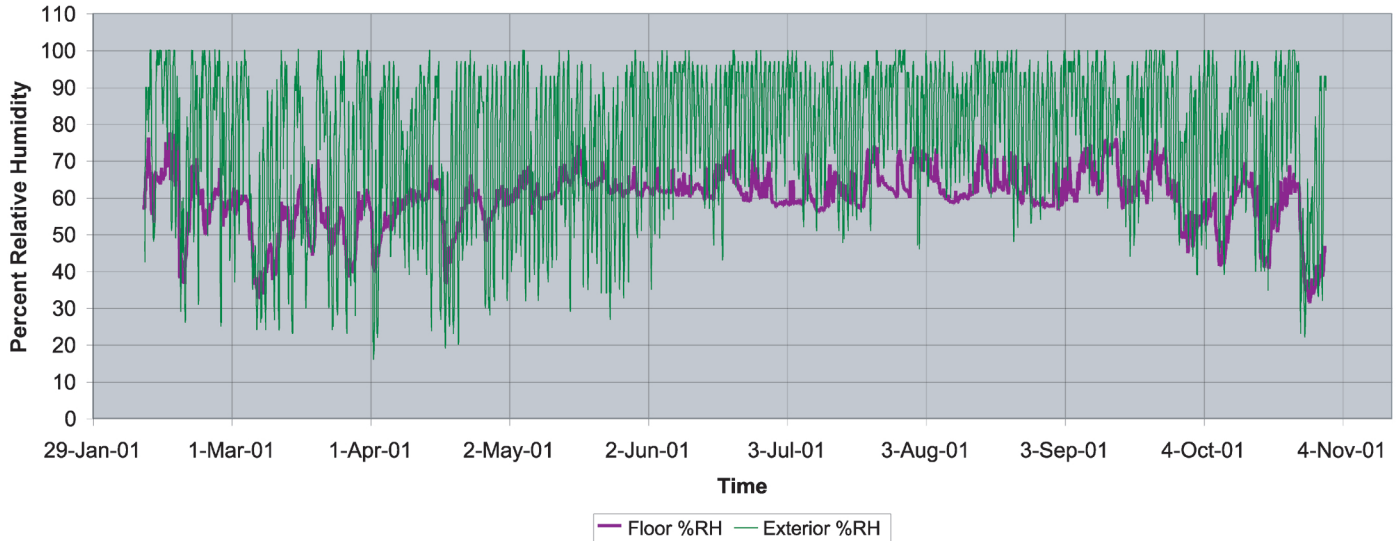
**Figure 4**  
**Edisto Beach Relative Humidity Conditions**

Figure 4 illustrates the relative humidity conditions for the exterior and the floor. Overall, the floor relative humidity (RH) has a smaller annual swing, and the summer RH is consistently lower than the exterior RH. The floor's RH data show only brief spikes above 70% RH and no periods above 80% RH. According to Hugo Hens in "Minimizing Fungal Defacement," the critical threshold for

fungal growth on building materials is an average relative humidity above 80%. While some fungi can develop at RHs as low as 65%, the elevated RH must be sustained for a long enough time for the fungi to germinate. The floor's RH remained above 70% for more than 24 hours only for short periods during mid-September. This may be a result of venting the floor to the interior of the home.
