# RISING *TO THE* CHALLENGE:

## Roofing Rehabilitation of the New York State Capitol

By  
James Jamieson, AIA,  
and  
Niklas Vigener, PE

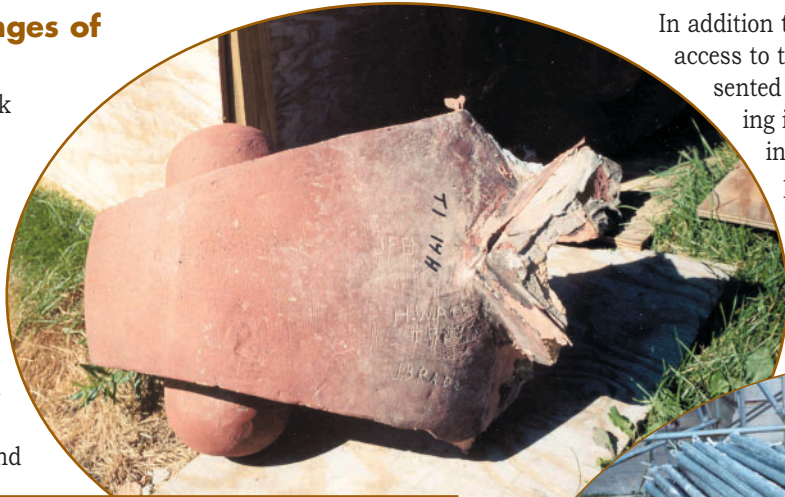
**Existing ornamental terra cotta corner "ram's horn." This piece weighs 275 lbs. and is one of four corner pieces and four center sections that make up the base decoration of the large finials.**

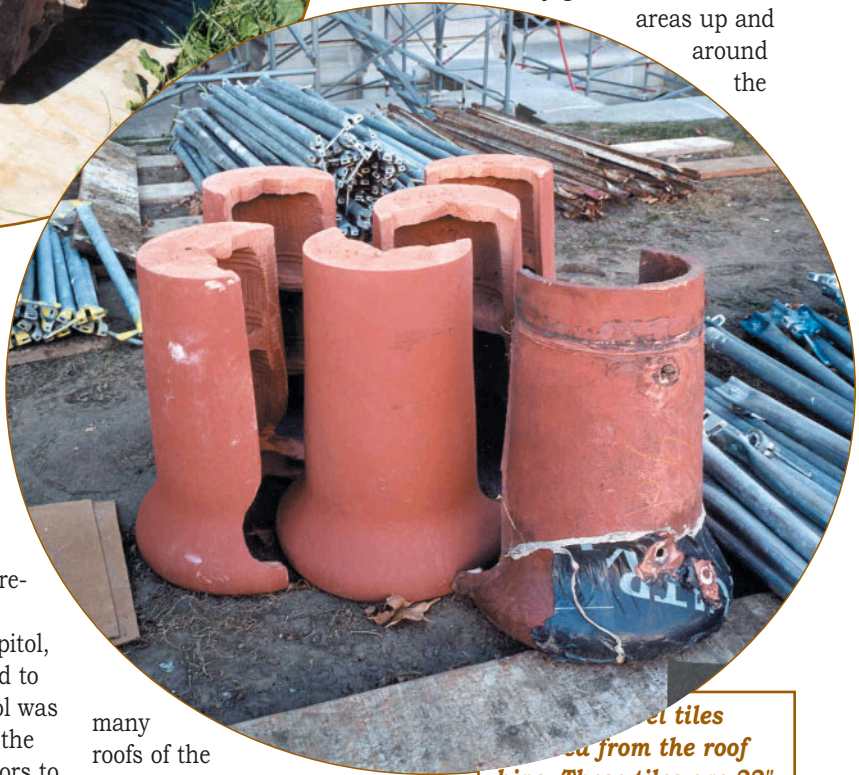
**Existing terra cotta roof tiles removed from the roof hips. These tiles are 22" long and weigh 70 lbs.**

Following initial field investigations and laboratory analysis, the design team concluded that existing terra cotta ornaments along the ridges, hips, and finials of the Capitol (including some of the last remaining original roof materials), were in such poor condition that reuse was unfeasible.

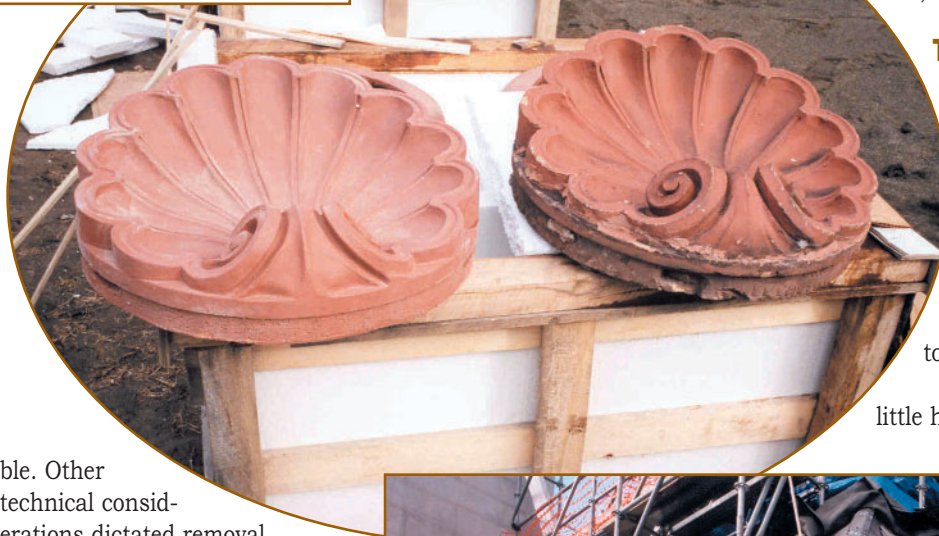
*Shell detail from the lower section of finials, new on the left, old on the right. Each shell weighs approximately 75 lbs. and is 28" across.*
