# METAL ROOFING

# & INTERIOR CONDITIONS

BY E. FRANK KELM, RRC

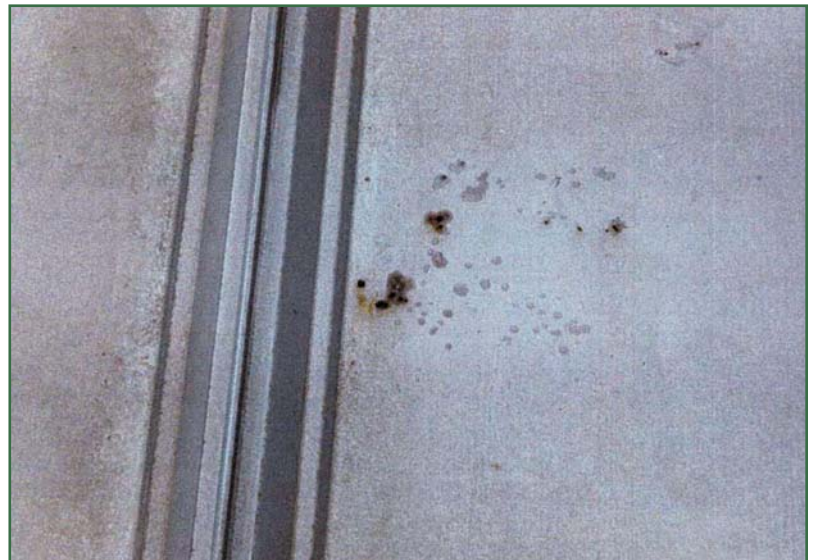
Photo 1: Moisture seeping through corrosion in roof panel.

How important is it to follow these recommendations? Each situation must be considered upon its own merits, but two examples are offered. The first involves a project located in Iowa with a standing seam roof installed with standard insulation, vapor retarder, and detailing (no special provisions for high humidity). The roofing system was seven years old and suffering from corrosion of the metal roof panels.

One could actually walk across the roof and see water seep out of the roofing system. Corrosion had penetrated the panel, and moisture was released by the saturated insulation when it was compressed by foot traffic ( see Photo 1).

In keeping with the previously listed recommendations, the manufacturer and a mechanical engineer should have been consulted during the design process. A few extra dollars spent up front could have saved the owner the frustration and expense of a costly and premature repair.

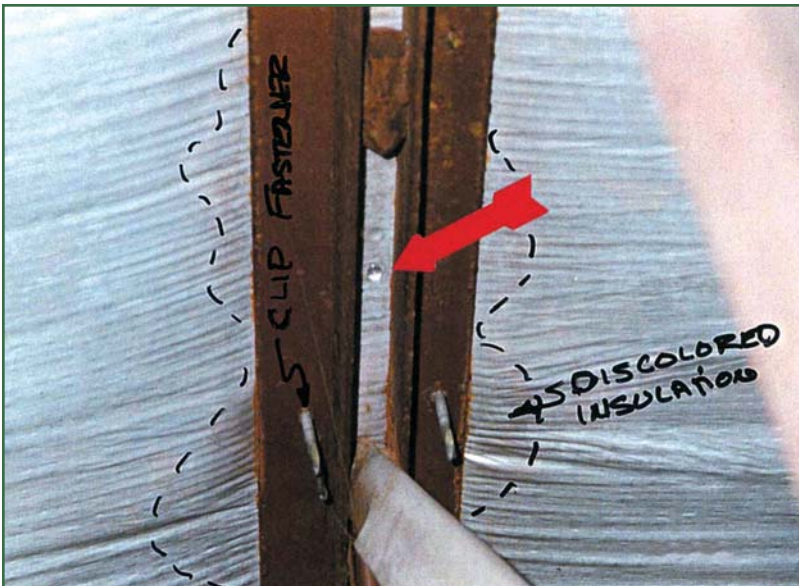
Photo 2: Condensation forming on insulation facer.

Inside, virtually all of the roof insulation blankets were discolored and sagging. In several instances, condensation could be viewed on the surface of the vapor retarder (Photo 2).

interior temperatures and humidity. Conditions recorded in the damaged area ranged from 36% to 68% RH and temperatures from 67°F to 81°F. The worst case recorded was an interior temperature of 75°F, RH of 62%, with a resulting dew point of 61°F.

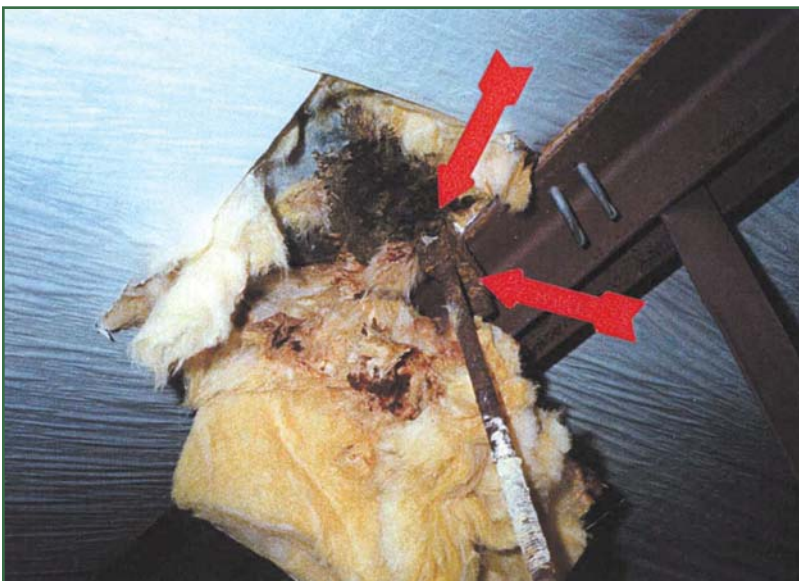
Above: Photo 3: Deterioration of beam clamp and underside of roof panel.

to support a sprinkler line and was installed on the top chord of a truss. The head of the clamp had penetrated the vapor retarder and was in contact with the underside of the metal roof panel (Photo 3). The clamp, threaded rod, and deck panel were all badly corroded at this point.

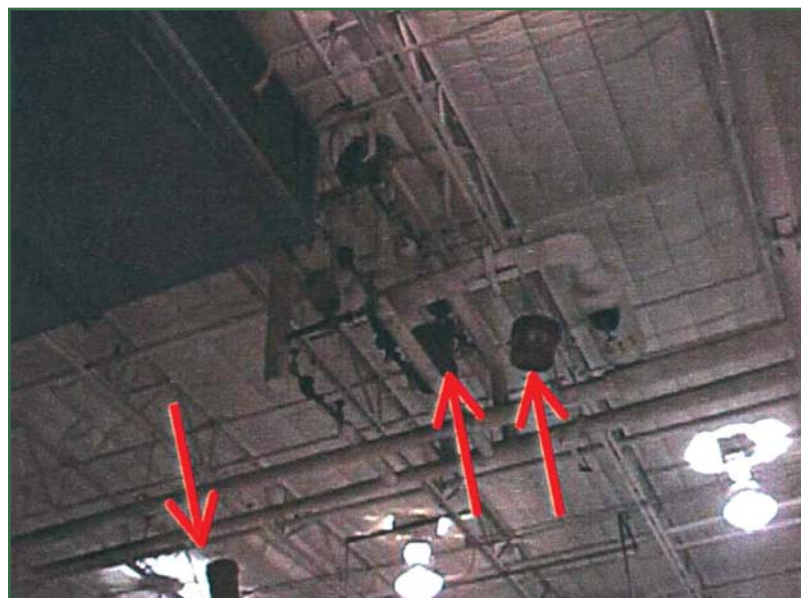
Photo 4: Buckets suspended from roof framing.

When we viewed the interior of the building, we found that a large portion of the insulation blanket was wet, sagging from position, and dripping water where it had been punctured. As the blanket insulation became wet and sagged, the owner periodically punctured the “low point” of the blanket to allow water to escape in an effort to prevent the blanket from becoming dislodged and falling.

As we walked through the plant, we noted that buckets had been suspended from the roof trusses. These had been placed in strategic locations to prevent water from dripping onto sensitive equipment (Photo 4).

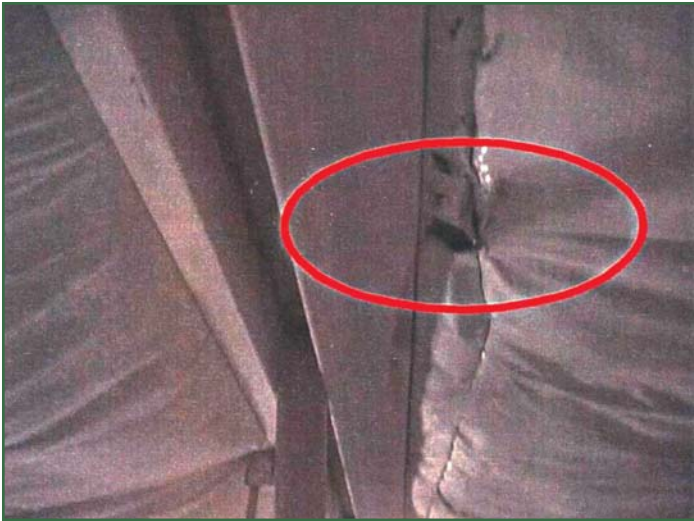
Photo 5: Insulation sidelap is “open” and not centered over framing member.

The sidelaps of the blanket insulation were found to have gaps and were not taped or sealed together (Photo 5). We also found that the blanket insulation had not been sealed around projections (Photo 6).

Had the designers heeded (or been aware of) the guidelines listed above, they may have been able to prevent this unpleasant surprise. As a result, the owner was faced with an expensive repair that could have been avoided. As is often the case, the cost to make repairs after the fact is much greater than if these enhancements were incorporated into the original construction.

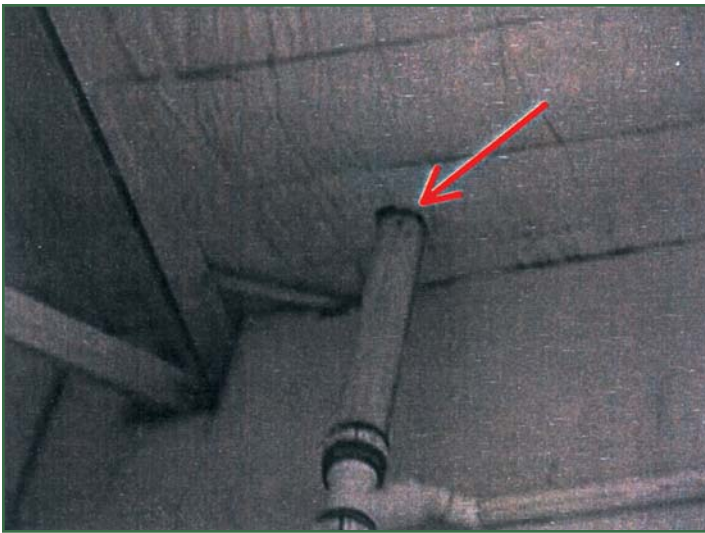
Photo 6: Insulation facer is not sealed around projection through roof.
