# CASE STUDY

## Good Architecture, Poor Roof

BY THOMAS L. SMITH, AIA, RRC

A terne metal roof was specified and installed on a new church during the winter of 1996-1997. The building is located in the eastern part of the U.S., in an area subject to snowfall. Shortly after construction, leakage periodically occurred at clerestory windows and some roof areas. The architect, general contractor (GC), and roofing contractor attempted to address the problems, but their attempts were unsuccessful. In 2001, the author was retained by the building owner to investigate the leakage problems. Because they could not be effectively repaired, in the latter part of 2001 and early 2002, all of the roof coverings were removed and replaced. The clerestory windows were also removed, new sill flashings installed, and the windows reinstalled.

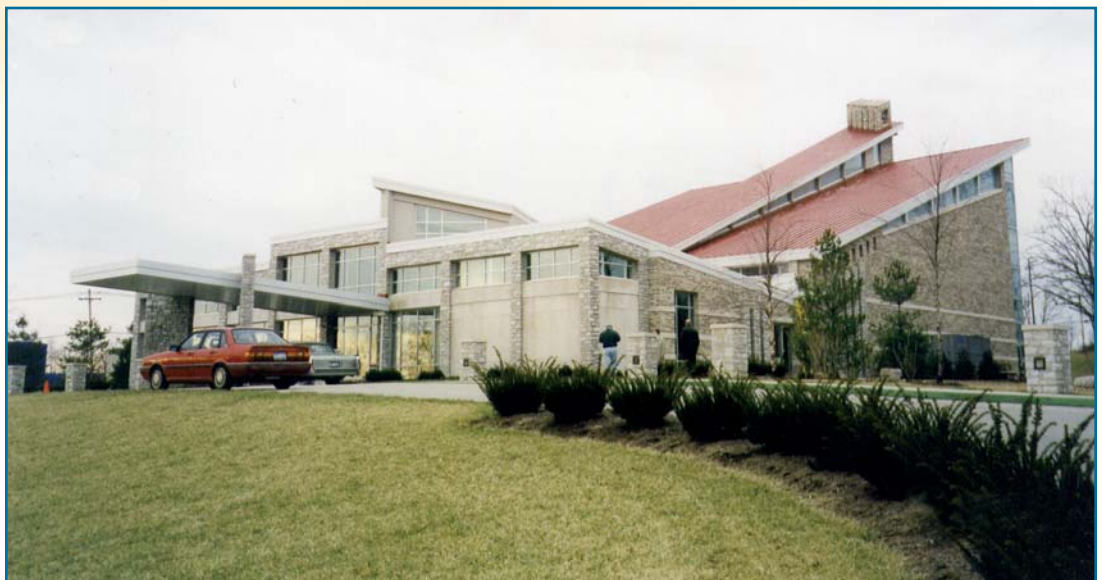
Figure 1: General view of the roof.

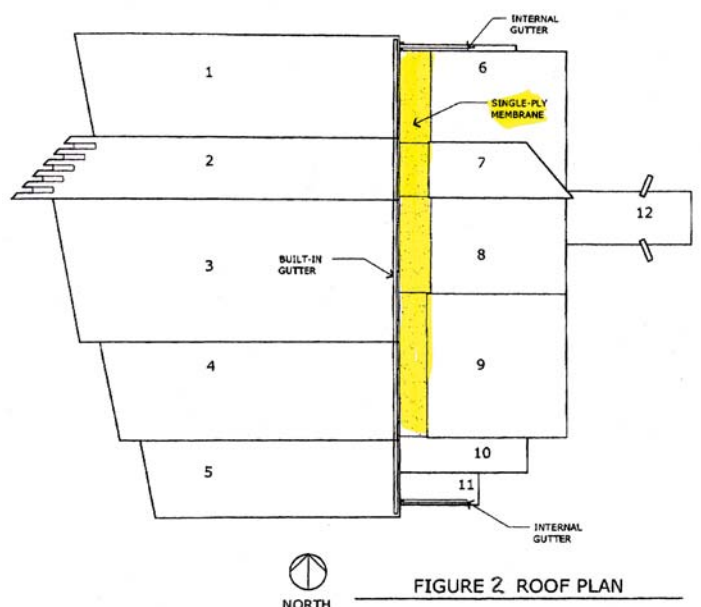
FIGURE 2. ROOF PLAN

Figure 2: Roof plan.

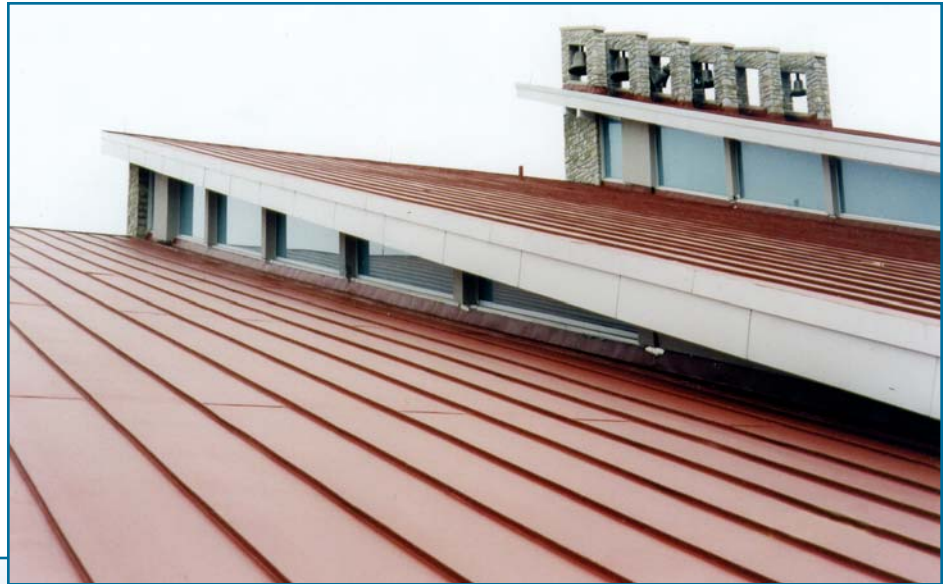
*Figure 3: View of some of the clerestory windows. Although the roof overhangs provide some protection from rainfall, they do not protect the windows from wind-driven rain.*

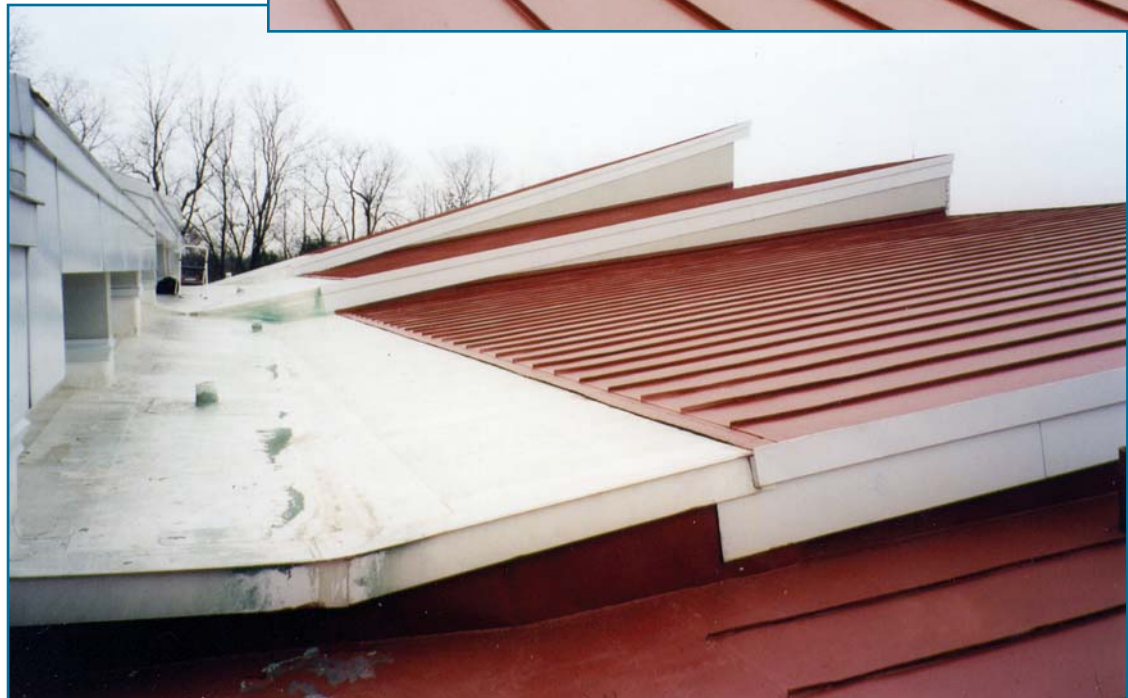
*Figure 4: View of the TPO membrane in the valley area. Water falling from the TPO membrane eroded the paint on the terne below.*

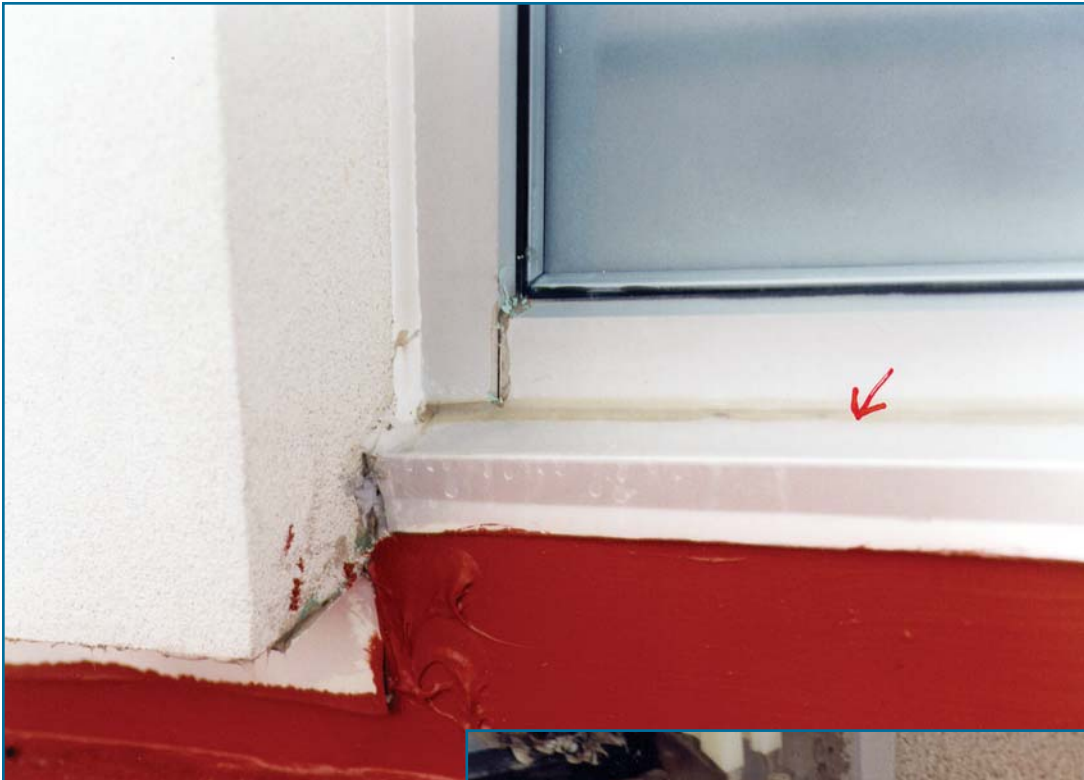
Figure 5: In a misguided attempt to solve the window leakage problem, the general contractor applied sealant (noted by arrow) at the drainage slot between the sill flashing and sill face cap.

As previously noted, the window drainage slots should not have been sealed.

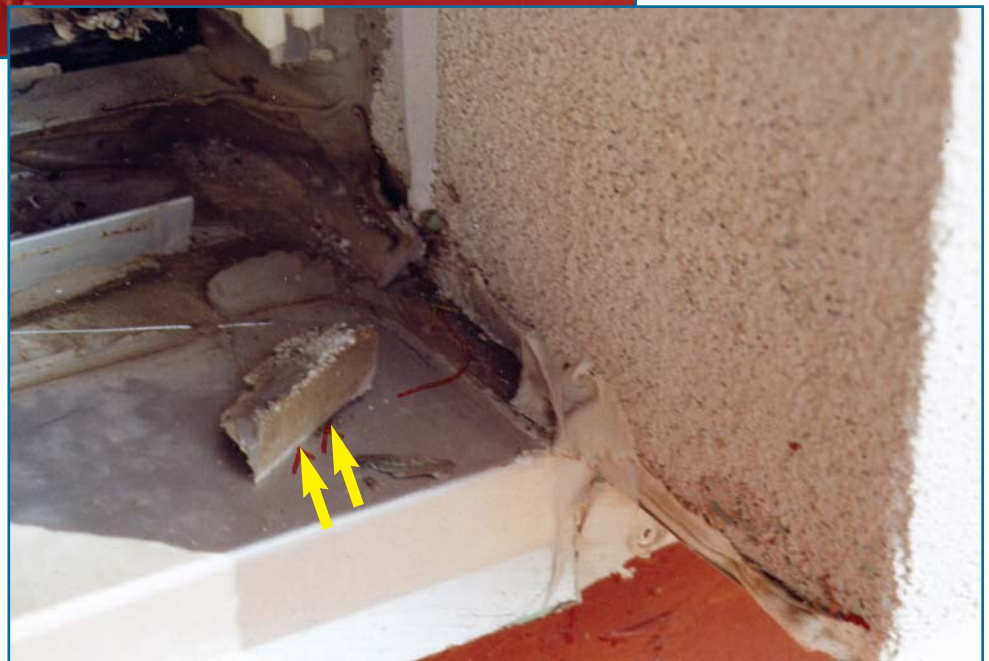
Figure 6: View of the down-slope end of the sill flashing after removal of the face caps and glazing. The only provision preventing water running down the sill from entering the building was a fillet-profile sealant joint between the sill flashing and EIFS. The double arrows show a piece of the sealant joint. The sealant was not well adhered to the EIFS or sill flashing. Water was able to flow past the sealant, where it had an unobstructed path into the building.

During the author's initial investigation, a technical representative of the window manufacturer was on-site, as well as representatives of the general contractor, roofing contractor, and glazing contractor. The author directed the glazing contractor to remove some of the glazing caps. After removing the caps, it was apparent that due to lack of upturned ends on the sill flashing, water was

able to flow past the window frame (Figure 6).

The clerestory windows were removed, new sill flashings with upturned ends installed, and the windows were reinstalled.

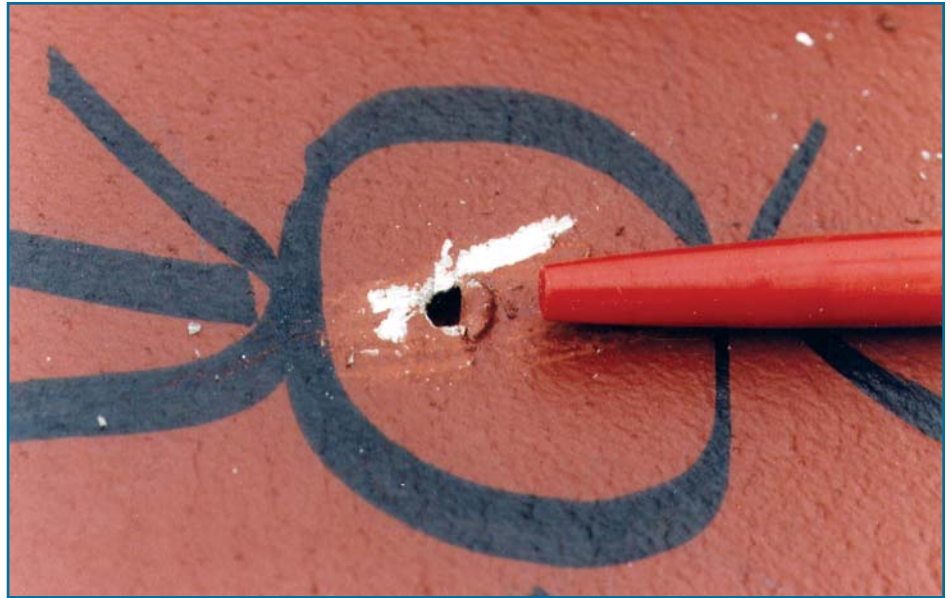
*Figure 7: A hole through the terne at roof 6. This hole was caused by mechanical damage.*

At the leakage area at roof 6, two small holes through the metal panels were found (Figure 7). These were caused by mechanical damage. A tear was found through the nearby TPO. At another TPO area, the membrane was torn by a nail head emerging from the OSB. The leakage at the canopy

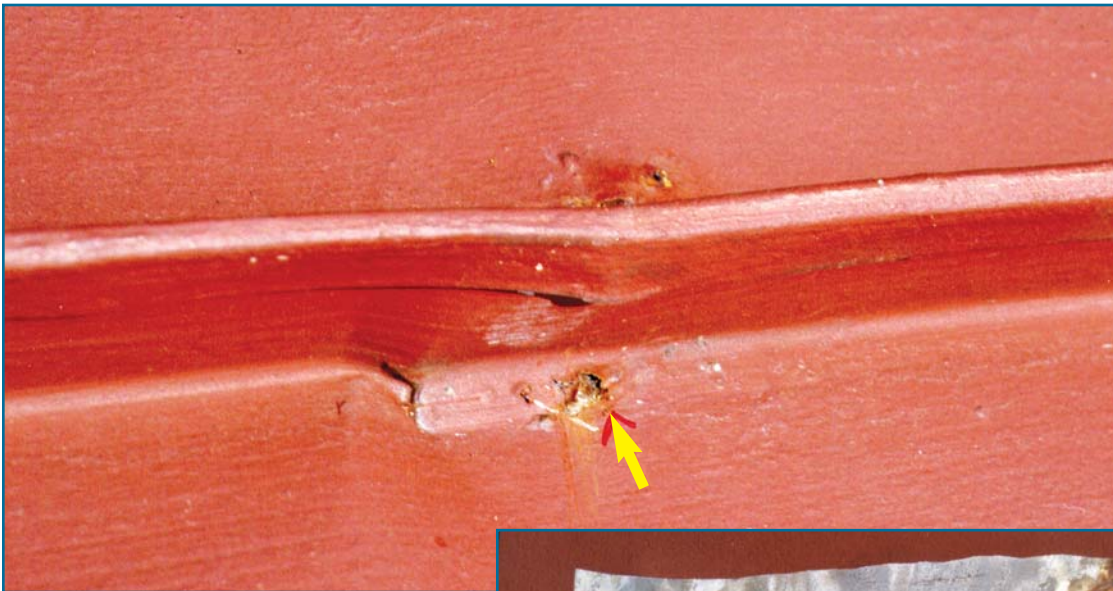
*Above: Figure 8: View of corrosion-induced holes through the terne on roof 3. Holes occurred on both sides of the rib. These holes occurred a few inches upslope of an endlap. Note the buckled rib. See Figure 9.*

During the summer of 2001, additional holes were discovered through the metal panels. The author performed a follow-up investigation in August 2001. During this investigation, several metal panels and ridge cap flashings were removed. Severe corrosion was observed on the underside of the panels (*Figures 8 and 9*). Wind-driven water and water from power washing prior to painting had driven past the ridge cap flashing and flowed underneath the panels. Water was also driven underneath the endlaps (*Figure 10*). Water had also leaked through some of the ribs on the low-sloped roofs. Enough water had reached the underside of the panels and enough time had elapsed by August 2001 that the corrosion was penetrating the panels in numerous areas. In addition to panel penetration, the corrosion had significantly impaired several of the concealed clips, hence the roof was vulnerable to wind blow-off.

Because the corrosion attack was coming from the underside of the panels and it was in an advanced state, the panels could not be effectively repaired. To avoid damage to the OSB and wood decking, the author recommended that the entire roof covering be removed and replaced. Reroofing work commenced that fall.

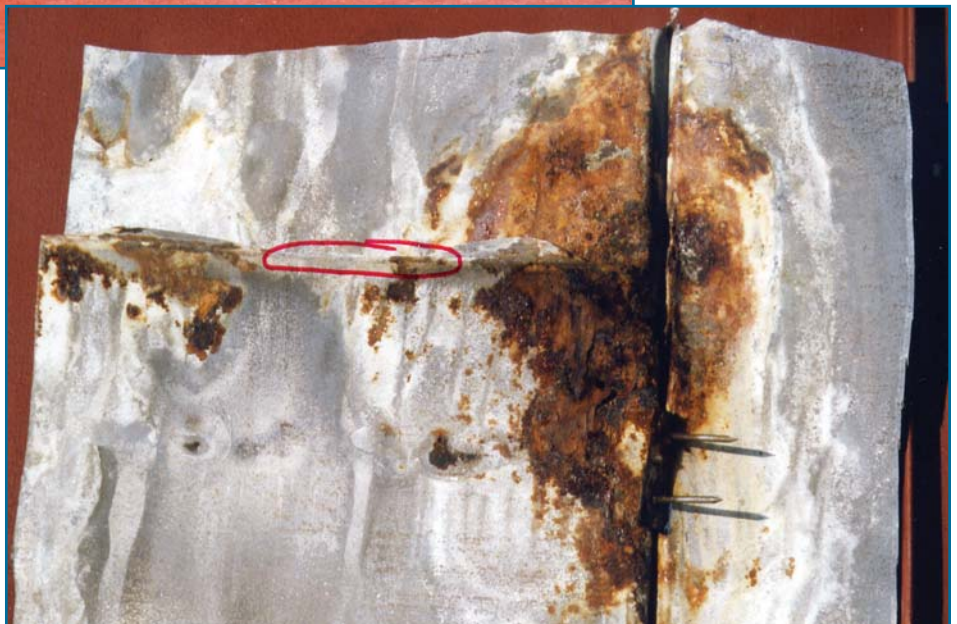
*Right: Figure 9: View of the underside of the panel shown in Figure 8. The circle indicates the upper end of the down-slope panel. A panel clip with two nails occurs in the lower right portion of the photo.*

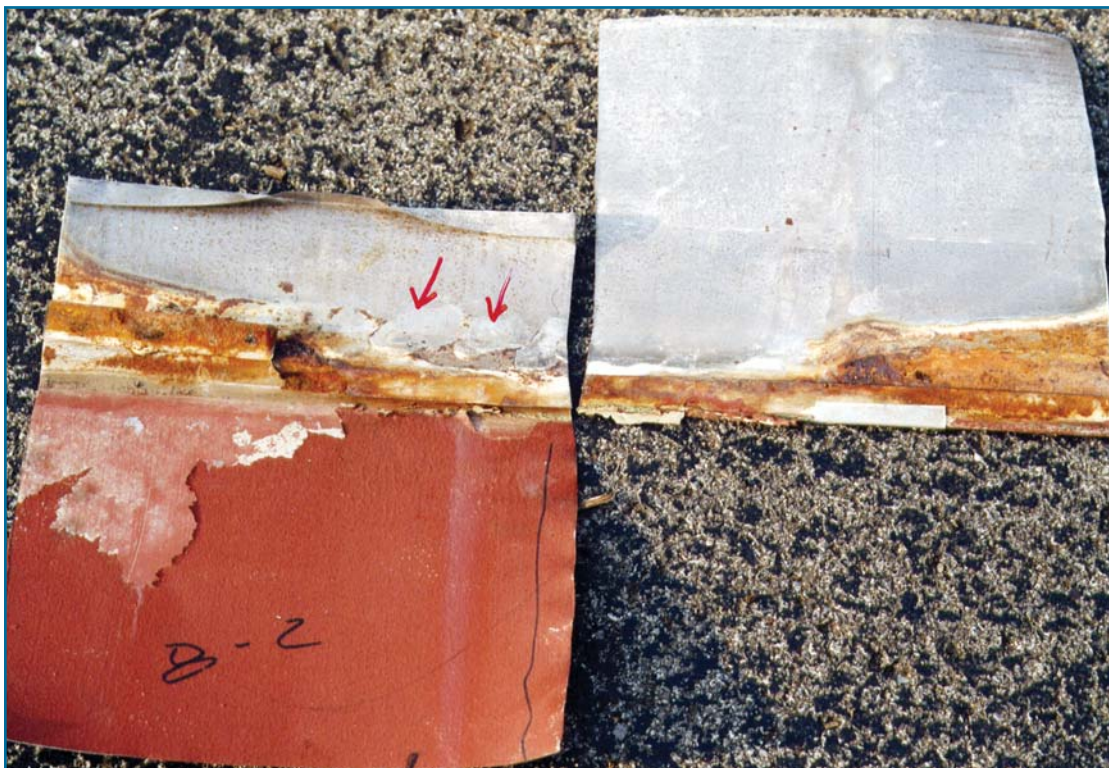
*Figure 10: The left panel is the down-slope panel. The arrows indicate solder that was used to attach the lock-strip. Both sides of the lock-strip were very corroded. The right panel is the underside of the up-slope panel.*
