METAL ROOFING

& INTERIOR CONDITIONS

BY E. FRANK KELM, RRC

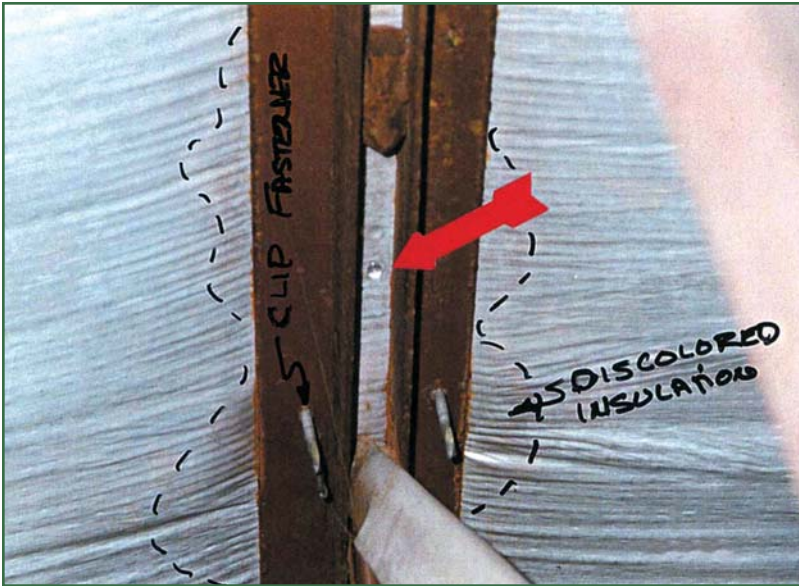
Photo 2: Condensation forming on insulation facer.

Inside, virtually all of the roof insulation blankets were discolored and sagging. In several instances, condensation could be viewed on the surface of the vapor retarder (Photo 2).

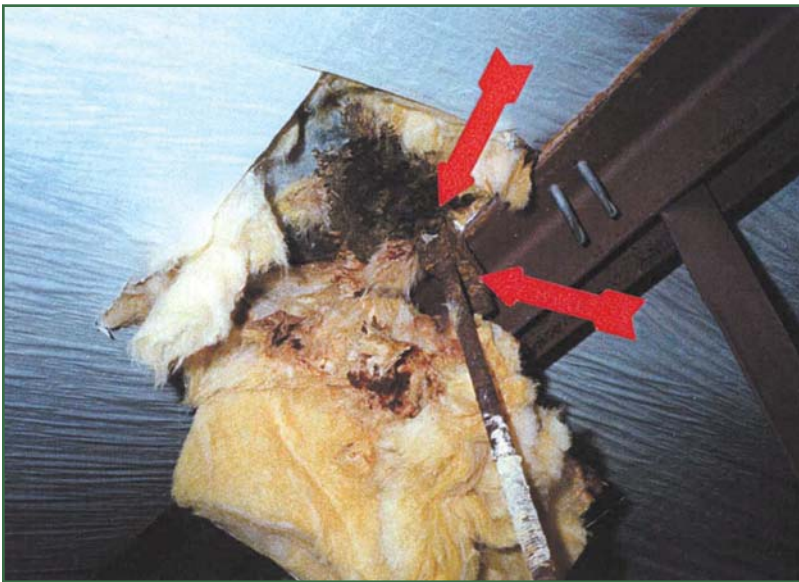
Above: Photo 3: Deterioration of beam clamp and underside of roof panel.

support a sprinkler line and was installed on the top chord of a truss. The head of the clamp had penetrated the vapor retarder and was in contact with the underside of the metal roof panel (Photo 3). The clamp, threaded rod, and deck panel were all badly corroded at this point.

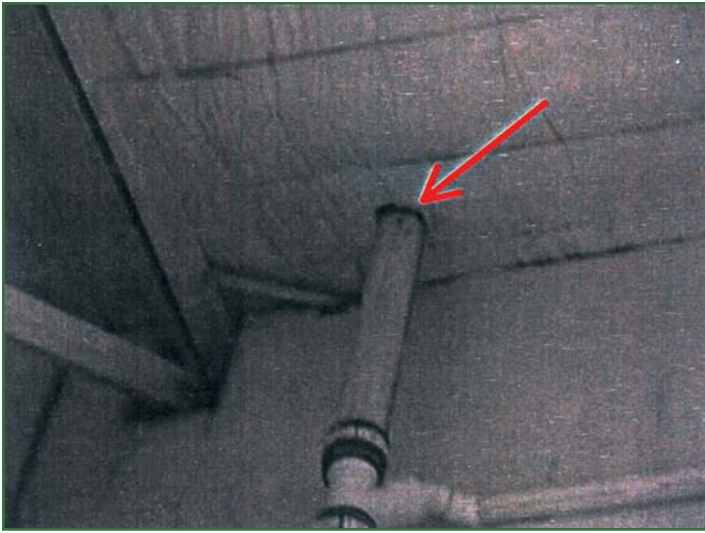
The sidelaps of the blanket insulation were found to have gaps and were not taped or sealed together (Photo 5). We also found that the blanket insulation had not been sealed around projections (Photo 6).

Photo 6: Insulation facer is not sealed around projection through roof.
