Variables for Forensic Evaluation of Degradation of Structural OSB Panels Experiencing “Wet” Service

By Colin Murphy, RRC, FRCI, and Lonnie Haughton

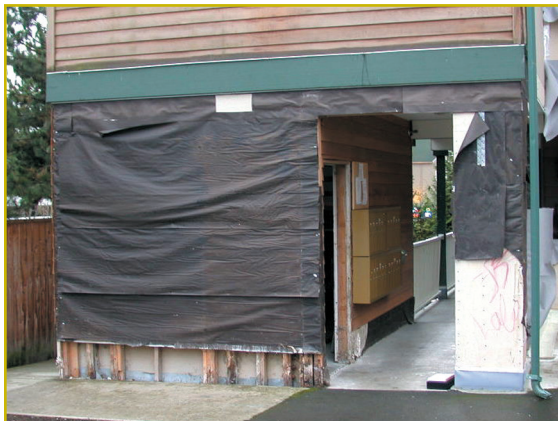
Photo 1 - Overview of the work area.

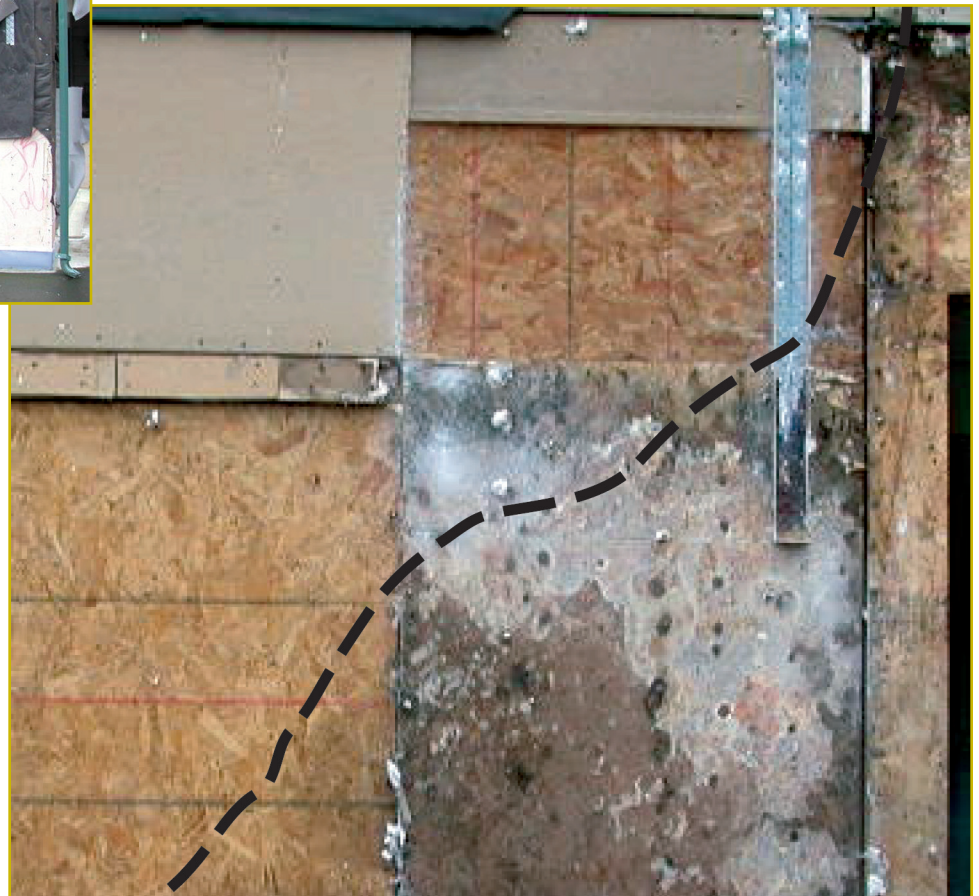
Photo 2 - Hardwood OSB sheathing with severe white-rot decay is surrounded by relatively undamaged hardwood OSB. The dashed line traces the upper limit of the migrating water. Note that the white-rot deterioration has spread upward from the water line. (The localized brown-rot decay at the upper right is spreading from underlying infestation of a softwood-framing member.)

Photo 1 shows an overview of the work area. In *Photo 2*, note the severe white-rot deterioration at one of the sections of hardwood OSB sheathing, while the surrounding hardwood OSB sections are relatively undamaged except for some localized brown-rot damage at the upper right corner. (The observed brown-rot decay has spread from an infested softwood-framing member behind the hardwood sheathing.)

The OSB panels were installed at the same period of construction, as evidenced by the overlying steel strap seen in *Photo 2*. It is possible that the damaged panels had been infected with the white-rot fungi prior to installation, but the almost total absence of white-rot damage at the adjacent OSB sheathing is strong evidence that the OSB panels from Minnesota were highly resistant to this particular wood decay fungus.

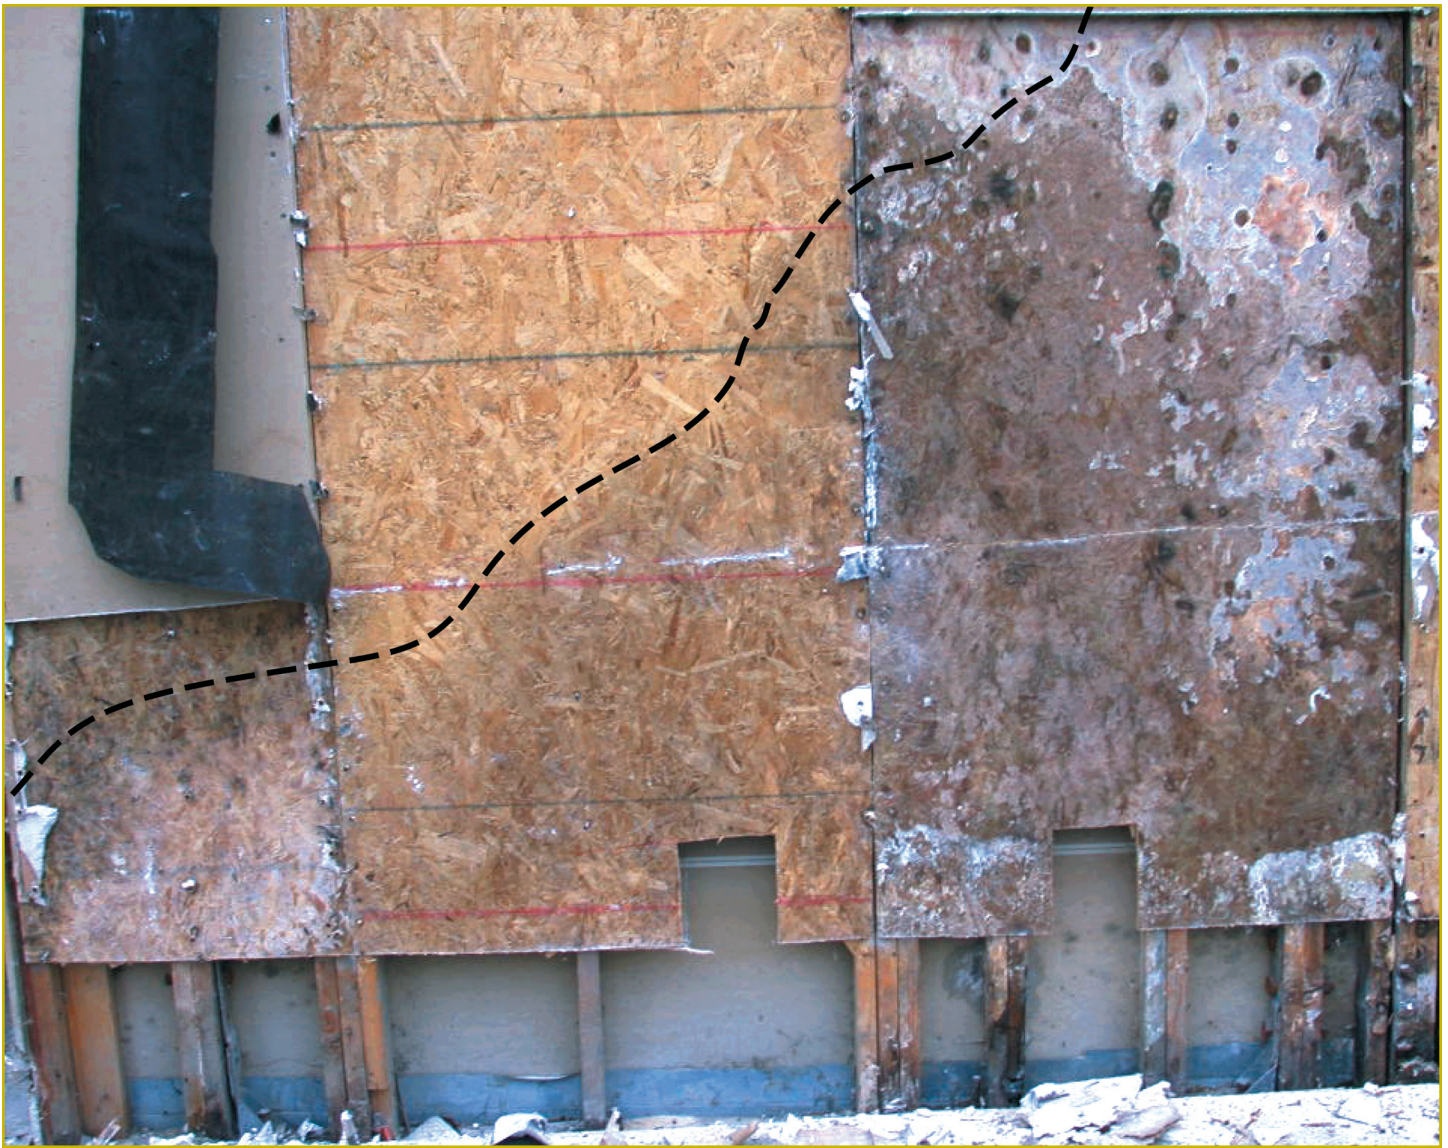
The dramatic differences between the hardwood OSB panels are further highlighted in *Photo 3*. Note the water staining across the face of the otherwise undamaged middle section, tracing the route taken by the migrating moisture that promoted the severe white-rot damage at the OSB section at the right. Further, note that this moisture also has resulted in severe white-rot damage at the OSB section at the far left. Both damaged OSB sections are by the same manufacturer.

The severity of the white-rot deterioration at the left and right sections is advanced. As the panels became saturated and spongy, the fungi were able to spread vertically above the visible path of water flow denoted by the water stain. In striking contrast, the middle OSB section remains sound, firm, and undamaged.

The undamaged OSB sections were the panels manufactured in Minnesota.

Photo 3 - Undamaged center panel is sandwiched by two white-rotted panels. (The dashed line traces the upper limit of the migrating water.)
