THE WHATCOM MUSEUM OF HISTORY AND ART

BELLINGHAM, WASHINGTON

By David A. Rash, RRC

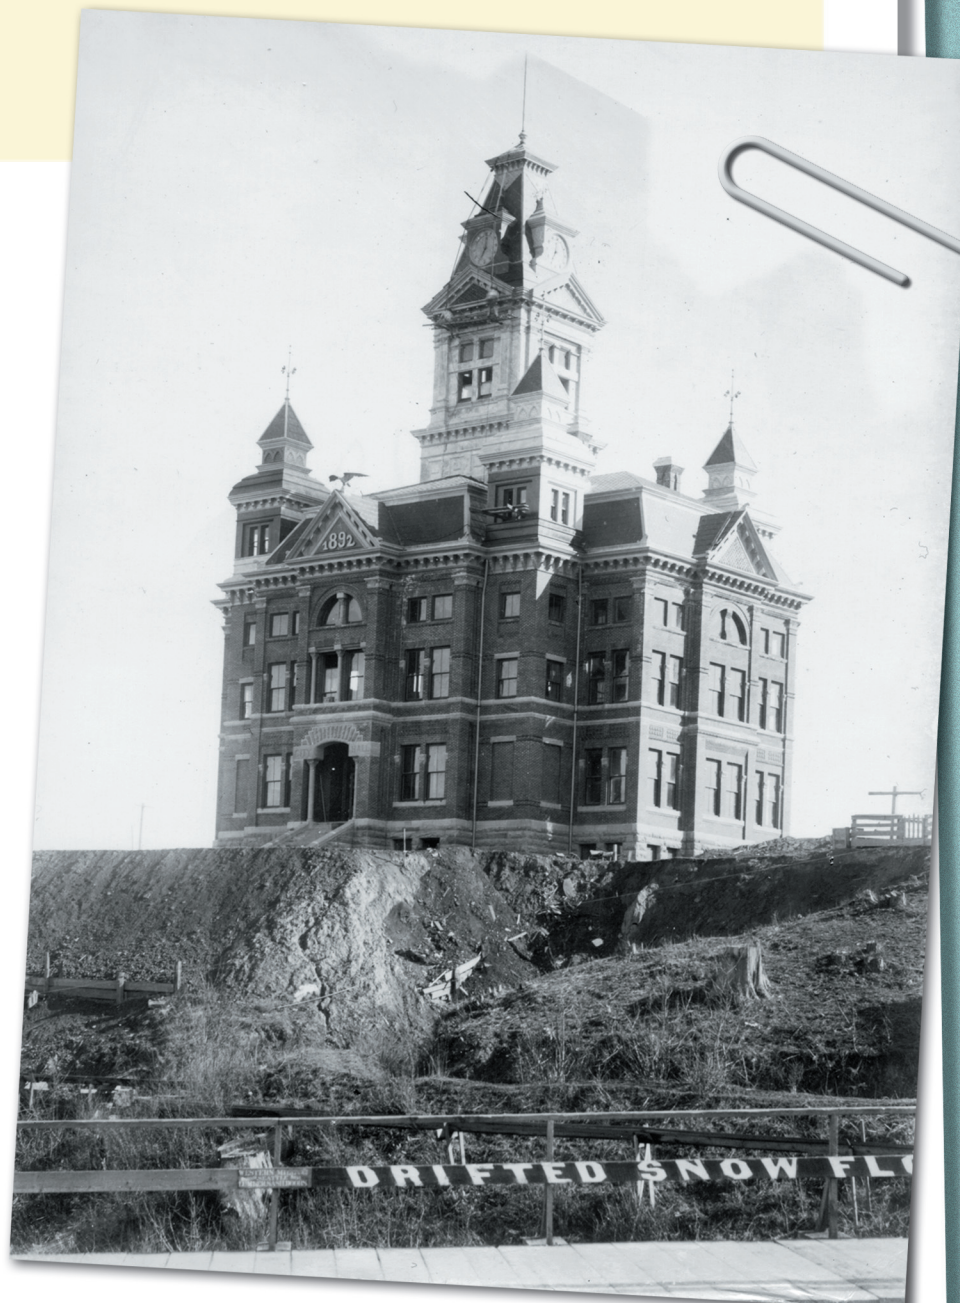
As the New Whatcom City Hall approached completion in 1893, the elaborate metal roof received its first coat of paint with the painters at work on the west side of the central clock tower in this first ever photograph of the building. (Courtesy, Whatcom Museum of History and Art, Bellingham, WA, 1893.)

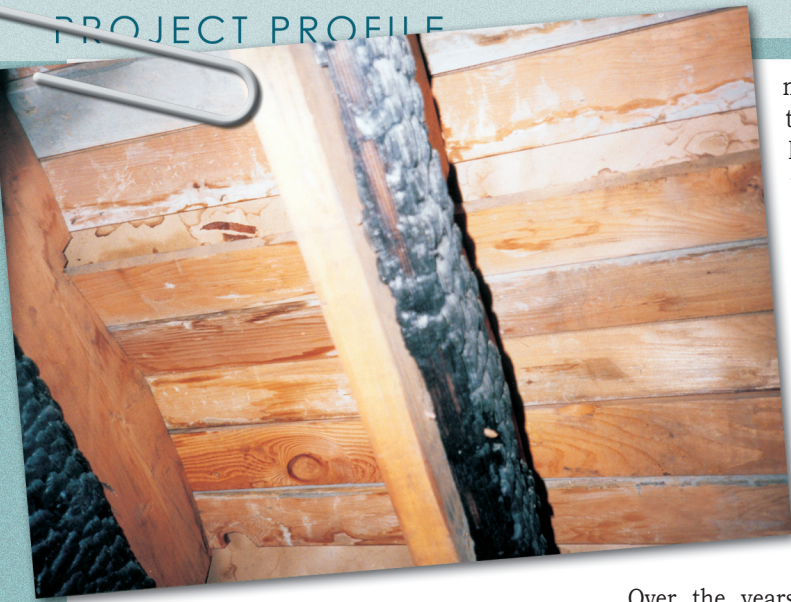
Charred framing members from the 1962 fire were still evident underneath the roof. Here, they had been supplemented by new framing members immediately adjacent. The underside of the wood roof decking had numerous water stains indicative of the metal roof failing.

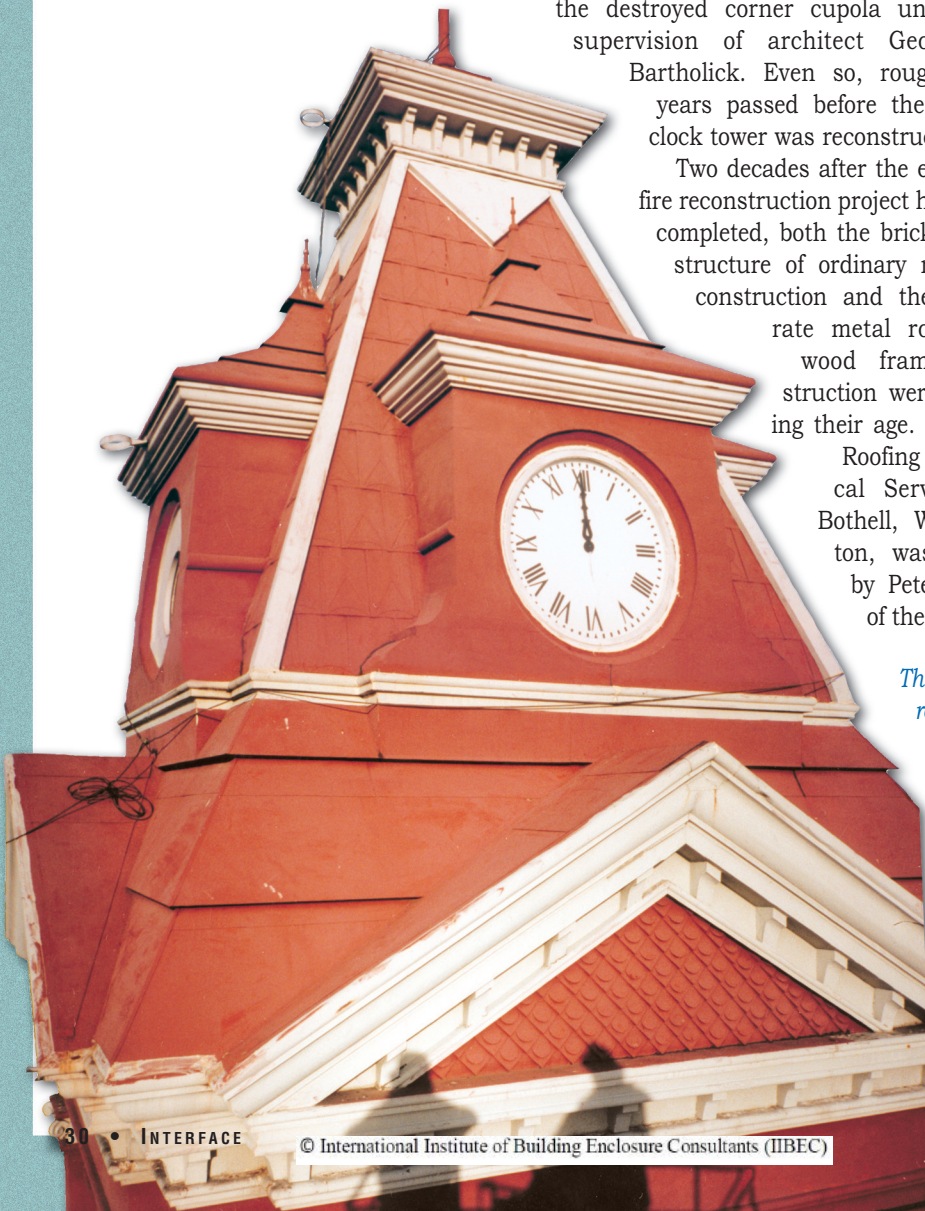
The lower section of the central clock tower roof had gable roofs clad with flat seam panels that intersected with a three-coursed Bermuda-type roof. The end gables themselves featured pediments with "fish-scale" infill and cornices supported by concave corbels. The upper section of the central clock tower roof had metal-clad dormers housing the clock faces, each capped with an attenuated Bermuda-type roof. The dormers intersected with a steeply pitched hip roof clad with metal shingles which was capped by a corbelled cornice that in turn was capped with yet another Bermuda-type hip roof. The clocks were removed and reinstalled by the owner.

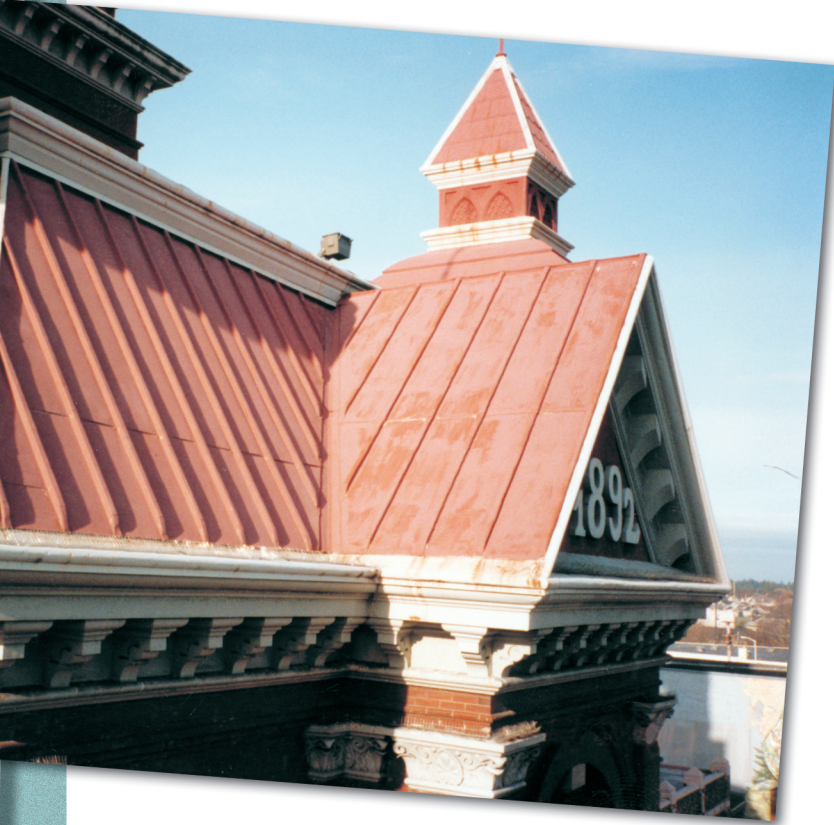
Rust stains on the leading edges of virtually every white-painted trim surface were another indication of significant failure of various metal roofs and cladding.

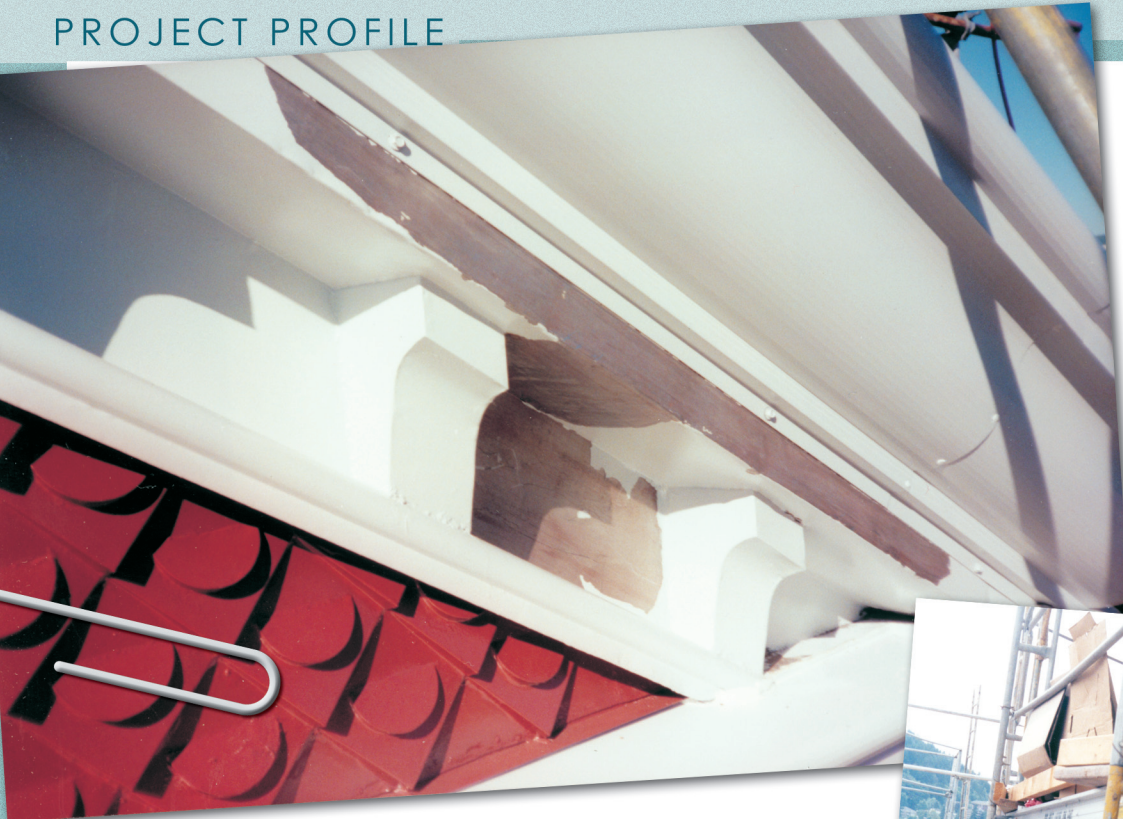
Below: The existing paint finishes were lead-based, requiring the use of polyethylene sheeting to catch and allow for the proper disposal of the removed paint.

Inadequate paint adhesion was first noticed on the corbels of the central clock tower lower cornice on August 25, 1998. Within a week, the problem manifested itself in larger areas, as seen in the photograph of the gable cornice on September 3, 1998.

A problem with the specified paint finish for the ornamental sheet metal work developed later in the project. The original specification anticipated that only 30% of the existing paint on retained sheet metal work would need to be removed prior to repainting with Tnemec "Stranlok" fiber-reinforced epoxy paint. Unfortunately, the application of the epoxy paint over the existing paint finish tended to result in a loss of adhesion by the existing paint from the base metal through no fault of the painting subcontractor, Swinburnson Painting. Ultimately, the abatement subcontractor, Welch Enterprises, had to either rescrape or use "peel away" paint remover (depending on the complexity of the sheet metal work) to remove as much of the existing lead-based paint as possible prior to the application of the epoxy paint.⁷

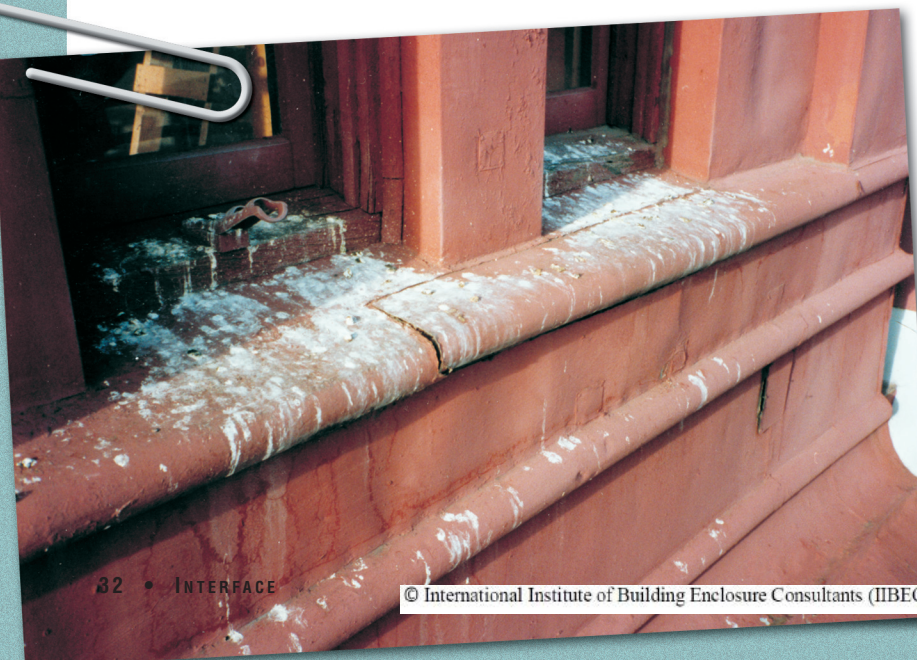
This detail view of the metal cladding at the southeast corner cupola clearly revealed the failed seams, multiple small repairs (some of which had also failed), and the accumulated bird excrement to be dealt with.

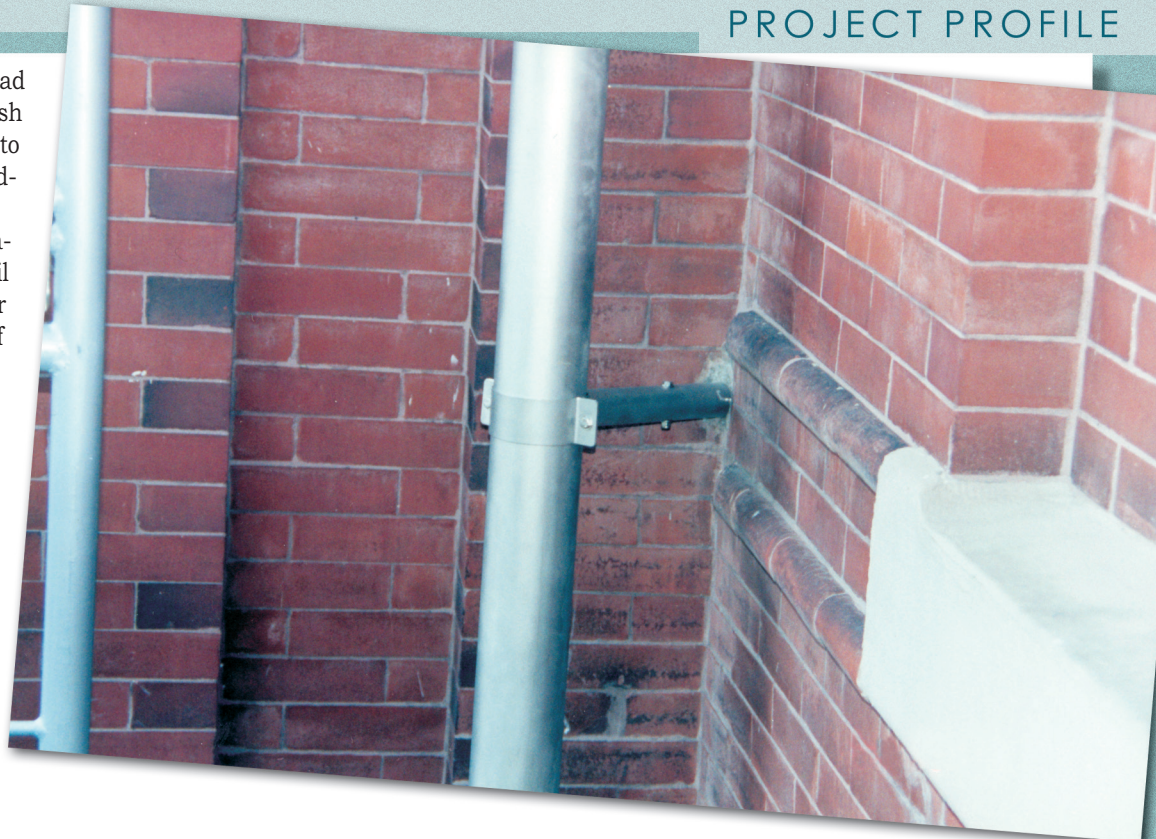
Severe water staining is evident on the brick masonry where the former downspouts had broken open. The replacement downspouts were fabricated from TIG-welded 16 ga. stainless steel. The water stains themselves are awaiting later building envelope work.

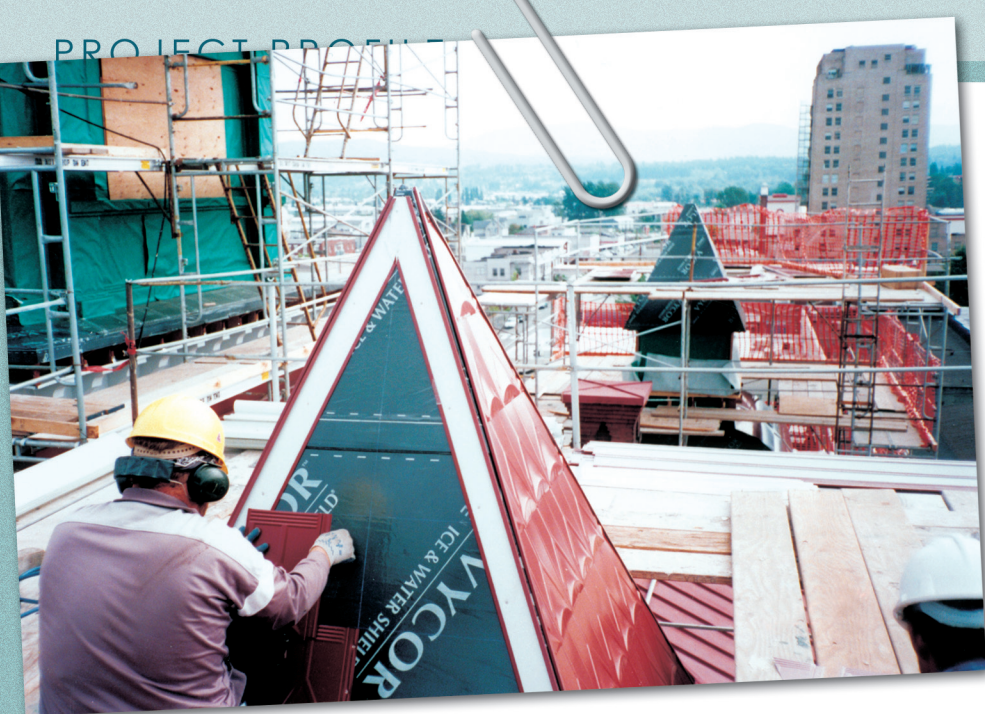
The foreground cupola is being shingled, while the background cupola has only the self-adhering waterproofing underlayment in place and breathable underlayment is being installed at the central clock tower.

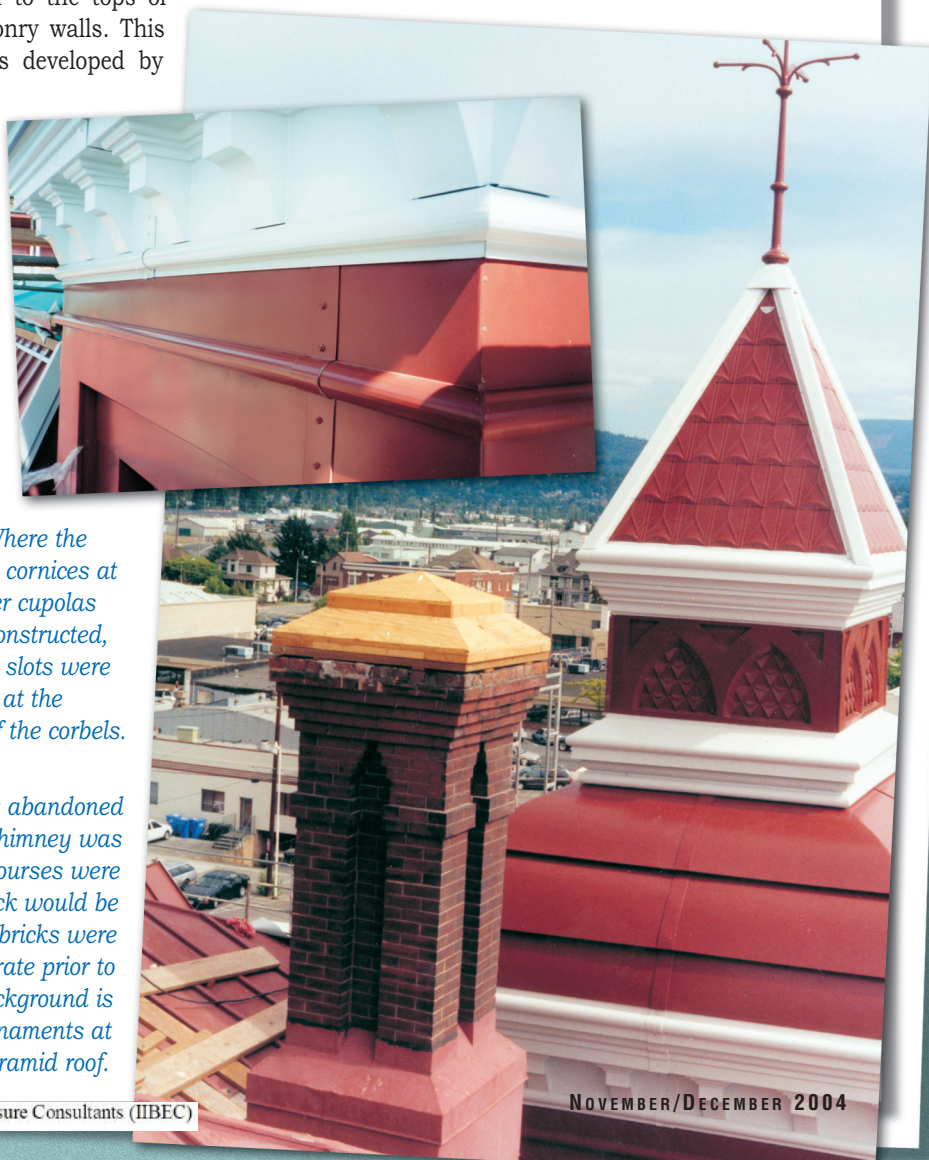
Above: Where the corbelled cornices at the corner cupolas were reconstructed, drainage slots were provided at the bottom of the corbels.

Right: The building's two chimneys were functionally abandoned long ago. When the sheet metal cap of the southeast chimney was removed for replacement, portions of upper brick courses were found to be missing. Even though upper courses of brick would be concealed beneath a new sheet metal cap, the missing bricks were replaced to allow the construction of a new wood substrate prior to installing the new cap. The southeast cupola in the background is basically complete, lacking only the "drooping leaf" ornaments at the peaks of each face of the pyramid roof.

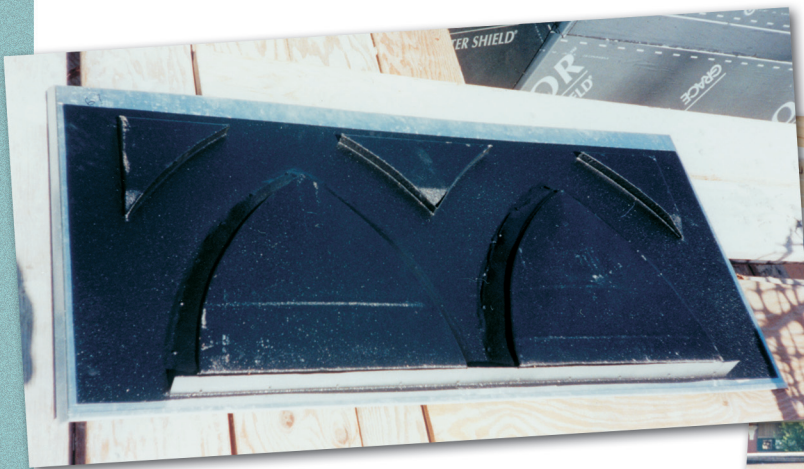
Above: The back side of a cupola "fish scale" panel reveals the polyurea resin coating that was applied to stabilize the panel. In addition, the panel edges were reinforced with galvanized steel formed angles.

initial mock-up of coating a prepared panel proved successful in stabilizing the panels sufficiently to allow all of them to be reused. The "fish-scale" in-fill panels at other locations were not affected by this change, as they were scheduled for replication or to be refinished *in situ*.

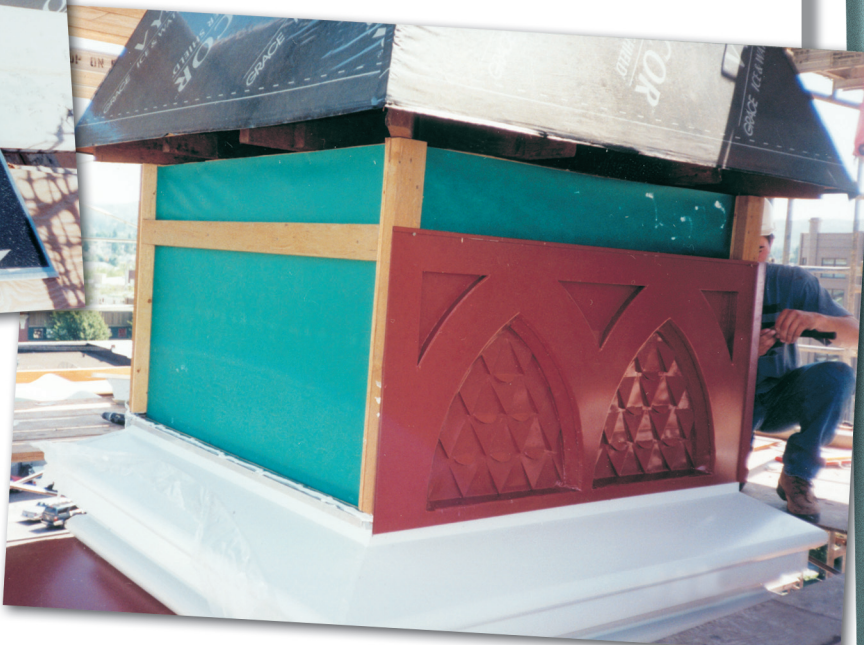
Right: "Fish scale" panels are being reinstalled at the northeast cupola with new wood blocking at panel perimeters. Note the use of breathable underlayment at the cupola wall and waterproofing underlayment at the pyramidal hipped roof above.

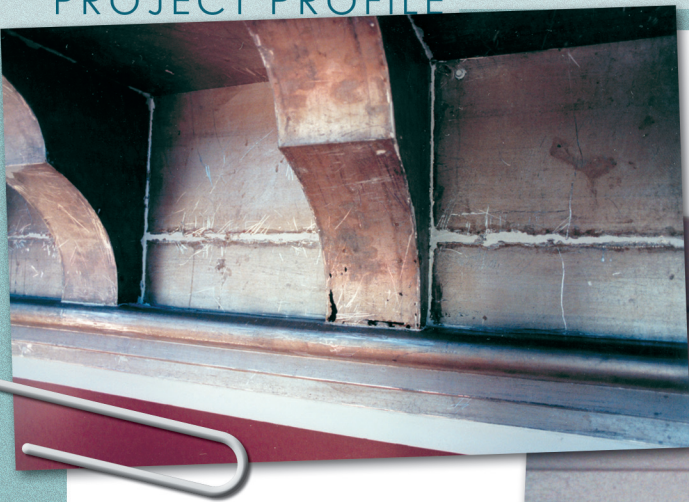
Left: Where paint removal revealed deteriorated metal where decorative sheet metal had been intended for retention, the sheet metal was repaired in situ.

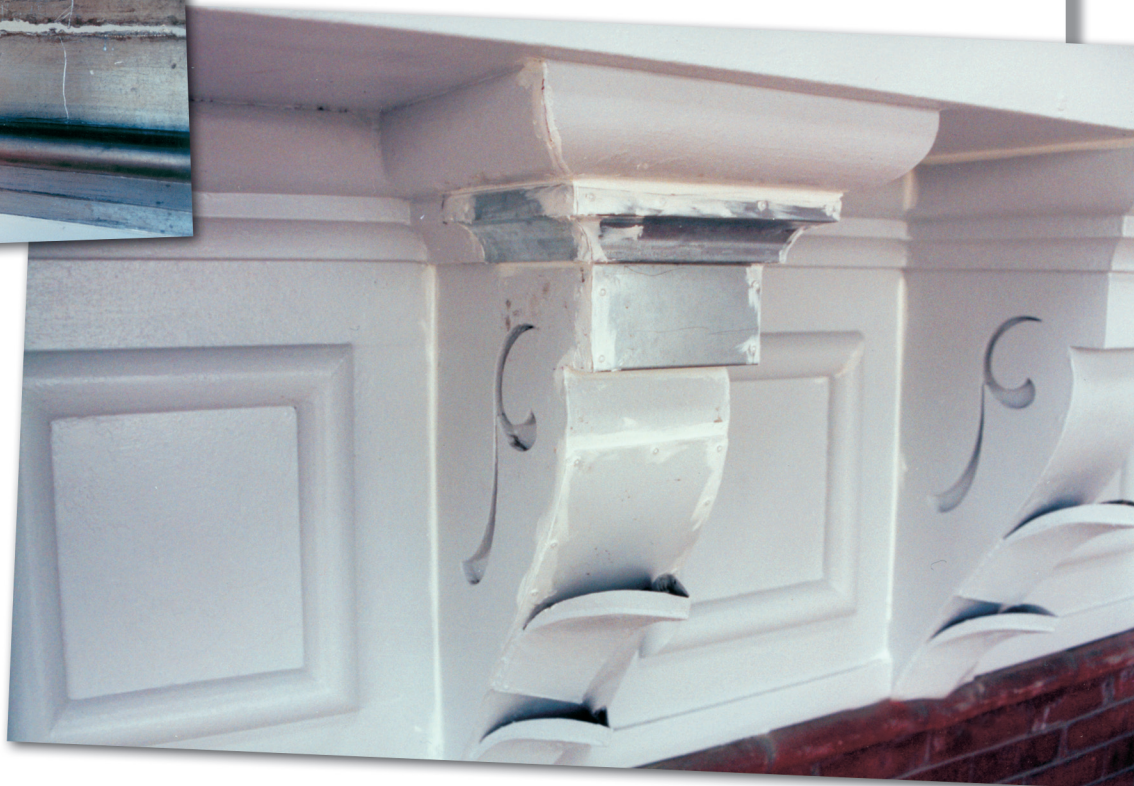
Below: A typical in situ repair of a retained corbel at the main building cornice.

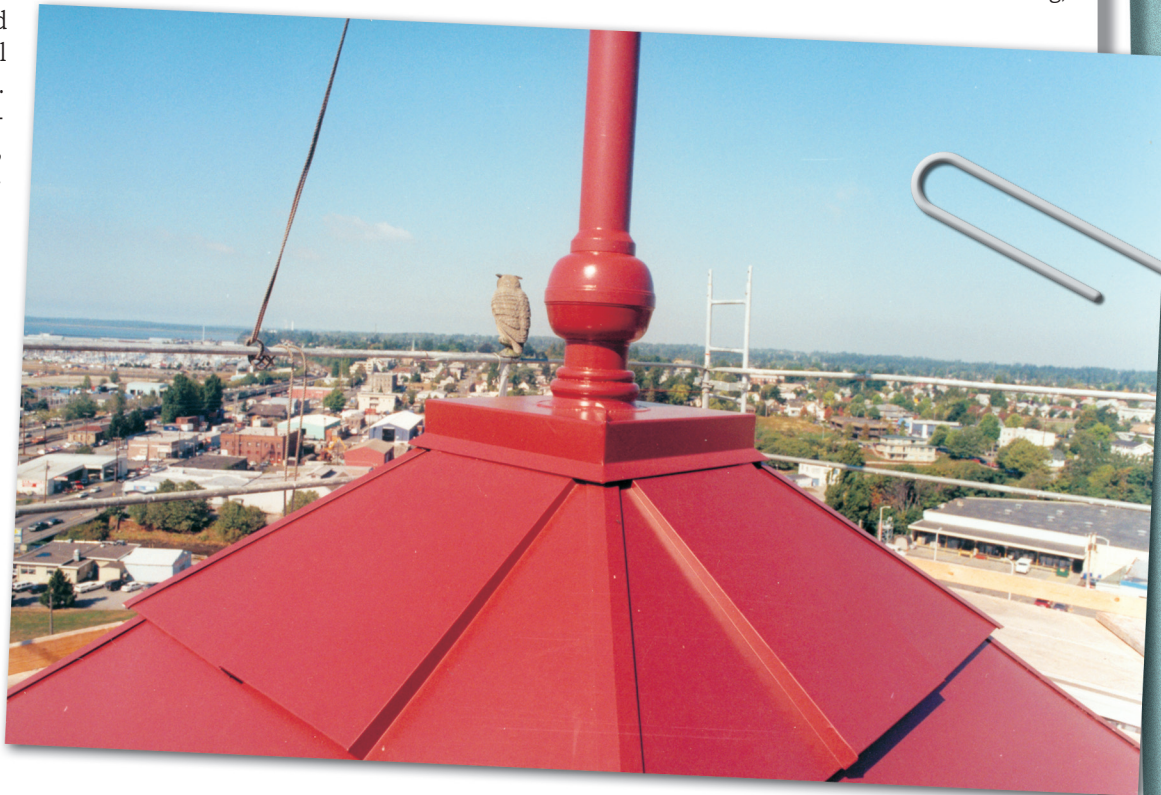
A particular highlight of the work was the completion of the uppermost Bermuda-style roof with its raised central panels that caps the central clock tower.
