THE WHATCOM MUSEUM OF HISTORY AND ART

BELLINGHAM, WASHINGTON

By David A. Rash, RRC

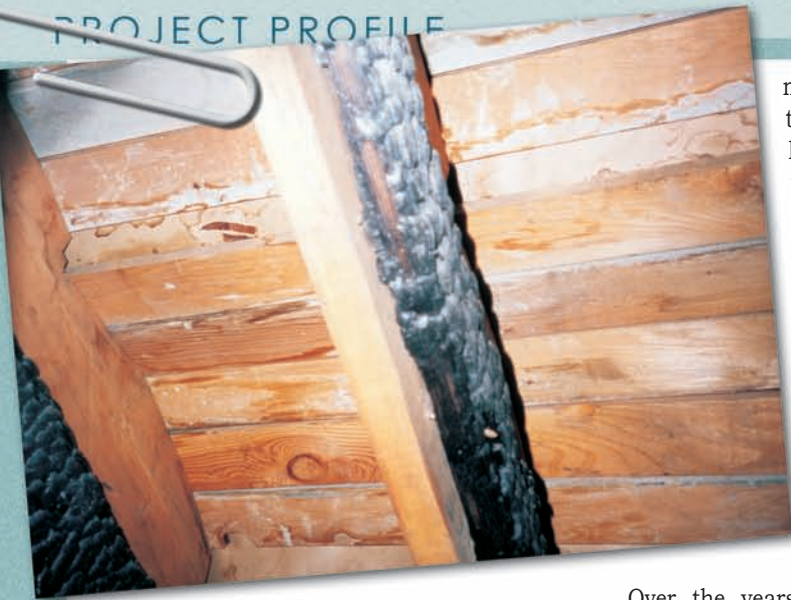
Charred framing members from the 1962 fire were still evident underneath the roof. Here, they had been supplemented by new framing members immediately adjacent. The underside of the wood roof decking had numerous water stains indicative of the metal roof failing.

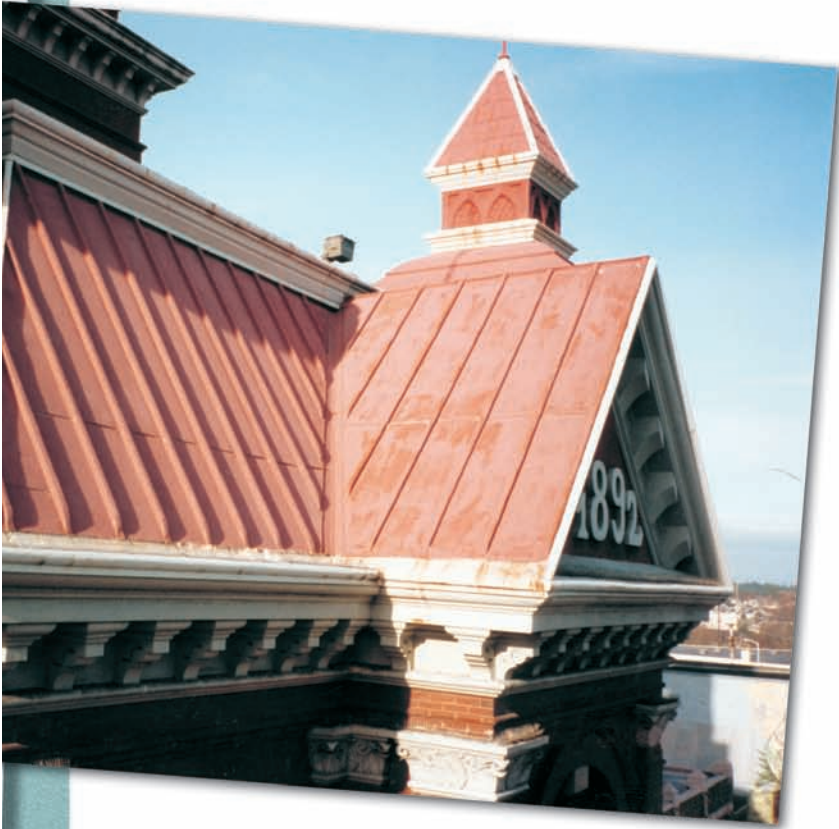
Rust stains on the leading edges of virtually every white-painted trim surface were another indication of significant failure of various metal roofs and cladding.

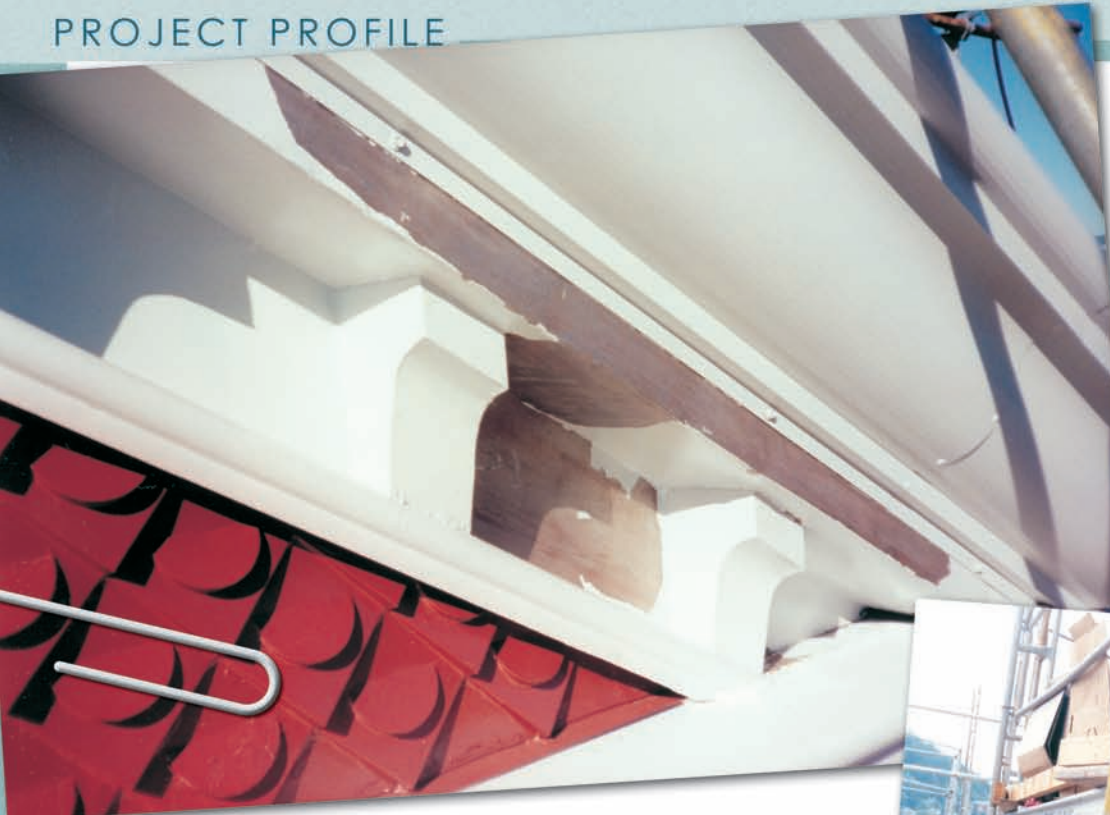
Below: The existing paint finishes were lead-based, requiring the use of polyethylene sheeting to catch and allow for the proper disposal of the removed paint.

Inadequate paint adhesion was first noticed on the corbels of the central clock tower lower cornice on August 25, 1998. Within a week, the problem manifested itself in larger areas, as seen in the photograph of the gable cornice on September 3, 1998.

A problem with the specified paint finish for the ornamental sheet metal work developed later in the project. The original specification anticipated that only 30% of the existing paint on retained sheet metal work would need to be removed prior to repainting with Tnemec "Stranlok" fiber-reinforced epoxy paint. Unfortunately, the application of the epoxy paint over the existing paint finish tended to result in a loss of adhesion by the existing paint from the base metal through no fault of the painting subcontractor, Swinburnson Painting. Ultimately, the abatement subcontractor, Welch Enterprises, had to either resrape or use "peel away" paint remover (depending on the complexity of the sheet metal work) to remove as much of the existing lead-based paint as possible prior to the application of the epoxy paint.⁷

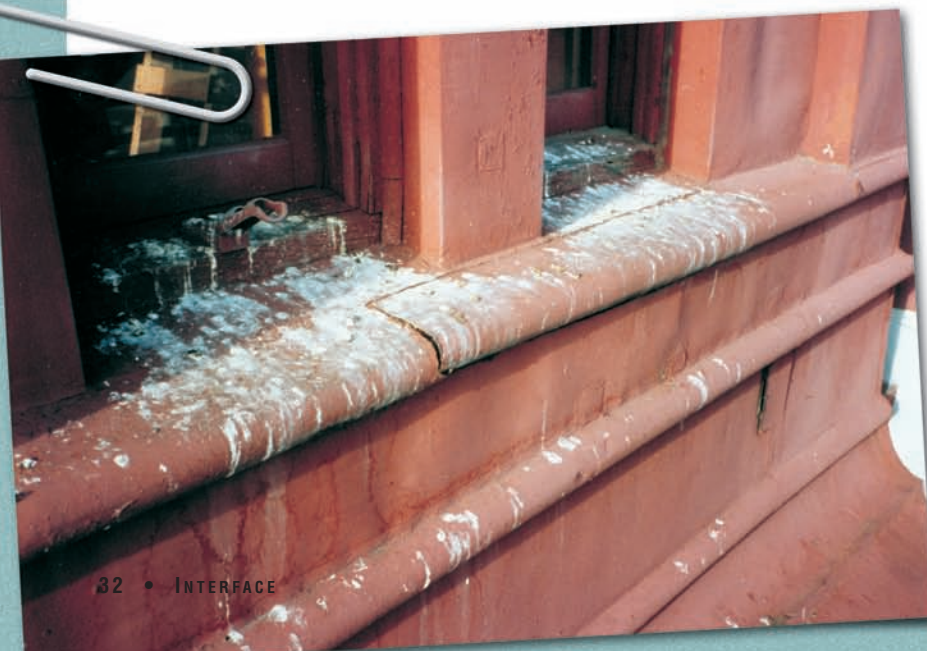
spouts of the terne-coated steel had also split, allowing water to splash onto the brick walls and migrate into the building. There were also individual occurrences of missing bricks.

Severe water staining is evident on the brick masonry where the former downspouts had broken open. The replacement downspouts were fabricated from TIG-welded 16 ga. stainless steel. The water stains themselves are awaiting later building envelope work.

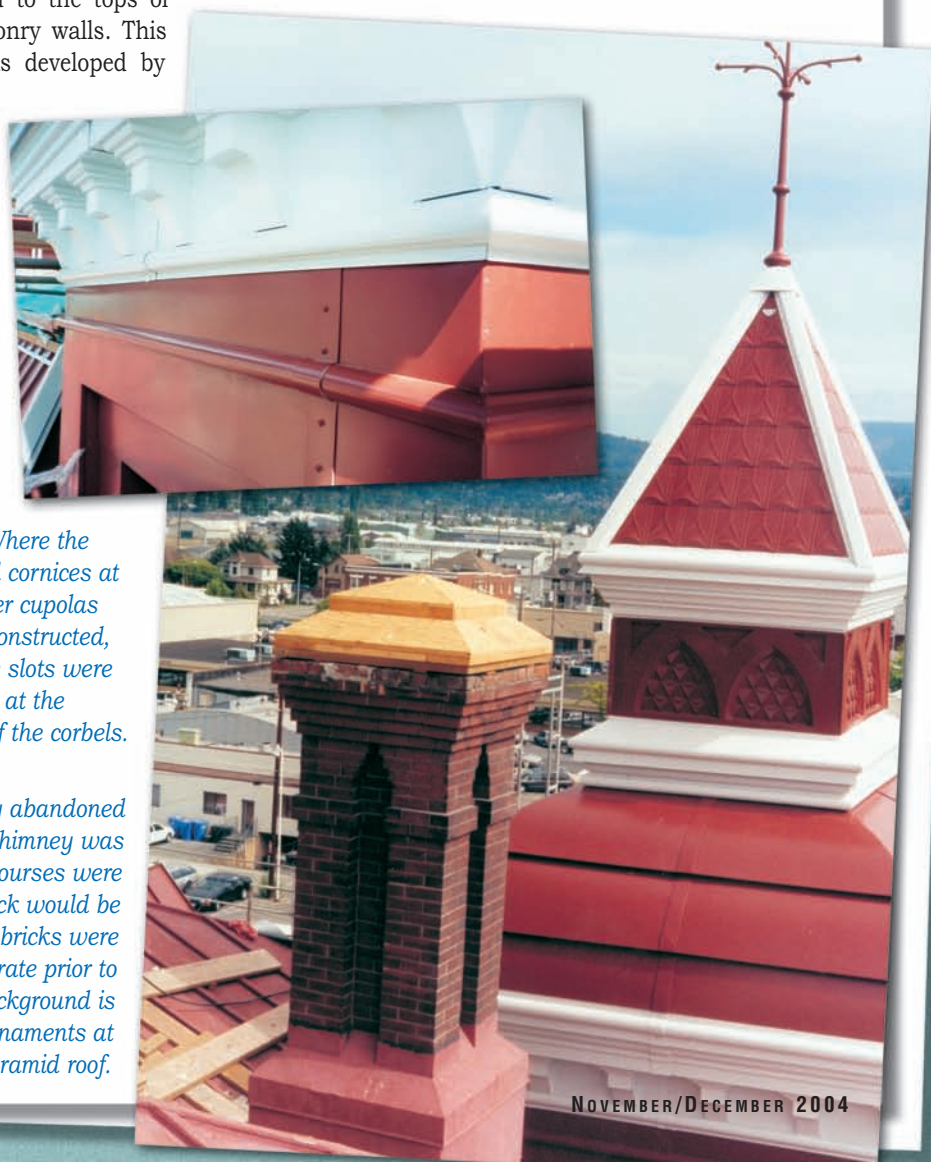
Right: The building's two chimneys were functionally abandoned long ago. When the sheet metal cap of the southeast chimney was removed for replacement, portions of upper brick courses were found to be missing. Even though upper courses of brick would be concealed beneath a new sheet metal cap, the missing bricks were replaced to allow the construction of a new wood substrate prior to installing the new cap. The southeast cupola in the background is basically complete, lacking only the "drooping leaf" ornaments at the peaks of each face of the pyramid roof.

Above: Where the corbelled cornices at the corner cupolas were reconstructed, drainage slots were provided at the bottom of the corbels.

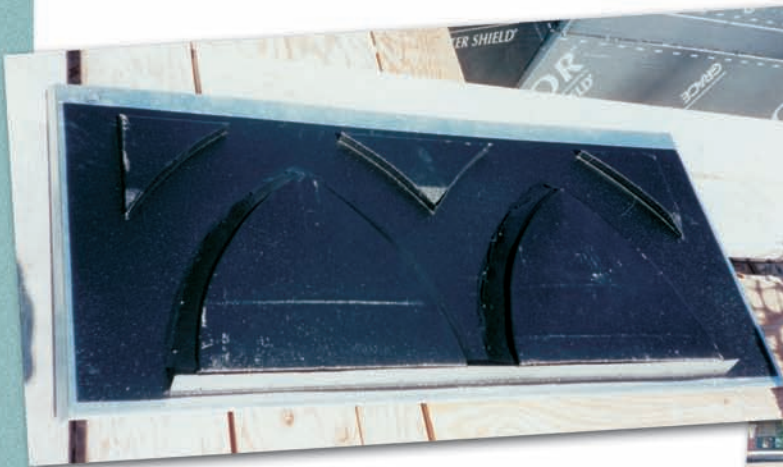
much of the original fabric as possible and to help keep costs within the project's budget. When the "fish-scale" panels on the corner turrets were removed, most were more deteriorated than anticipated. These panels were scheduled to be cleaned to their base metal, resoldered where needed, repainted, and then reinstalled. When removed, the back sides of the panels were significantly pitted from corrosion and concerns were raised that the cleaning process might further erode the existing soldered seams and leave insufficient material for attempting new soldered seams. The contractors proposed to apply to the back sides of these panels a polyurea resin coating that had been successfully used to create truck bed liners; otherwise, the intricate fish-scale pattern would have to be replicated by hand. The

Above: The back side of a cupola "fish scale" panel reveals the polyurea resin coating that was applied to stabilize the panel. In addition, the panel edges were reinforced with galvanized steel formed angles.

initial mock-up of coating a prepared panel proved successful in stabilizing the panels sufficiently to allow all of them to be reused. The "fish-scale" in-fill panels at other locations were not affected by this change, as they were scheduled for replication or to be refinished *in situ*.
