WITHSTANDING HURRICANE IVAN

By S.P. GRAVELINE

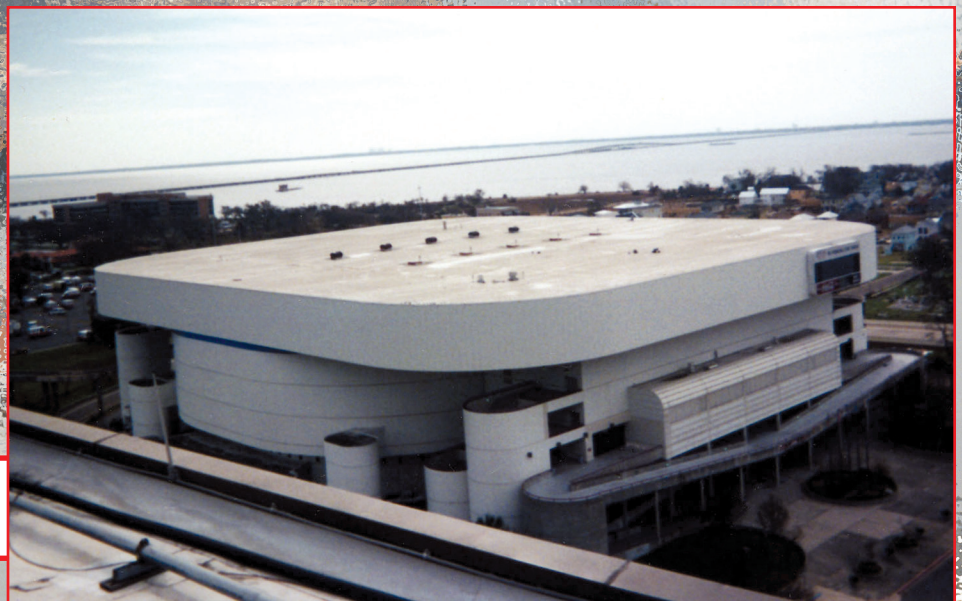
**Photo 1: Pensacola
Civic Center.**

The Pensacola Civic Center (*Photo 1*) was built in 1985. The 10,000-seat arena is a popular venue for major concerts, sporting events, and trade shows. More importantly, the building is one of the region's emergency hurricane shelters. It is counted on to provide a safe haven through the worse possible storms.

A fully-adhered EPDM assembly was originally installed on its 136,000 square-foot roof. Hurricane Erin struck Pensacola in 1995 and did approximately \$7 million worth of damage to the building. More than 80% of the roof's surface, the facer had delaminated from the core of the insulation boards, which allowed the membrane to peel back.

A decision was made to re-roof the facility with a polyvinyl chloride membrane secured by lineal fixation elements.

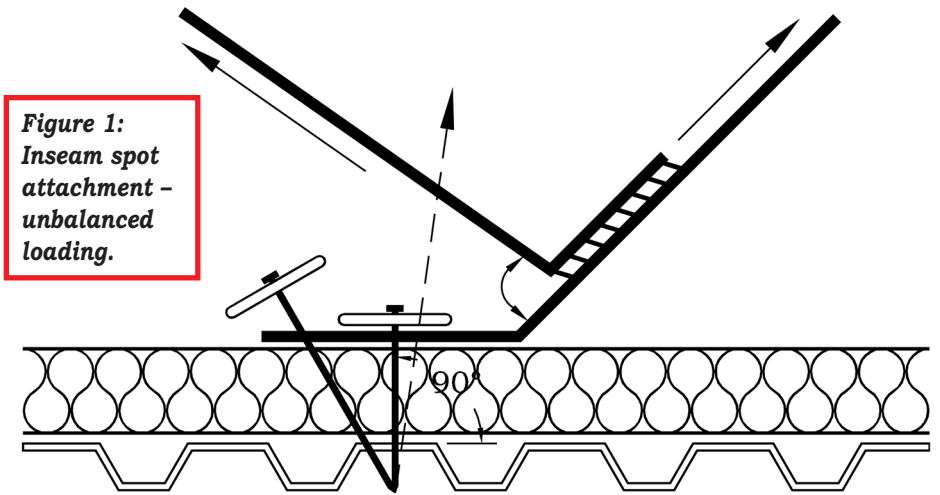
Figure 1:
Inseam spot attachment - unbalanced loading.

In a traditional mechanically-attached installation, the fasteners and plates are installed in the sheet overlap. Under wind loading, the membrane (and consequently, the fastening components) are subjected to unbalanced or asymmetrical forces (*Figure 1*). This imposes tremendous stress on the seams, on the membrane where it is penetrated by the fastener, and most importantly causes the fasteners to tilt slightly. Fastener pull-out resistance is reduced as the fastener is acting at an angle to the deck. Additionally, under cyclic wind loads, the fastener and plate assembly "rock" back and forth, potentially elongating the point at which the fastener penetrates the deck, further reducing pull-out resistance. Although these spot-attached assemblies have a good track record on roofs exposed to more modest wind loads, there was concern that such a system would not provide the level of performance required to protect this structure from hurricane-force winds.

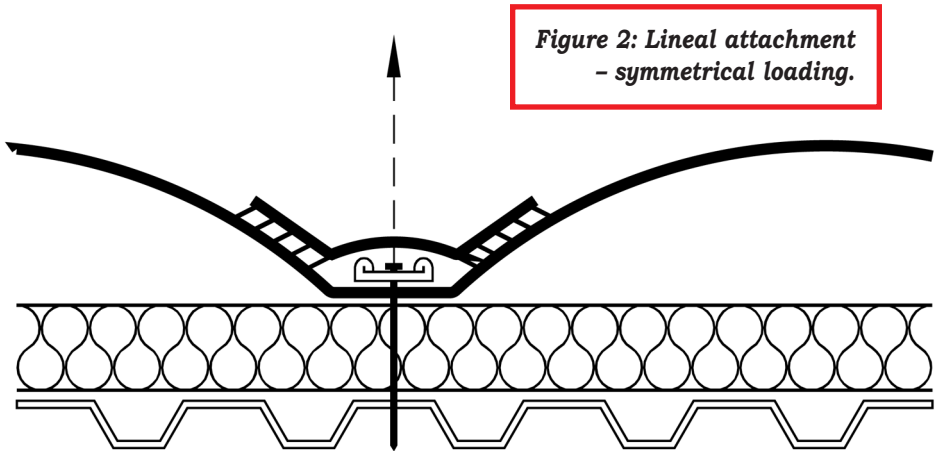
Figure 2:
Lineal attachment - symmetrical loading.

In a lineal attachment system, stiff 14-gauge, U-shaped profiles are used to distribute the wind loads. The bars are secured with fasteners through the membrane to the structural deck. The bars are then made watertight with cover strips hot-air welded to the base membrane. Such systems allow for a uniform load distribution on both sides of the fixation element (*Figure 2*).

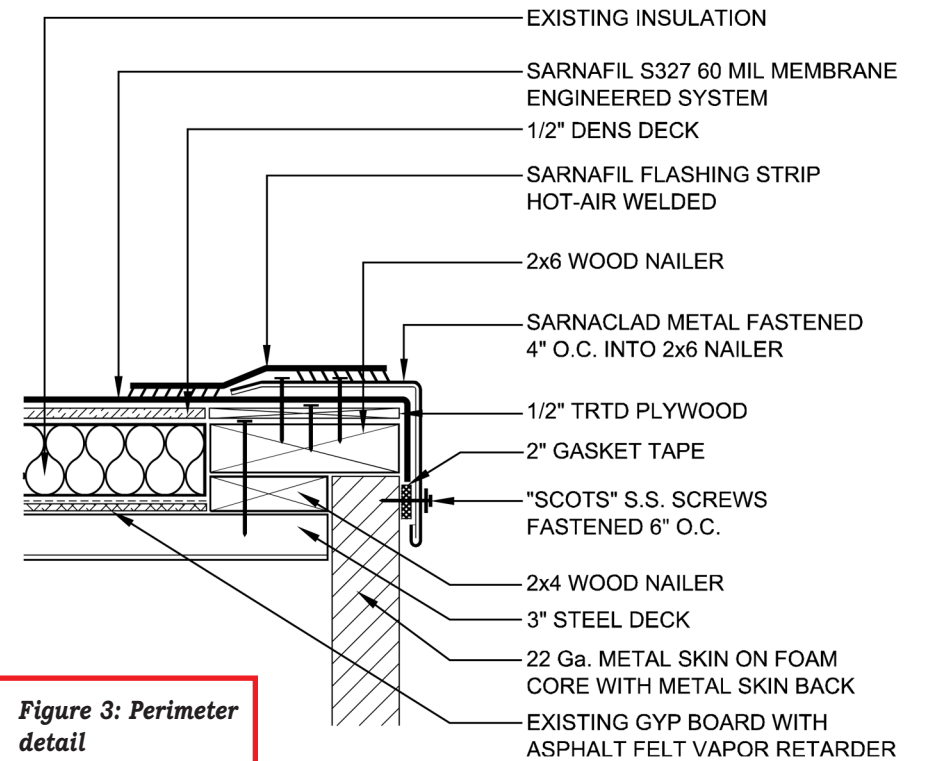
Figure 3:
Perimeter detail

The perimeter detail (*Figure 3*) was designed to ensure the critical edge of the roof was airtight. The fascia was face fastened through a gasket tape sealed to the wall panel.

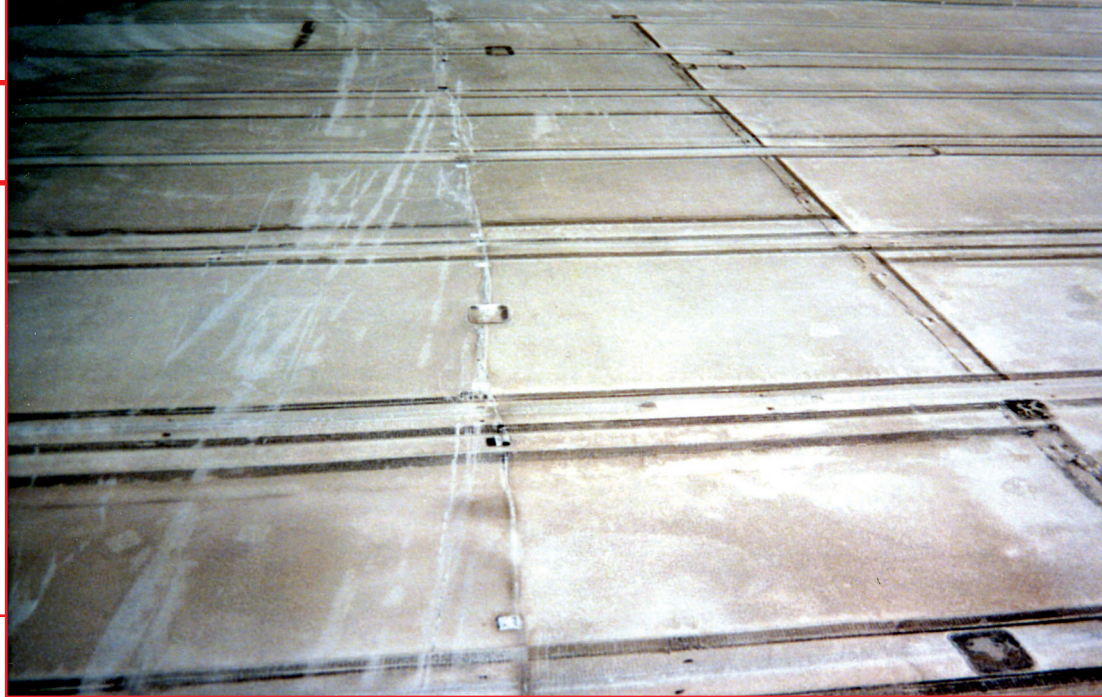
Photo 2: "Track" of one of the wind-blown HVAC units.

took the full brunt of Ivan coming in along the Gulf of Mexico. The 130-mph winds dislodged five rooftop exhaust units from their curbs. Each of the units was approximately 6 x 6 feet in size and weighed roughly 300 lbs. The units were literally blown across the roof surface, leaving their paths clearly marked on the membrane's surface (*Photo 2*). One of the units actually blew off the

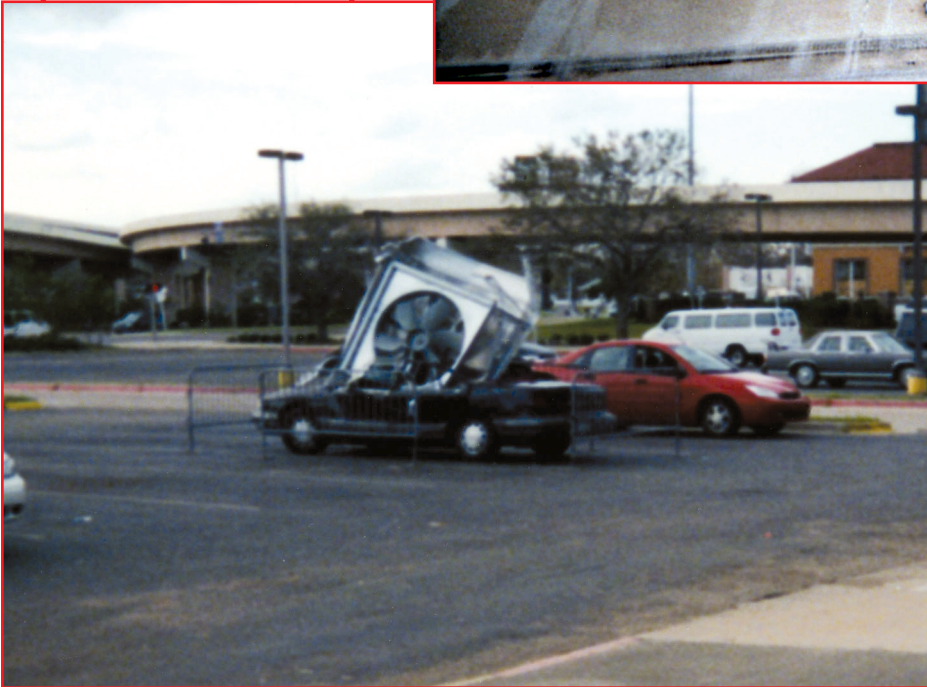
Photo 3: Exhaust unit blown off the roof.

roof and landed on a car in the adjacent parking lot (Photo 3).

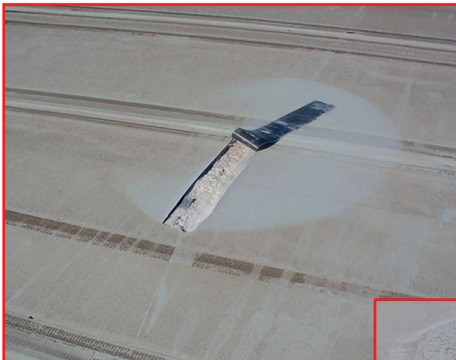
Photo 4: Membrane cut by an exhaust unit.

The membrane was cut or punctured in numerous locations (Photos 4 and 5). At one location, immediately adjacent to where a unit was ripped away from its base, the sheet was slashed along a 25-foot length (Photo 6). The large opening allowed air below the sheet, which in combination with the winds in excess of the design speed, caused slight lifting of some fixation bars (Photo 7) in the field of the roof. Despite the pull-out of a few fasteners, the bars remained in place, albeit slightly deformed. No bars were displaced or fasteners pulled out in perimeter or corner zones, where the highest loads are generated.

Within a couple of days of the storm, the contractor who had installed the roof in 1995 was able to repair all the cuts and punctures by hot air welding patches to the existing membrane. Having made the roof watertight, the roofer will return later to address the deformed bars. Less than 1% of the fixation bars were affected.

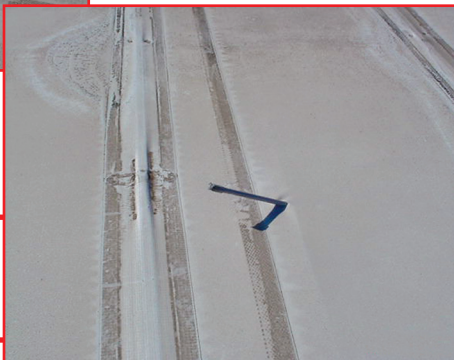
Photo 5: Membrane punctured by an exhaust unit.

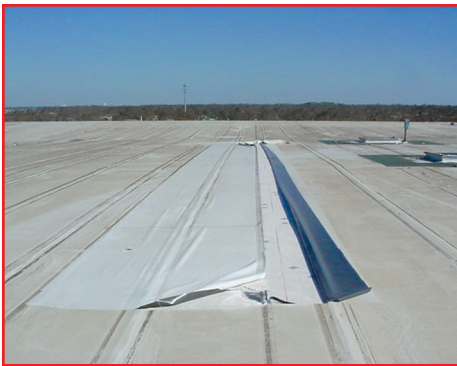
Photo 6: Membrane slit by a tumbling exhaust unit.

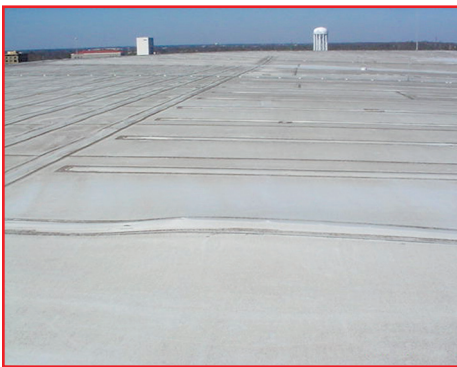
Photo 7: Partially deformed fixation bar.

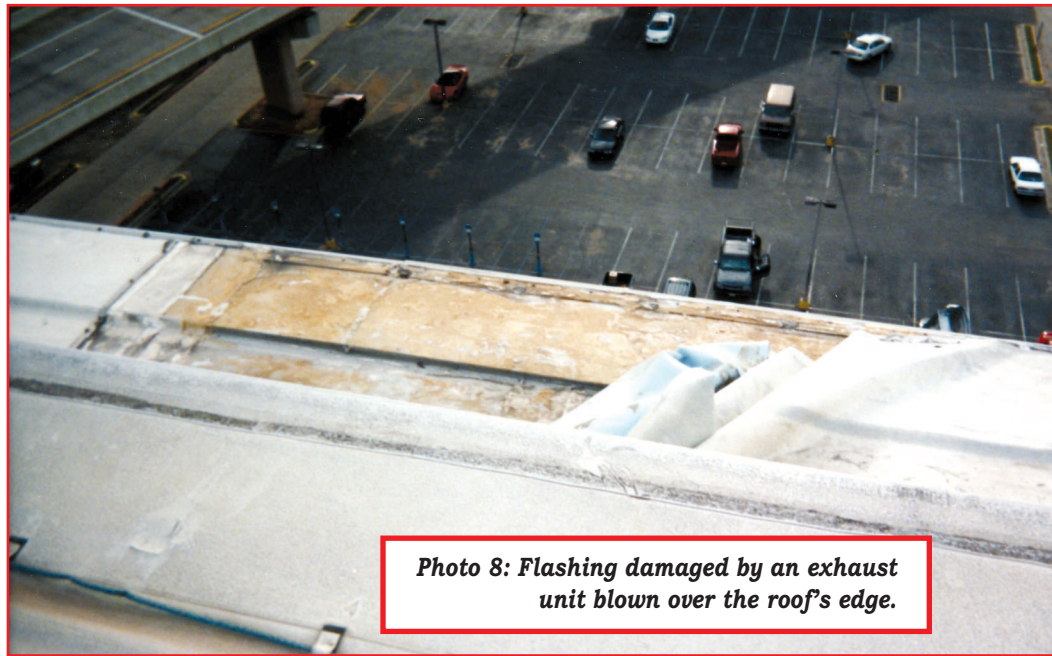
Photo 8: Flashing damaged by an exhaust unit blown over the roof's edge.

The flashing was damaged at the location where the unit went over the edge of the roof (Photo 8). Otherwise, the flashings remained fully intact and undamaged.

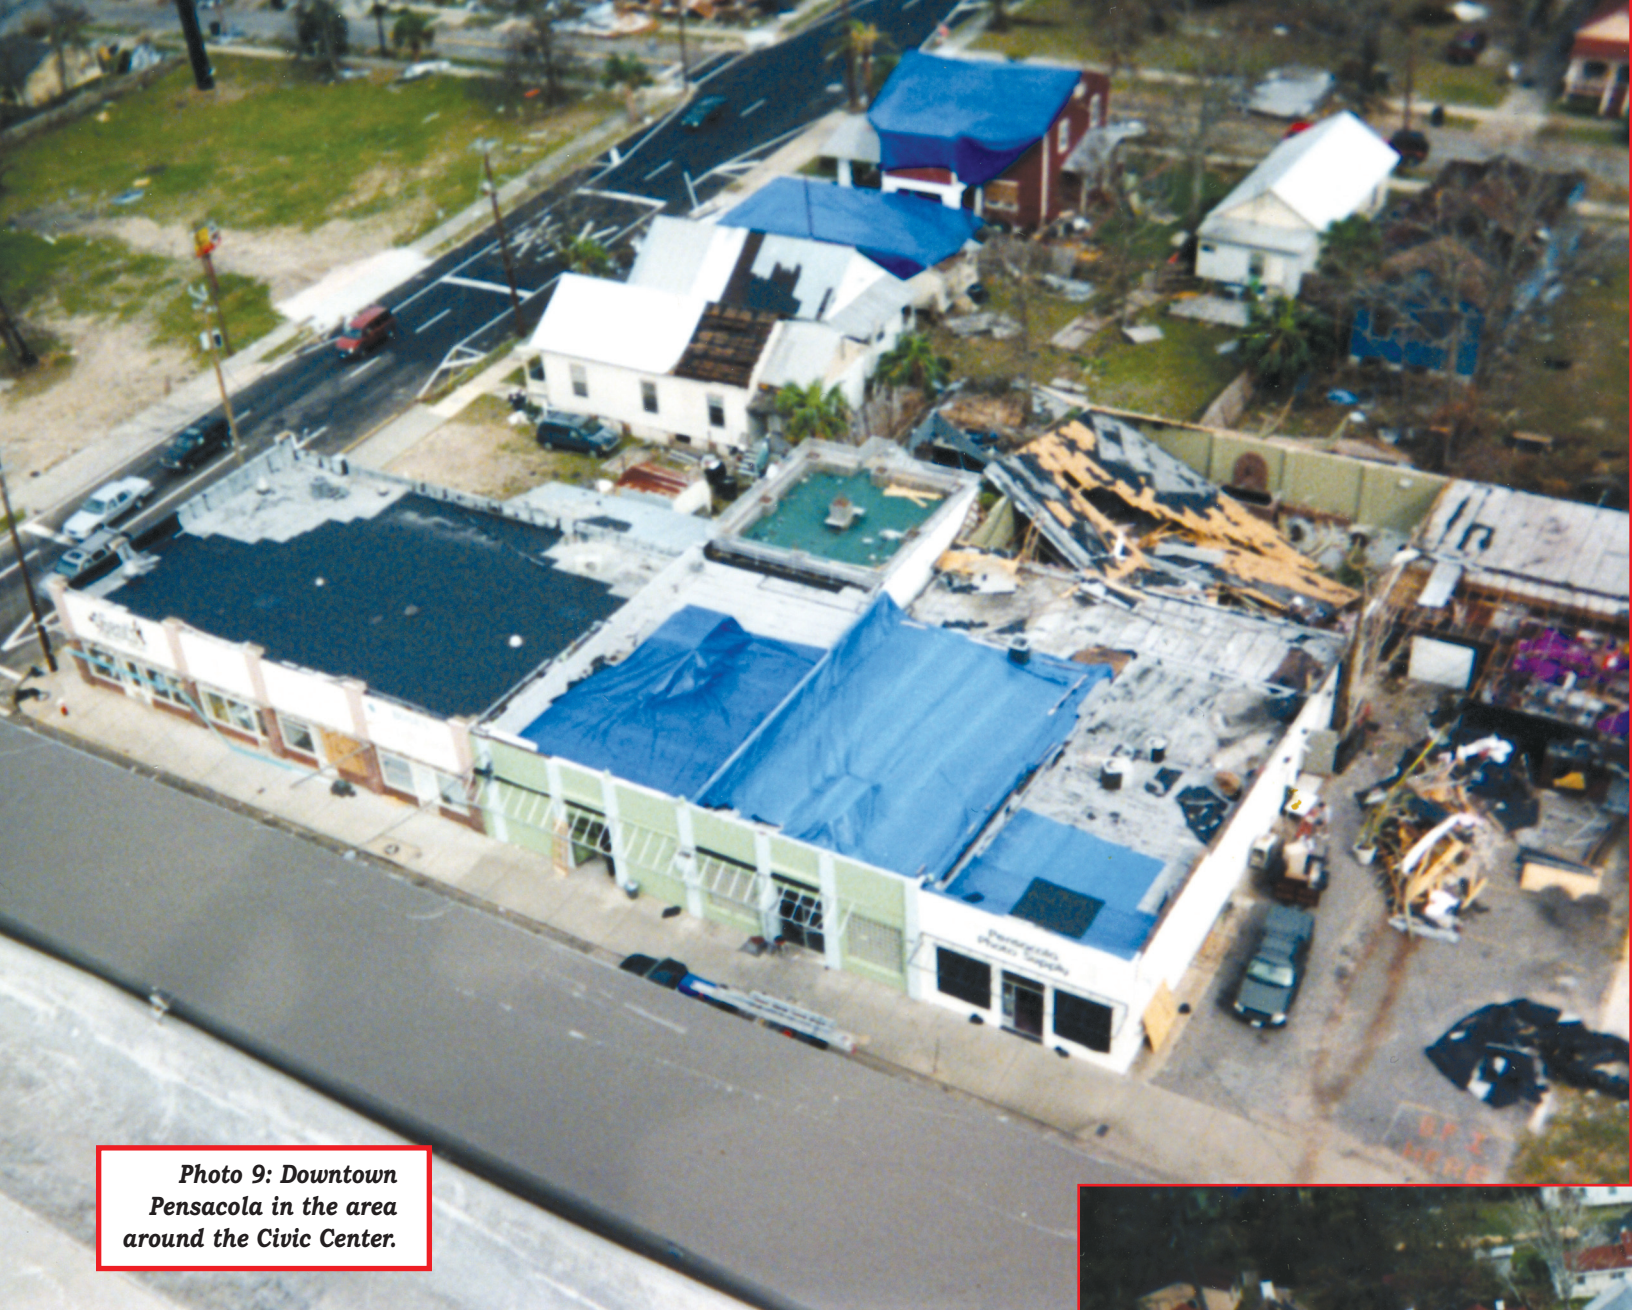
Photo 9: Downtown Pensacola in the area around the Civic Center.

Pensacola's downtown core in the area surrounding the Civic Center was absolutely devastated (Photos 9 and 10). However, although the noise from the displaced mechanical units rolling around the roof was disconcerting, the thousands of people

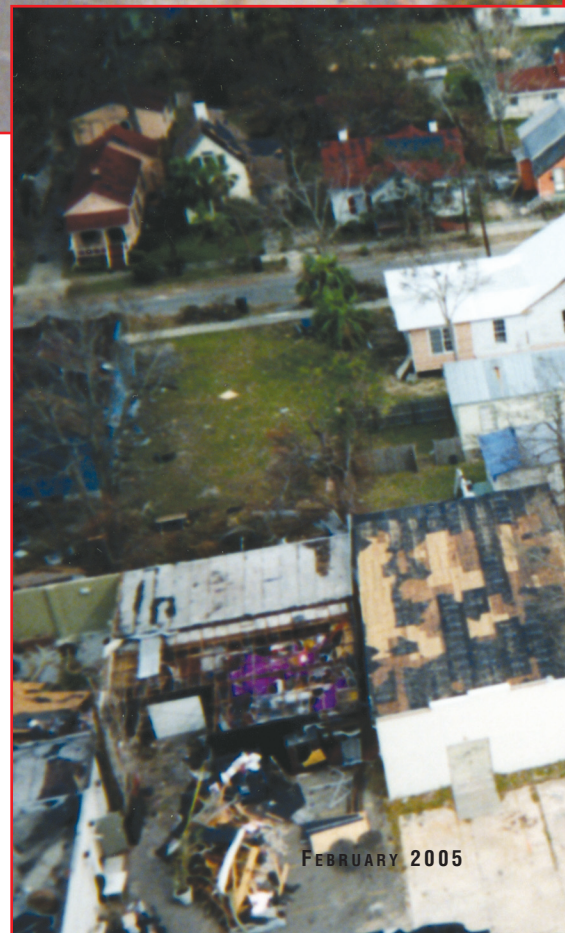
Photo 10: Downtown Pensacola in the area around the Civic Center.
