PRESERVING OUR BUILT ENVIRONMENT:

Restoration of EPDM Roofs Extends Service Lives

BY TIM SULLIVAN

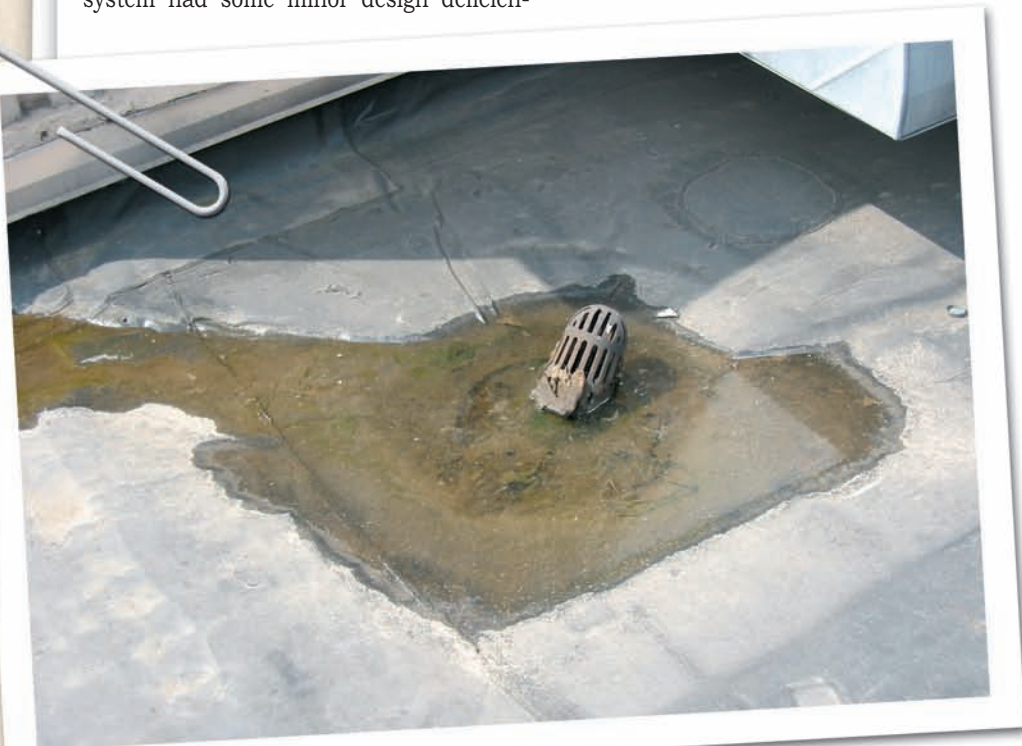
Other restoration measures were executed. The existing drains had been drastically sumped at three inches below the top of the roof surface, causing stretching of the membrane around the drains. The restoration involved raising the new drains for improved long-term performance. The garage parapet base flashings had been poorly executed, and the coping stone joints were badly deteriorated. The solution was to install plywood on the inboard side to reflash the wall and to install flashing over the coping to encapsulate the problem. Existing gutters above the low clerestory walls had not been properly attached, and the wind had pulled away from the existing securements. Work was completed to achieve additional securement of the gutters, as well as enhancement of the flashing on the gutter flanges. Similar measures were taken to repair wind damage observed on the high clerestory roof edges because the flashing was not clipped, and the wind had peeled it up.

The drainage system and roofing membrane were found to be in need of restoration on the roof of the City of Milwaukee Northwest Garage.

The garage roof restoration design called for all the lap seams to be cleaned and covered with semi-cured, self-adhering EPDM cover strips and the edges to be sealed with lap sealant. All abandoned roof curbs were removed, all existing roof curbs were reflashed, and the base flashing at the perimeter parapets was redesigned to "wrap" the wall and be covered with sheet metal copings in order to render the limestone coping joints watertight.

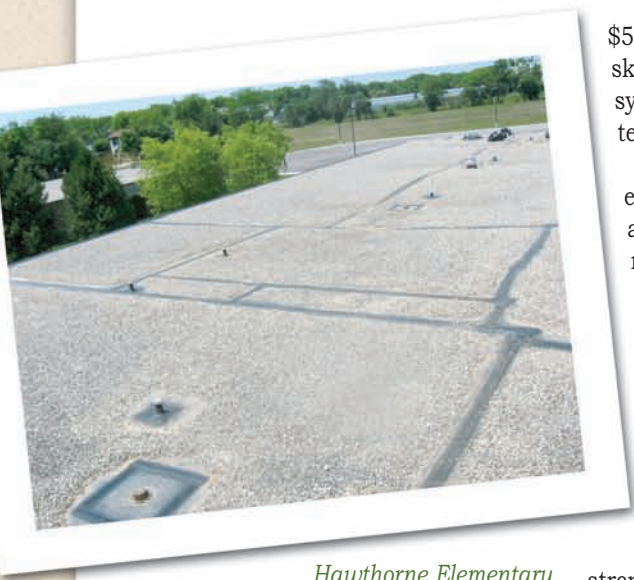
Hawthorne Elementary School, School District 73, Vernon Hills, IL.

Inspection of the roof revealed that no leaks had ever been reported but that a number of the building elements that impinge upon the roof, such as skylights and HVAC equipment, had flashing conditions that were beginning to deteriorate. The 45-mil EPDM membrane appeared to be in good condition, and a sample was taken for testing. Test results confirmed that the loose-laid, ballasted EPDM in place on the roof after 21 years of service had material characteristics that exceed the minimum requirement of membrane being manufactured today. The adhesive lap

seams were all found to be tight, with no known deficiencies. A small amount of bridging at the wall base flashing was observed. The recommendation to the school board was to restore the roof with the goal of achieving at least ten years more service life.

The restoration design at Hawthorne Elementary involved replacing all the skylights with OSHA-approved fall protection skylights, redesigning and improving the HVAC intersection with the roof, installing semi-cured, self-adhering EPDM cover strips over all lap seams, installing target patches at the roof drains, reflashing all roof curbs and base flashings, and installing a new cover strip at the gravel stop.

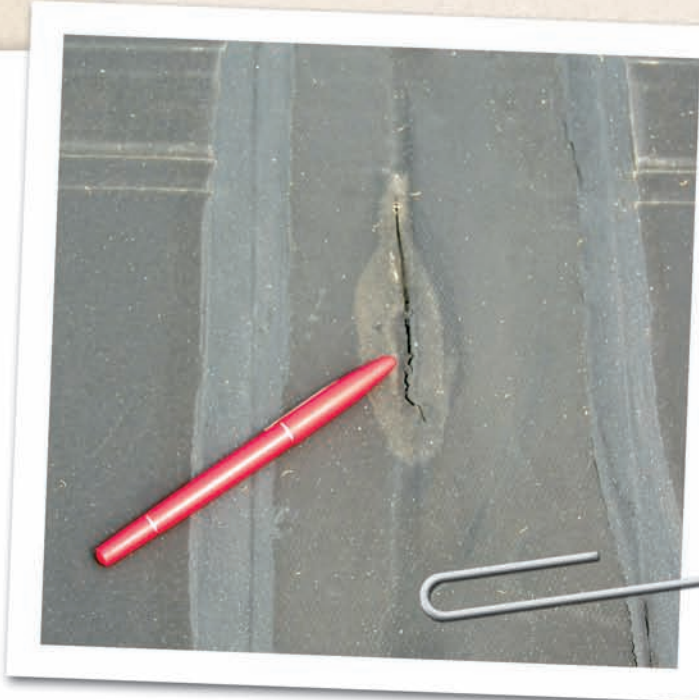
which included minor areas of poor detailing and wind damage. No major seam failure was found, but some minor delaminations and bridging were observed. Rather than removing and replacing the roof, it was the recommendation of the owners' Registered Roof Consultant (RRC) to restore and enhance the roof system.

Separation of the seams of the EPDM roofing membrane were visible during inspection of the roof on the Milwaukee Northwest Garage.
