EIFS:

Practical Solutions for Addressing Damages to Existing Buildings

By Derek A. Hodgin, PE, RRO, RRC, RWC, CDT

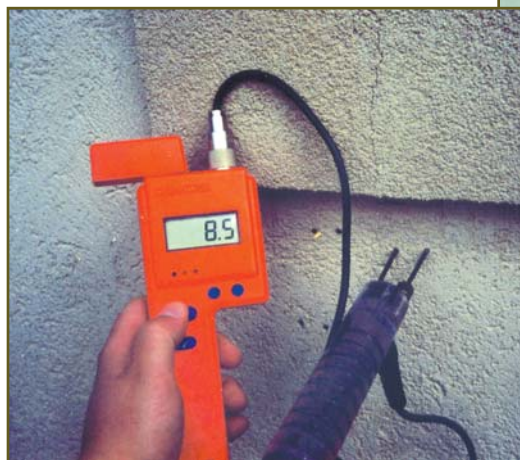
Figure 3

The survey of damages should be performed by a qualified inspector using a probing-type moisture meter (see Figure 3). While non-destructive moisture meters are handy for covering large wall areas (see Figure 4), they need to be “ground truthed” on every building elevation and may miss areas that have been previously damaged but are no longer associated with elevated moisture. The moisture meter probes should be used to provide a qualitative assessment of the condition of the underlying wall sheathing (i.e., soft, hard, etc.). In areas of damage, several probes should be made to estimate the area of possible sheathing replacement. These areas should typically be enlarged (in some instances, more than 100 percent) to allow for replacement of full sheets of wall sheathing as described below. Keep in mind that the

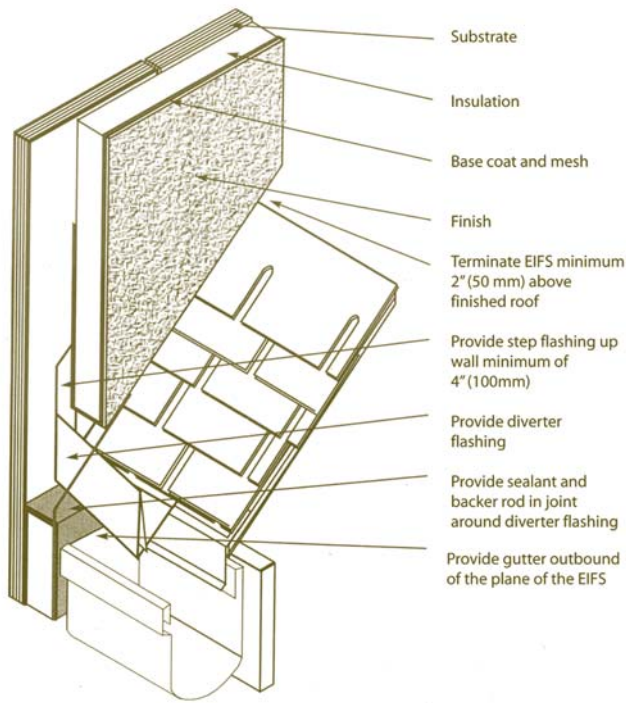
Figure 5

A “kick out” detail is typically included with current manufacturer installation instructions (see Figures 5 and 6). However, the importance of this detail was not recog-

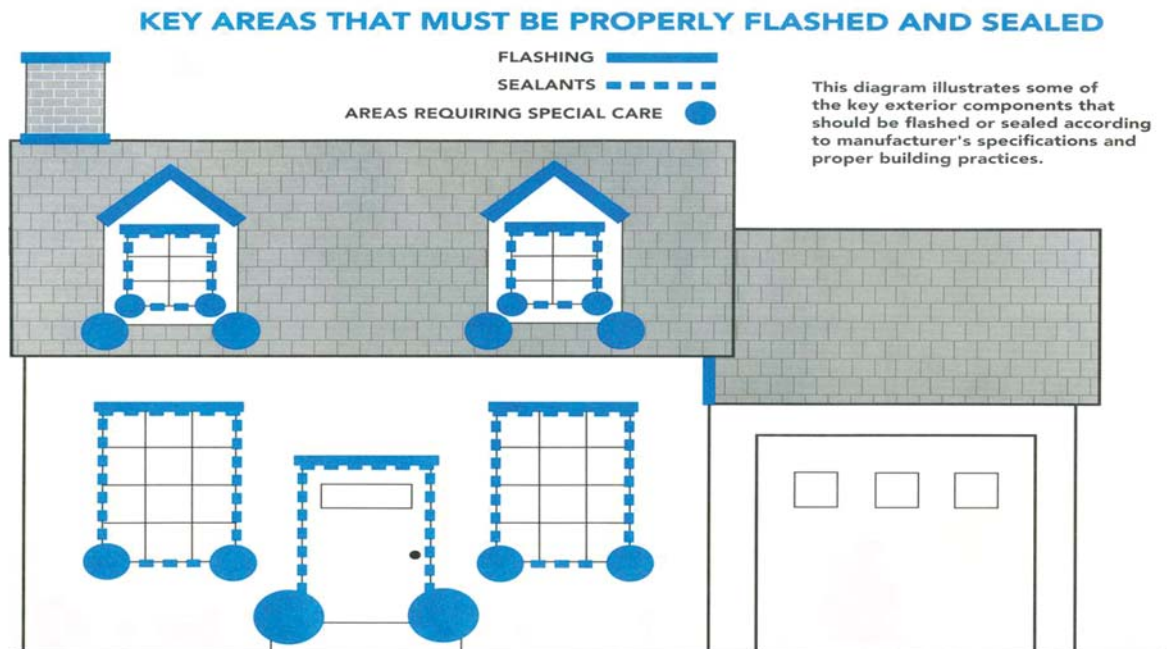
Figure 7

nized by the industry until after significant damages were documented and litigation was well underway. As late as 1994, details from the EIFS Industry Members Association (EIMA)⁴ did not specifically include “kick out” flashing. However, a general reference was made to flashing being required in this area (see Figure 7).

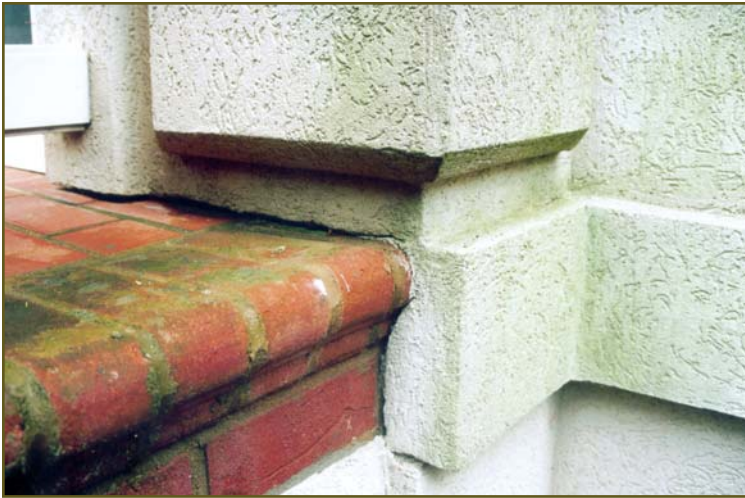
Figure 12

Of the various types of penetrations, decks and porches seem to pose the most potential for damage. This is because water flow from the surface of a deck or porch is typically much greater than the flow of water running down a vertical wall due to gravity. Damages at deck and porch intersections are often exacerbated by absence of positive slope (away from the exterior wall) and wind-driven rain (see Figure 12).

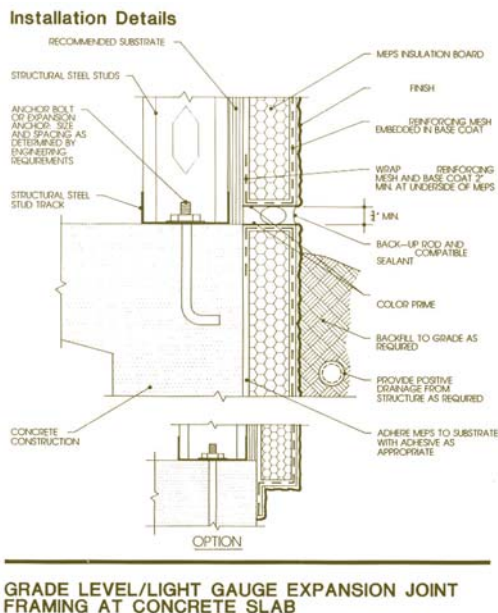
Figure 19

Depending on where one looks, EIFS should be terminated 6 to 8 inches above grade. Most building codes require a separation of 6 inches⁶, while most EIFS manufacturers and industry standards recommend a clearance of 8 inches between the EIFS and grade (see Figure 18). Unfortunately, this is not always the case. A limited number of EIFS manufacturers produced details showing their product extending below grade (see Figure 19). The author

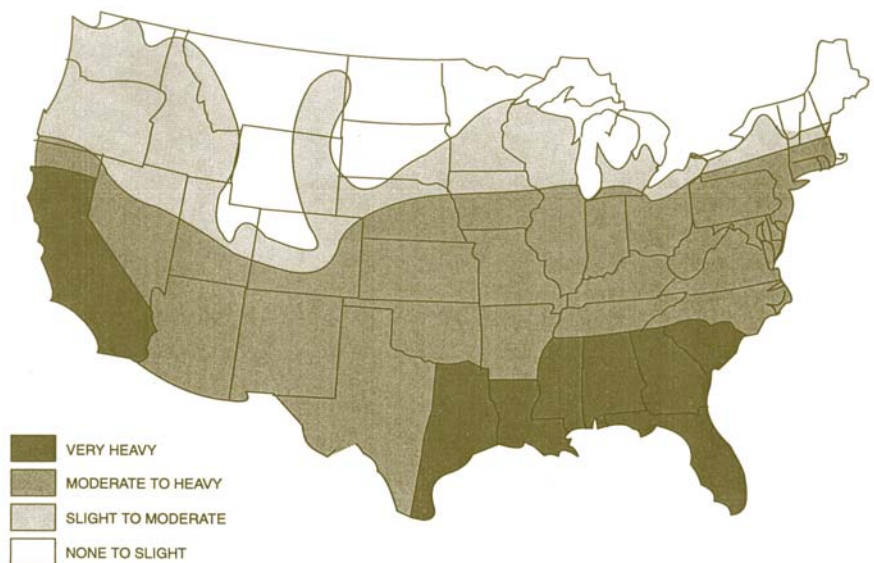
Figure 20

is unaware of any manufacturer details today that show EIFS extending below grade. This condition provides a concealed and continuous path for termites to travel into the building. Extreme damage can occur in the presence of water intrusion in an area of high termite infestation probability, such as the southeastern United States (see Figure 20).

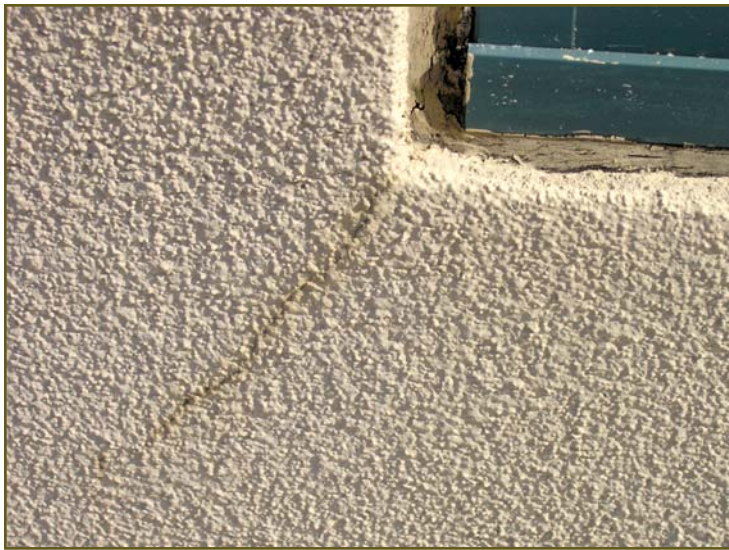
Figure 21

Cracks will develop at stress concentration points in the EIFS lamina. These points exist at corners of wall openings (see Figure 21), at points of transition where the lamina changes direction, and at aesthetic reveals where the insulation board changes in thickness. Unless a crack is located in an area of concentrated water flow (i.e., window opening, roof/wall intersection, etc.), damage is typically minimal. In the absence of an impact, cracks do not usually develop in the middle of a wall. Compression cracks can develop in EIFS; however,
