BERMUDA ROOF IN HARTFORD, CONNECTICUT

BY REMO CAPOLINO, RRC, PE

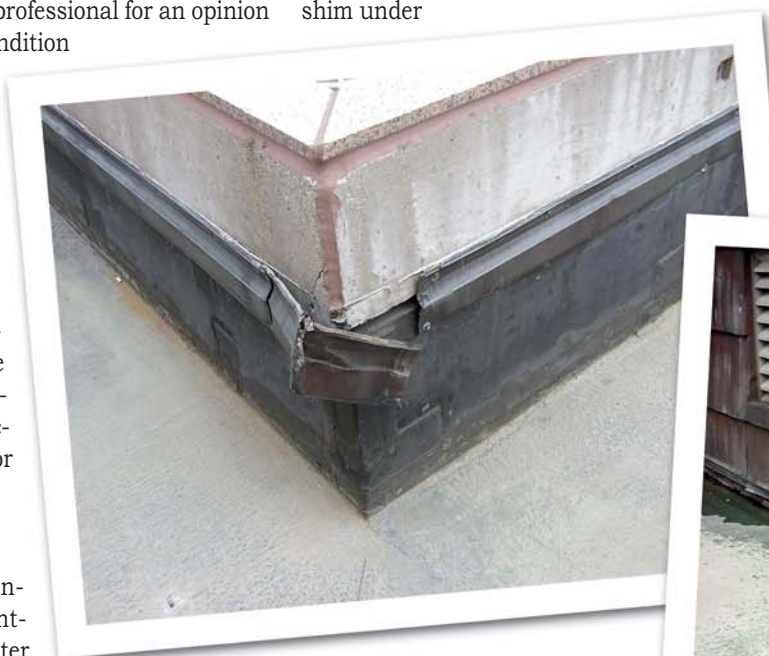
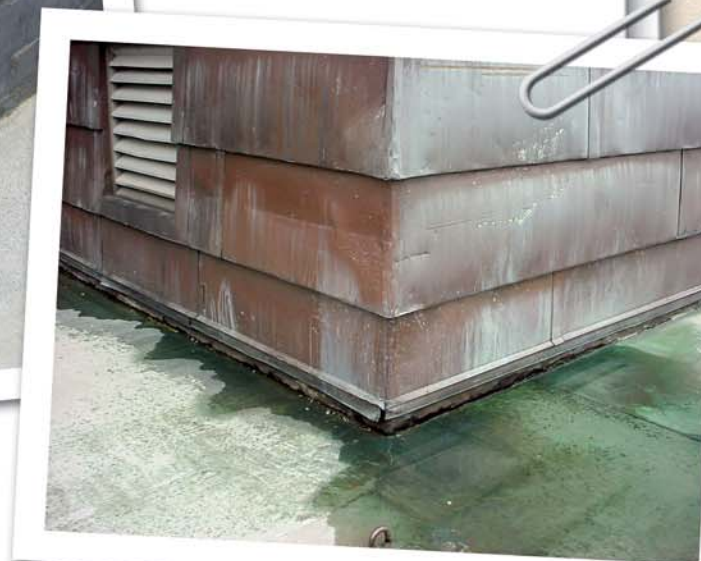
A visual observation of the roof showed many areas of impact damage on the vertical rising walls. This was caused by the window-washing rig that travels the perimeter ring accidentally hitting the wall at corners and other areas with limited clearances (see Photos 1 and 2). A significant number of

Photos 1 and 2: Damages cause by window-washing rig.

steel “bumper” system at all inside and outside corners to protect the copper-clad vertical walls. Protection is required from the window-washing rig as it goes around the building. It included the incorporation of a gutter made from bent and welded stainless steel plates that acts not only as a water collection device above the roll up door that provides the only access to the ring roof, but also serves to protect the copper soffit from damage by the washing rig. See *Photos 13, 14, and 15.*

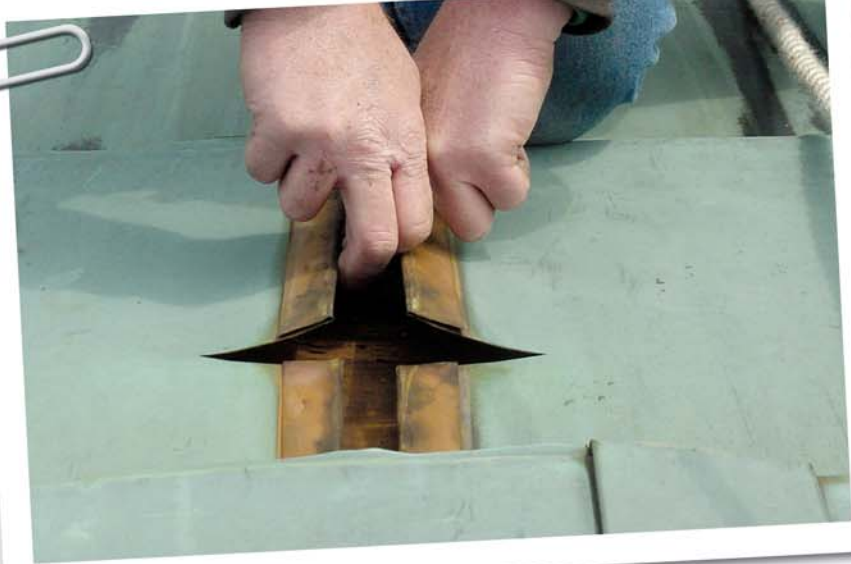
Photo 3: Cracks in copper at drive cleats.

cracks were also noted in the copper at the intersections of the Bermuda panels where the drives are installed between the panels (see *Photo 3*). Inspection openings in the copper cladding yielded multiple reasons for the cracked and deformed copper. At the drives between Bermuda panels, no cleats were present to prevent the wind pressure from repeatedly lifting the copper off the substrate. Over the course of 20+ years, the repetitive action caused the copper to fatigue, which allowed a crack to form and propagate. At the hips, the convergence of multiple planes of flat copper intersecting in one location and the lack of any provision to accommodate for thermal expansion and contraction, caused the unsoldered cuts (required to form the copper into the corner configuration at the time of initial construction) to tear. (See *Photos 4 and 5*.)

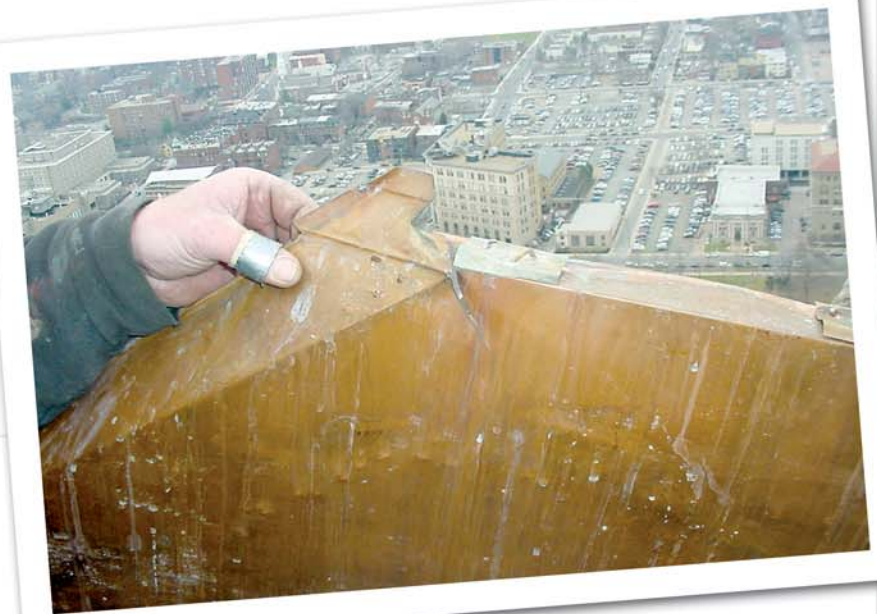
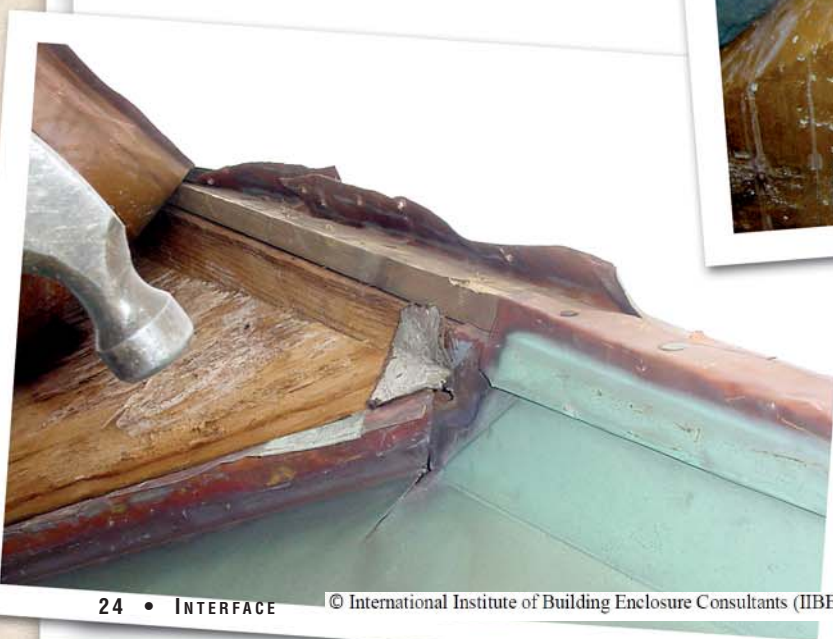
Photos 4 and 5: Tear in copper at hips.

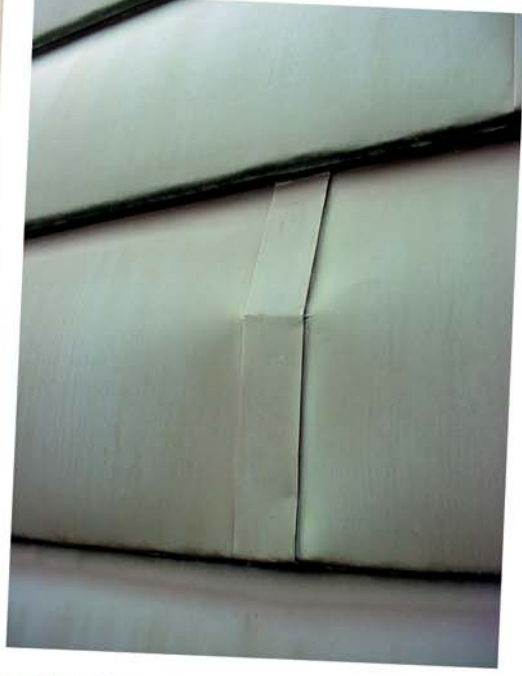
copper panels slipped from their original positions and gathered at the bottom leading edge of many Bermuda panels. This accumulation of materials pushed the copper panels outward from their original position and created the curved or bowed shape that was noted by the building management (see *Photo 6*).

Photo 6: Bowed copper due to accumulation of underlayments (felt and rosin).

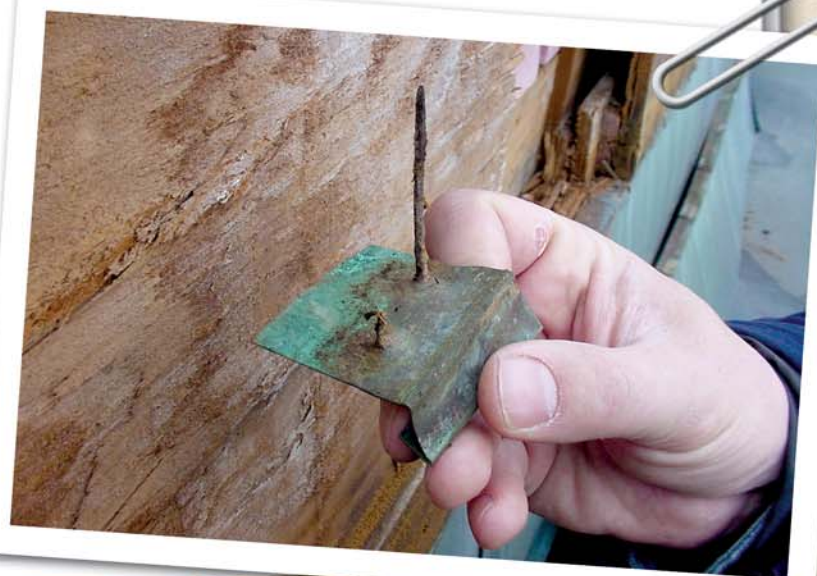
tion, the underlying plywood substrate was brittle, and the nails used to secure the copper cleats to the plywood were heavily corroded. The combination of fastener corrosion and plywood degradation resulted in significant sections of the copper panels detaching from the building (see *Photos 7 and 8*). The only attachment to the building was indirectly through 3/4-inch locks to the adjacent copper panels in the Bermuda courses above and below.

Photo 7 (above): Corroded copper fastener.

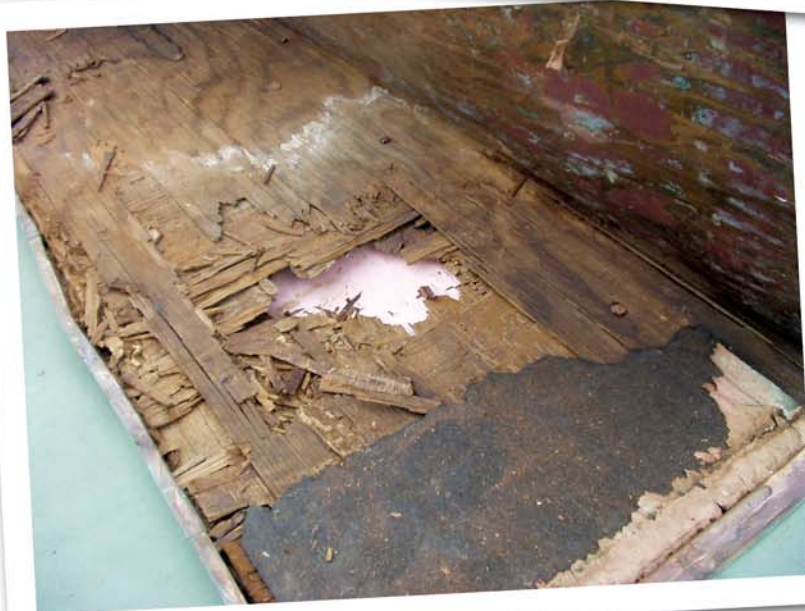
The condition of plywood in many areas on this roof was such that if the copper cladding were not there to spread the load, the foot pressure of an individual on the roof could punch through to the underlying XPS insulation. These FRT issues created a situation that significantly impaired the ability of roof cladding to withstand high winds.

Photo 8 (left): Brittle plywood substrate.

Based upon the roof’s condition, it was decided that it could not be repaired. As a result, the entire roof assembly, including all wood blocking and insulation, would have to be removed and replaced.

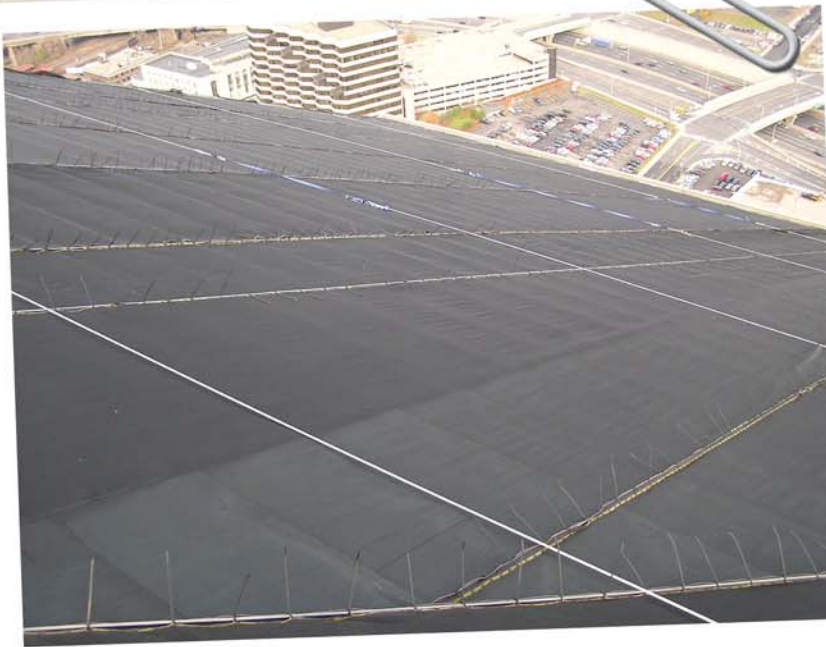
Photo 9: Debris netting on north elevation.

porary securement for the existing assembly were proposed. The first was the installation of screws and plates into each copper panel to directly engage the metal decking. This work would have been difficult due to the extremely steep slopes and the need to be “face to face” with every panel in order to install the screws. The second method was the installation of a dual-purpose safety and debris netting assembly. The netting assembly was designed to be secured into the concrete topping slab of the perimeter ring roof, extend up the sloped roof areas, and be secured to a railing connected to the building’s steel frame at the small upper roof area (see *Photo 9*). With the bid process unable to outpace the on-

coming storm, the building management made the decision to directly contract with the netting installer on an emergency basis. This direct action by the building management in installing the netting protected the building, its occupants, and innocent passers-by from harm. After the storm passed, areas of the installed netting were noted to have been stressed; however, no failure of the roof or netting was observed.

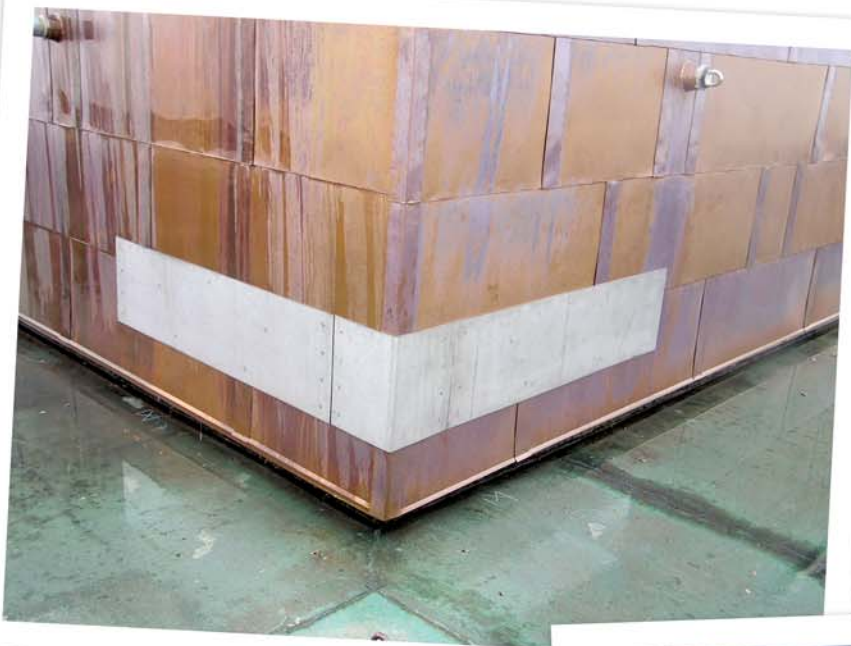
Photo 13: Stainless steel bumper.

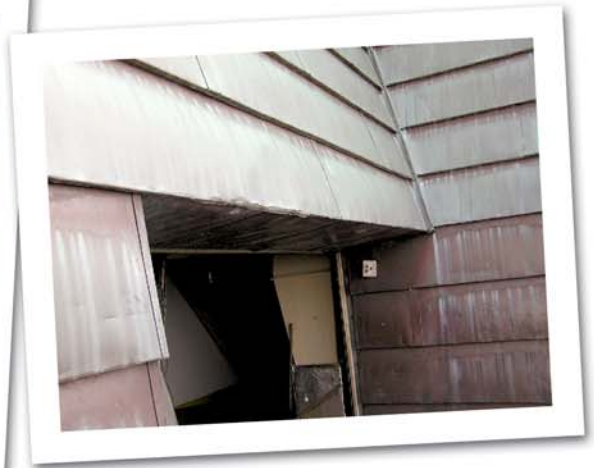
Photo 14: Roll-up door soffit damage.

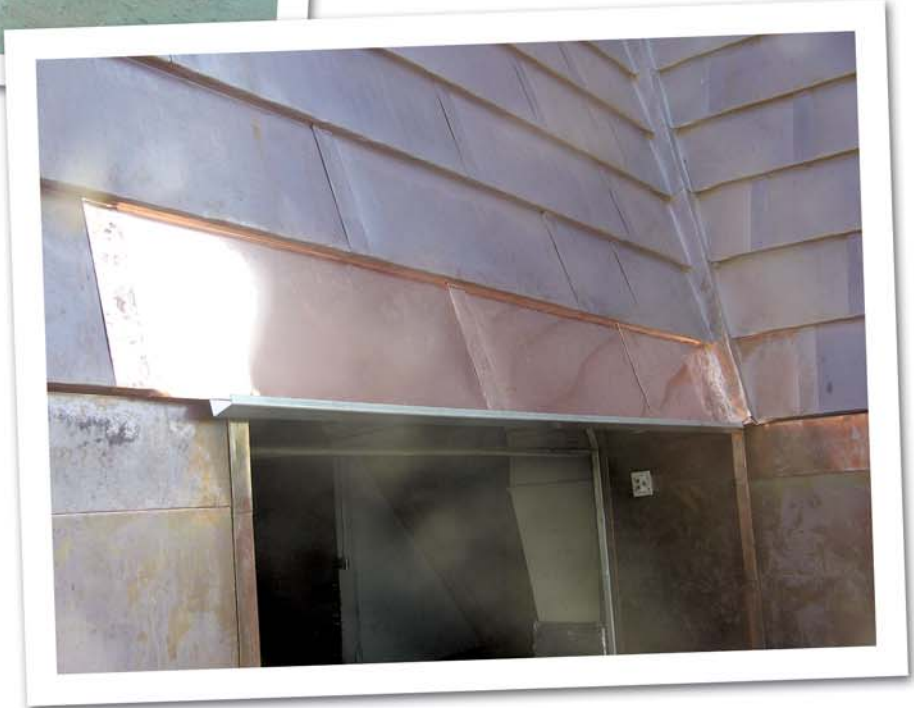
Photo 15: Roll-up door with protective gutter/bumper.
