# Three-Tab Shingle Performance During Hurricane Ivan, 2004

By David Rash, RRC, Assoc. AIA

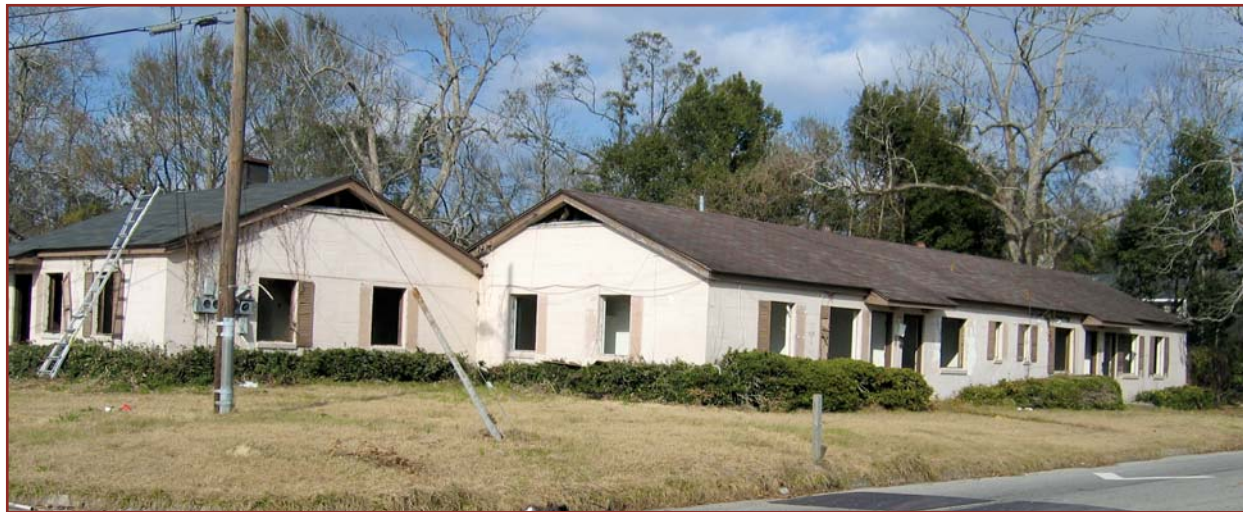
Photo 1 – Typical configuration and condition of building structure within the housing complex.

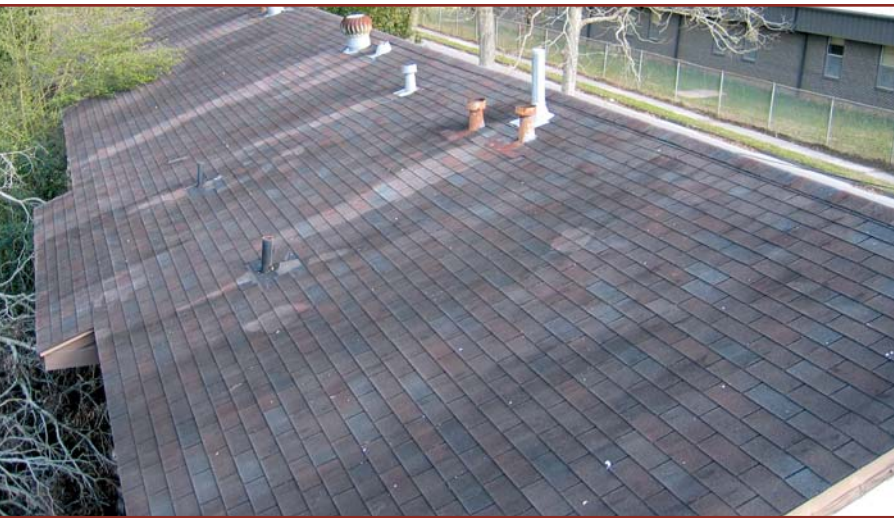
*Photo 2 (left) – The long wing of Building 1 had an “old” shingle roof, typical of nine buildings in the complex.*

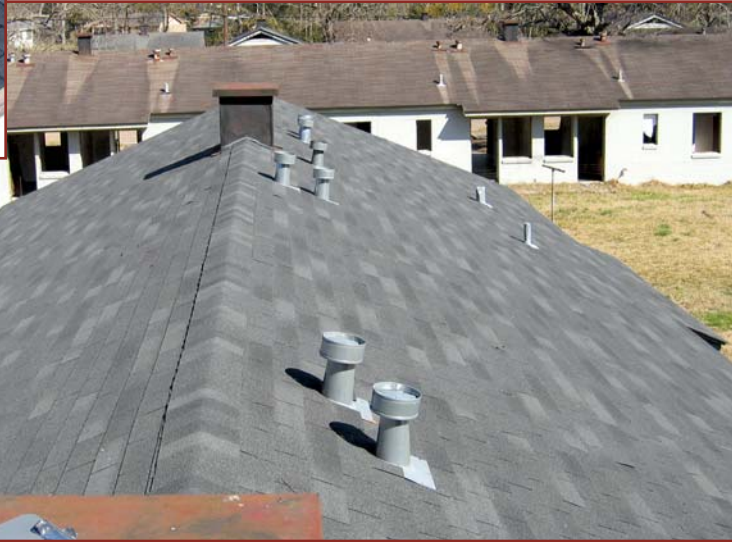
*Below: Photo 4 – The long wing of Building 16 had a “moderately old” shingle roof, typical of five buildings in the complex.*

The total ground area covered by buildings was approximately 48,971 square feet. The total sloped area of roofs covered with three-tab, asphalt-composition shingles was approximately 58,535 square feet. The ages of the shingled roofs were unknown. Topical observation suggested that some of the roofs might have been part of the original (30+ year construction) and are noted in this paper as “old” (see *Photo 2*). Some shingles were definitely installed recently (less than five years ago), and are noted in this paper as “recent” (see *Photo 3*). Other shingles were likely of less recent installation but not original construction (10 to 15 years old), which are noted in this paper as “moderately old” (*Photo 4*).

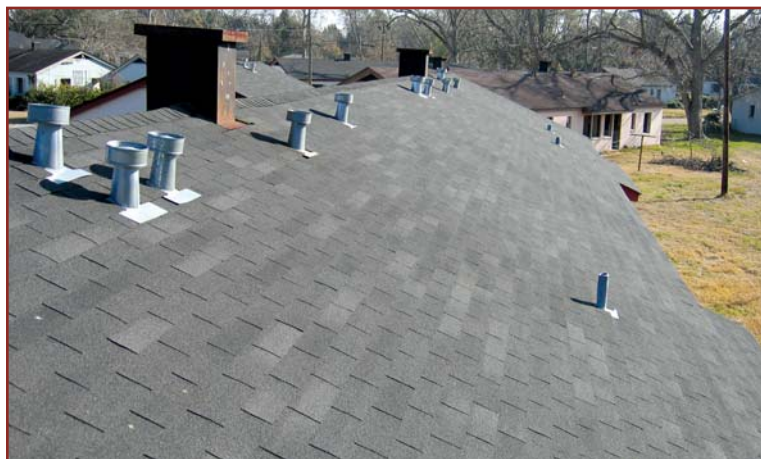
*Photo 3 – The center wing of Building 12 had a “recent” shingle roof typical of four buildings within the complex.*

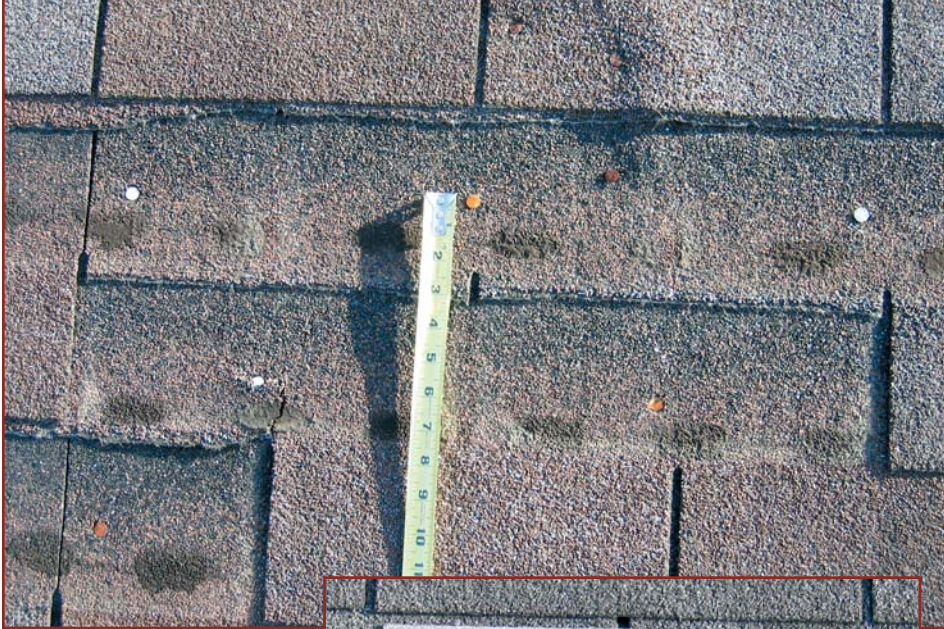
Above: Photo 5 – Nails were underdriven and located too high with the “old” shingle roof installation on Building 10.

weather. Lightly rusted or non-rusted nail heads would suggest recent exposure; heavily rusted nail heads would suggest exposure prior to the hurricane. In addition, in some areas where shingles were recently lost due to a wind event, installation deficiencies undoubtedly contributed to the shingle loss. In particular, under-driven nails or nails located so high as to secure only one layer of shingles, rather than the intended two layers, resulted in roofs susceptible to wind damage (Photos 5, 6, and 7).

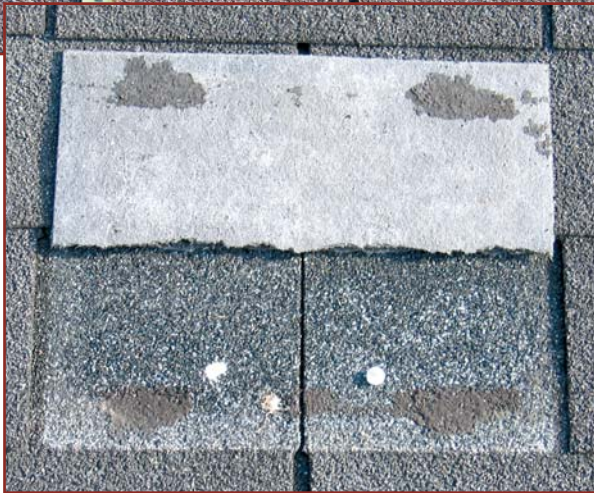
Above: Photo 6 – Nails were underdriven and located too high with the “moderately old” shingle roof installation on Building 2.

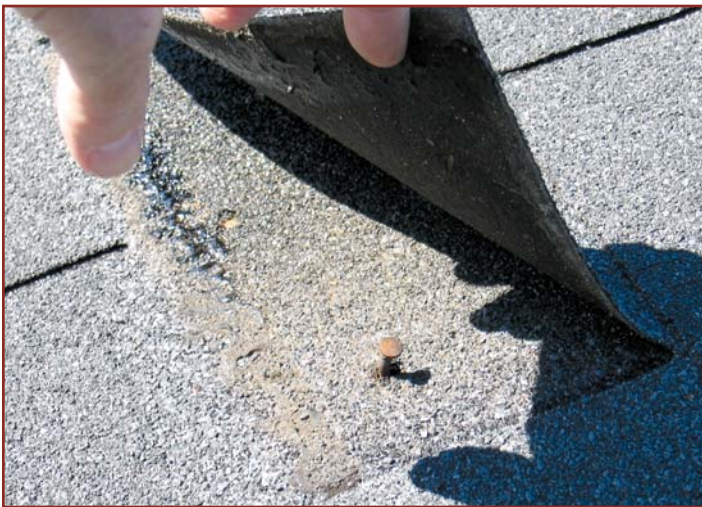
Photo 7 – Nails were underdriven and located too high with the “recent” shingle roof installation on Building 15.

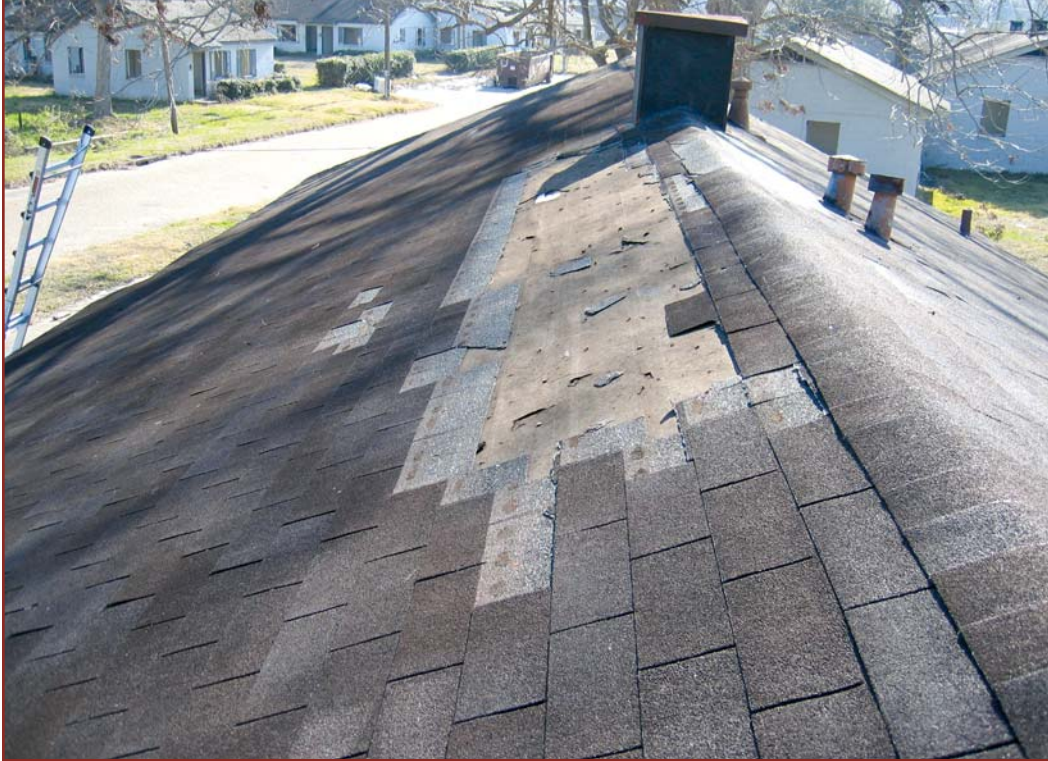
*Left: Photo 8 – The most extensive wind loss of shingles occurred near the roof perimeter and with the “old” shingles, such as on Building 13.*

nificant damage to the shingled roofs outside of vandalism and age. Uplift forces near the perimeter of the roof structures were sufficient to remove shingle tabs from portions of some roofs, particularly the older ones (Photos 8, 9 and 10).

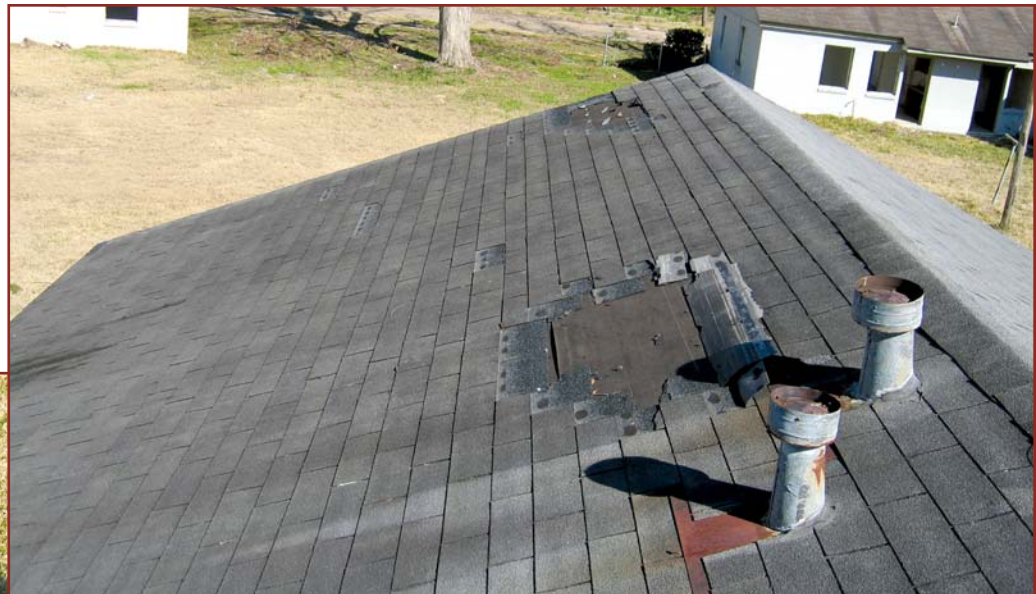
*Above: Photo 9 – Less extensive wind loss of shingles occurred with the “moderately old” shingles, primarily near the roof perimeter, such as on Building 18.*

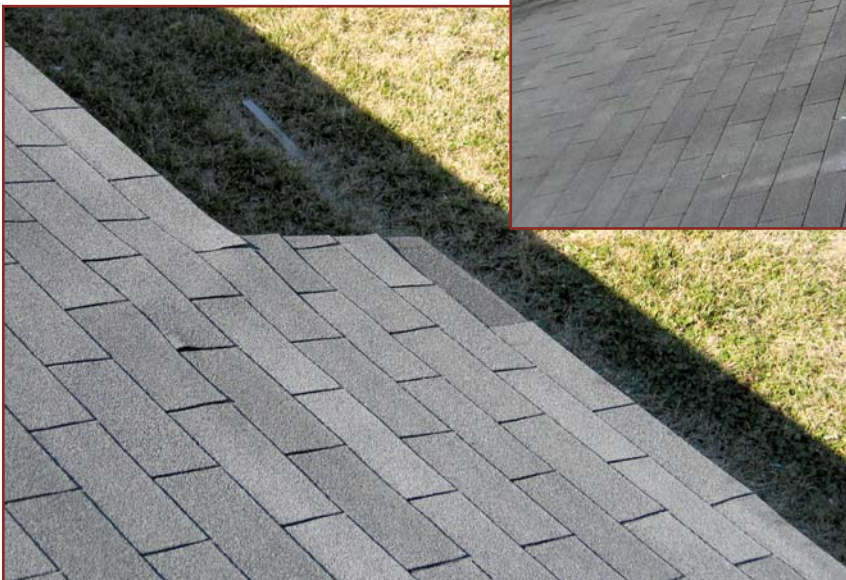
*Photo 10 – Very little wind loss of shingles occurred with the “recent” shingles, such as on Building 15.*

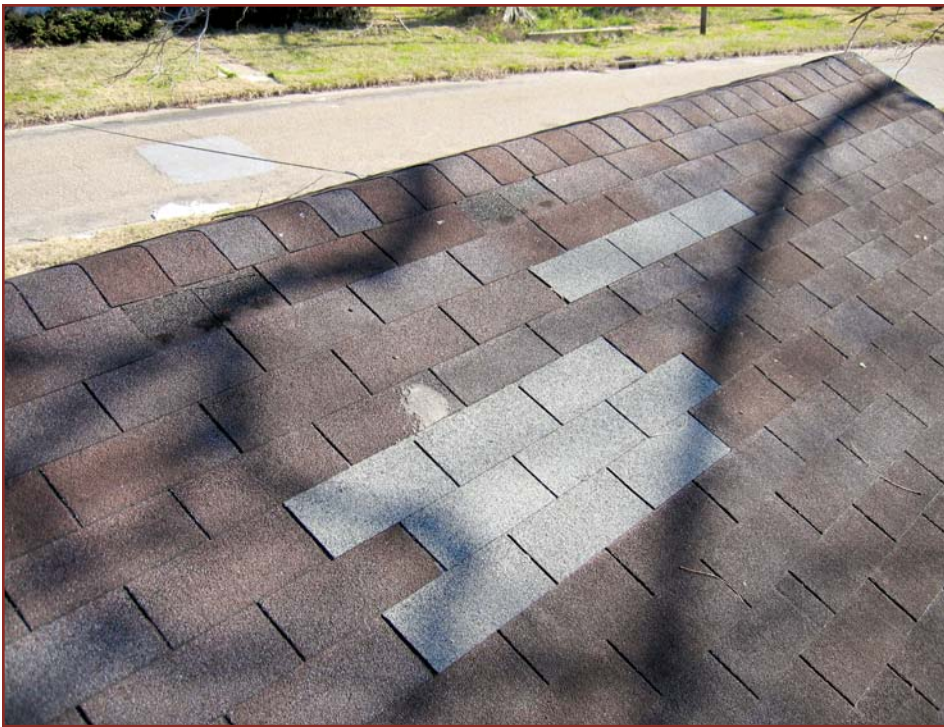
*Photo 11 – Despite overexposure, repaired portions of “old” shingle roofs performed well during the hurricane, such as these repairs on Building 13.*

portion of this report. In determining what might be appropriate in regards to repairs, we have based our suggestions for repairs on the types of maintenance repairs previously performed at the site. In regard to the roofs, many existing roofs have had damaged or lost shingle tabs replaced by indi-

vidual shingle tabs rather than full roof replacement (*Photo 11*). Only Building 3 (which suffered structural damage from a fallen tree, *Photo 12*) sustained sufficient damage to warrant full replacement of the shingles on the roof. Only three of the 18

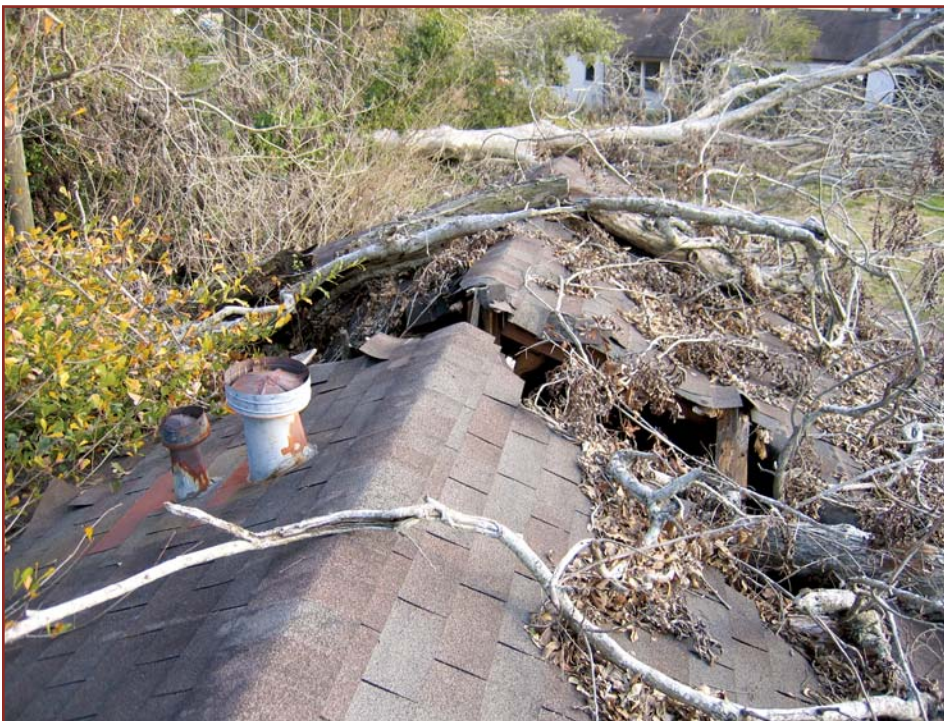
*Photo 12 – Although the “old” shingles on Building 3 suffered very little direct wind damage, structural damage from this fallen tree would necessitate replacement of the shingles.*

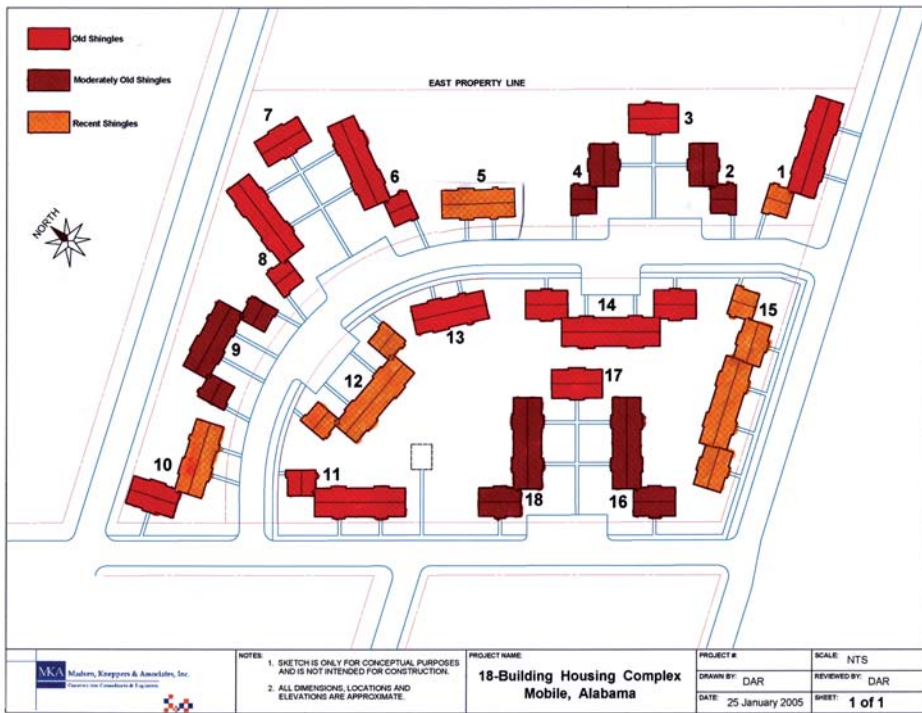
Figure 1 – The “old,” “moderately old,” and “recent” shingle roofs were each widely distributed throughout the housing complex, as can be seen with the project site plan.

three buildings had “old” shingles (see Figure 1). For a complete breakdown of shingle loss per building, see Table 1 for a building breakdown and Table 2 for unit breakdown.
