UNUSUAL SUSPECTS

By E. Frank Kelm, RRC

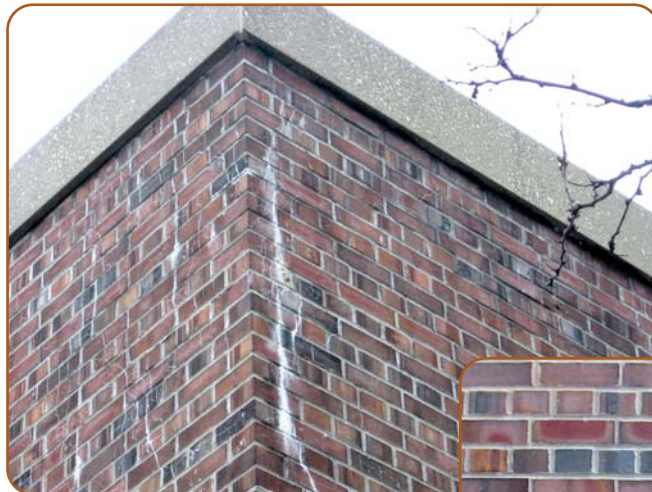
Stained, cracked masonry units.

ed next to the wall was perforated by corrosion. The steel joists bear upon the inner CMU wall and the joist pockets appeared to be reasonably sealed. Portions of the CMU wall showed evidence of efflorescence, staining, and dampness.

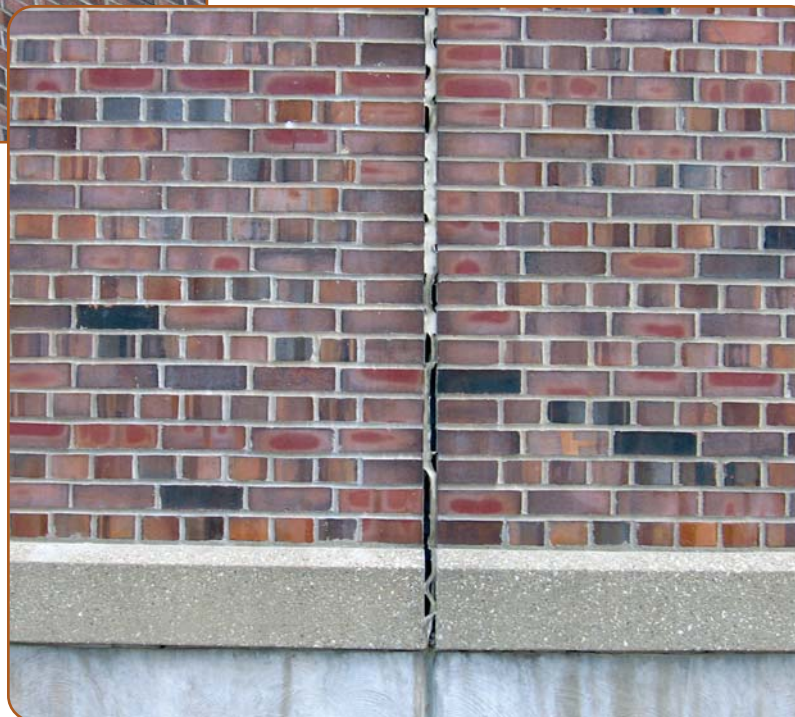
Upon arrival, it could clearly be seen that the existing control joint had separated. A large amount of staining, or what appeared to be efflorescence, occurred on the brick veneer of the addition.

Separated expansion joint.

The engineer was fairly certain that the cracking was due to settlement caused by poor compaction and/or poor soils condition. A geotechnical investigation and soil report would be required to establish the structural repairs. Structural repairs were estimated at a construction cost of approximately \$30,000.

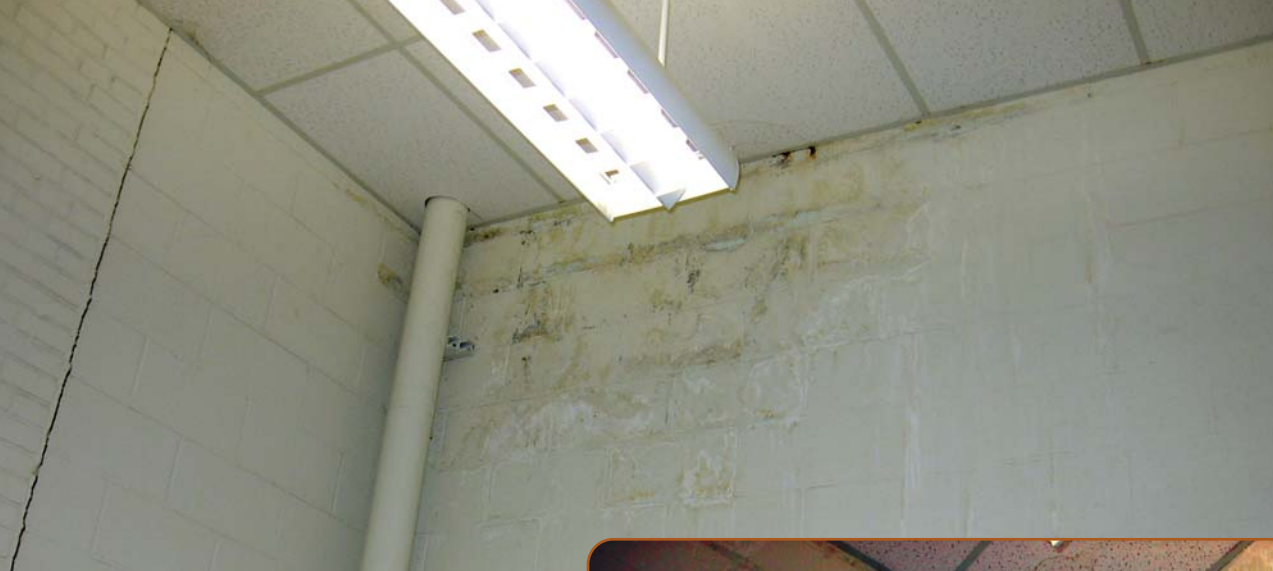
While the client described to the engineer the control joint and how it was getting wider, the author took stock of the general condition of the room. Several ceiling tiles were stained and portions of the interior wall were water damaged. The client said they “couldn’t keep the ceiling tiles replaced.” Had they considered the possibility of a roof leak? the owner was asked.

Left: Interior wall and ceiling damage.

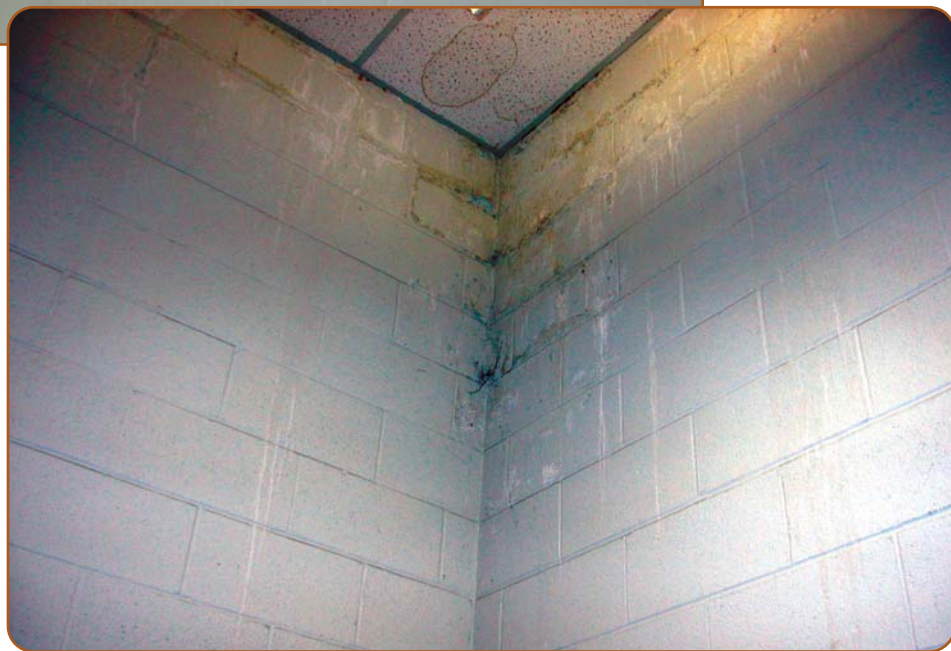
Below: Interior damage.

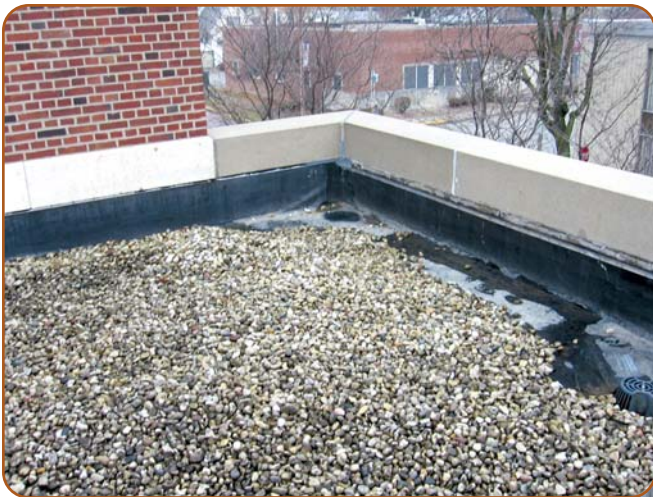
The author noticed, however, a recently applied bead of caulking along the bed joint of the stone coping. When a section of caulking was peeled away, it was obvious that it had covered a small crack between the coping and the parapet wall. Looking along the interior and exterior bed joints of the coping stone, there was no evidence of a through-wall flashing or weeps.

Above: Roof perimeter showing coping stone.

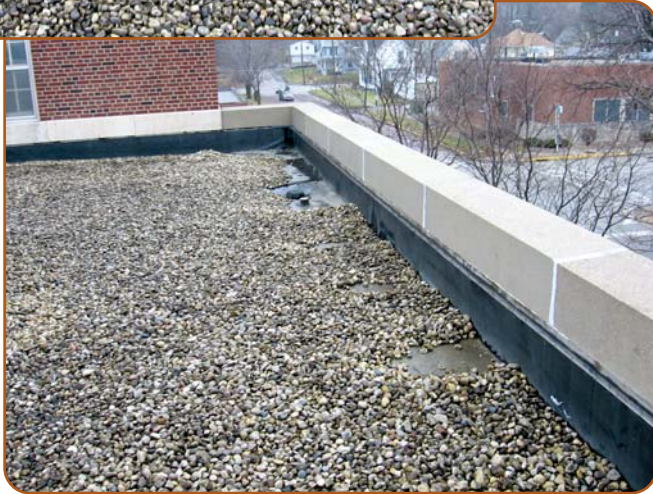
Right: Overview of roof edge.

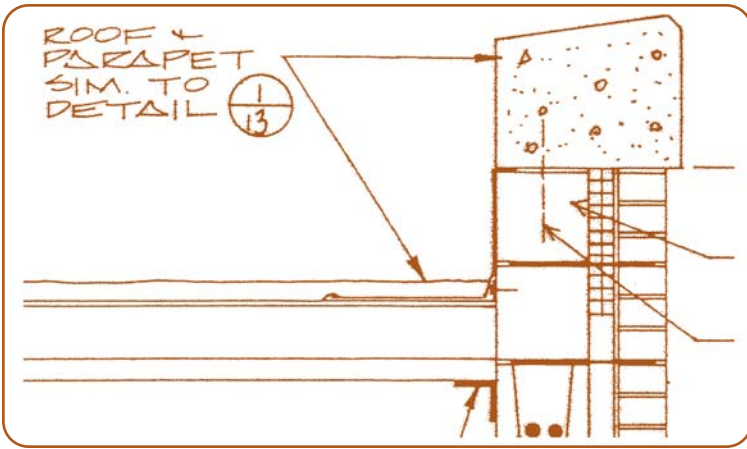
- The coping stone had been set directly on top of the masonry without a through-wall flashing.
- The wall cavity is 2-3/8-inches wide with two inches of rigid insulation, leaving only a 3/8-inch clear space for drainage.
- The coping stone lacks a defined drip edge.

- Through-wall flashings should be installed under copings.
- Copings should have a minimum of one drip edge.
- Maintain a minimum 1-inch clear air space in the cavity.

The addition struck out on all three requirements. A through-wall flashing placed under the coping would have diverted water penetrating the coping and its joints to the exterior, preventing it from entering the wall cavity. A well-defined drip edge would have stopped most water drips from reaching the bed joint of the coping (and entering the wall through capillary action). Finally, a 1-inch cavity is deemed as the minimum clearance required for both proper construction and to allow the wall to drain.

Exterior wall coping detail.

The masonry repairs will prove to be more extensive and costly. The existing coping stone could be removed and salvaged for re-use, with new through-wall flashings installed, deteriorated portions of the brick veneer demolished and replaced (approximately one-third of the wall), damaged and wet cavity insulation removed and replaced, and the remaining brick ties examined for corrosion and repaired as needed.

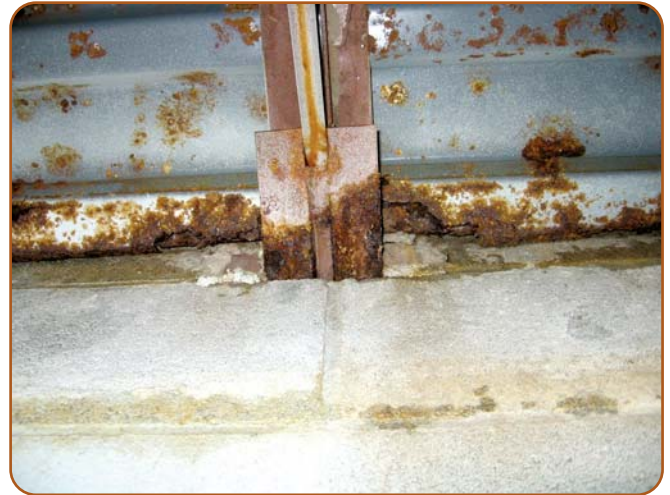
In addition, there was corrosion on the underside of the steel decking and bar joists. It was also apparent that the corrosion was more severe where these components contacted or penetrated the exterior wall. In fact, a portion of steel decking locat-

Deteriorated metal decking.

A brief recap of the roof consultant's findings of the roof and exterior walls of the addition showed that at a minimum, the wet roof insulation and deteriorated metal decking should be removed and replaced for an estimated cost of approximately \$5,000. This left the client with a 15-year-old ballasted roof, which might not be the best investment of \$5,000. An estimated cost of \$16,500 was given to replace the ballasted roof with a fully adhered one, and included the cost to replace deteriorated metal decking.
