"WINDS OF CHANGE"

IN ASPHALT SHINGLE SPECIFICATION AND APPLICATION

BY EDWARD L. FRONAPFEL, PE

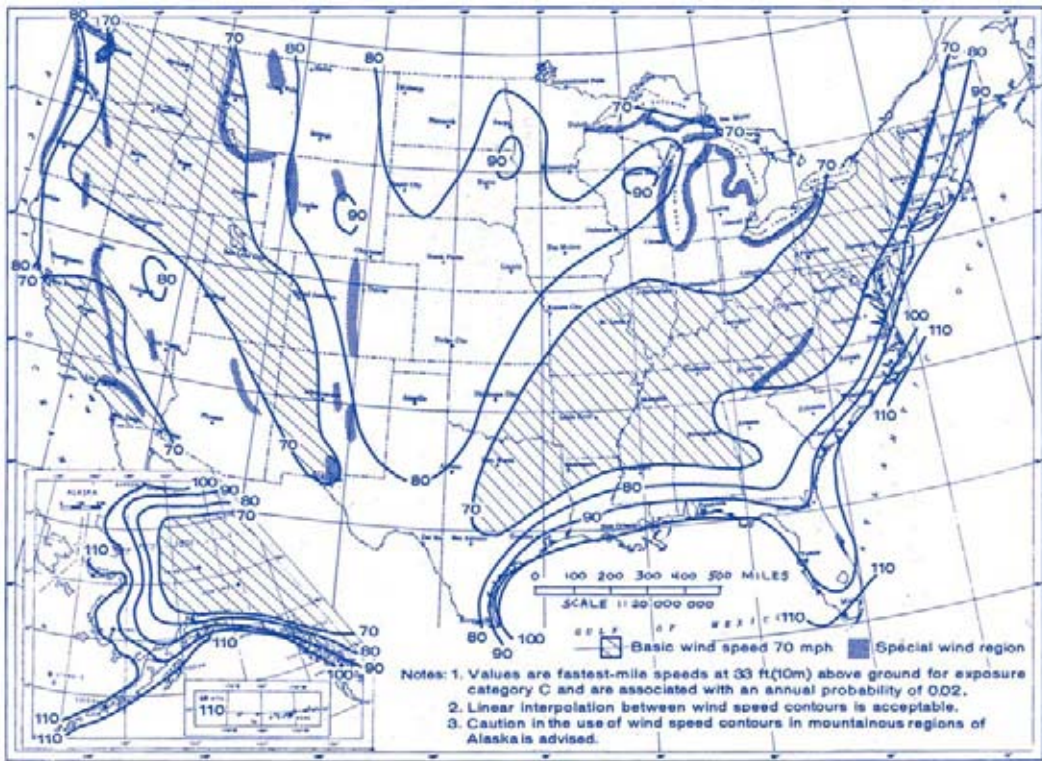
Figure 1. From American National Standard ANSI A58.1-1992.

Note that the area shown in southern Colorado is west of the 105th Parallel. This map has an obvious flaw; the eastern down-slope hillside of the southern Colorado Front Range was not properly shown as a high wind area.

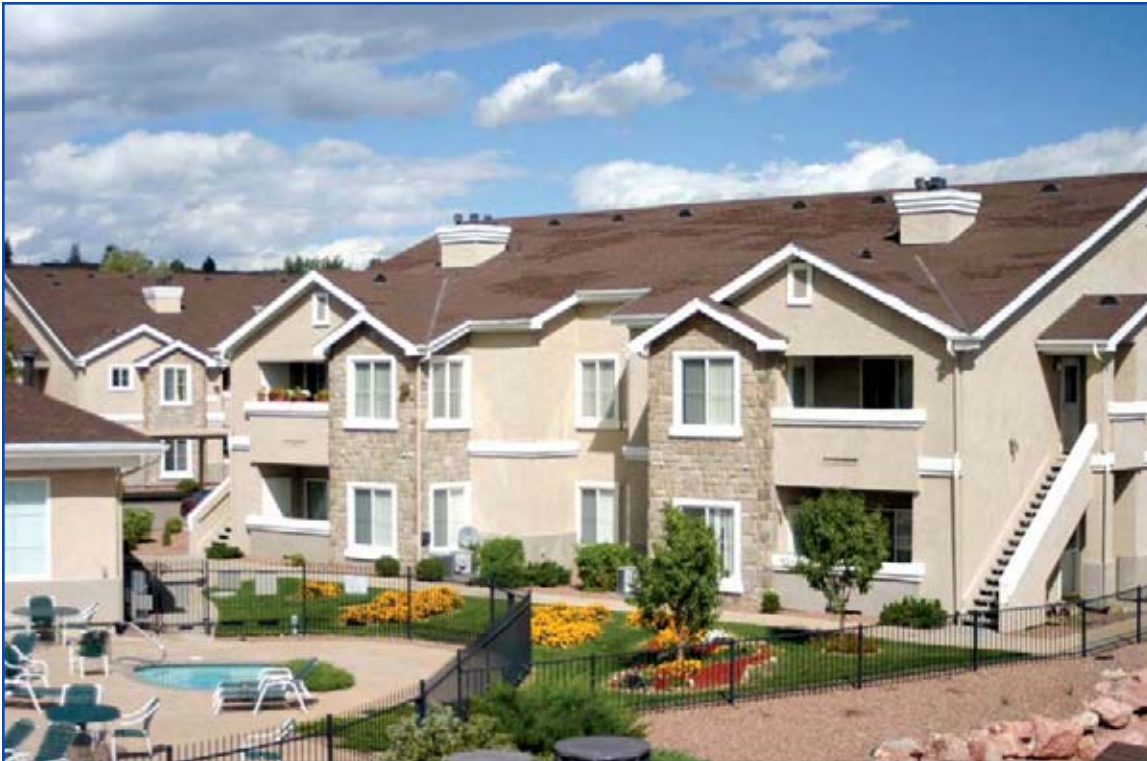
Photo 1. Overview of a building on the property, showing the loss of shingles.

The nails used to secure the shingles were discovered to be improperly placed, and the shingle blow-offs propagated from many apparently unsealed edges. Photo 1 shows the patterns and large areas of blow-off (now replaced; see darker patched areas).

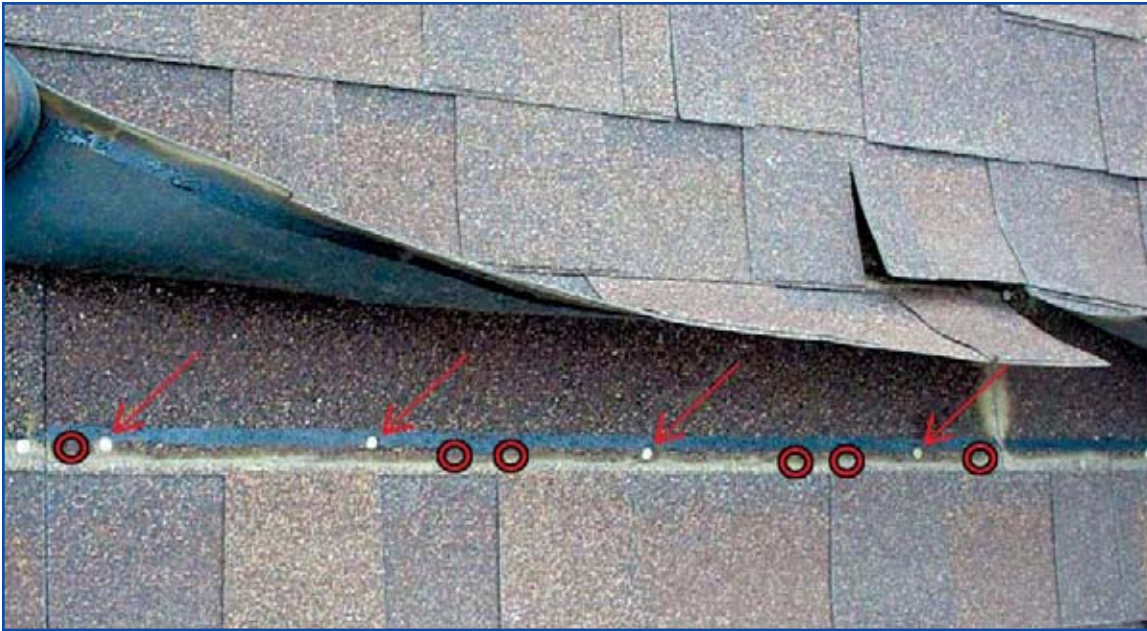
Photo 2: Discovered conditions on the buildings.

It was discovered that on the roofs that experienced blow-off, the shingles had not been installed with either a proper four-nail or six-nail pattern. Photo 2 depicts the conditions found on many of the roofs. The red circles note where the nails should have been placed in a six-nail pattern. The shingles were also found to be improperly lapped with the corresponding shingles, and many seals were loose. The nails were placed too high on the shingle. This misinstallation results in a nail that penetrates through only one laminate of the shingle. It was determined that the nails were located too far inward from the edges. The product was rated by warranty to 60 miles per hour, Exposure B. This 60-mph-rating does not meet the building code's requirement for this specific area, defined by local code as 85 miles per hour.

The shingles are, therefore, not installed to the more stringent conditions for the high wind design requirements; and, in fact, the product chosen does not meet performance requirements of the building code.

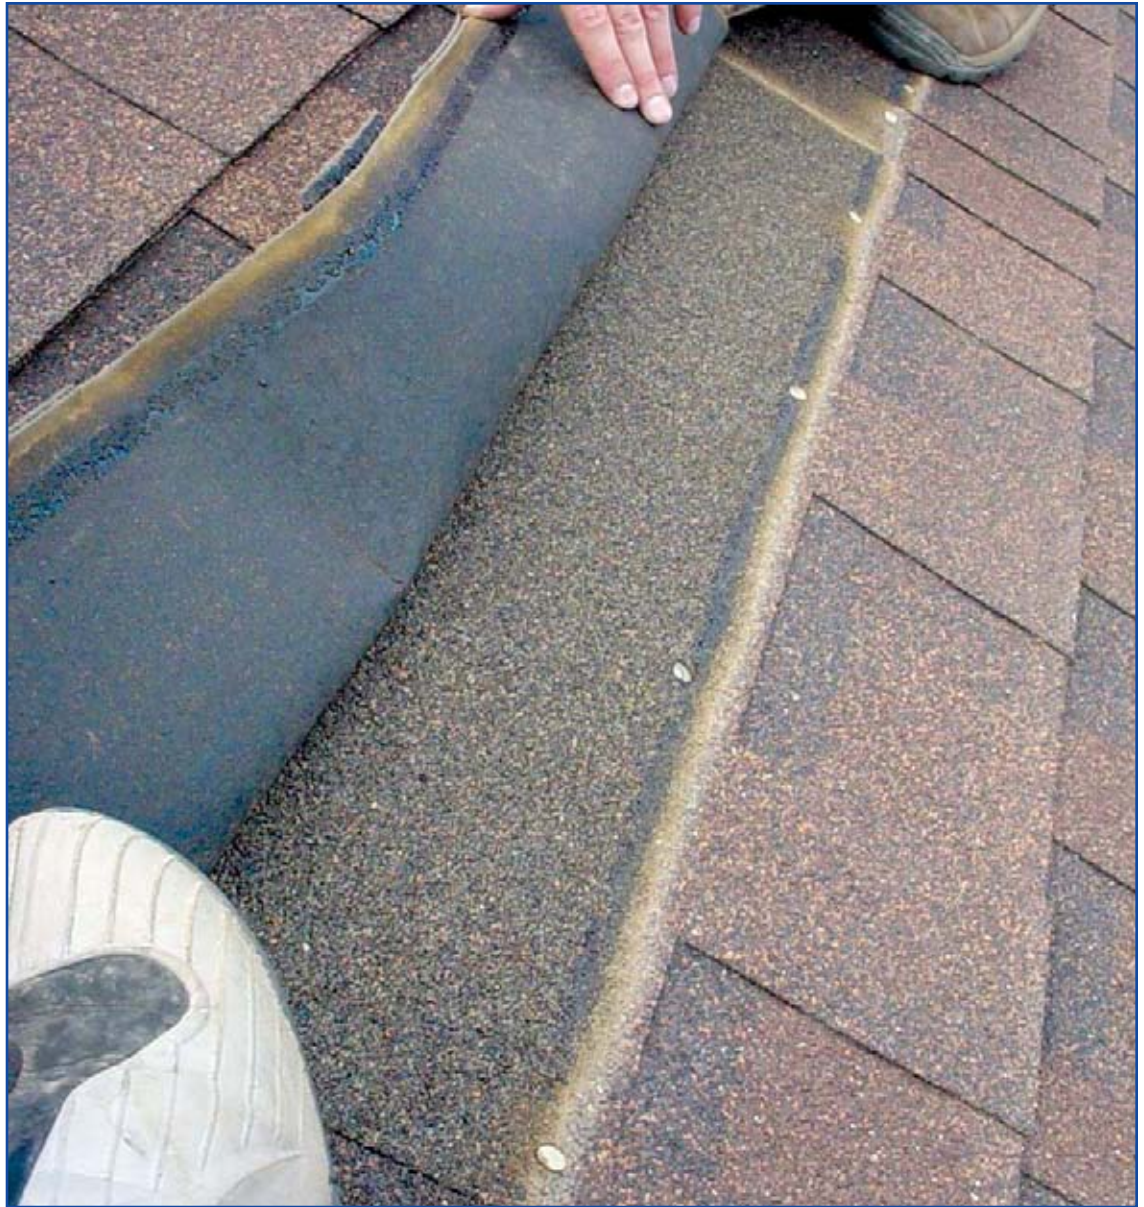
Photo 3: The nails are placed not only in the wrong locations, but also above the asphalt seal line, resulting in penetration of only one of the laminate shingle layers.
