# FAÇADE INSPECTIONS – BEYOND THE

# VERTICAL PLANE

BY DON KILPATRICK

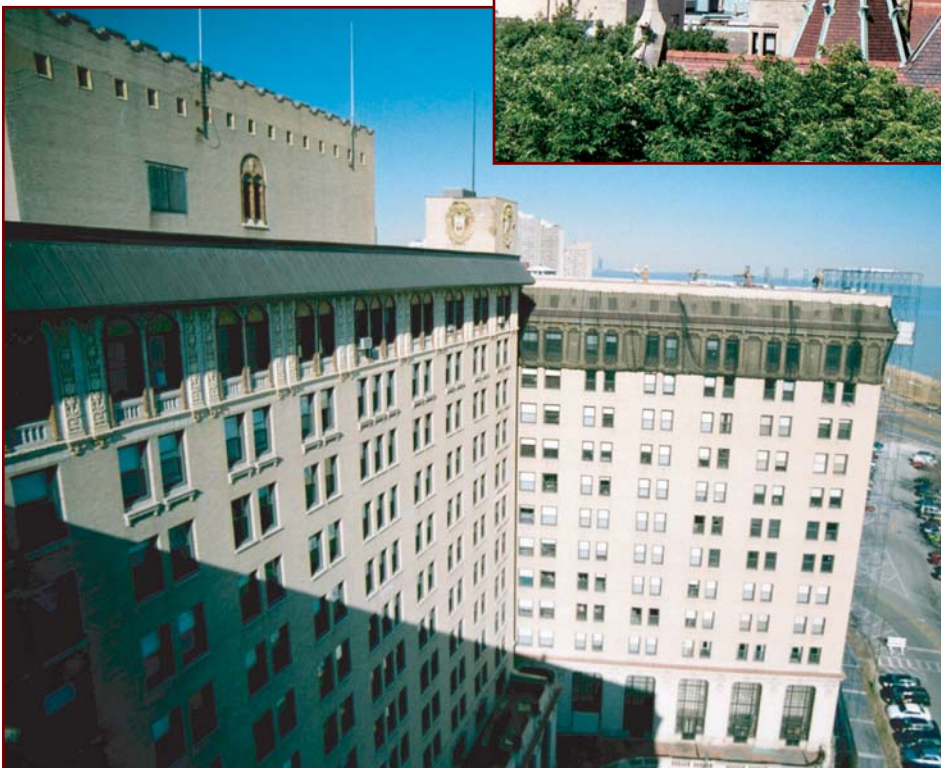
*Above: Figure 2 – Suspended scaffolds are routinely used as a means to access the varied cladding features.*

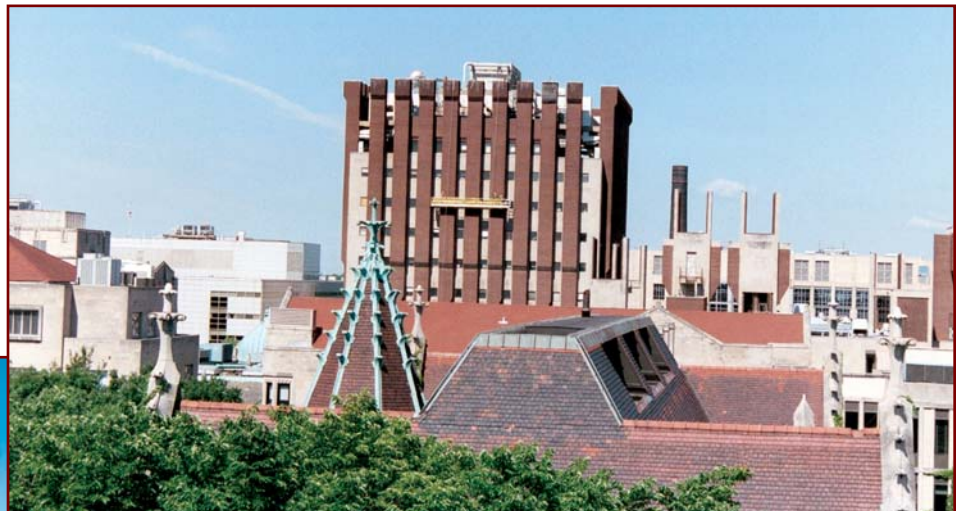
*Figure 1 – Code language can require engineered “make-safe work” to mitigate hazardous conditions in the form of netting or temporary shoring.*

or “imminently hazardous.” The final report submitted to the city establishes a repair timeframe by which the owner is required to execute either repairs or, in some instances, emergency stabilization of the identified distress conditions (Figure 1).

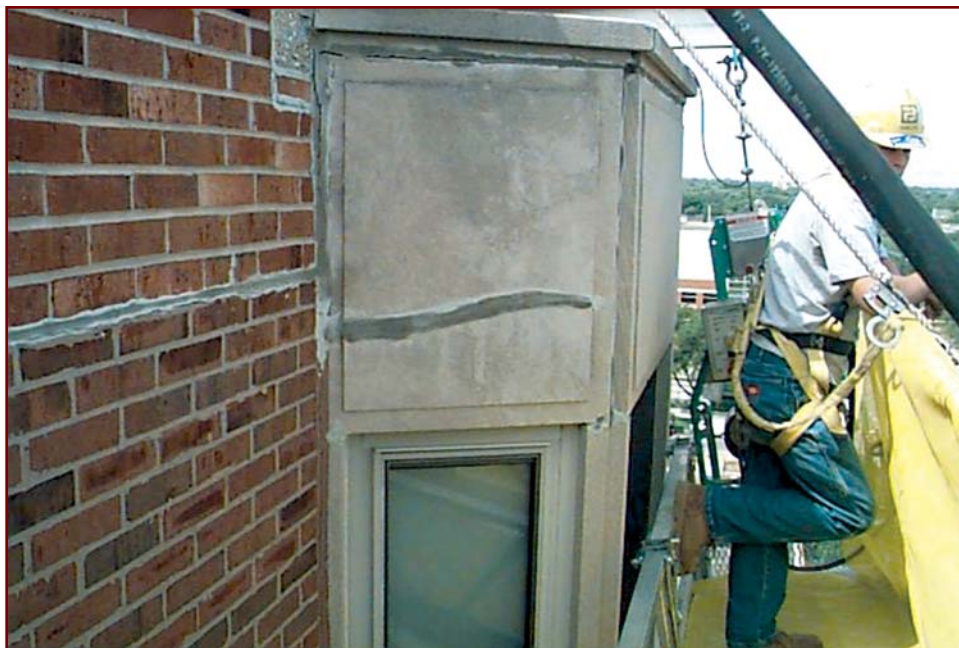
Figure 3 – Area of localized distress in cut limestone cladding.

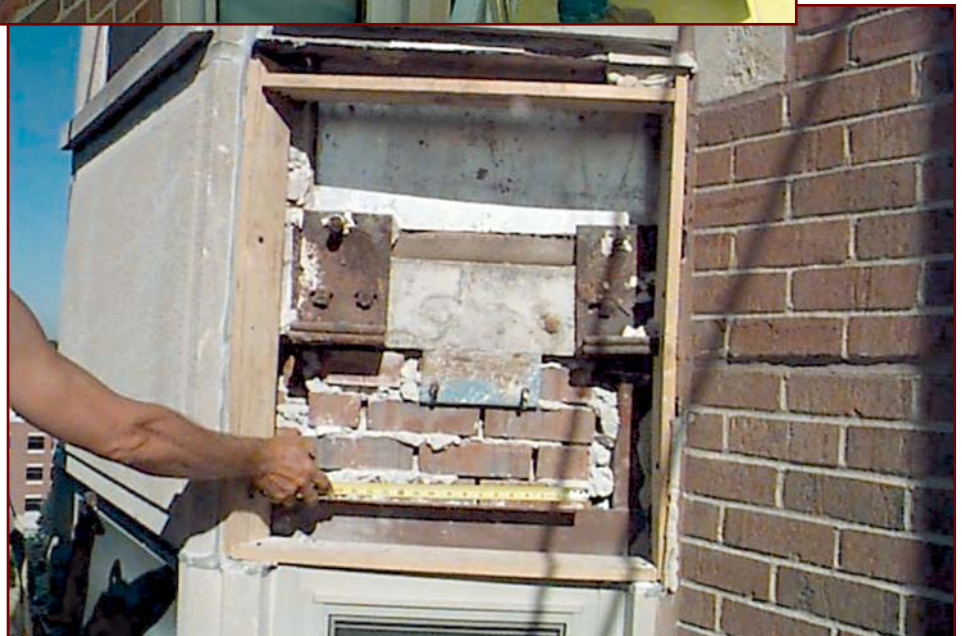
Figure 4 – Inspection opening to establish as-built condition(s) contributory to the cause of the distressed cladding feature.

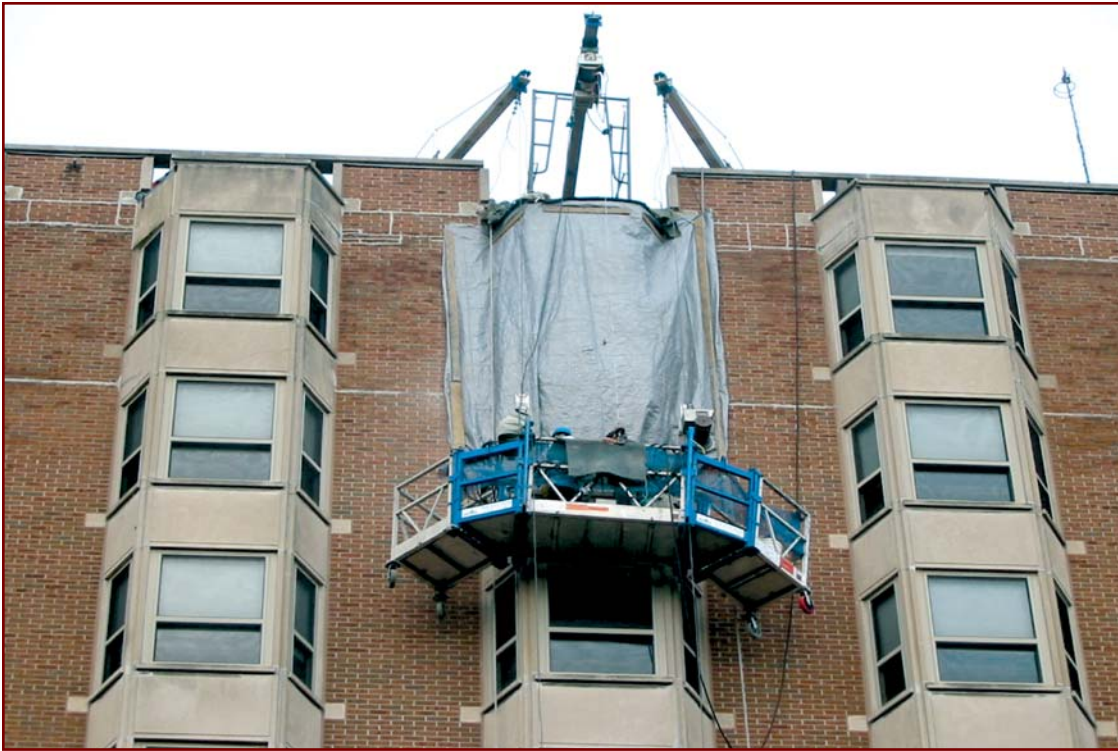
Figure 5 – Large-scale selective removals of cladding features.

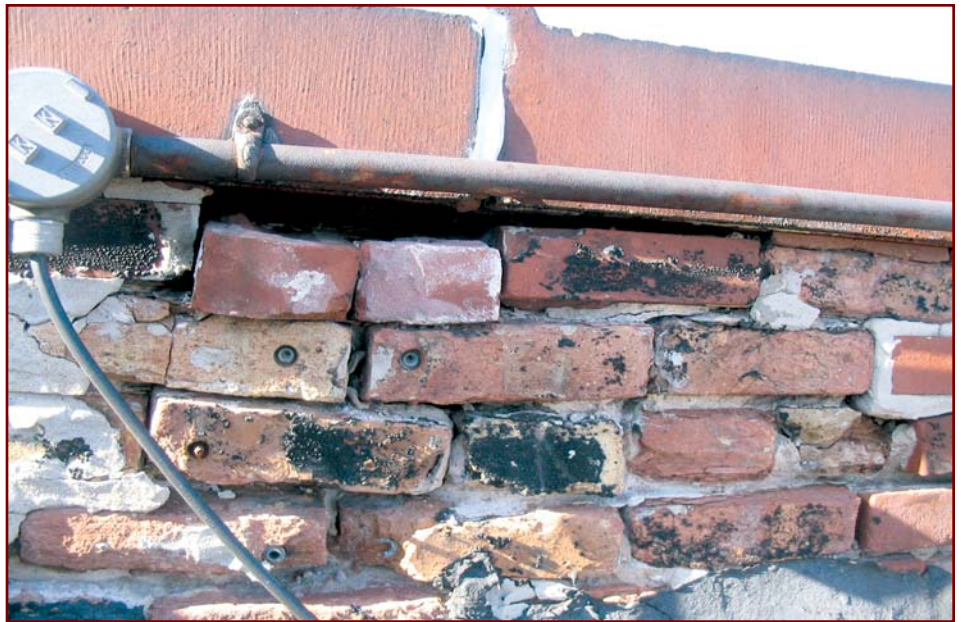
*Figure 6 – Typical conditions observed on the inboard face of multiple-wythe parapet wall.*

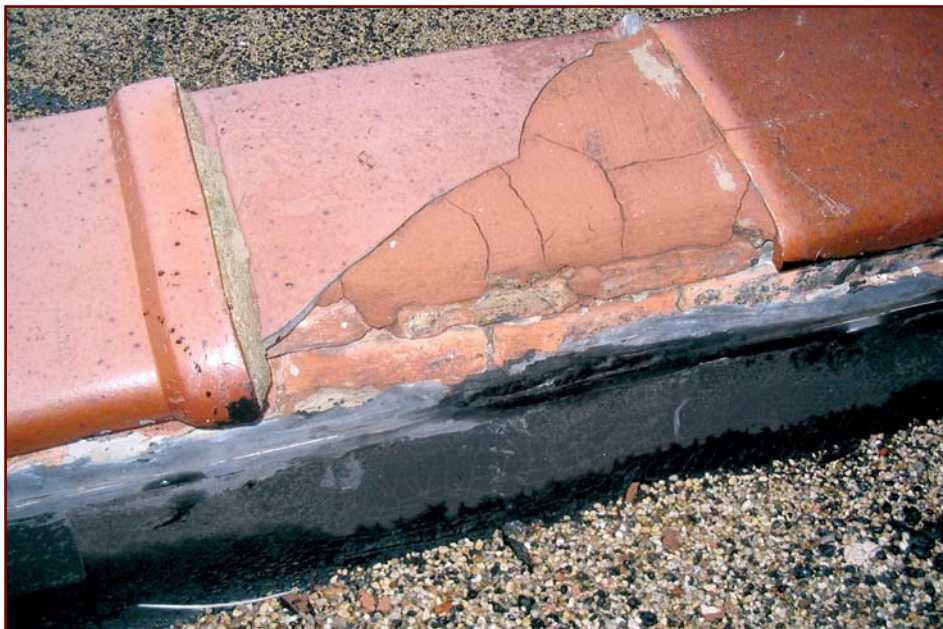
*Figure 7 – Typical, overall poor condition of above-roofline parapet wall and coping.*

the above-roofline masonry is the receiving substrate for liberal applications of plastic cement (Figure 7).

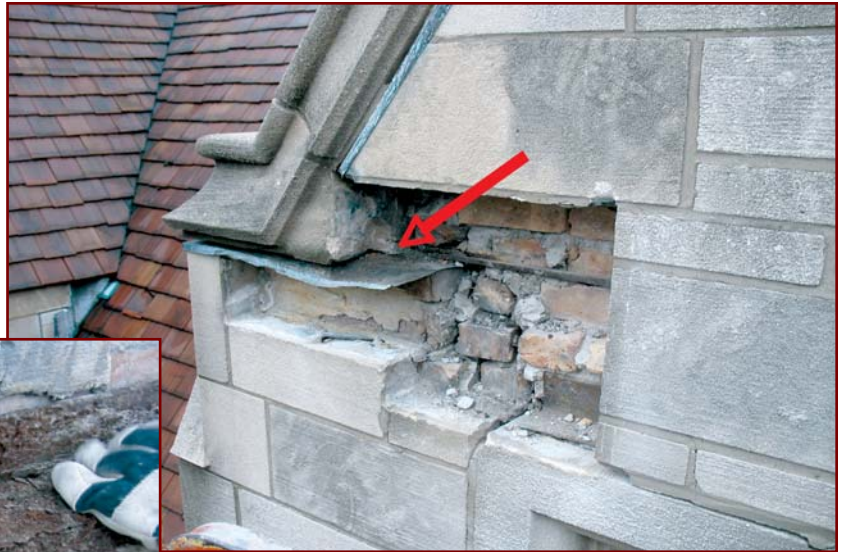
Figure 8 – A lack in continuity of the 1930s-era through-wall flashing below the stone coping resulting in out-of-plane conditions.

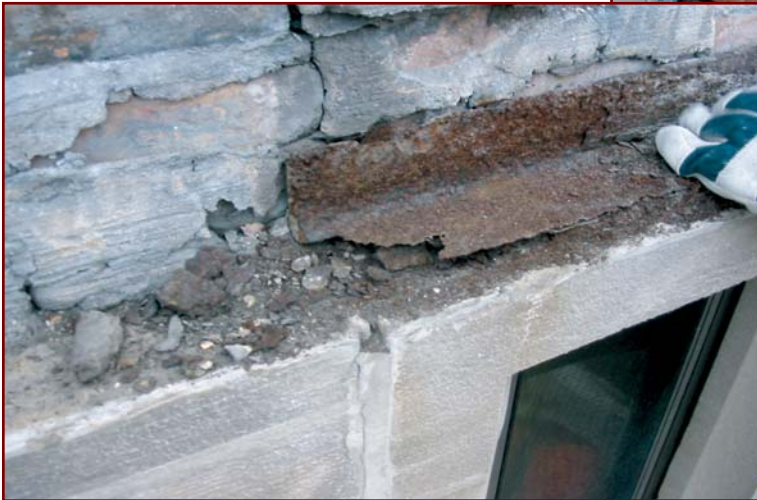
Below: Figure 9 – Heavy corrosion of steel window head lintel. Note the minimal bearing tolerances at the end of the steel lintel and cut limestone “surround” of the window opening.

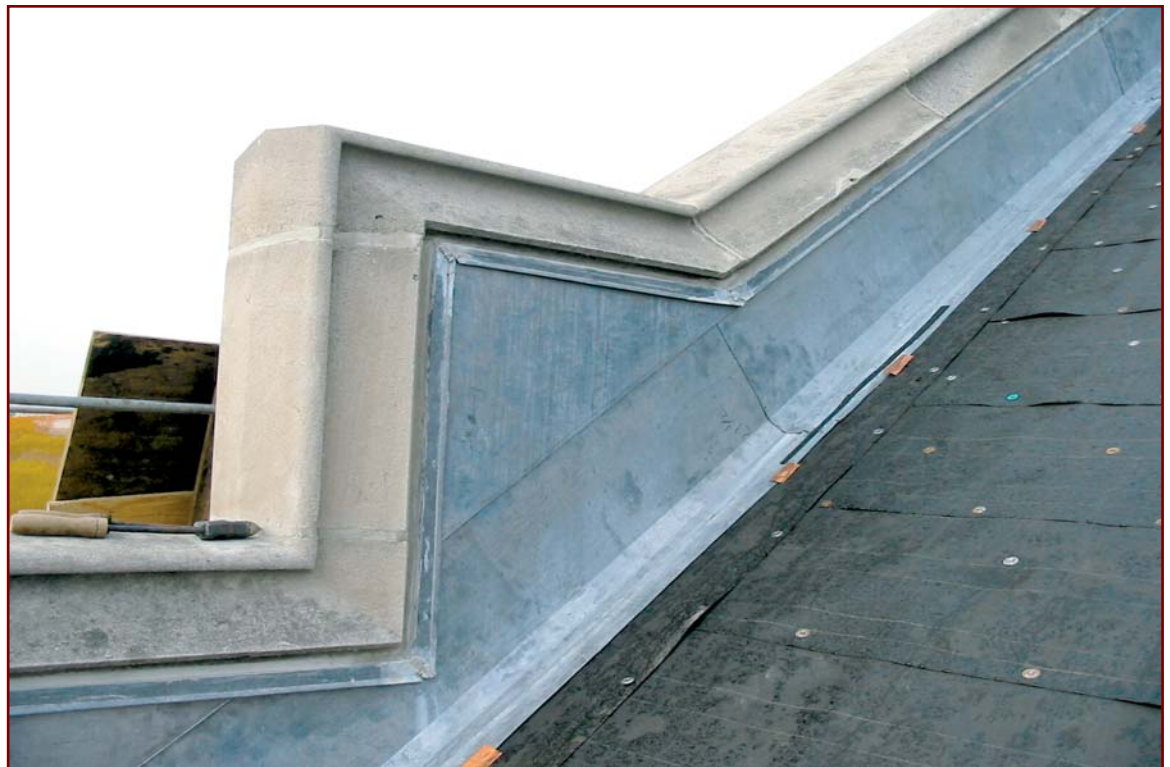
Figure 10 – Above-roofline masonry offered protection by sheet metal cladding interfaced with a new, continuous through-wall flashing below the limestone cladding.

underside of the sheet-metal cap flashing or stone coping, down the parapet wall interior, lapped on top of the finished membrane flashing (Figure 10). Many large expanses of masonry have been successfully over-clad with continuous concealed flashings and sheet metal counterflashing to minimize the predictable continual maintenance of the underlying masonry construction.

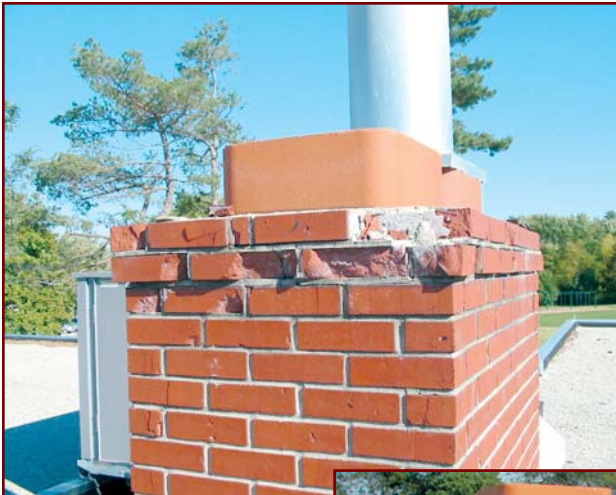
Left: Figure 11A – Typical chimney damage due to water infiltration and subsequent freeze/thaw damage (2002).

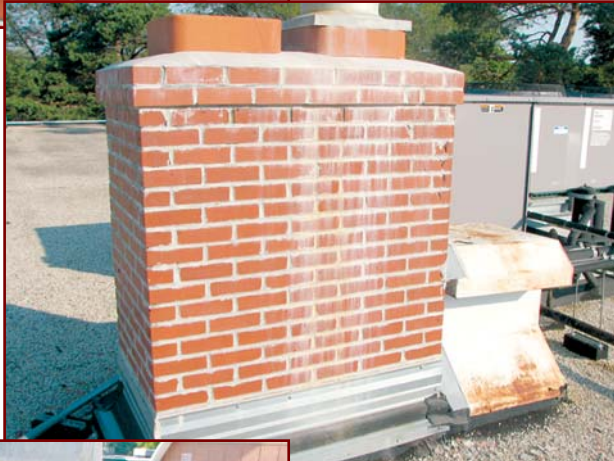
Right: Figure 11B – Post repair water damage due to water infiltration (efflorescence and spalled brick).

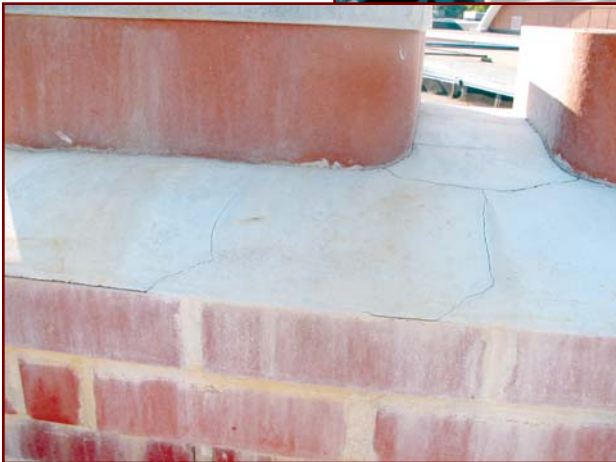
Left: Figure 11C – Latent defects in mortar-topping material contributory to the cause of the efflorescence and spalled brick (2004).

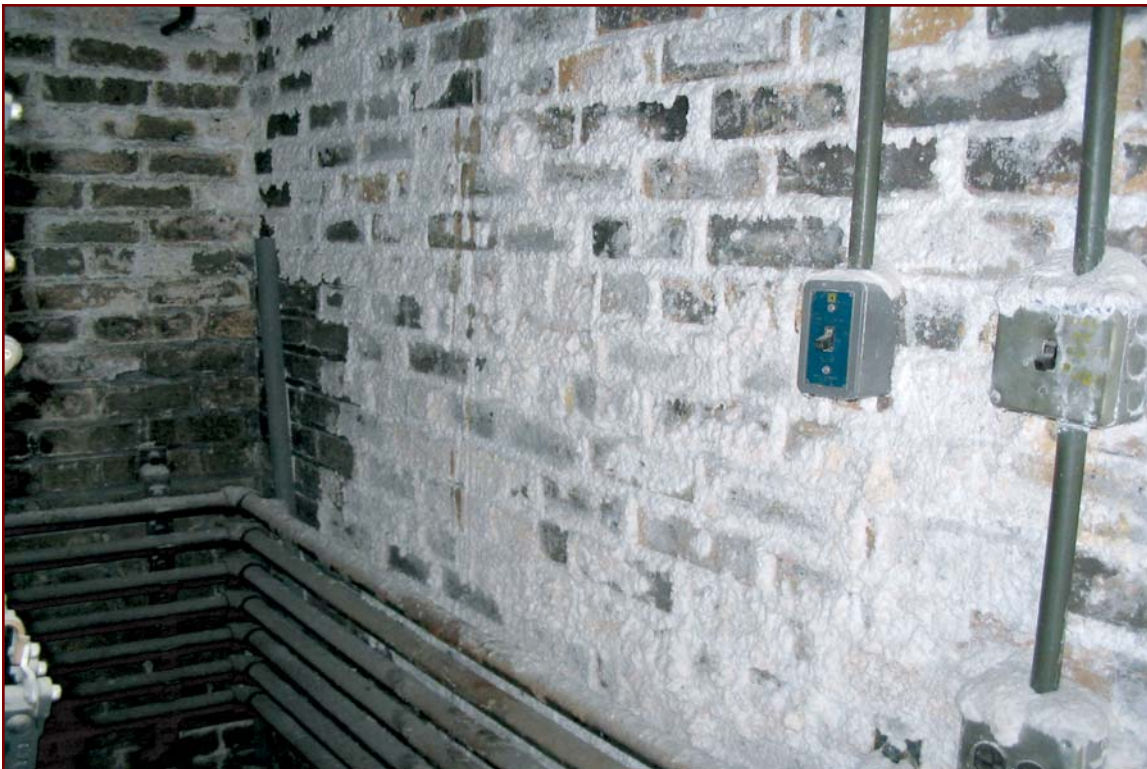
*Figure 12 – Heavy concentration of efflorescence on the interior of outside walls is a clear indicator of moisture infiltration.*

identified as free moisture that enters the confines of the wall-in section and is not presented on the building interior (Figure 12). These solid-wall structures were not afforded the benefit of current-era, cavity-wall construction; more specifically, the presence of a drainage plane intended to harmlessly discharge moisture from the component assembly. In some instances, efforts to introduce modern materials (through-wall flashings and weep systems) into the repair of solid wall construction may be impractical, as the surrounding components of the assembly fail to benefit from the perceived added value and cost of same.

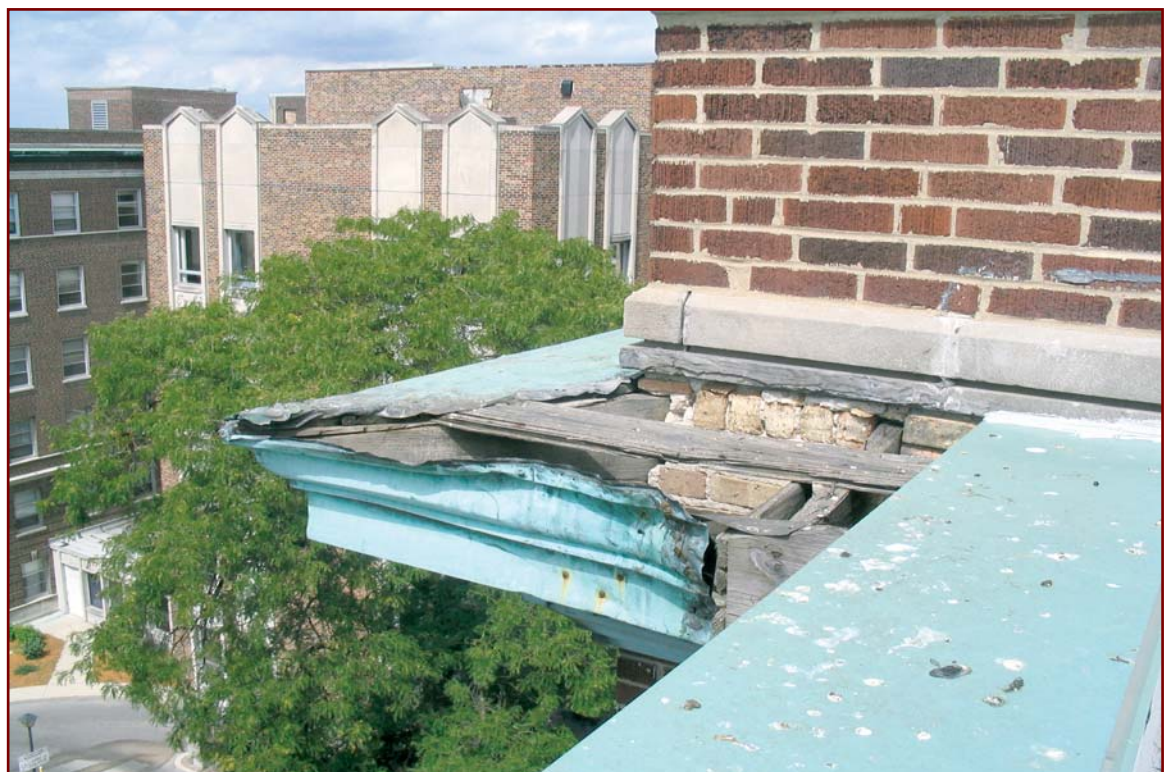
*Figure 13 – Damage to wood-framed, copper-clad cornice feature.*

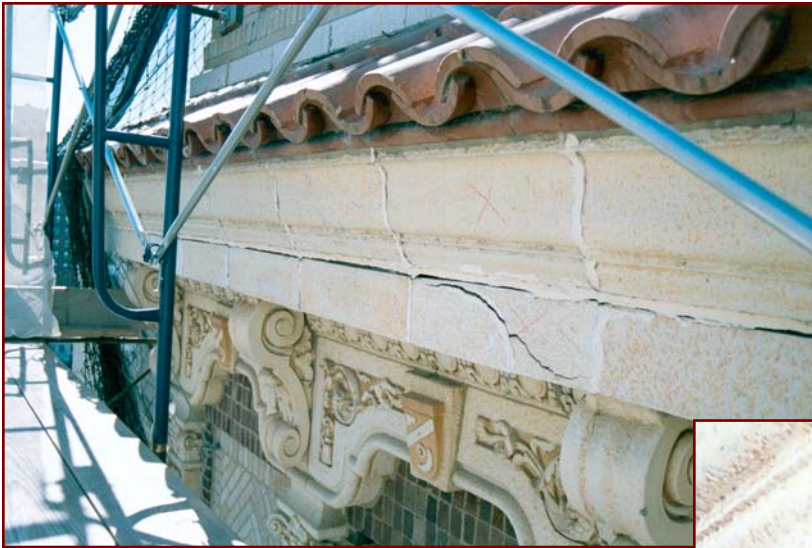
Left: Figure 14 – Terra cotta cornice classified as in an unsafe condition.

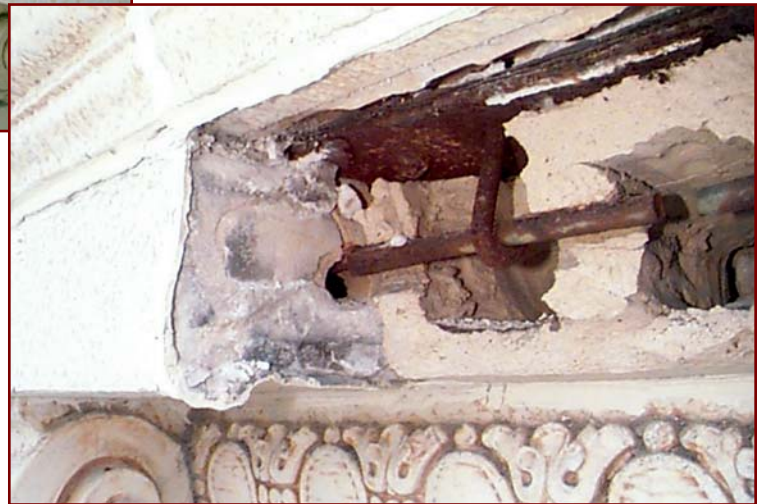
Below: Figure 15 – Concealed structural support mechanism for terra cotta cornice.

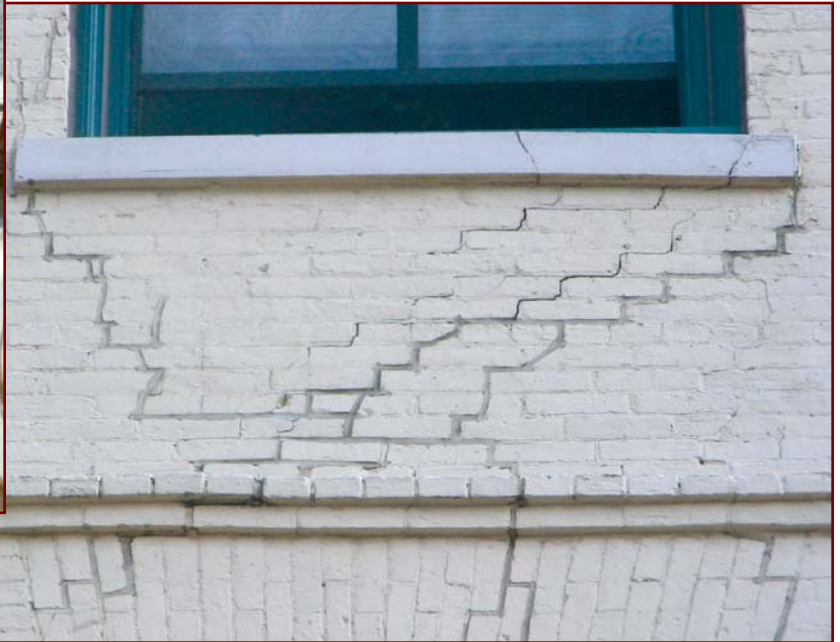
Figure 17 – Stair cracking common to window openings in solid wall construction.

as part of the original construction to carry the load of cladding materials across the span of a window-head opening. They can be affixed to the structural steel frame of the building, masonry back-up materials, or set loose, placed with the horizontal leg bearing on the exterior jamb-cladding component of the window opening. The process of corrosion and resultant volumetric expansion across the horizontal plane of the steel angle results in stair cracking, usually presented at the upper inside corners of the window opening (Figure 17).
