HERITAGE BUILDING ENVELOPE RESTORATION

JOHN DAM, PENG, LEED AP

READ, JONES, CHRISTOFFERSEN, LTD., VANCOUVER, BC

*The Institute of Roofing, Waterproofing,
& Building Envelope Professionals*

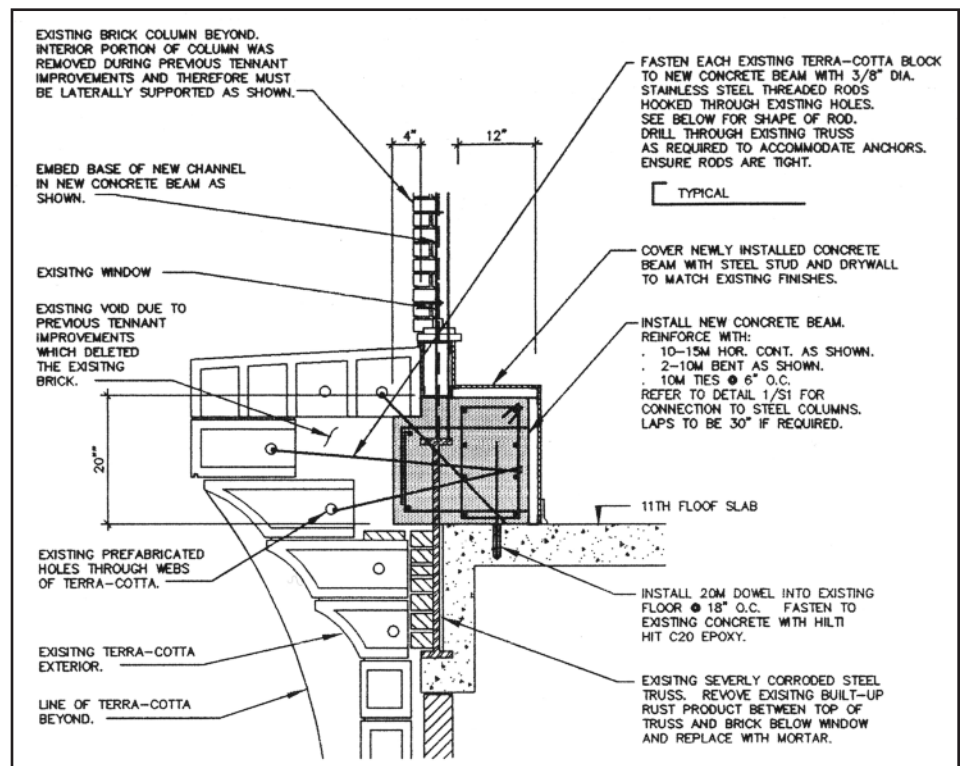
Figure 3 - Concrete replacement beam.

Another durable replacement option is to utilize concrete where possible (*Figure 3*). Steel beams can be effectively replaced with reinforced concrete if space permits, the increased load can be supported, and effective connections made. This option often provides a more economical reassembly of the wall system utilizing the concrete material for a variety of structural support conditions.

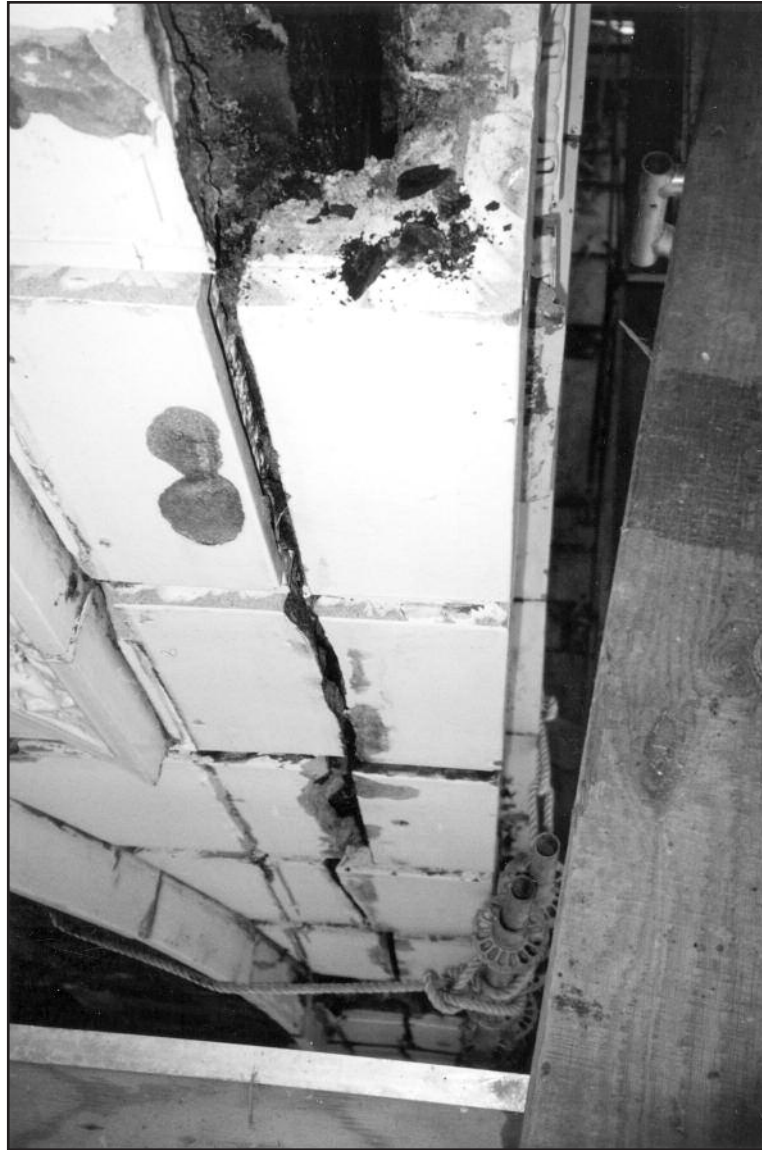
Figure 4 - Deteriorating terra cotta.

The cracking and breaking apart of terra cotta cladding is often attributed to material displacement within the wall system, be it the infill masonry or the structural steel. Terra cotta also expands with age, often stressing itself and delaminating the face shell. Other forms of deterioration are impact force and freeze/thaw cycling, which can spall the surface of the unit; and poor repair methods such as the cutting of the glazed protective layer while repointing the mortar is common. These forms of deterioration all expose the porous clay material, which easily draws in water.

manner, which will become visible over time, and they take away from the heritage integrity of the cladding. Considered a better option – the casting of concrete units, utilizing a variety of concrete mixes, including the option of white cement – can provide quite favorable results (*Figure 4*). The units can be “glazed” with a concrete sealer to better match an original glazed terra cotta unit. The end result is a heavier but more durable replacement unit that can be affixed in the original manner to the wall system. A concrete unit would “age” better than a fiberglass unit, but the drawback once again is the loss of heritage integrity of the cladding.

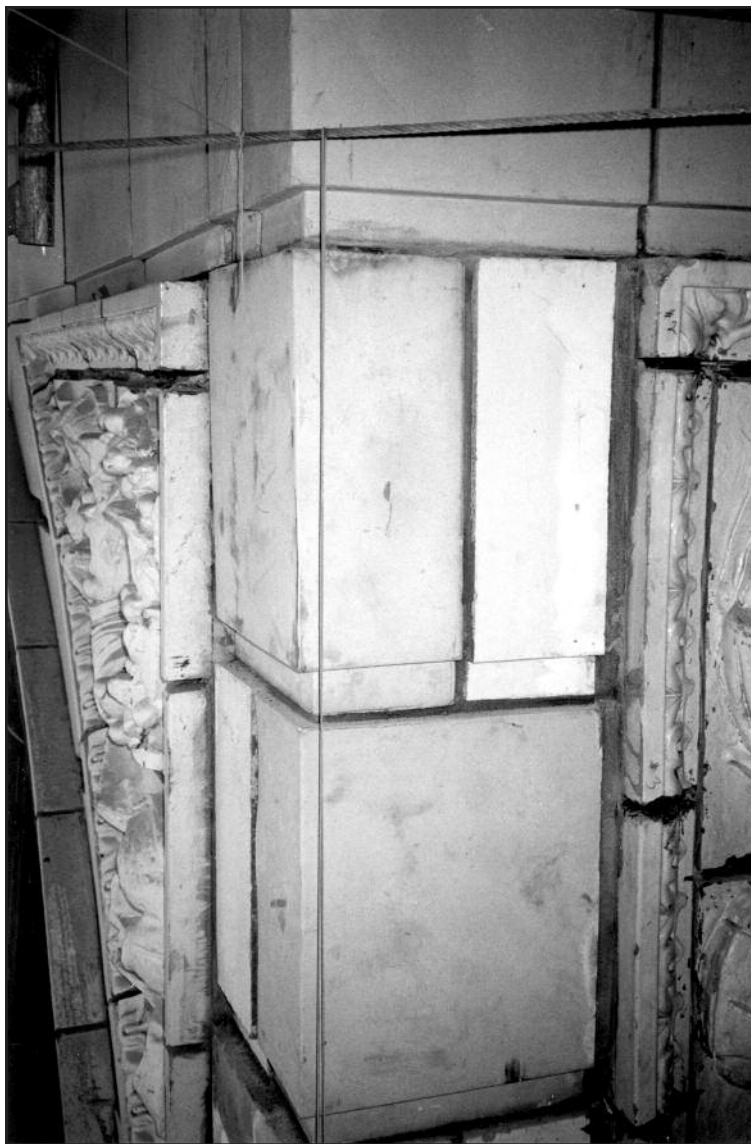
Figure 5 – Concrete replacement units around original terra cotta unit.

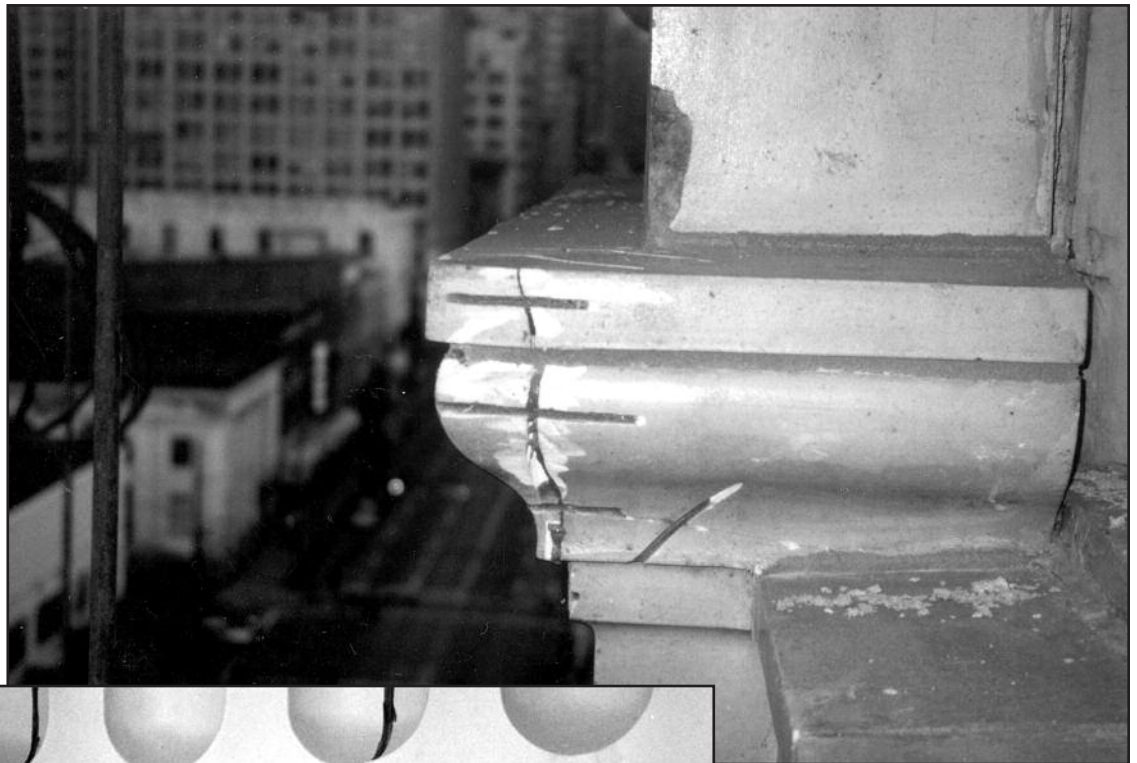
Figure 6 – Pinned terra cotta unit.

Especially in seismic zones, deteriorated ties should be replaced. This is an easy task if the wall is being reconstructed. Galvanized or stainless material should be utilized for its durability. If these elements are to be installed *in situ* without disturbing the wall material, they can often be inserted by drilling through the exterior mortar joints or the body of masonry elements. A 1/4-inch, stainless-steel rod with a t-end can be installed from the exterior side of the wall cladding or epoxy adhesive can be used along the length of a straight, threaded, stainless-steel rod (Figure 6). Where ends of a rod must be slotted into a terra cotta unit, care should be taken regarding where the

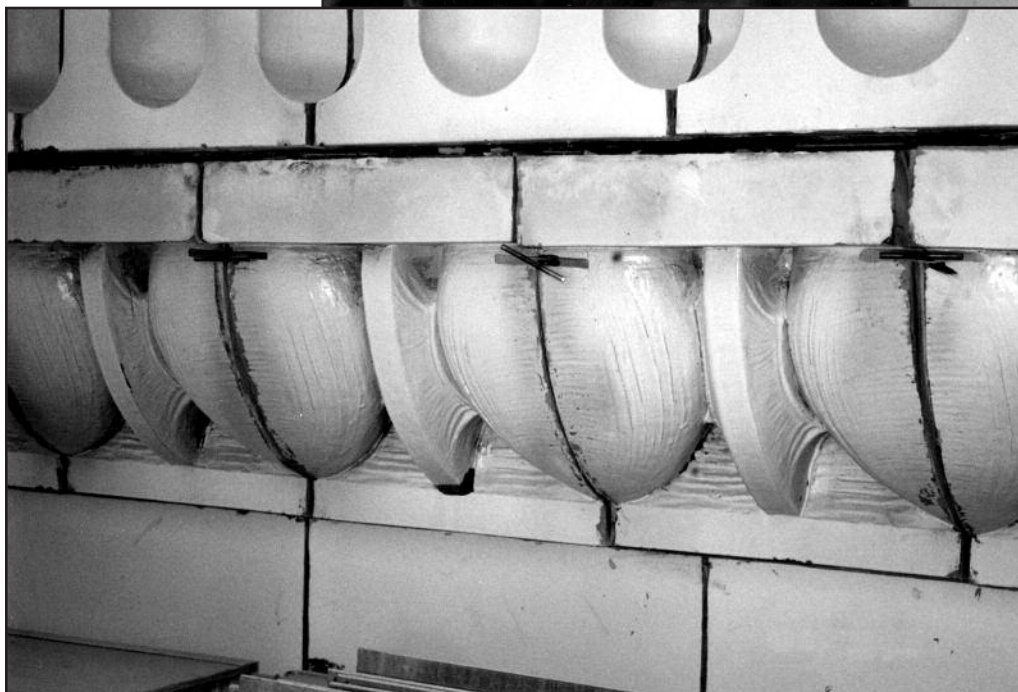
Figure 7 – Anchor rods slotted into terra cotta units.

slot is cut and how the terra cotta unit is patched over the rod to blend in with the remaining glazed surface.

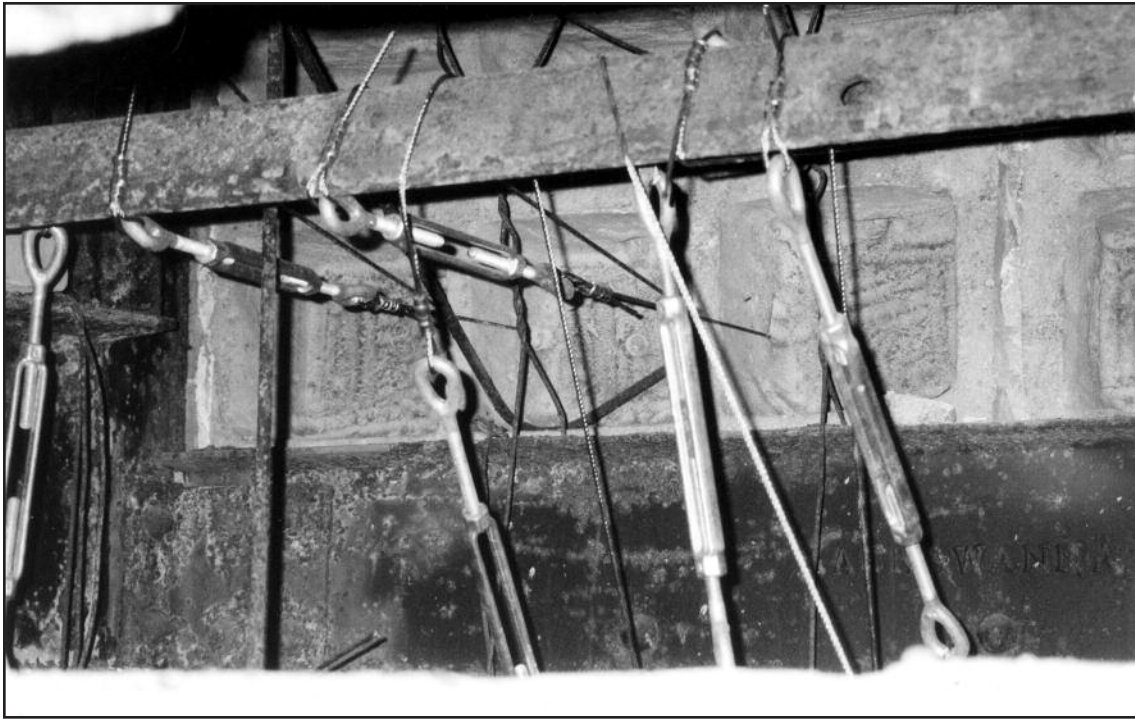
Figure 8 – Cornice ties with turn buckles.

beams or are supported by an overhanging floor slab. In the case of the overhanging elements, replacing the existing support elements, often wire ties, is sufficient. The existing steel ties, being small in section, are often found to be severely corroded and a more durable tie material should be used to address the rapid deterioration of small section elements. Stainless steel is a preferred option, especially if solid ties are being used as the zinc coating of galvanized material will flake off when the ties are twisted in place. Another proven option is to thread stainless steel cable ties through the original holes cast in the terra cotta units and crimp the ends in place. Turn buckles (Figure 7) can be used to tension the wire with care taken to avoid over tightening the wire as the terra cotta shell fin is easily sliced or broken off. The replacement tie can be secured back to the structure by drilling holes in the structure to pass the wire through, welding the tie to the structure, or threading the ties through clamps that are welded in place.
