# THE EXTERIOR RESTORATION OF 90 WEST STREET, NYC

RICHARD W. LEFEVER, PE, AND MARK ANDERSON, AIA  
*FAÇADE MAINTENANCE DESIGN, PC, NEW YORK, NY*

## PROJECT SUMMARY

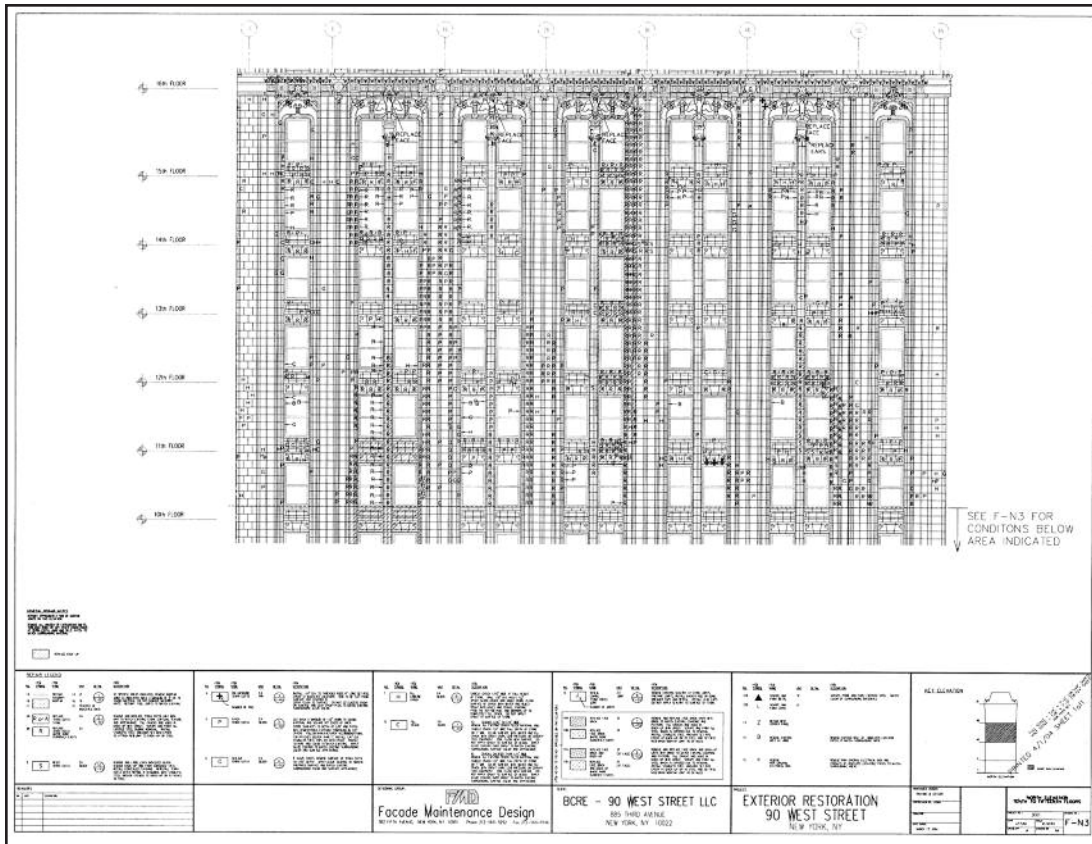
Figure 5 – Typical elevations with noted repairs.

façade that were completely missing (Figure 5).

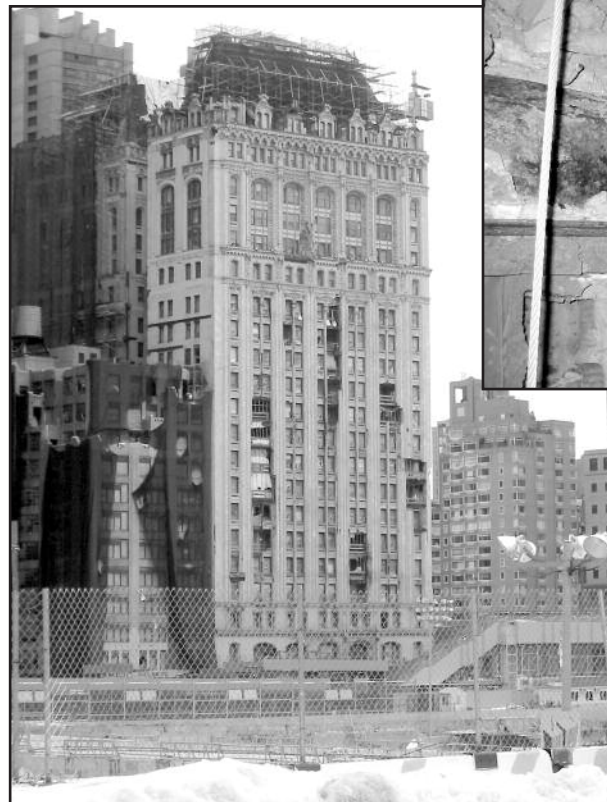
Figure 6 – North facade – as the building looked after initial cleaning, removal of loose materials, and before the mast-climbing scaffold was installed.

The brick was cleaned with “Light Duty” restoration cleaner (Prosoco) and the terra cotta was cleaned with Lemon Joy dishwashing liquid and warm water. Loose and unsafe areas of the façade needed to be removed and shored up before work could begin (Figures 6 and 7). Access to the façade was gained through an elaborate assortment of pipe scaffolding, swing scaffolding, and mast climbers.

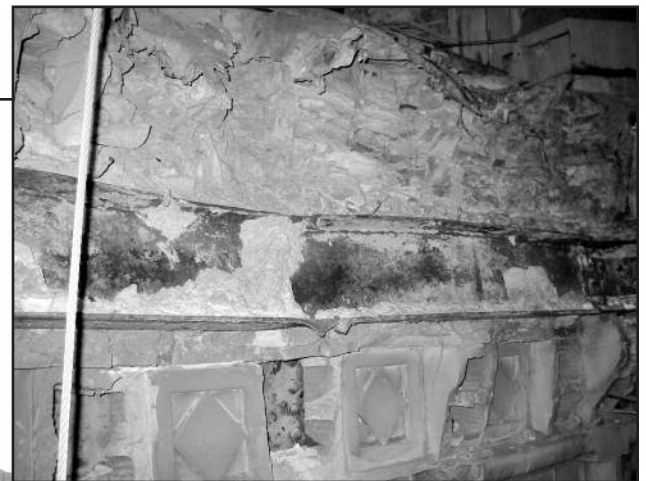
The facade was completely missing at several locations, due mostly to impact (Figure 7).

Figure 7 – North facade – impact damage crushes terra cotta, bends, and nearly shears through a steel spandrel beam.

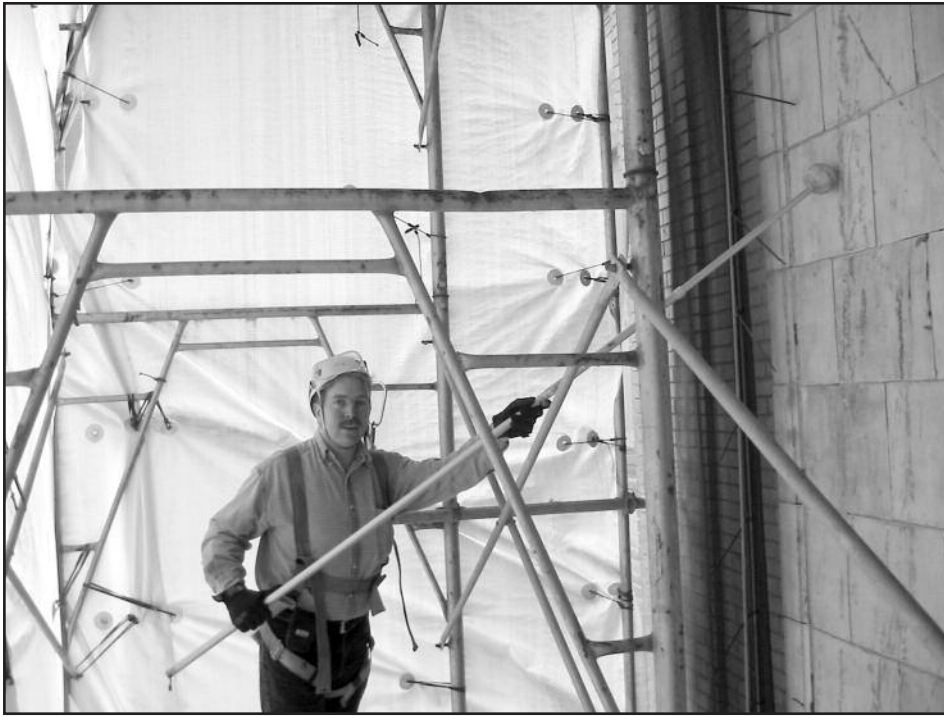
Figure 8 – North elevation – sounding of terra cotta with “sounding ball.”

terra cotta. A “sounding ball” attached to a telescoping pole was designed and used by FMD to evaluate each stone (Figure 8).

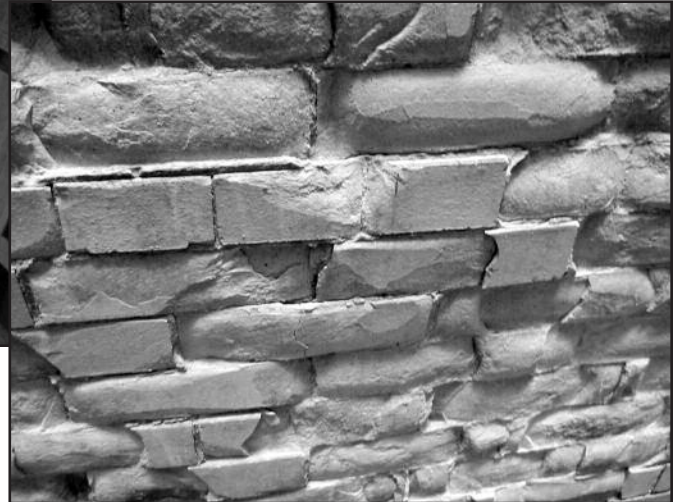
Figure 9D – Brick spalls due to heat of fire in the courtyard.

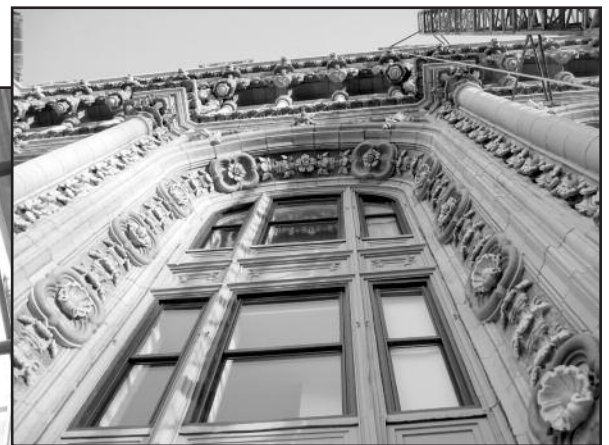
Figure 11 – North elevation – completed restoration of devastated area at top of north elevation.

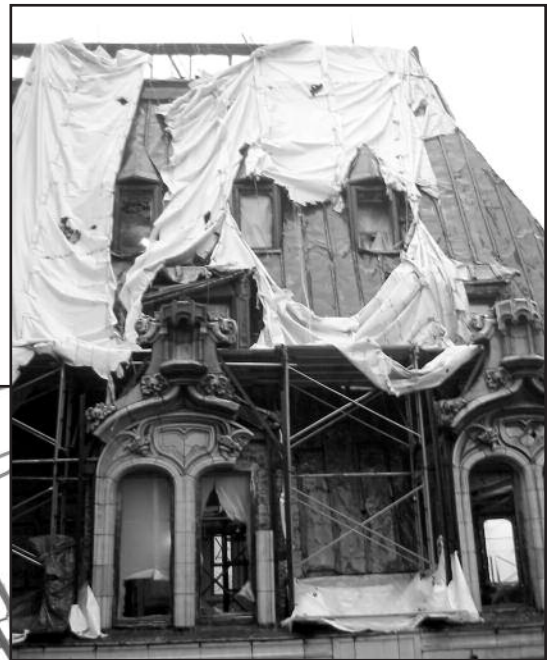
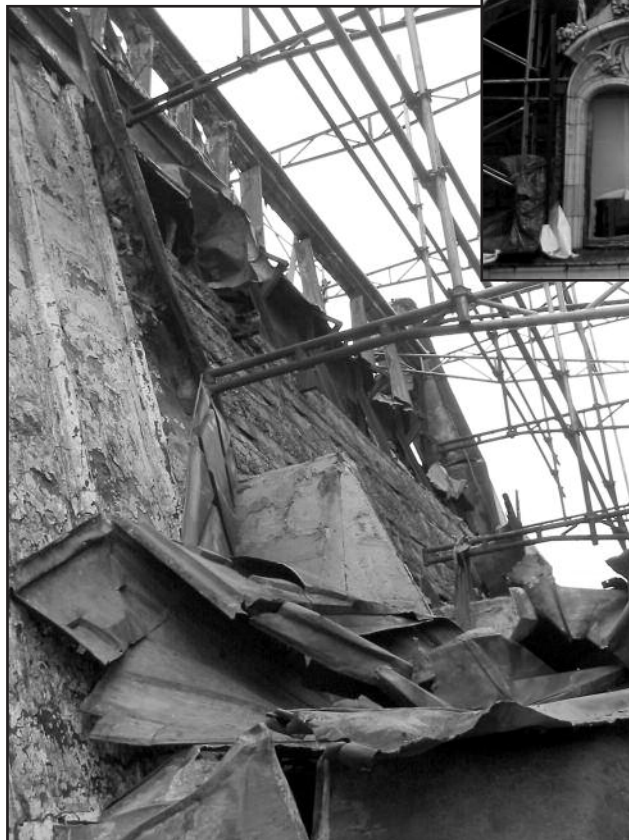
The original copper mansard roof and stamped copper balustrade had been repaired and coated with various sheet and liquid membranes numerous times prior to 9/11. Fire burned the coatings, deformed the copper, burned the underlying wood nailers, and exposed previously

unseen deterioration of the roof's attachment (*Figures 13A and B and 16A and B*).

**Figures 13A and 13B – Mansard roof – copper sheets melted and wood nailers burned from fire.**

- The copper mansard was removed down to its cinder fill substrate, and new batten-seamed copper was laboriously installed by Eagle One Roofing to match the original roof (*Figures 15 and 16*).
- The entire balustrade was replaced with custom fiberglass panels by Seal Fiberglass (*Figures 15A and B*).
- The 23rd floor dormers were replaced with copper, while the 21st and 22nd floor dormers were repaired with copper wherever necessary.

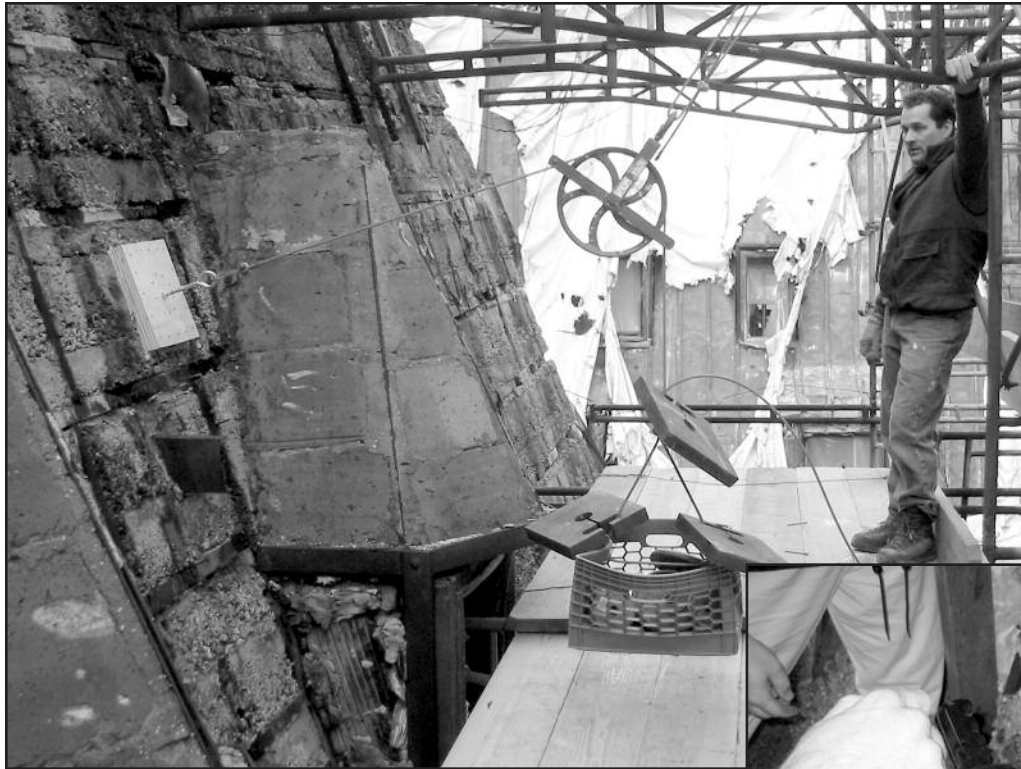
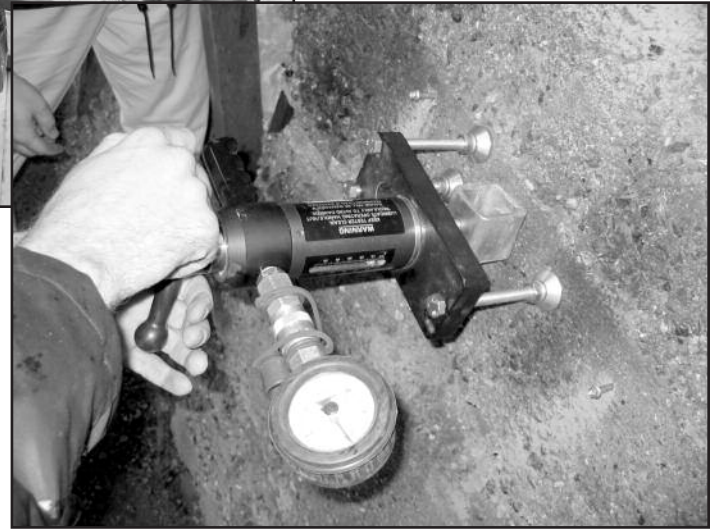
**Figures 14A and B – Tests performed on the roof parge.**

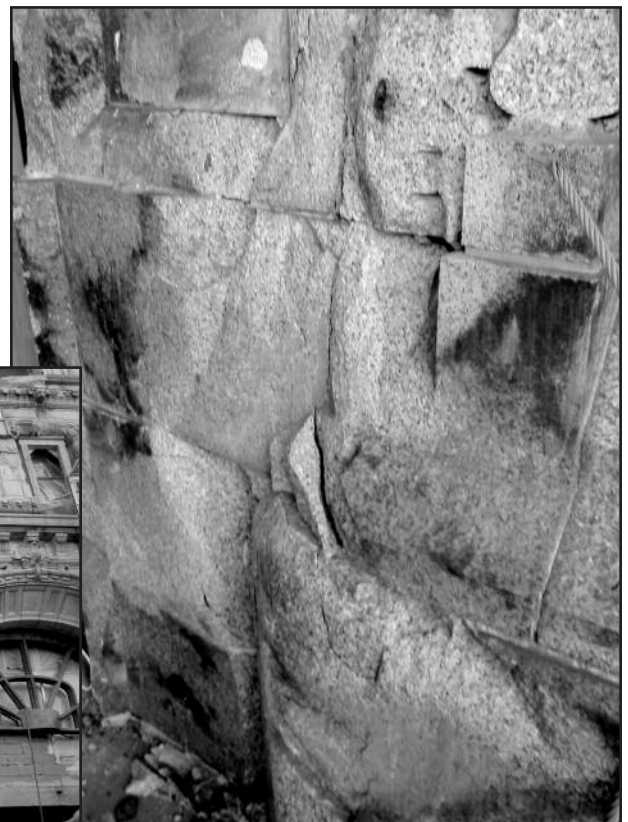
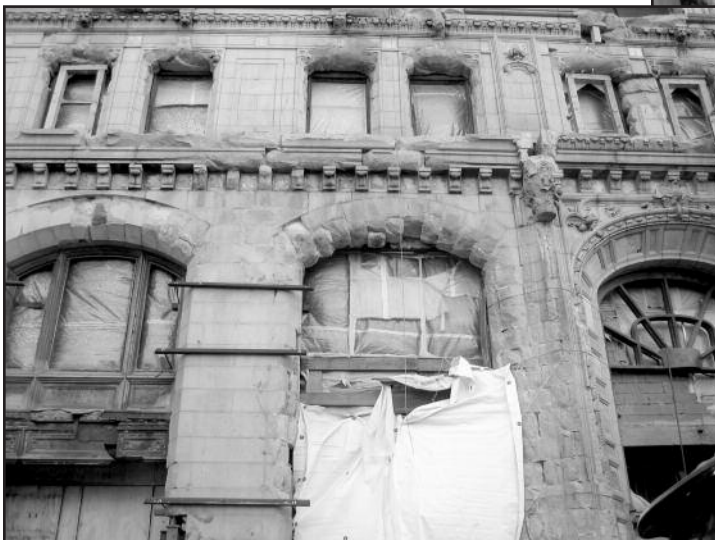
Eighty percent of the north elevation granite base needed to be removed due to excessive impact and fire damage (Figures 17A, 17B, 18, and 19). New ornamental stone was expertly cut and carved in Canada and Italy (Figure 20).

**Figures 17A and 17B – North granite base – fire and impact damage rendered much of the north base unrestoreable.**

An innovative, steel-framed panel system was employed to replace the heavily damaged granite base at the north elevation. This panel system met aesthetic (Figure 22) requirements, as it provided the

installation of both new and original stone, a first on such a large scale. A galvanized, welded steel tube skeleton was constructed of 3-in x 4-in tubes that new and existing veneer stones were attached to with stainless steel threaded anchors. New stone was cut approximately 3-in thick in a “hooker” pattern, which replicated the original stone configuration without additional joints as commonly seen on new panel systems (Figures 19, 21, 23, and 24).

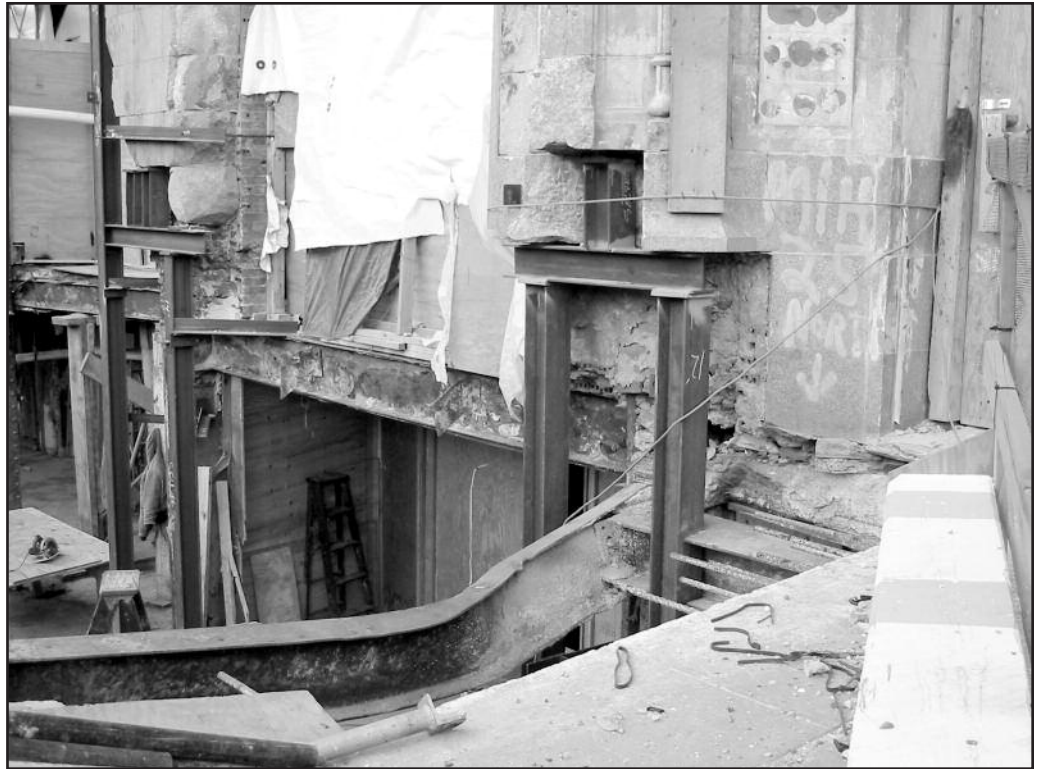
*Figure 18 - Much of the north sidewalk, which supported the granite, was missing.*

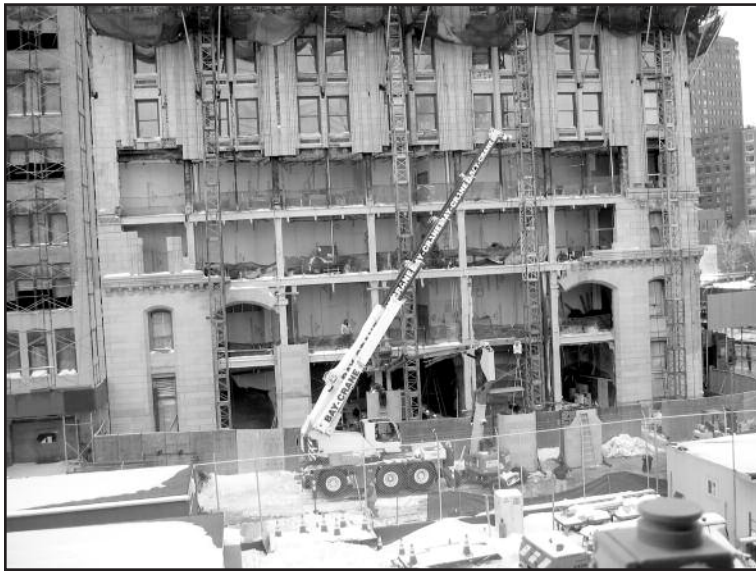
*Figure 19 - North base - most of the north façade granite was completely removed.*
