HISTORIC PRESERVATION FOR BUILDING ENVELOPES: ERDMAN HALL DORMITORY EXTERIOR REHABILITATION

JEFFREY S. LEVINE

LEVINE & COMPANY, INC., ARDMORE, PA

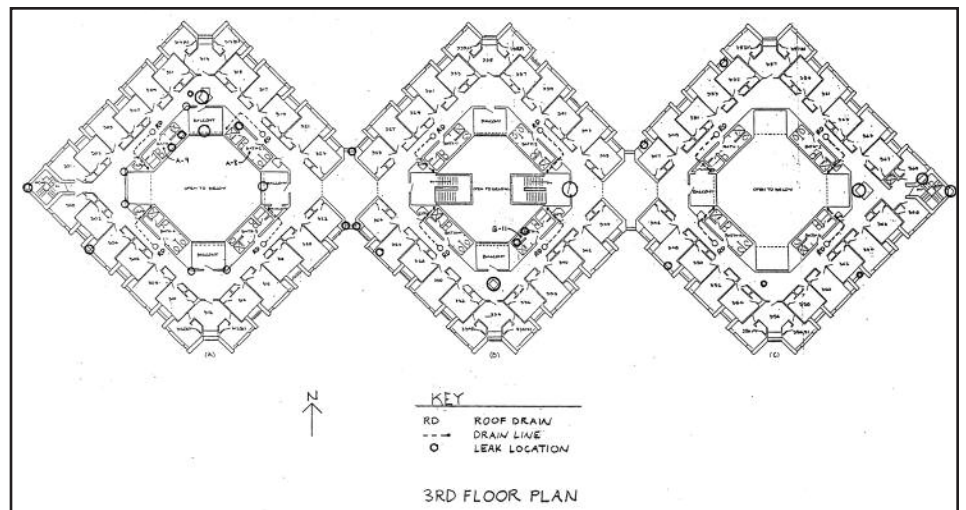
Figure 2 – Erdman Hall, 3rd floor plan showing active leak locations in 1999.

brane in several test locations. And, there were some 30 ongoing roof leaks (*Figure 2*).

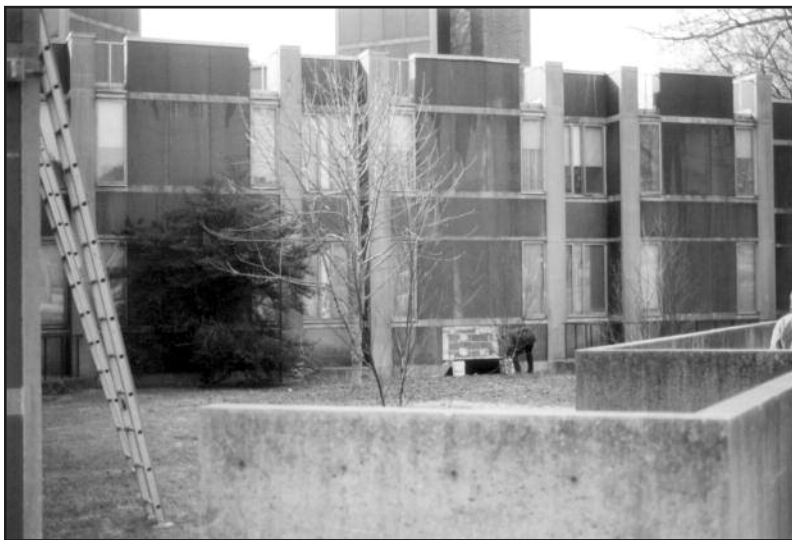
When the project began in 1999, Erdman Hall was not looking too good (Figure 4). Panels were stained. Bronze-colored silicone sealant altered the appearance of the walls, giving them a more monolithic appearance. Some of the sealant had failed. Moisture was observed below the roof mem-

Figure 4 – North elevation, fall 1999.

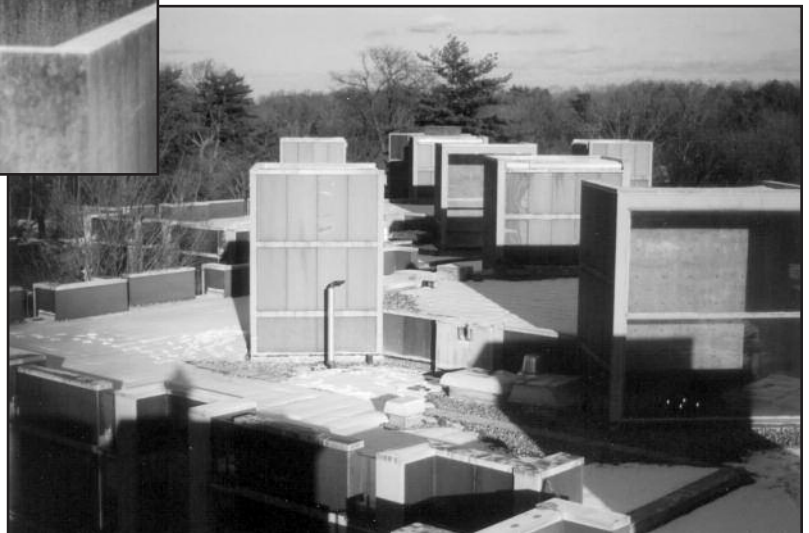
Figure 5 – View of roof prior to rehabilitation.

The project started off simply as a roofing project. All the penetrations and complicated wall geometry had challenged many an architect and contractor, resulting in three roofs in a period of about 35 years (*Figure 5*). The leaks also really challenged the college's ability to preserve Kahn's legacy. It is very difficult to run a dormitory that is plagued by leaks and for which a reliable roof system cannot seem to be had.

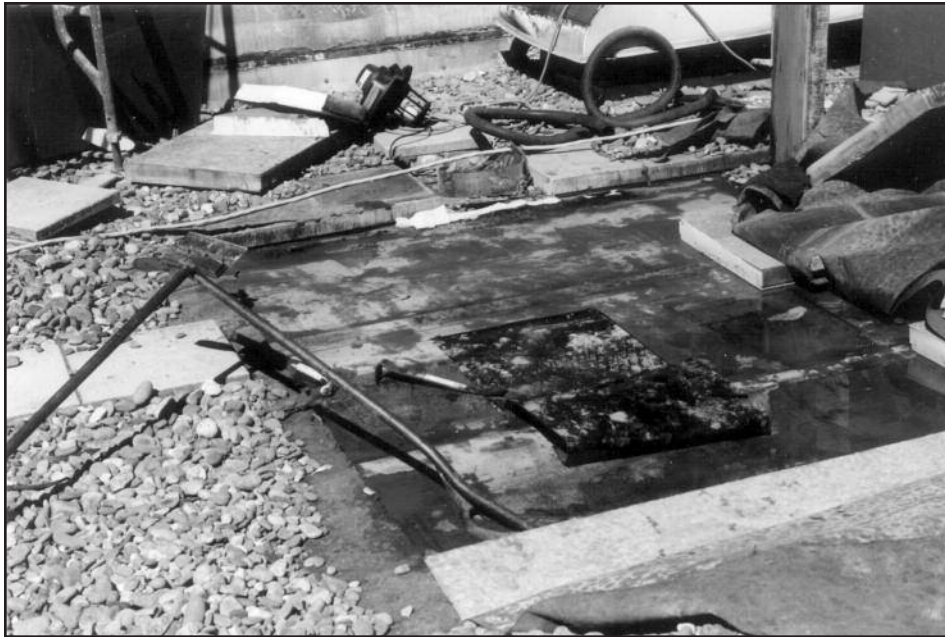
Figure 6 – Test opening in existing IRMA roof system.

the building were an asphalt-based, built-up roof covered with slag; followed by a spray polyurethane foam roof by Dow Corning (a spray-applied foam insulation and spray-applied, weather-resistant, elastomeric coatings); followed by a torch-down modified membrane installed in an inverted roof membrane assembly, or IRMA system (also called an insulated roof membrane assembly, *Figure 6*). These systems lasted about 20 years, five years, and ten years respectively.

Based on repair records, the IRMA roof seems to have leaked from day one.

Puddling, due to inadequate roof slope and sagging of the concrete roof deck, was causing large areas of the insulation to float, including areas in front of the stair tower doors. This made it difficult to open the doors after a rain. For the new roof system, the college was very interested in one that would hold up well under water, as it was assumed that the puddling problem could likely be mitigated, but probably not completely eliminated. A five-ply, coal-tar pitch, built-up roof with a 25-year manufacturer's warranty and an expected service life of 50 years (based on past experience) was recommended, and ultimately selected by the college (*Figure 7*). Designing the new roof system would be the next logical step in the process.

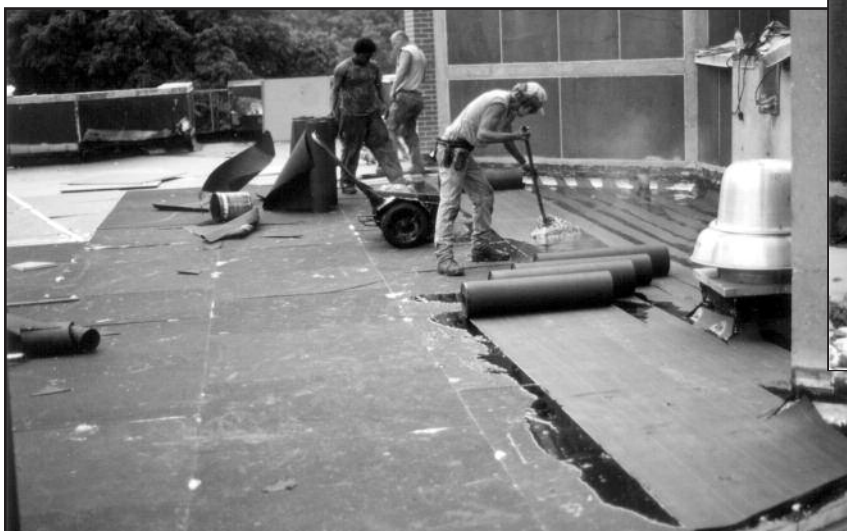
Figure 7 – Installation of new roofing system.

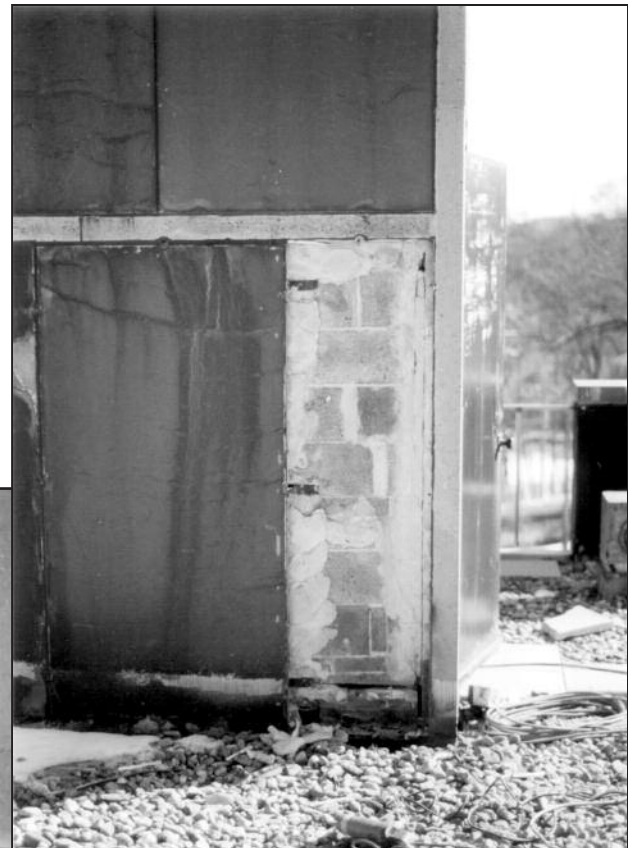
Figure 8 – Test opening at stair tower wall.

One of the test openings was at a stair tower wall where a change in the roof membrane's base flashing height from 0 inches to 8 inches was anticipated (Figure 8). When one of the slate panels was removed, it was found that the clips securing the panel to the backup CMU wall were completely corroded (Figure 9). The College then reported that it had found the same thing when it had made a new door opening at grade to create more secure access to the dining area. Further test openings on the main exterior walls revealed that there was no apparent pattern to the corrosion. It was not as if the clips on the north elevation were all corroded and those on the south were fine.

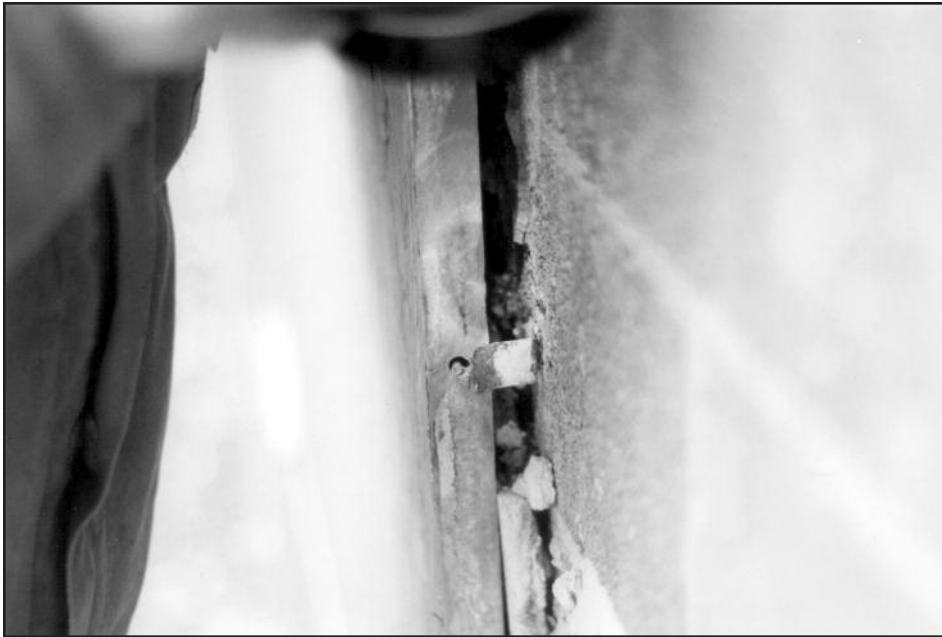
Figure 9 – Outer portion of steel clip engaging stainless steel pin is completely corroded away.

slate panels consisted of an L-shaped, light-gauge, galvanized steel strap held in place with two hardened steel masonry nails. A pin that passed through a hole in the strap and engaged a hole in the edge of two adjacent panels was made of stainless steel.

All of the above options are irreversible and would have severely detracted from the historic appearance of the building. We also explored the option the college eventually chose – removal, salvage, and reinstallation of the slate panels using a stainless steel anchor assembly. This was clearly the best option. It would allow the contractor to know exactly what he was setting anchors into because the backup masonry would be exposed. It permitted better sealant preparation because all edges of the panels would be exposed. It is also the option that best preserved the historic integrity of the building. It was, of course, also the most expensive option.

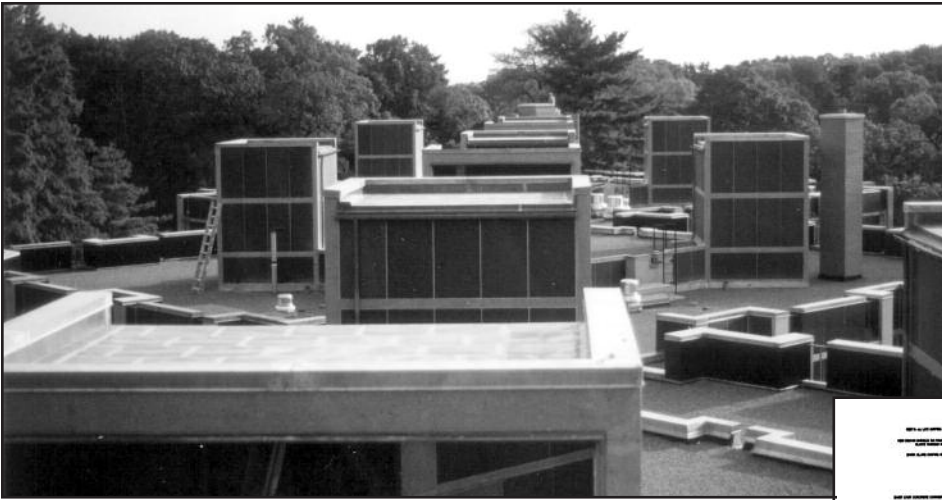
Figure 15 – New clerestory roofing.

- The clerestory and stair tower roofs were changed from a membrane system to flat seam copper. Gutters and downspouts were added to better

direct the flow of rainwater away from the masonry walls (Figure 15). The gutters and downspouts are not noticeable from grade.

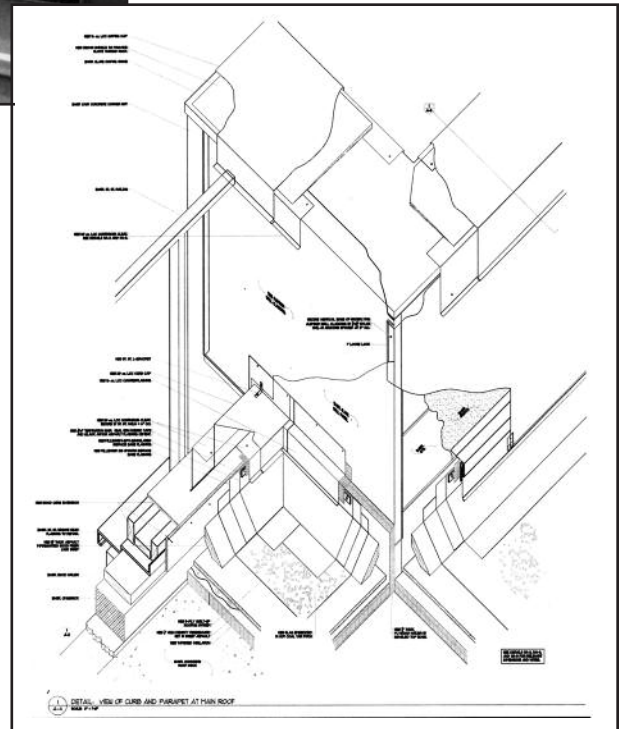
Figure 16: – Detail view of new flashings at embrasures.

- Curbs at the openings (embrasures) in the parapet were raised approximately 4 inches to obtain an 8-inch base flashing height (Figure 16). This change, although visible from grade, is not recognizable as such because there is no reference point for comparison. That is, there is no “before” view and the 4-inch difference in height is not enough to capture the eye (Figures 17 and 18).

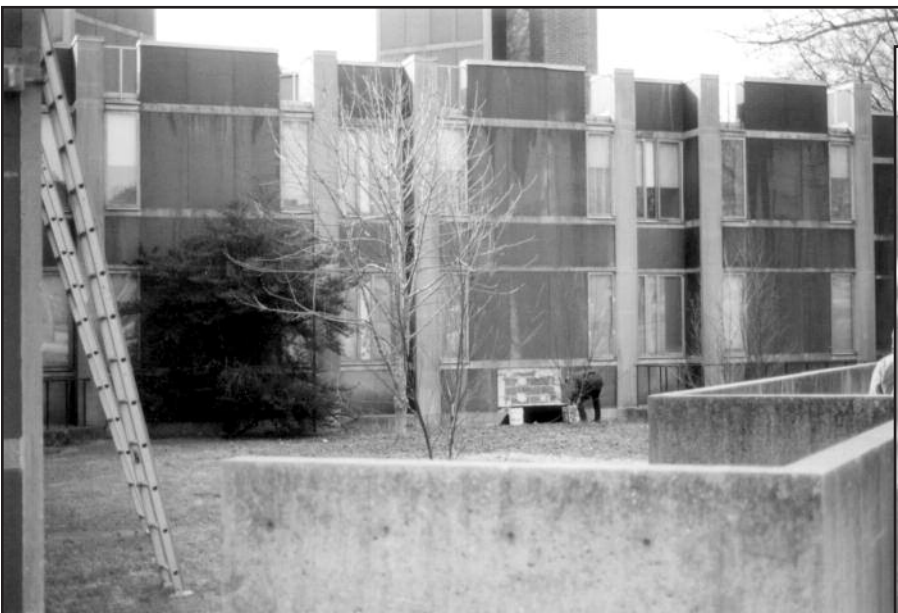
Figure 17 – Embrasures before rehabilitation.

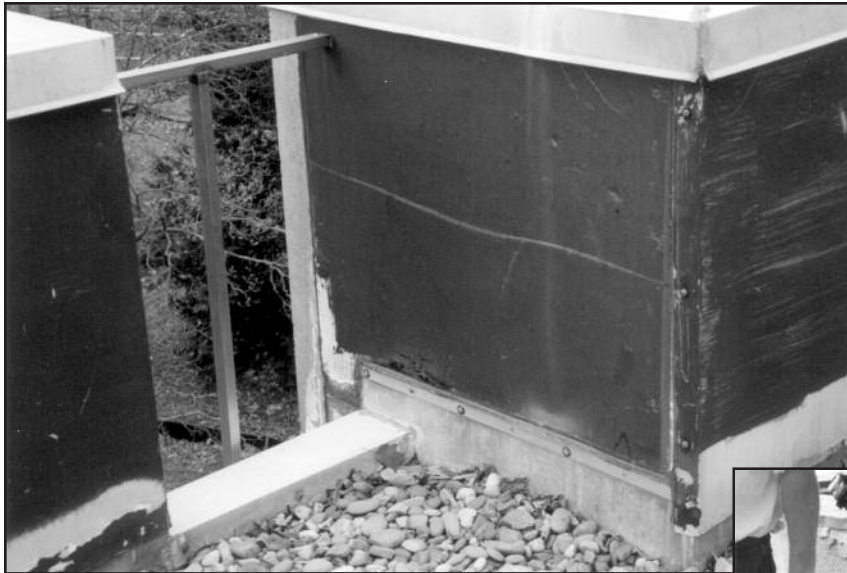
- The backs of the parapets were clad with heavy-gauge, black aluminum because the stucco on CMU was simply not watertight enough to prevent water from getting below the new membrane. This

Figure 19 – Parapet flashing before rehabilitation.

had been done before, probably in the 1980s (Figure 19). To help mitigate the chance of leaks at the window heads below, the aluminum cladding was carried around to cover the slate panels on the parapet end walls as part of the rehabilitation (Figure 20). Again, this change is visible from grade, but the color and gloss match to the slate is so good that it is not noticeable (see Figure 18).

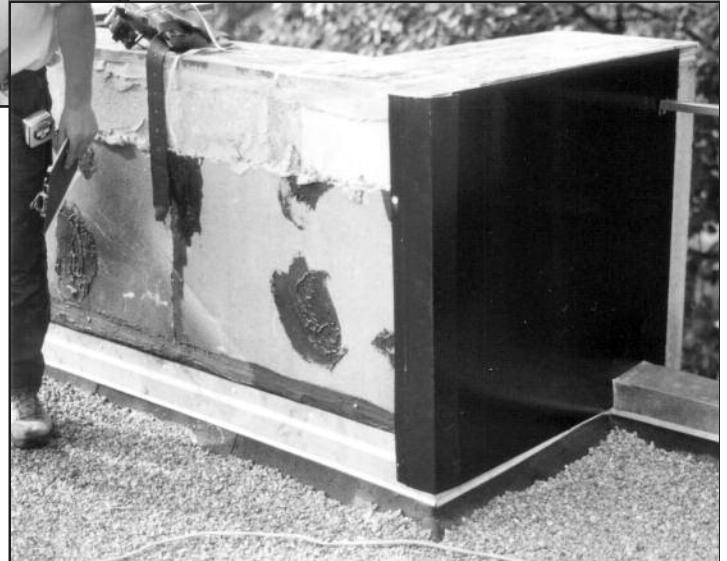
Figure 20 – Parapet flashing during construction.

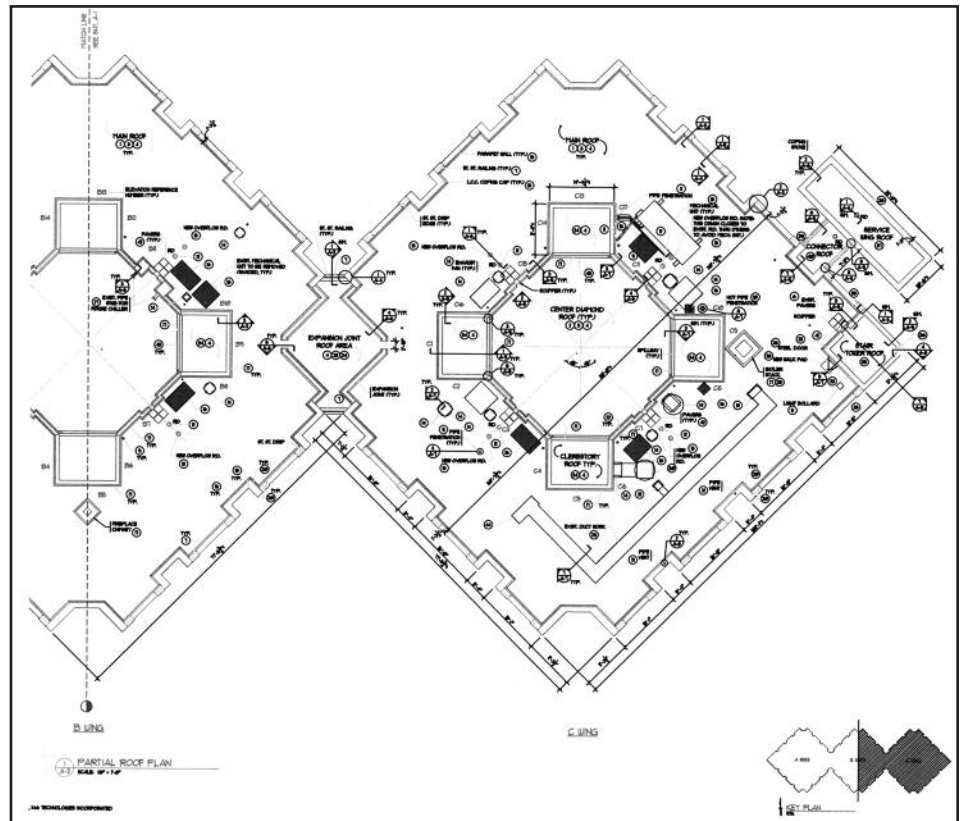
Figure 21 – Partial roof plan. Objects shown in black were to be removed.

- Two non-functional light bollards and some rooftop equipment were removed to eliminate as many roof penetrations as possible (Figure 21).
- Twelve overflow roof drains were installed, four per wing. As a result, short lengths of insulated pipe are now visible in the hallways on the top floor of each wing.

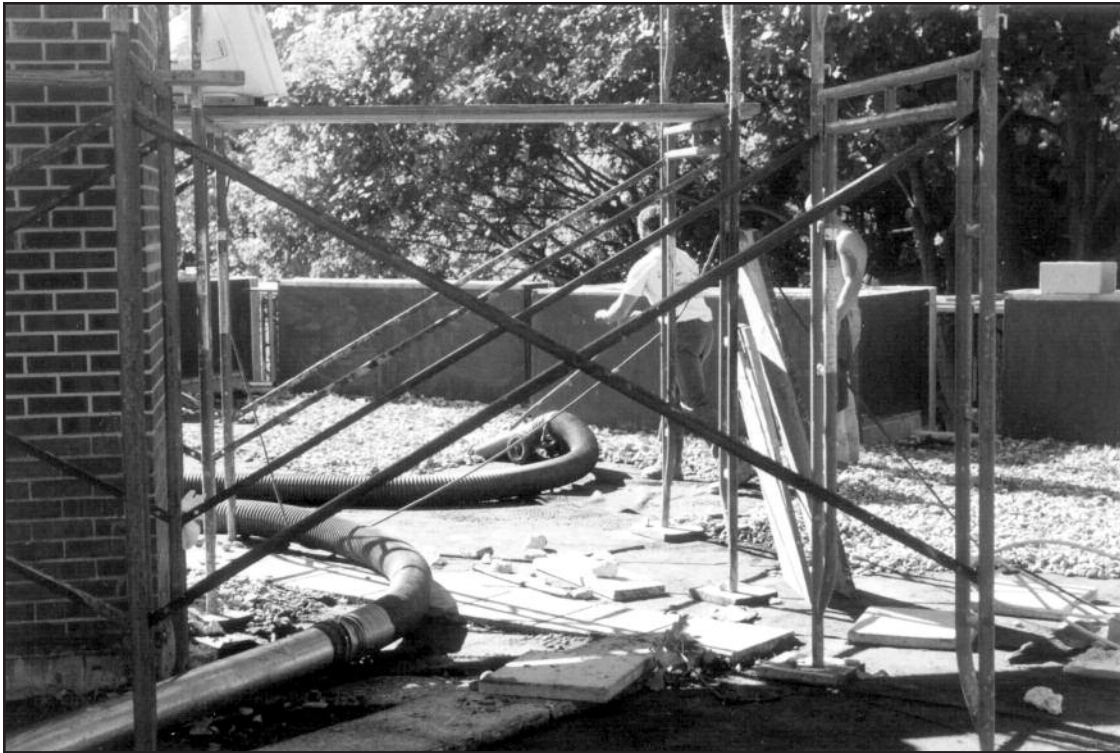
Figure 22 – Vacuum removal of ballast in progress.

In the spring of 2001, the ballast and insulation were removed from the roof (*Figure 22*) and the roof basically became a small lake after each rain, due to deck deflection (*Figure 23*). The contractor could do nothing but sweep and pump each day prior to starting work.

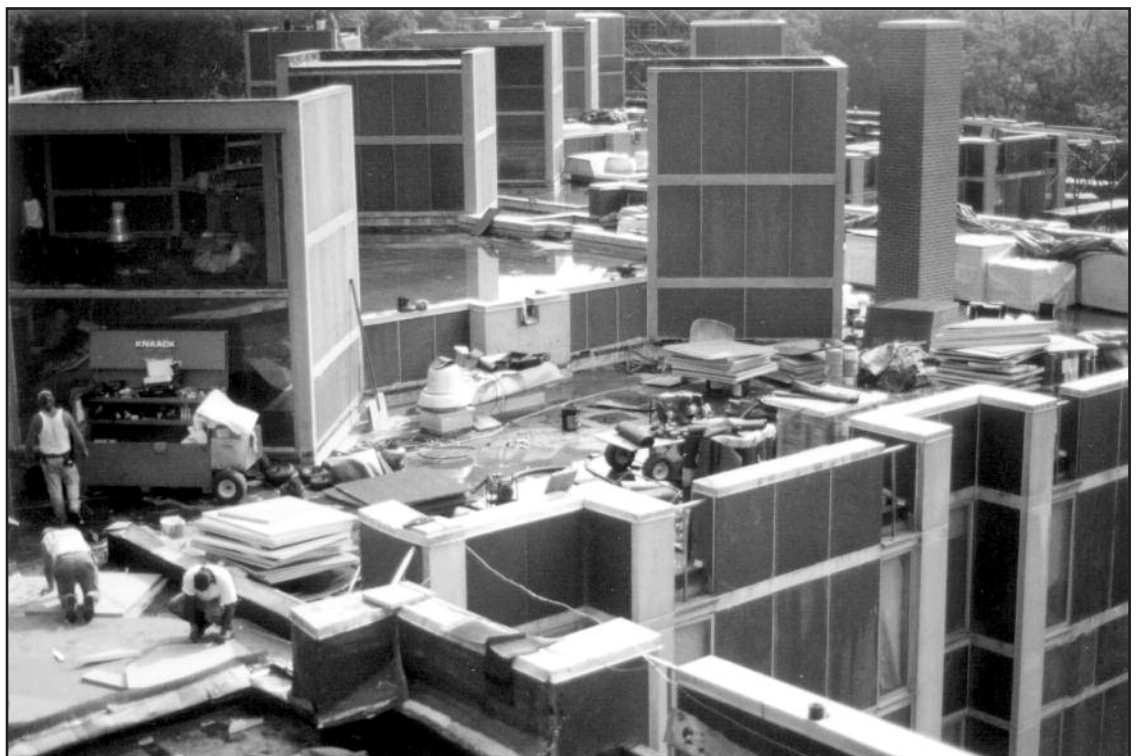
Figure 23 – Puddling on roof during construction.

sives was chosen for re-sloping the concrete roof deck after some test panels and much debate about using mechanical fasteners. Lightweight concrete was also considered, but, in the end, it was felt that there was insufficient time available to wait for the concrete to cure fully. After several go-rounds, the final tapered insulation layout plan developed for re-sloping the 10,000 square feet of roof deck in each wing vastly improved each roof's drainage (*Figure 24*). In the end, however, ponding could not be completely eliminated, due primarily to restrictions imposed by curb heights at the embrasures in the parapet. The slight bit of ponding that remained will

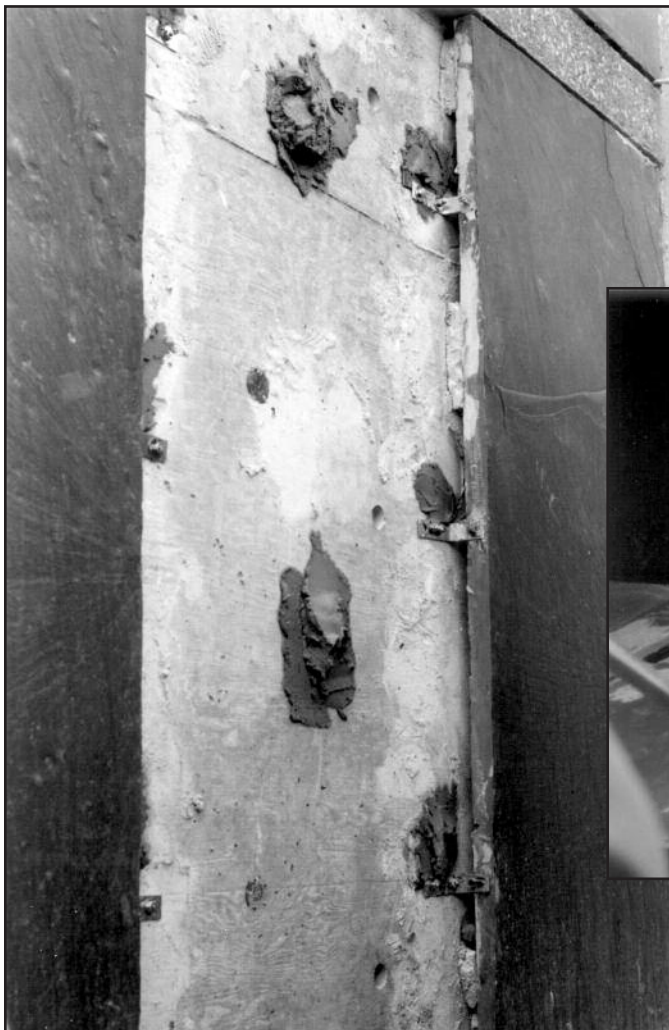
contractor than expected (Figure 25). It all looked nice and clean on the drawings: just drill two or three holes and start installing the assembly. Several things made this a challenging exercise: The 1-1/4-in thickness of the slate panels left no room for play; the anchor pretty much had to be dead center. But, the panels are not all exactly 1-1/4-in thick; they varied between 1-1/8-in and 1-1/2-inch in thickness, and for the finished wall to look good, any variances had to be taken up on the backside. Complicating this even further was the fact that some of the panels were a little warped. Then consider that the panels weigh several hundred pounds each, that their overall lengths and

widths varied, and that the joints between panels had to be 1/4-in plus or minus a 1/16-in, and it is not hard to imagine that trying to get three or four 3/16-in diameter pins into 5/16-in diameter holes aligned precisely across from each other in two panels got a little tricky.

Figure 25 - Reinstallation of slate wall panels.

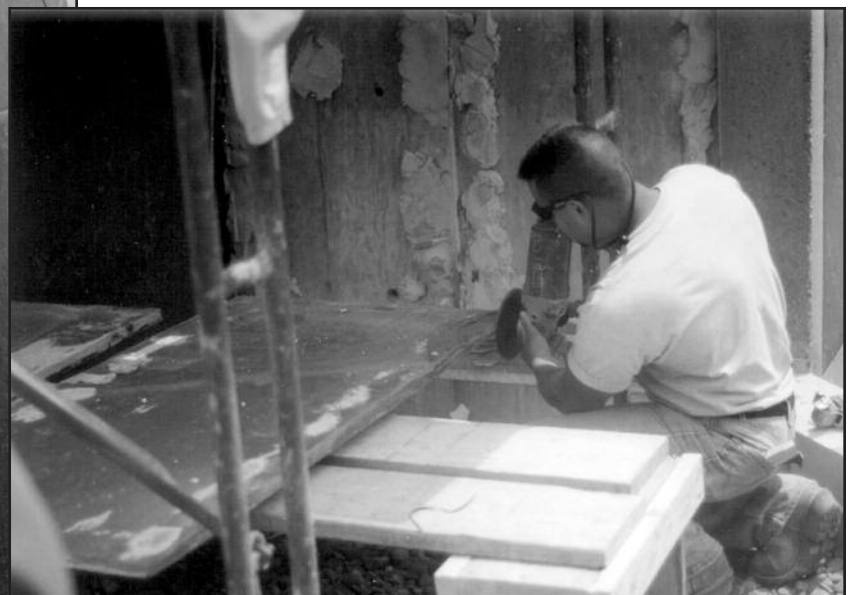
At least two, and in some places, three sealants had been used in the joints between the panels over the years, including polysulphide and silicone sealants. The new sealant was to be a two-part polyurethane. None of these was compatible with another. So, it was very important that all of the existing sealants and any residues be removed right down to the bare slate. This was accomplished using a rigid protocol of scraping, buffing with a fabric wheel (Figure 26) and solvent wipes, followed by an equal-

Figure 26 - Removal of existing sealant from edge of slate panel prior to reinstallation.

ly rigid pull-testing program that ratcheted down as acceptable and consistent adhesion results were confirmed.

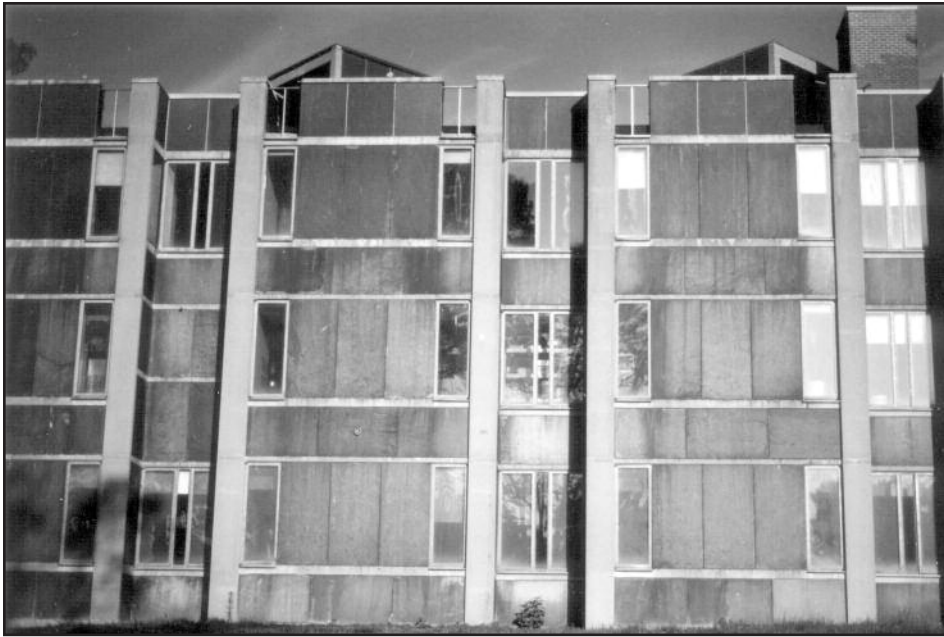
Figure 27 – East elevation prior to rehabilitation.

The engineer of record who worked with Kahn related how white was originally chosen: Kahn had just had cataract surgery and from 15 feet away, took about nine seconds to select white from a group of four or five different shades. Pre- and post-rehabilitation images of the building prove that sealant color has an unexpected, yet significant impact on the appearance of the building (Figures 27 and 28).

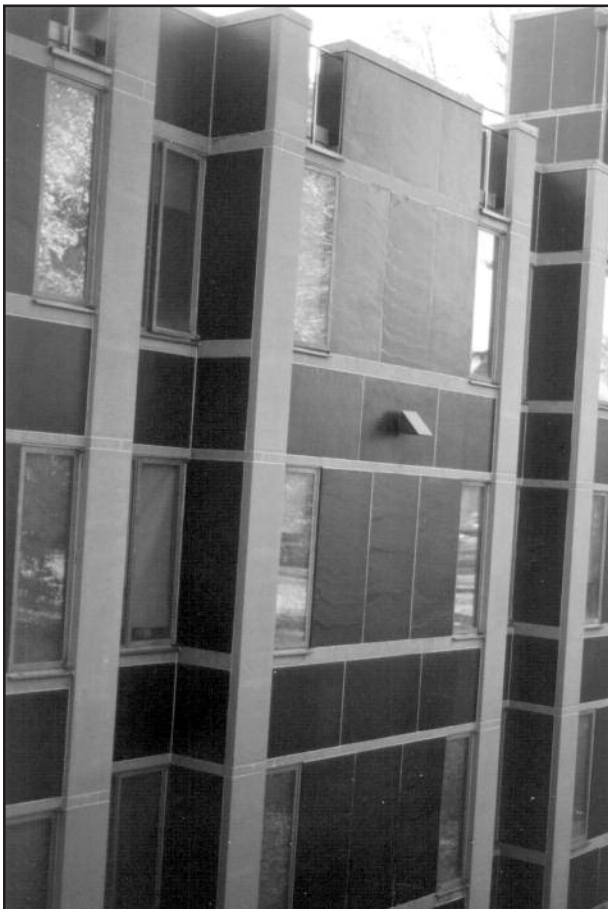
Figure 28 – West elevation after rehabilitation.

sealer the whole rest of the way down the façade. There was no choice but to seal the panels – not for waterproofing, but for aesthetic reasons. An acrylic, anti-graffiti coating by Chemprobe Coating Systems was selected based on test panels. Although it was a very small part of the work, sealing the slate panels had the greatest restorative impact, unifying the panels' appearance, and making the building look like new (see *Figure 28*).
