Mold in Building Constructions in the Nordic Countries – With Emphasis on Roofs

Erik Brandt
Danish Building Research Institute (SBI)
Tommy Bunch-Nielsen
Danish Roofing Advisory Board (TOR)

Mold in Building Constructions in the Nordic Countries

– With Emphasis on Roofs

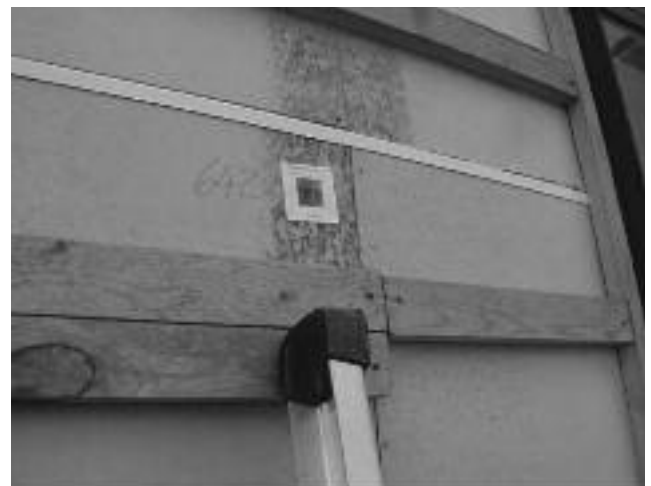
Most often, attack of mold is seen in lightweight façades, i.e., ventilated façades with board materials – especially gypsum board – and an outer skin of metal or natural stone. For such a façade to function properly, it is a prerequisite that any water penetrating to the ventilated cavity must be drained out again. Problems typically occur where the drainage is insufficient or where the wind barrier is not protected from direct (driving) rain.

Figure 1 – Example of a ventilated façade with mold growth on the wind barrier (made by gypsum boards). Often mold growth in façades is due to water penetrating behind the cladding without being drained out (fast enough).

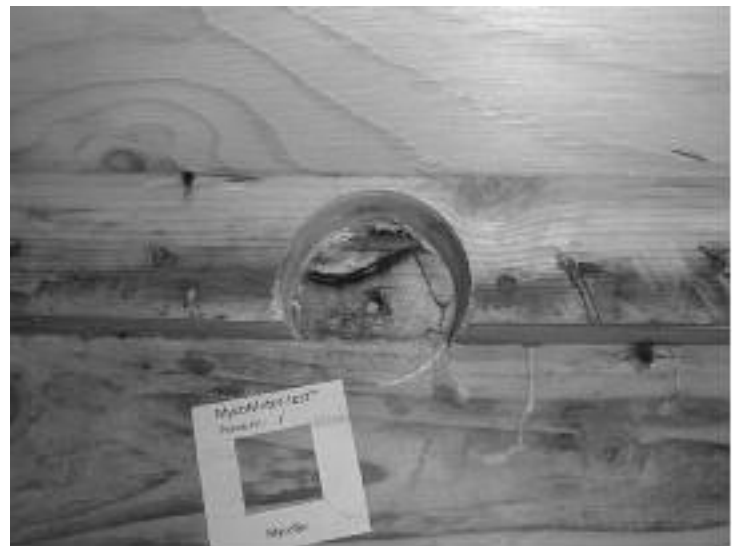
Figure 3 – Roof element in a new school with massive mold growth. The roof elements are prefabricated and meant to be sealed immediately after assembling. Lack of sealing, however, leads to penetration of water and eventually mold growth. The renovation included opening of the prefabricated elements, removal of insulation, and cleaning of the wooden surfaces in the elements. Afterwards, the elements were restored with new insulation and vapor barrier.

In some cases, materials or components for the roof are stored on the building site where it might be soaked if not properly protected. Other problems have been seen with materials left wrapped in plastic. When the sun shines, moisture is released from the wood. When it cools down again, the moisture condensates on the plastic, leading to mold growth during the storing period. For roof elements assembled on-site, the major reason for failure is lack of sealing the joints between elements immediately after assembling.

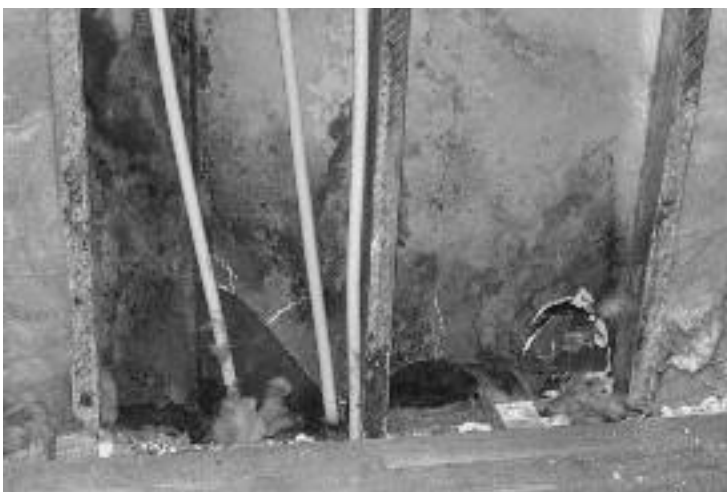
Mold growth in lightweight bathrooms is most often seen where a watertight membrane is either missing or is not made properly. Problems are often seen at details like joints between wall and floor and pipe penetrations. Any leaks in bathrooms provide excellent growing conditions, with favorable temperature and humidity for mold growth, and might eventually be followed by fungi and dry rot.

Figure 2 – Severe attack of mold on the backside of a gypsum board partition in a bathroom due to lack of a watertight membrane (the wall was tiled directly on the gypsum board).

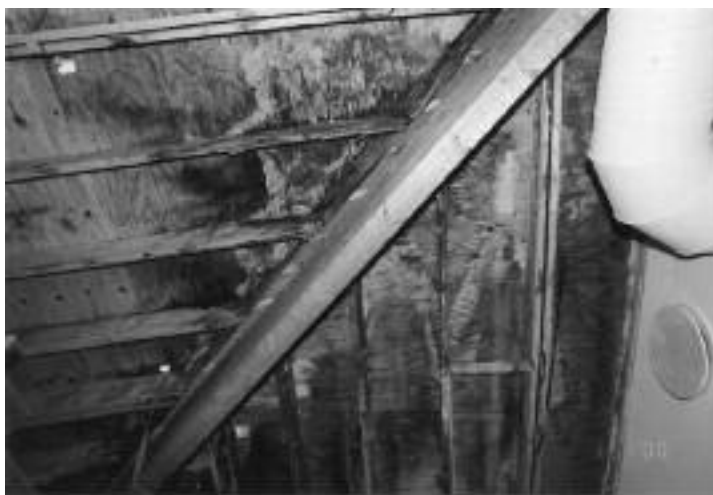
Figure 4 – Mold growth and deterioration of plywood in a sloped roof made from wood-based elements assembled in situ. Due to leaks in the interior joints between elements in the corners - and consequently also leaks in the vapor barrier – humid air has penetrated into the construction, where it condensates on the cold surfaces above the insulation.

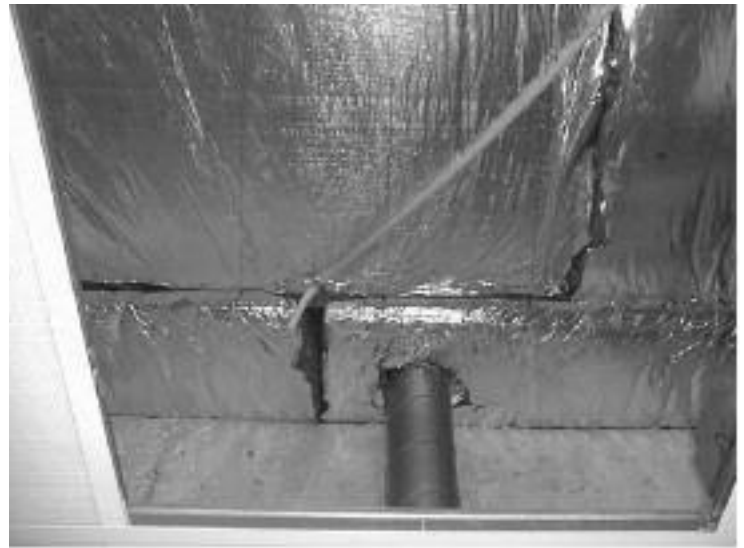
Problems with leaking vapor barriers are seen on flat as well as on sloped roofs. This is an example of a technical problem with an easy and well-known solution: namely, introduction of a decent airtight vapor barrier (if necessary) and use of existing directions on how to design the roofs.

Figure 5 – Vapor barrier with leaks at joints and pipe penetration in a school. The entire school was built in the same way. The consequence was that there was massive mold growth in all roofs and that a major renovation was necessary to remove the mold.

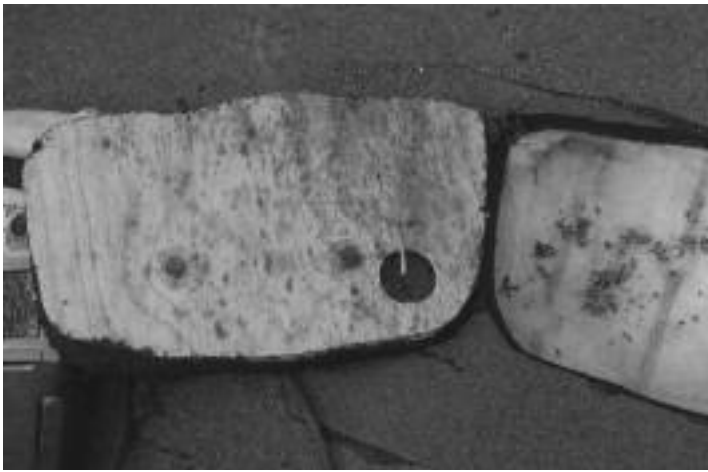
Figure 6 – Mold on plywood in roof element with Hygrodiode. This roof element was in the shade from a higher part of the building and consequently was not heated sufficiently to force the moisture down to the inner surface.

However, it is necessary for a proper functioning that the moisture is actually driven down in the roof in summer time; i.e., it is dependent on the sun to get a decent temperature gradient over the roof. In practice, this means that the roof must not be in the shade, either from other buildings, or from roof coverings laid with a ventilation gap underneath.

A number of fairly large projects have been constructed without paying attention to the requirement for solar heating. The result has always been the same - in the shaded parts of the roof, the moisture will gradually build up to a level where mold (and eventually also fungus and dry rot) can grow.

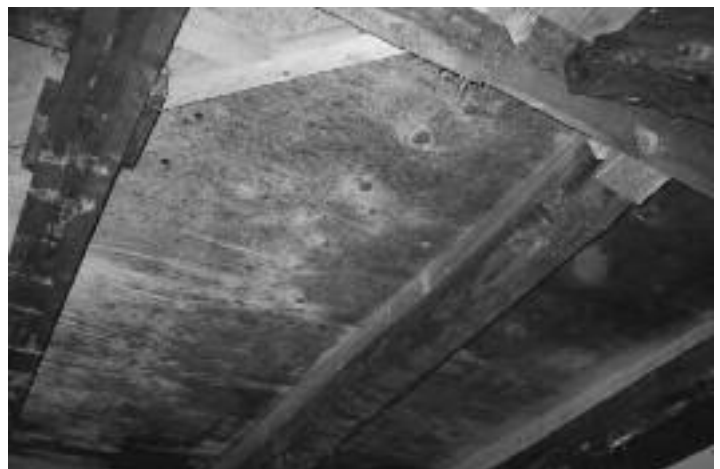
In ventilated roofs, the inner side of the roof is quite often boards or plywood. In recent years when still more insulation has been used, the inner side of the roof has become very cold (it receives almost no heating from the building). Radiation to the sky on clear nights might (under winter conditions) result in sub-cooling of the inner surface, bringing the temperature below the dew point where condensation will occur.

The condensation facilitates the growth of mold, and especially on plywood, the growth can be considerable. In Finland and Sweden, plywood for roofs is now treated with wood preservatives in order to avoid the problem.

Figure 7 – Mold growth on plywood substrate for roofing felt in a ventilated roof due to sub-cooling caused by radiation to the sky. Plywood is more vulnerable to mold growth than boards, probably due to the treatment during production.
