# **Architecture or Sculpture? Case Study of the Roof and Skylight Replacement on the Everson Museum of Art, Syracuse, NY**

**Dennis C. Spina, AIA  
Bell & Spina, P.C. Architects - Planners  
Syracuse, New York**

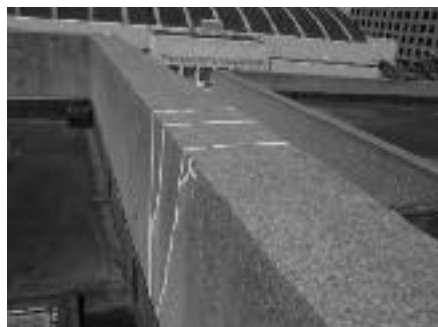
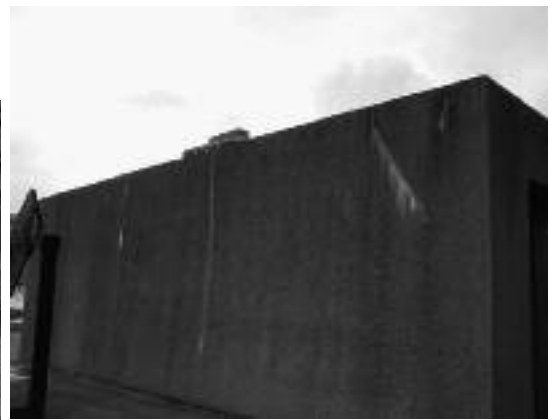
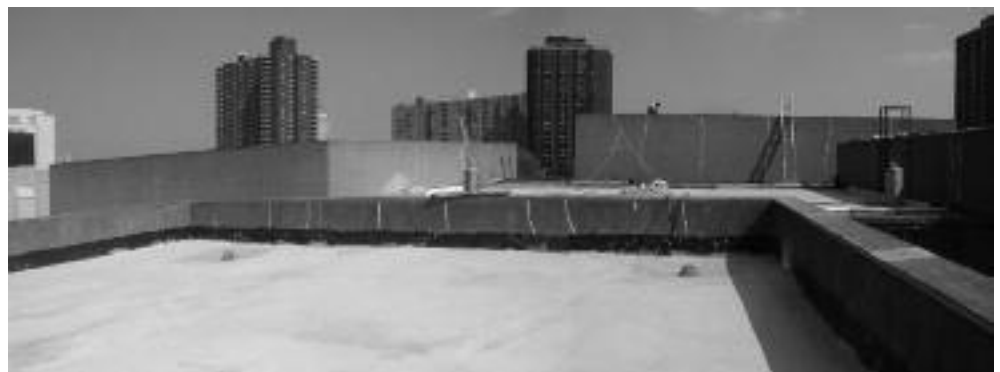
*Below: cracks.*

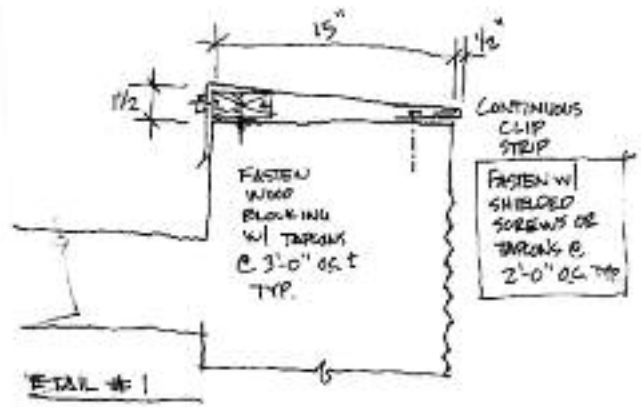
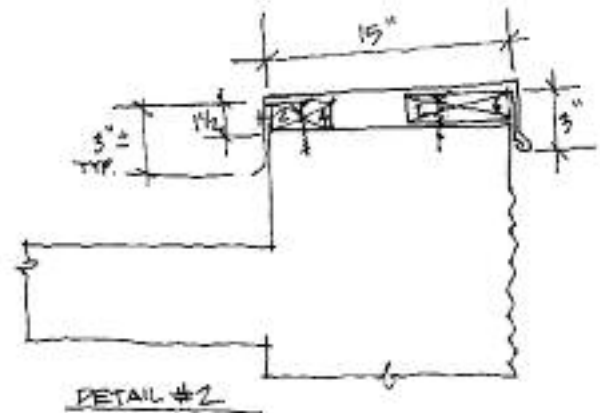
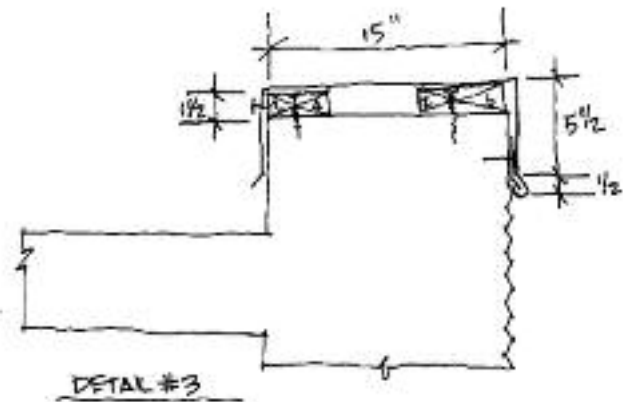
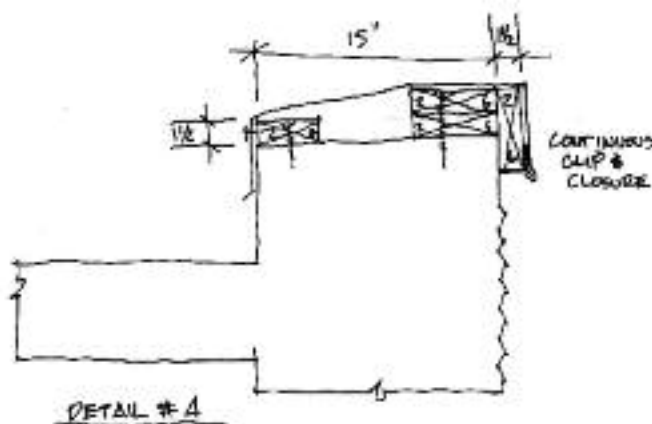
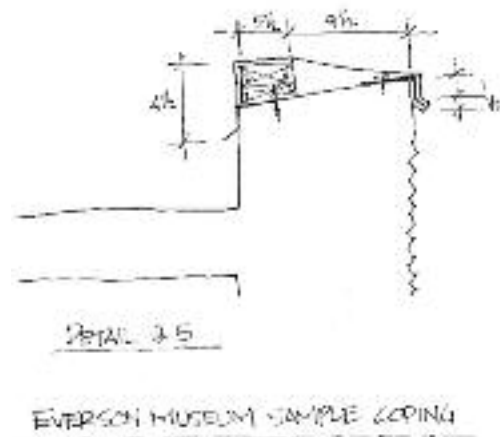
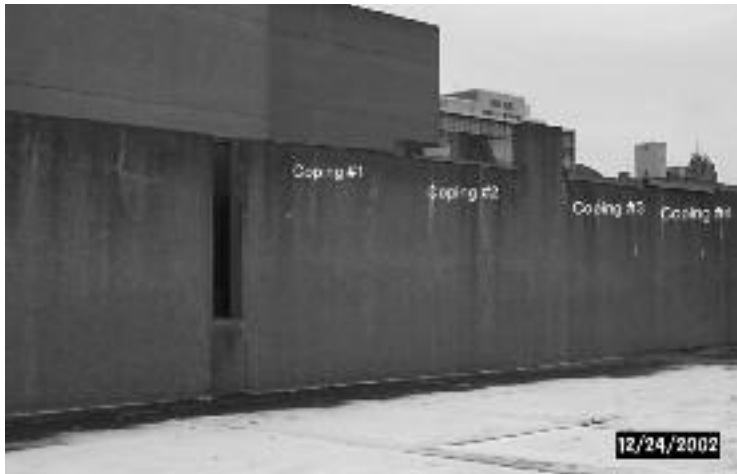
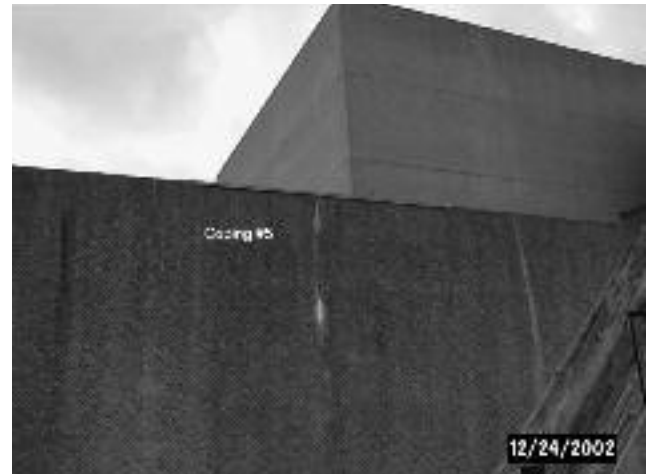
There were three edge details proposed: coping mock-up #1, which did not break the edge and relied on sealant for protection; coping mock-up #5, which had been previously approved; and a variation called 5A that had a straight rather than 45-degree drip, intended to present less of a shadow line.

Total vote: six for detail #5A; two for detail #1, one for detail #5.

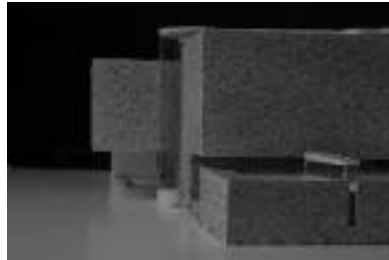
This skylight was similar to skylight 4, with a lack of slope and height to flash. It had previously been agreed that the director's office skylight would be eliminated. The committee desired to keep this design element and voted to keep it with the recognition that it would be below the manufacturer's minimum slope requirements and would not be guaranteed watertight.

***Skylight 5 was completely covered over. The light well became more gallery space.***
