WIND DAMAGE ON LOW SLOPE ROOFS FROM HURRICANE KATRINA

By Cheri Panasik, PhD and André Desjarlais

Hurricane Katrina

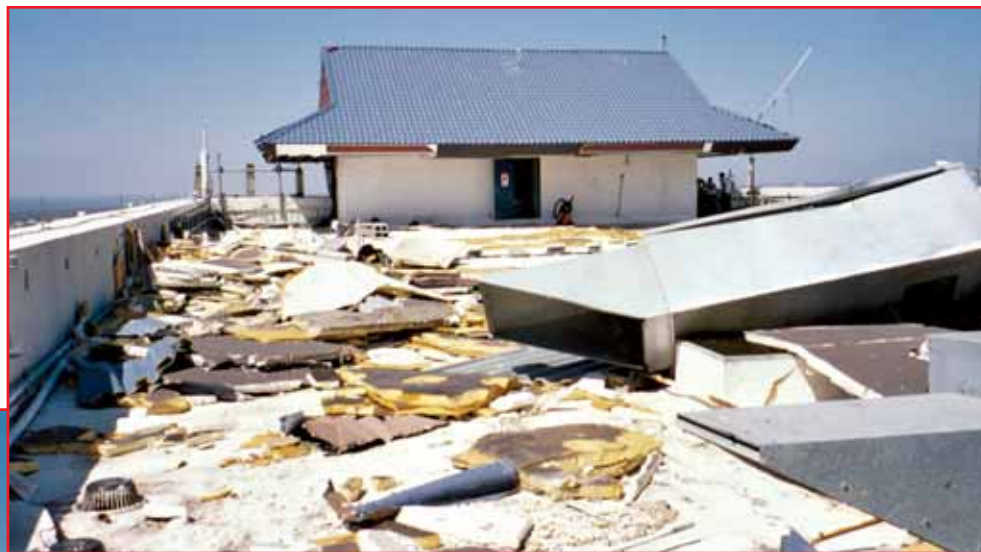
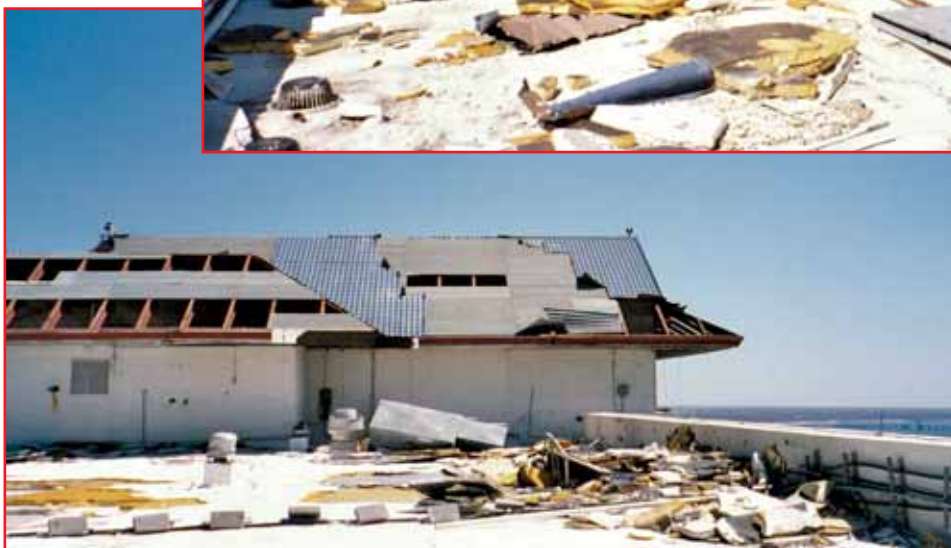
*Photos 1 and 2 –
Impact of reduced
fastening patterns.*

The investigation team inspected several types of low-slope roofs, such as SPF, SBS, BUR, and metal. The team found some of the same issues as seen in previous hurricane investigations. Some damaged membrane and edge details were not secured according to standard fastening pattern guidelines. An extreme example of this issue was found on a waterfront hotel in Biloxi, Mississippi. The SPF roof was only five years old and blew off during Hurricane

Katrina; however, the fastening pattern used did not match any prescribed method (see Photos 1 and 2).

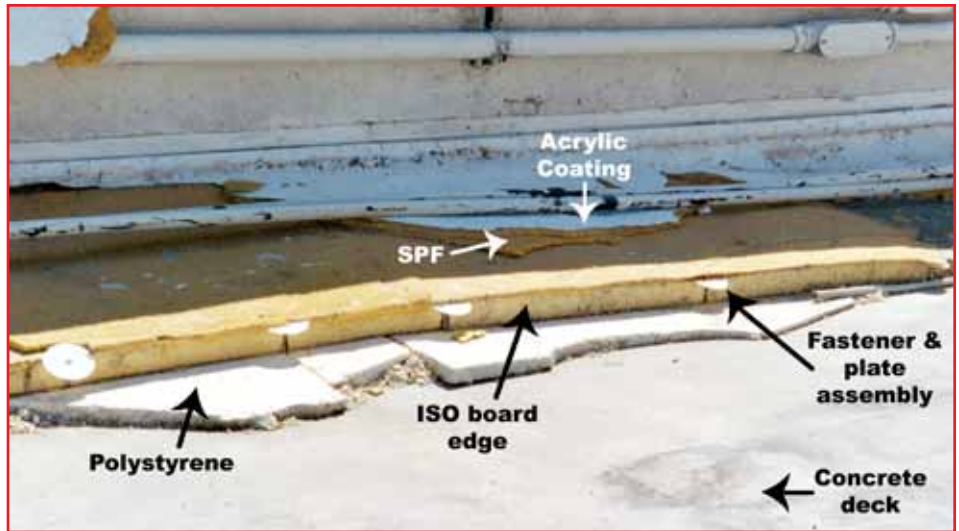
Photo 3 – Cross sectional view of roof system.

The SPF roof system of a 350-foot-tall waterfront hotel in Biloxi, Mississippi, consisted of a white acrylic coating; 1/2-inch-thick, 4-ft by 8-ft ISO insulation; and expanded polystyrene fastened to cast-in-place concrete using screw anchors (Photo 3). Three screws with plastic roofing plates were used to fasten each 4-ft x 8-ft board and the rest of the required fasteners were

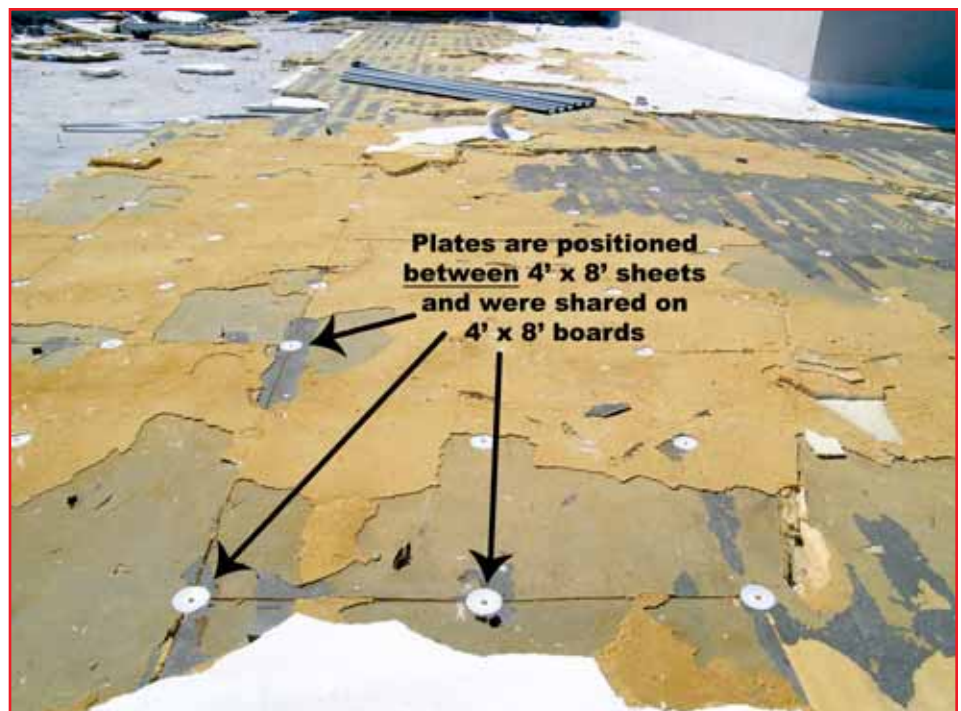
Photo 4 – Three screws with plastic roofing plates were used to fasten each 4-ft by 8-ft board at edges.

not installed (Photo 4). Additional fasteners were placed between each 4 x 8 board, thus not following any prescribed fastening pattern. The corner of each board was secured by fasteners that were installed between the board corners with the plastic plate straddling three ISO boards (see Photo 5).

Insulation fastening should be installed a minimum of six inches from the edge of the insulation board and never shared between boards. Perhaps an inspection by a qualified inspector during roof construction could have detected and stopped such a fastening pattern. As a result of the fastening mistakes, over 50% of the roof was blown off, leaving only the screws and plates secured to the concrete deck.

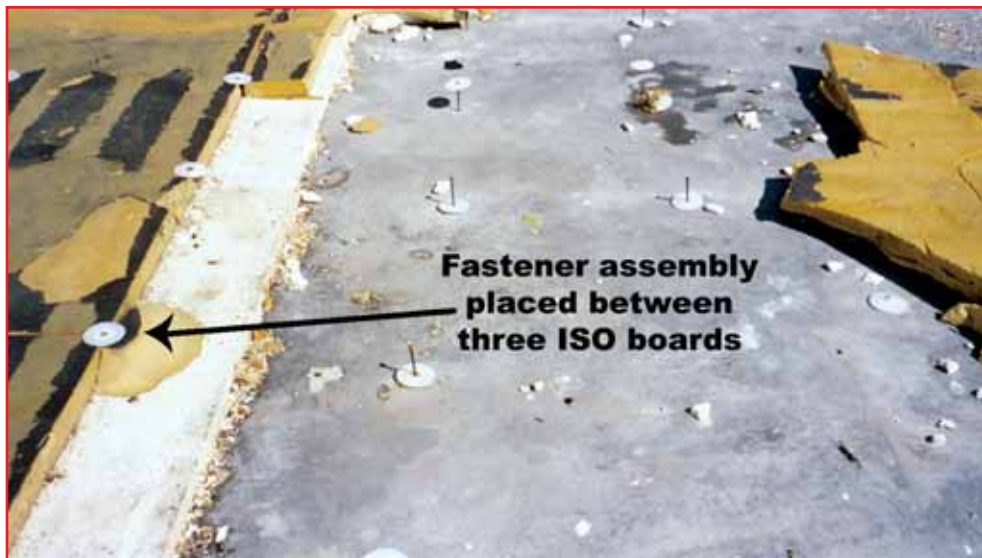
Photo 5 - Fasteners were driven between ISO sheets, shared by adjacent boards.

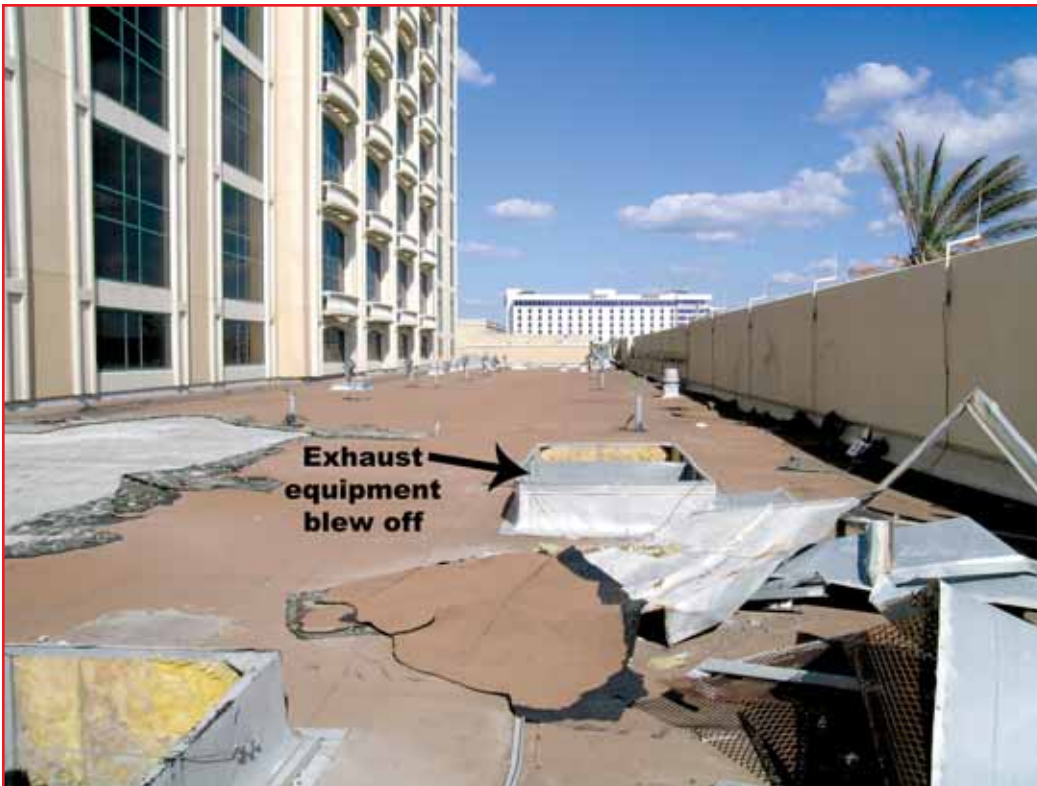
An SBS roof on a waterfront hotel constructed in 1999 performed well until damaged by exhaust equipment (see Photo 6). The building was 36-feet-tall and located in Biloxi, Mississippi. The SBS membrane had a granular surface. Two and three-fourths-inch-diameter plate assemblies, spaced ten inches apart, were fastened into lightweight

concrete. Five percent of the membrane was damaged. Thirty percent of the wood nailer was detached. The expansion joint was exposed. Damage initiation evidence showed that the exhaust equipment was detached from its location and blew across the length of the roof, damaging the membrane as it was dragged along. The damage seemed to

be due solely to the exhaust equipment cutting and tearing the membrane.

Photo 6 – Developing and following a prescribed method to secure HVAC systems to curbs could reduce membrane damage from equipment dragged or thrown by the wind.

Developing and following a prescribed method to secure HVAC systems to curbs could reduce membrane damage during high winds. Year after year, roofing organizations cite findings of membrane failure solely due to being cut by a roof-mounted

item breaking free and dragging along. Establishing robust fastening system requirements could reduce membrane damage.

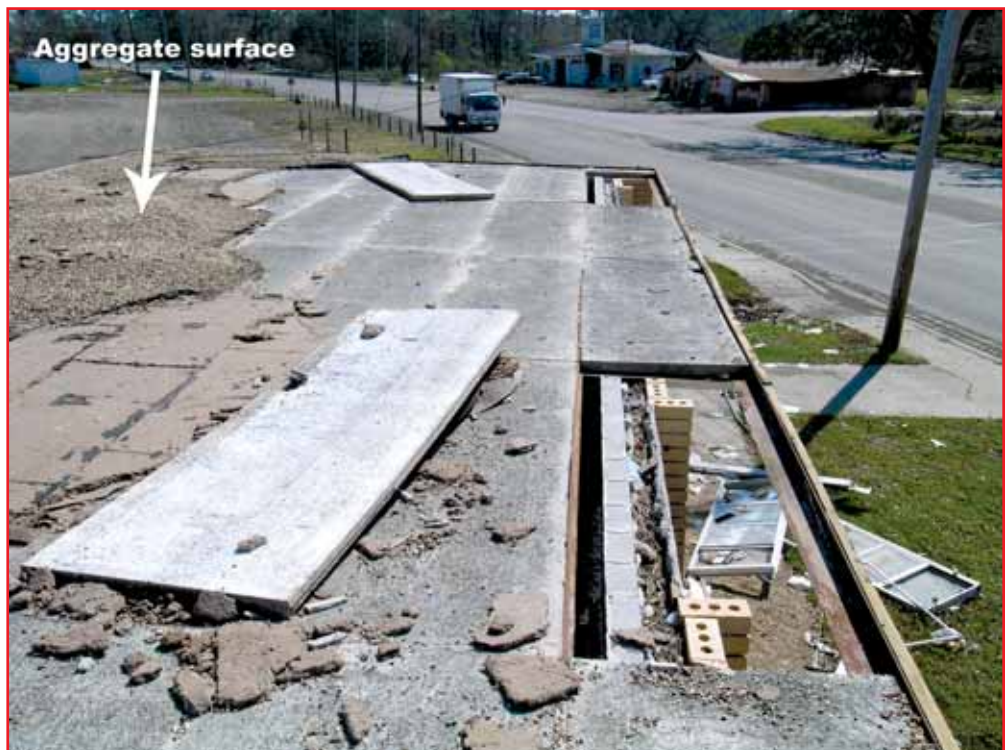
Several BUR systems performed well; however, the BUR and windows of a middle school building built in 1959 located in Di’Iberville, Mississippi, were unable to resist the hurricane. Ninety-five percent membrane damage and complete window blow-out allowed massive content damage. The membrane was a four-ply system with aggregate surfacing (*Photo 7*). It was mechanically attached with split-shank, sheet-metal barb nails in a three-per-square-foot fastening pattern in the perimeter zone. The roof deck was cementitious wood fiber and was secured to steel joists using sheet metal H clips fastened every eight feet on center.

Twenty-five percent of the edge nailer was detached. The system attachment substrate had 90% damage. Deck movement occurred in the southeast corner. The deck was detached from the secondary support.

The sheet-metal H clips were corroded and pulled out of place from the steel bar joists. The base sheet split nail fasteners pulled out. The base sheet, membrane, and deck panels detached from the roof as uplift

Photo 7 – This four-ply, aggregate-surfaced, BUR system suffered 95% membrane damage.

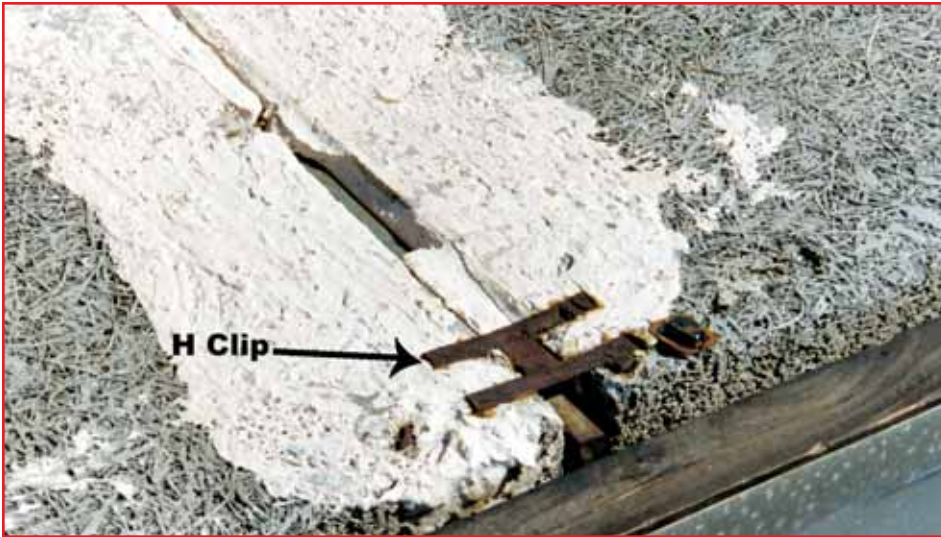
forces pulled H clips out of the steel joists. The remaining H clips were easy to lift and remove from the steel joists, thus not providing resistance to uplift forces (*Photo 8*). Numerous roof deck panels were displaced.

Photo 8 – The sheet metal H clips were corroded and easily pulled out of the steel joists, providing insufficient resistance to wind uplift forces.

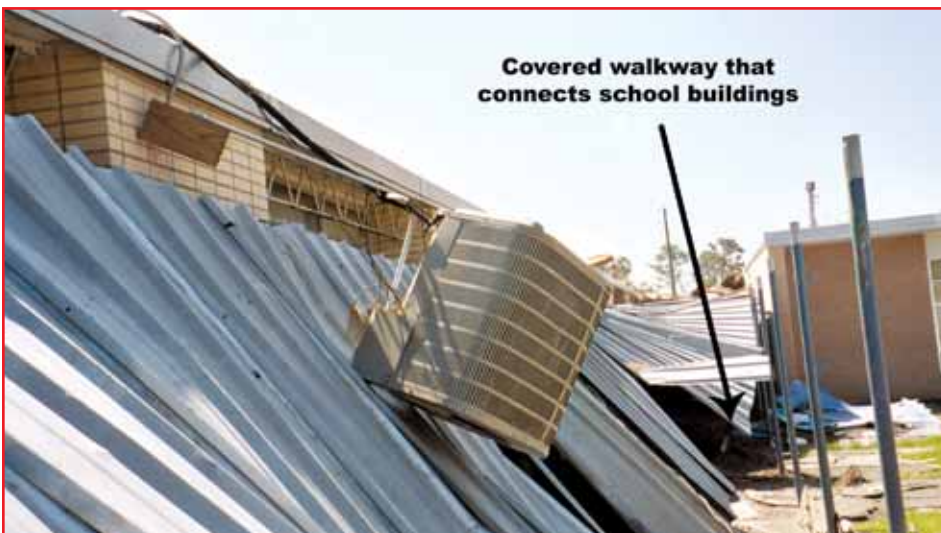
A roof-mounted air conditioning system landed on a covered walkway (*Photo 9*). Developing and following a prescribed method to secure such units to the roof could reduce damage from this equipment during high winds. The inside of the building and its contents were destroyed.

Photo 9 – A roof-mounted air conditioning system landed on a covered walkway.
