# ENEMIES OF THE ROOF

BY JOHN W. WELLS, RRO

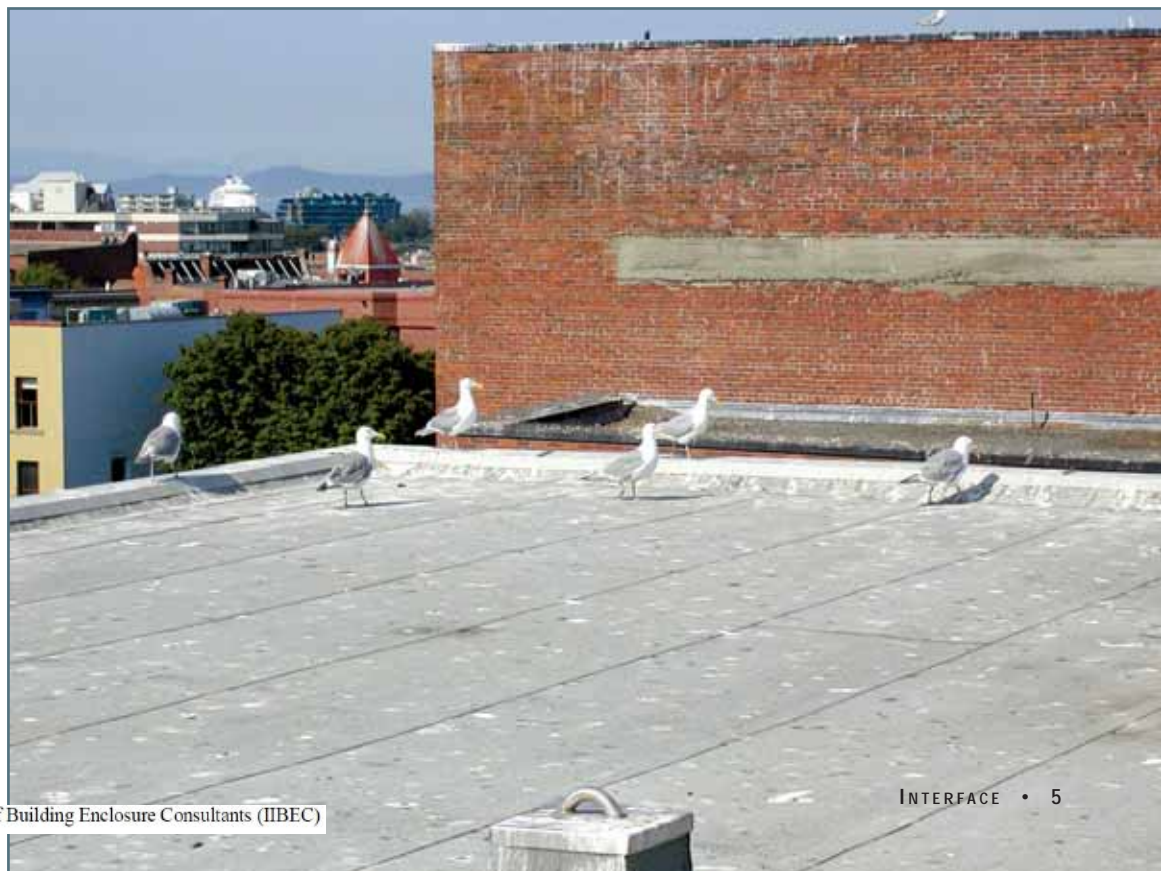
*Photo 1 – Gulls are sociable birds.*

*They like to roost on a place higher than their nests, where they can see the nesting area. In this case, the area is below and to the right on a nearby building. Unfortunately, this “sociability” includes another function.*

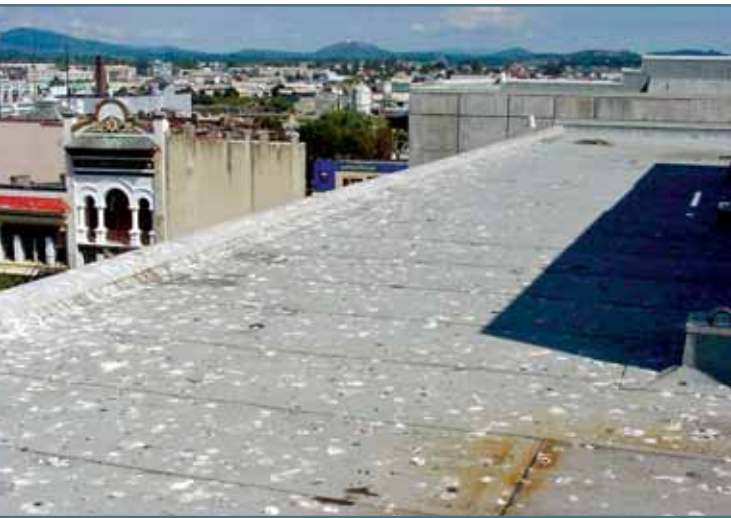
in certain locales and conditions, revealed a unique limitation with these materials. Concentrations of bird droppings can contribute to the rapid removal of the granule cover. The surface granules on the top ply or cap sheet supply the UV resistance to the membrane assembly and are a critical item in the long-term performance and life expectancy of the roof membrane assembly. Degradation caused by bird droppings can expose the asphalt beneath to localized UV deterioration (see *Photo 2*).

*Photo 2 – The amount of fecal matter and damage discovered on the first site visit was quite astonishing... and the smell wasn't great either!*

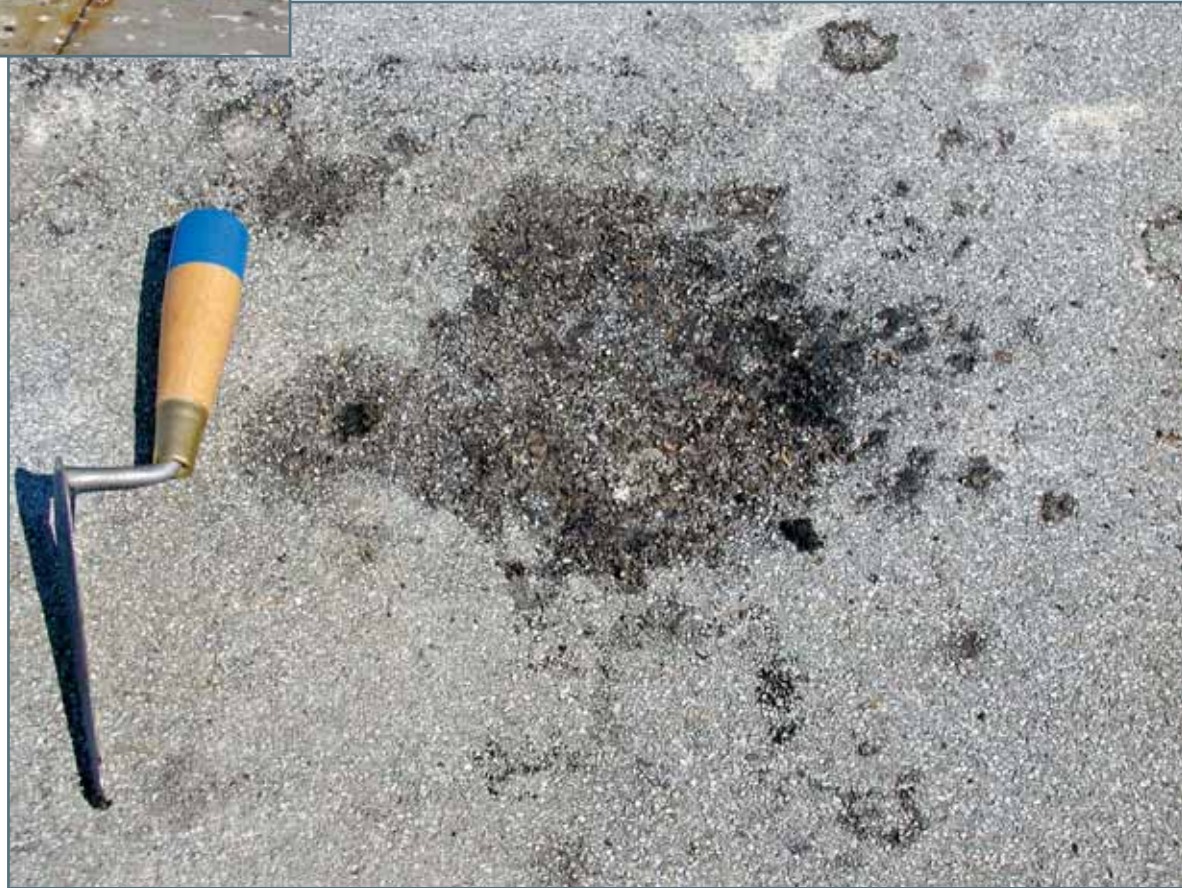
*Photo 3 – This picture demonstrates damage to the membrane that almost reaches the reinforcing mat. Granular degradation is devastating; the asphalt blend is softened and contaminated.*

In many spots, the effects of the droppings had actually not only removed granules, but softened or affected the top portion of the asphalt membrane proper, similar to hydrocarbon or oil contamination. In limited locations, membrane reinforcing had been exposed, indicating the erosion (removal) of granules and perhaps 1.5mm of asphalt sheet! (See Photo 3.)

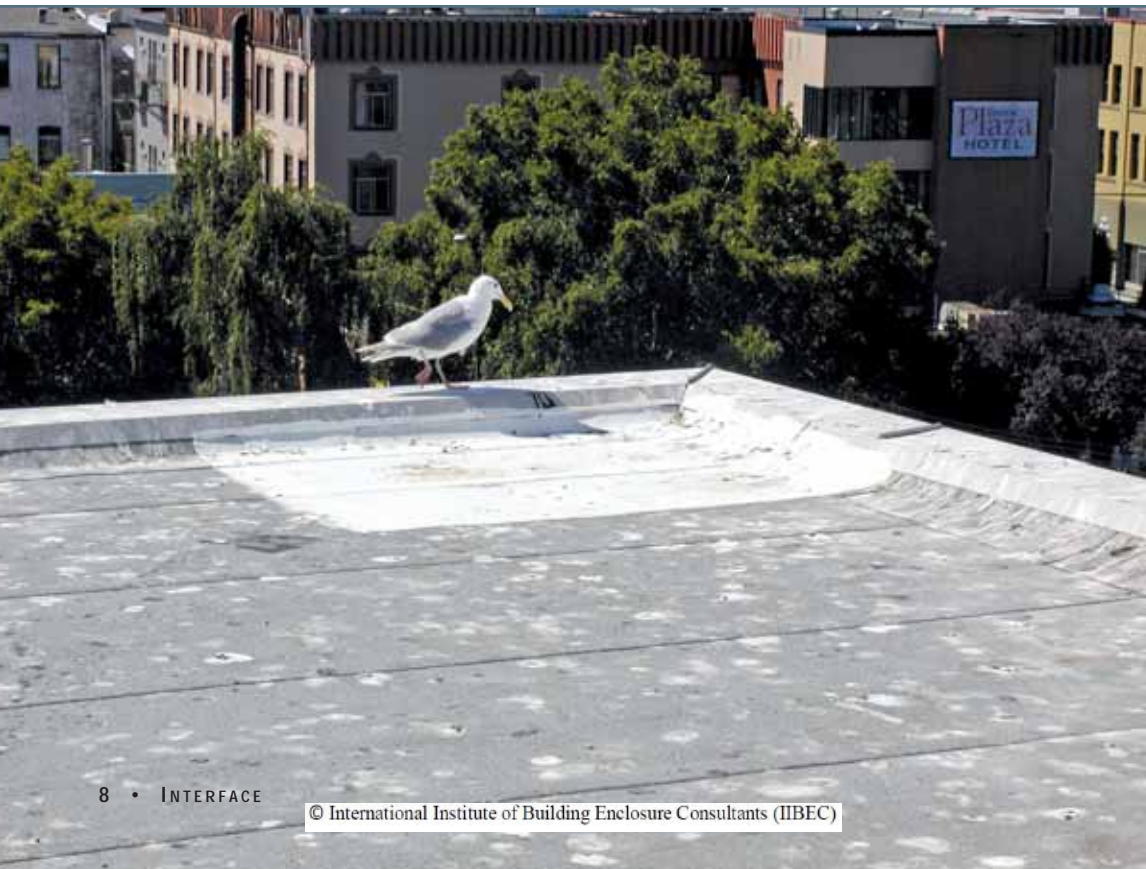
*Photo 5 – One of the attempts to “fix” the problem was an elastomeric coating. As demonstrated, the birds loved it. This particular coating proved ineffective.*

Membrane repairs on this building will be extensive and expensive in order to restore the roof to any semblance of its normal life expectancy. Specialized elastomeric coatings (see *Photo 5*), methacrylate coatings, an additional layer of cap sheet, or even the addition of a hot asphalt pour coat and gravel surfacing are plausible considerations.

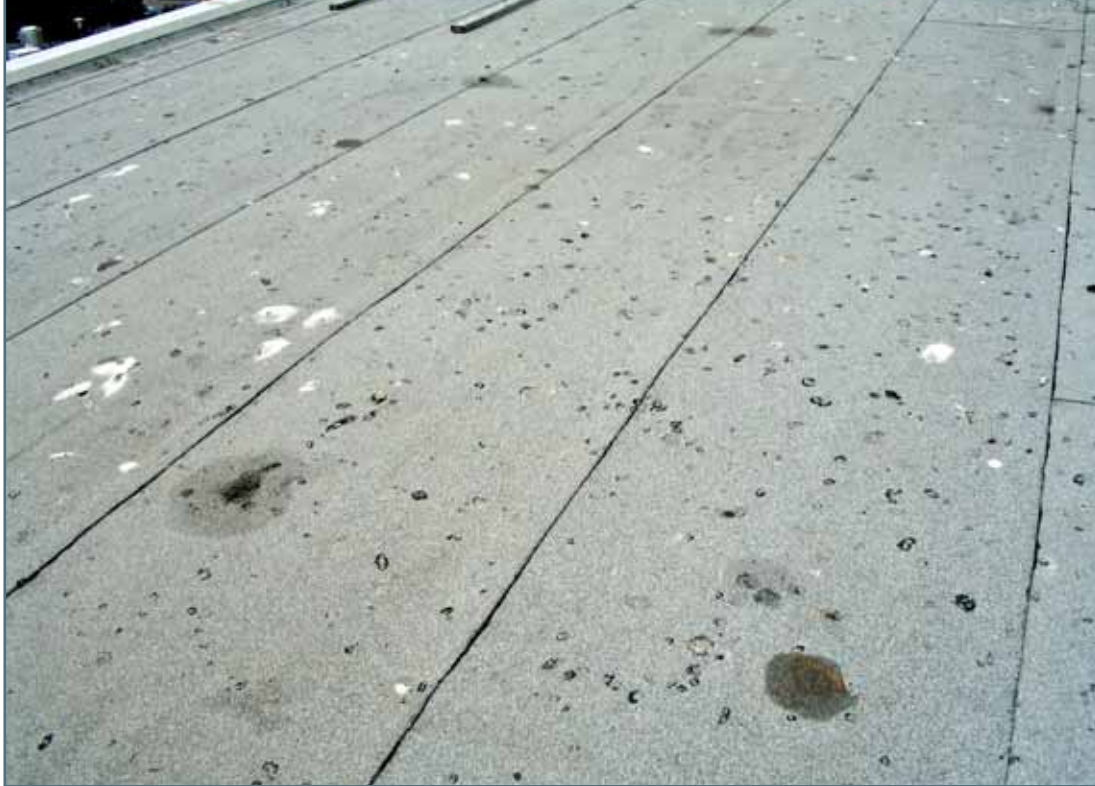
*Photo 6 – This photo was taken after the roof had been well washed by rain. The small, round marks are typical of granule loss damage to modified bitumen membrane caused by gull droppings. The larger, “splotchy” marks exhibit damage to the actual membrane, down to the reinforcing, in some locations. Some of what these birds eat and defecate dissolves or softens asphalt!*

order to keep the build-up of fecal matter to a minimum. Even if the coating protects the membrane as envisioned, the bird droppings will still have to be eliminated if further build-ups occur. Extreme care must be taken not to remove protective granules

unless another protective measure is identified (see *Photo 6*).
