LIGHTNING STRIKE ANOMALY

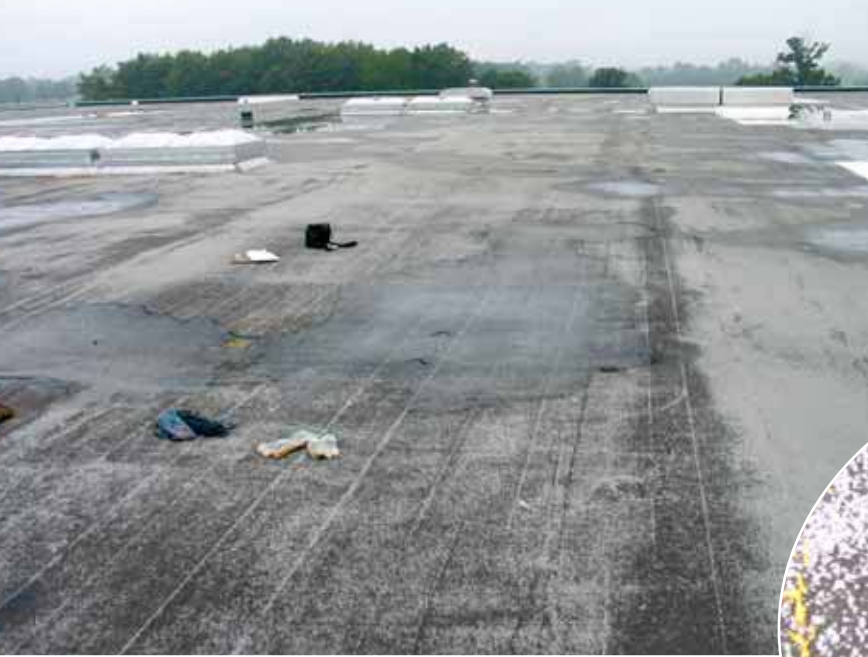
The open area where the lightning struck in several spots.

The adjacent photos are of anomalies of what this writer concluded were the results of a lightning strike found on a 300,000-sq-ft facility our firm had been working on for several years. Last summer during a thunderstorm, the night shift at the facility reported massive leaks in a warehouse area that had never leaked before. The next morning we carefully measured the location inside, then accessed the roof and found the defects (shown here) in an open area at considerable distance from the nearest mechanical equipment.

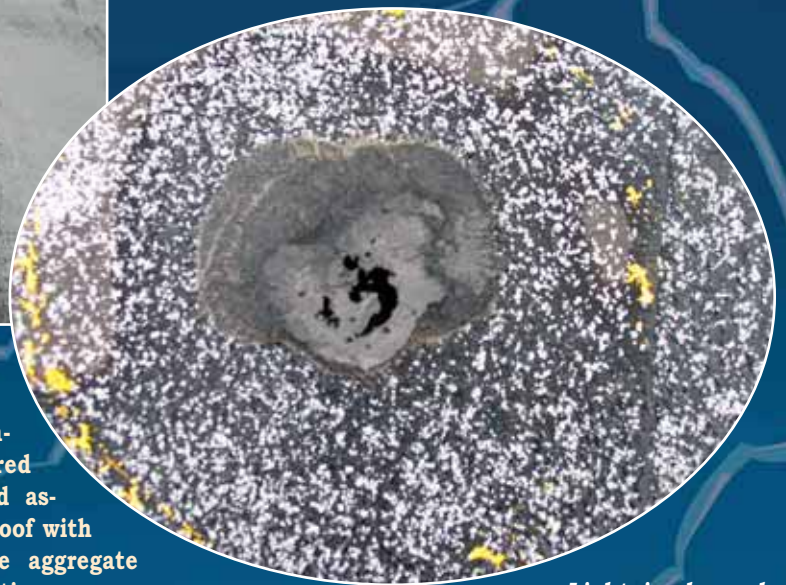
The lightning appeared to have hit the roof directly over one of the split-leg fasteners and then traveled horizontally

Lightning burned through the asphalt membrane.

in several directions under the membrane. In a couple of places, it caused the roof membrane to be torn apart from within as if there was an explosion in the roof assembly, leaving torn tabs sticking up. We suspect that there may have been some moisture entrapped in these areas that expanded rapidly when energized by the lightning.

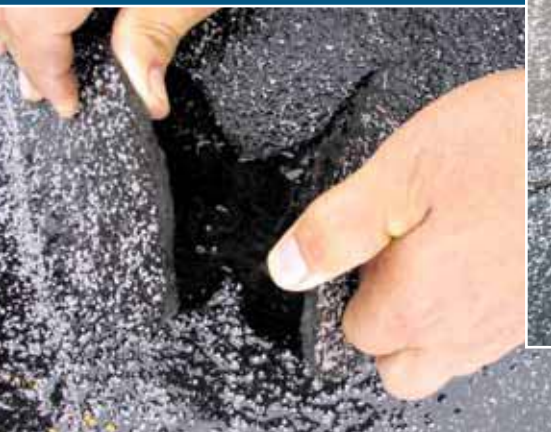
A metal fastener in the gypsum deck where the lightning hit.
