# Case Study: Common Design and Workmanship Issues Related to Brick Veneer Masonry of a Modern Mid-rise Building

Warren R. French, PE, RRC, RWC, FRCI, CMRS  
*French Engineering, Inc.*  
Houston, Texas

This paper will present the findings of a forensic investigation conducted on a 12-story, multi-family residential building recently constructed in New Orleans, Louisiana. We were retained by the owner's representatives to assist in determining a cause for the interior water infiltration being experienced, as well as to develop a plan for cladding system remediation and renovation.

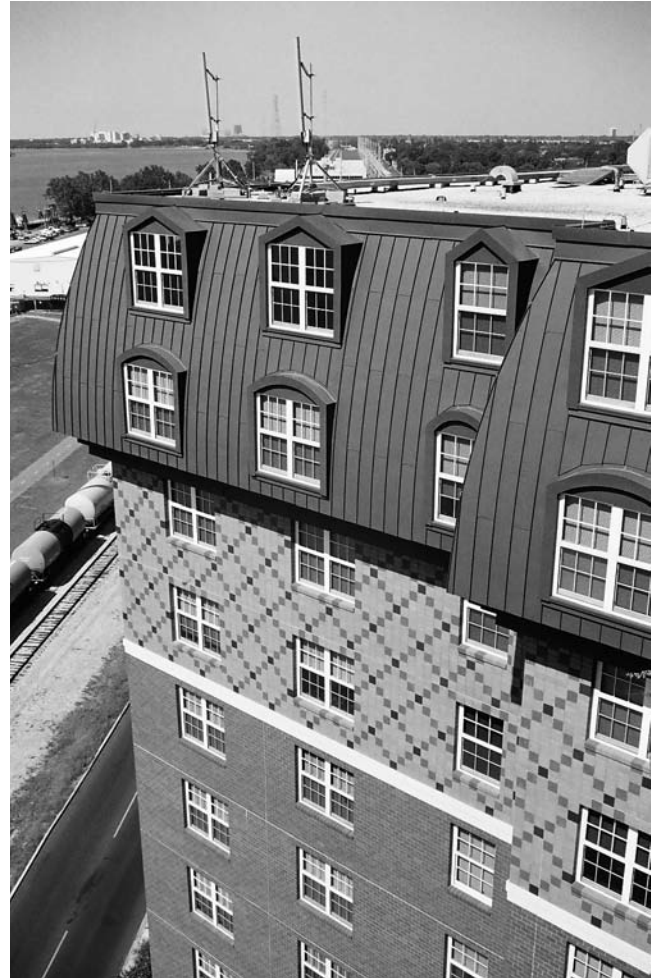
**Figure 1 – Typical elevation showing intricate masonry.**

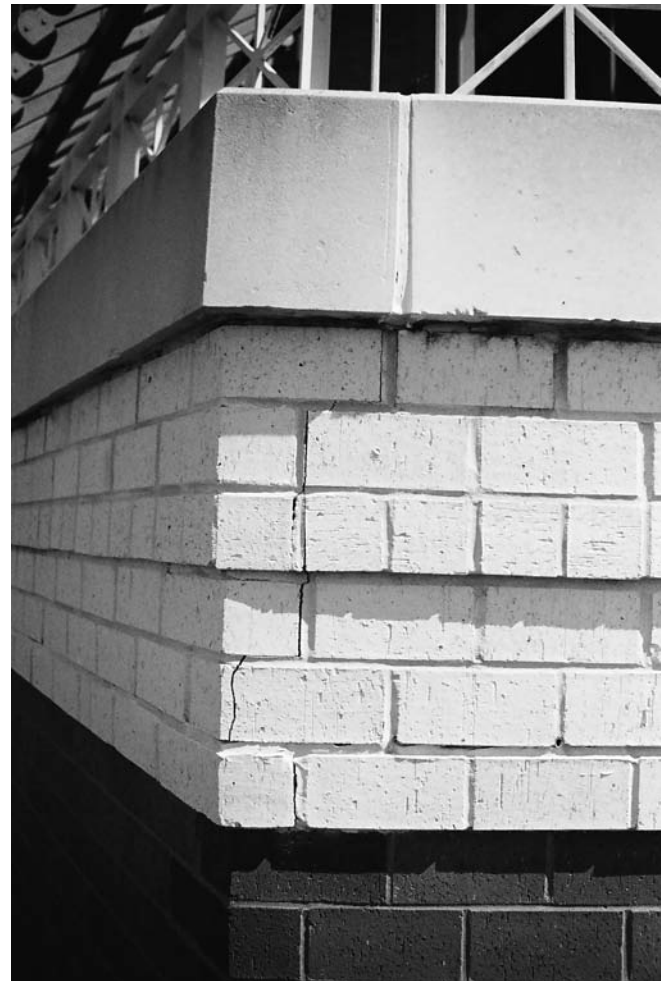
**Figure 2 – Cracks in brick veneer at corner.**

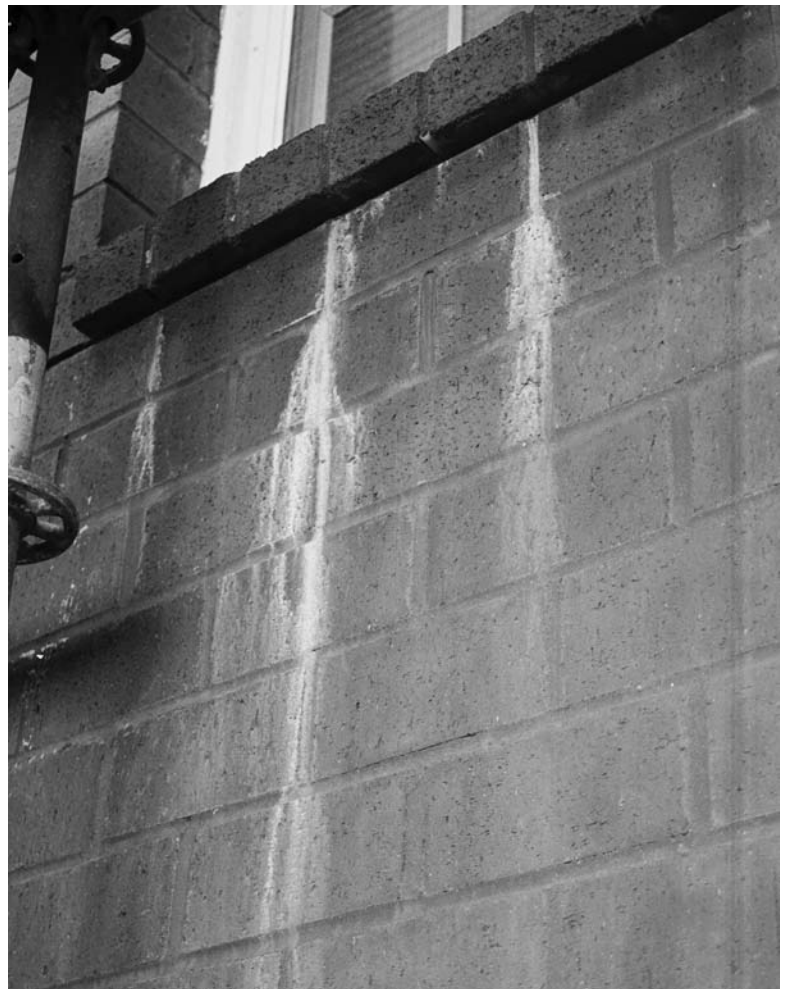
Our firm observed widespread efflorescence stains on the face of masonry units throughout each elevation of the building. Efflorescence is normally attributed to faulty design and construction practices. In addition, our firm observed that the horizontal joints in the masonry at the steel shelf angles were approximately 3/8-in wide and there is no space between the shelf angle and the masonry veneer occurring below. This orientation does not allow an effective means for accommodating vertical movement due to thermal expansion within the cladding assembly or due to deflections and racking of the structure. The horizontal masonry joint at the steel shelf angle was completely filled in with sealant and the through-wall flashing was not visible. Above this masonry joint were hollow plastic tubes for weeps. However, at several locations, the weeps were spaced greater than 16 inches on center. Since the membrane stops short of the exterior plane of the wall, since the horizontal joints were filled with

**Figure 4 – Efflorescence and water stains below brick sill.**

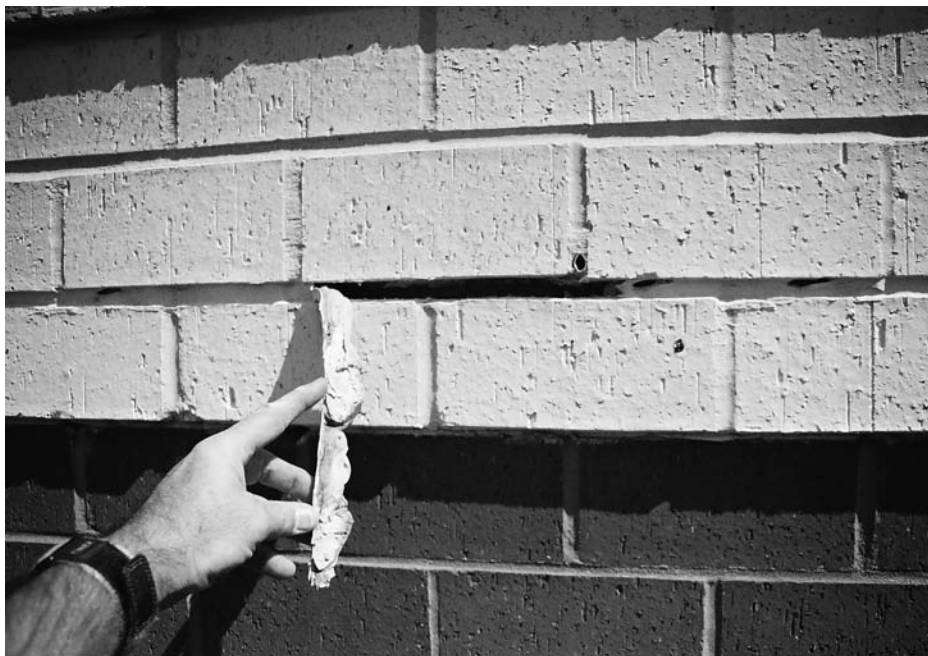
**Figure 5 – Sealant installed with no backer rod.**

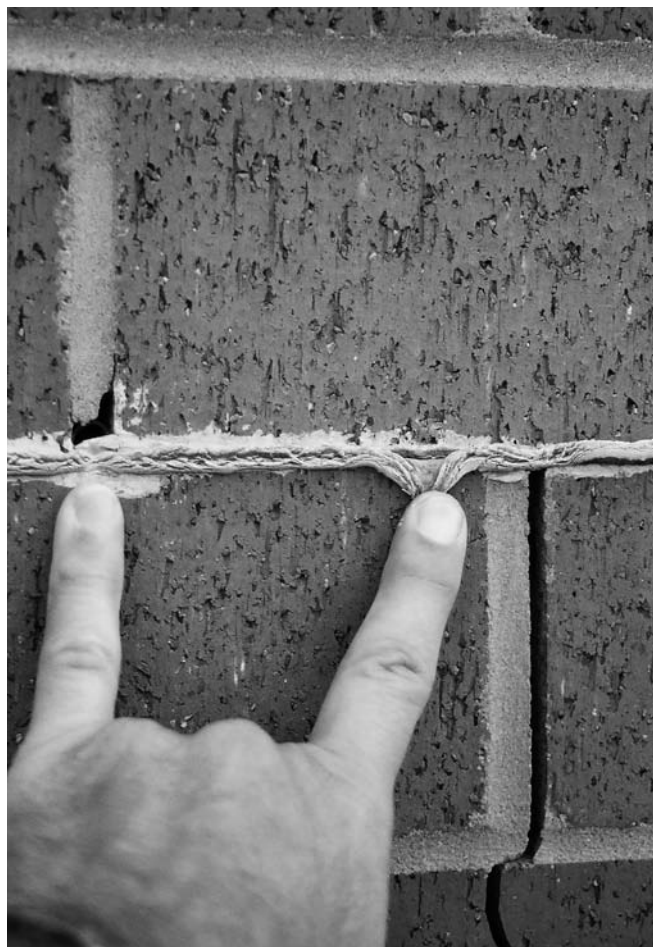
**Figure 6 – Sealants failing in compression: masonry cracks.**

stack bond were repaired with sealants due to an opening in the mortar joint. Additional stress cracks, similarly repaired with sealant, were also observed at the south end of the east elevation, on lower floors where the brick is in a running bond. This cracking and displacement is normally caused by excessive compressive loads being imposed on individual brick masonry units without adequate joint relief below the shelf angle or due to the lack of a shelf angle.

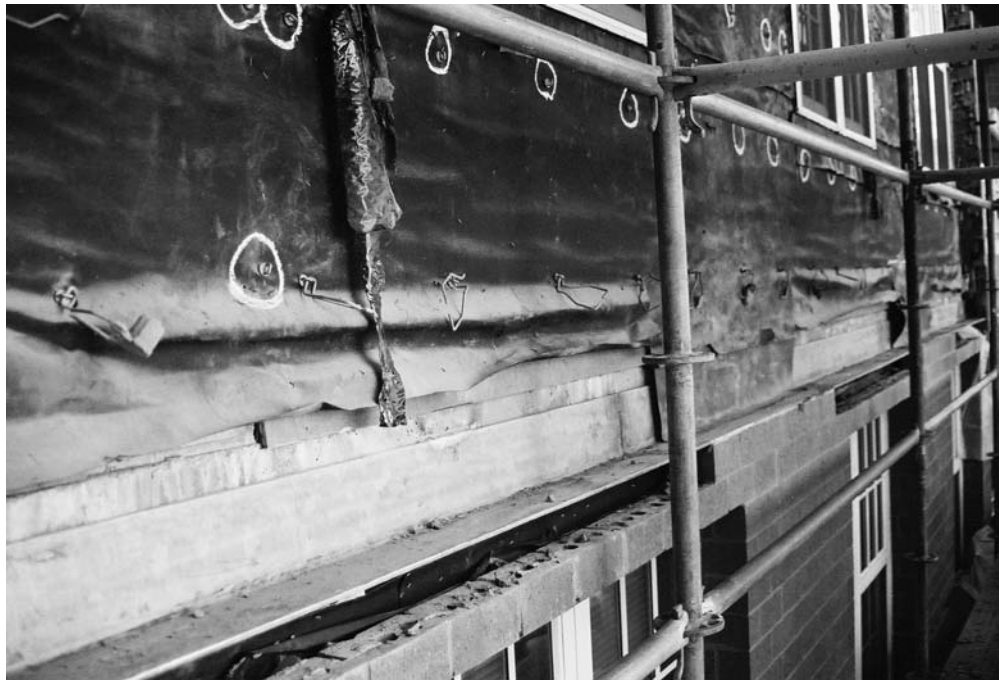
**Figure 8 – Weather-resistive barrier not integrated with shelf angle; missing wall ties.**

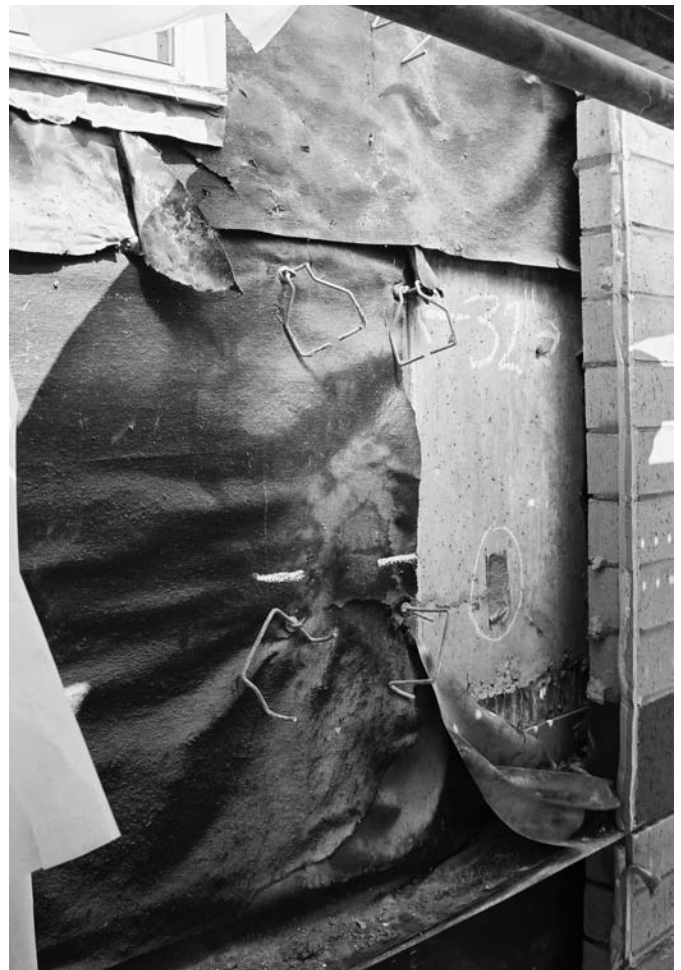
er barrier was generally poorly installed at the termination of the stud wall. We observed terminations of the weather barrier at these locations that were unsealed and were typically discontinuous across the concrete or CMU portion of the wall, leaving exposed cut edges of the sheathing without any protection against water absorption from the brick cavity.

**Figure 9 – Weather-resistive barrier stops short of column; not sealed at terminations.**

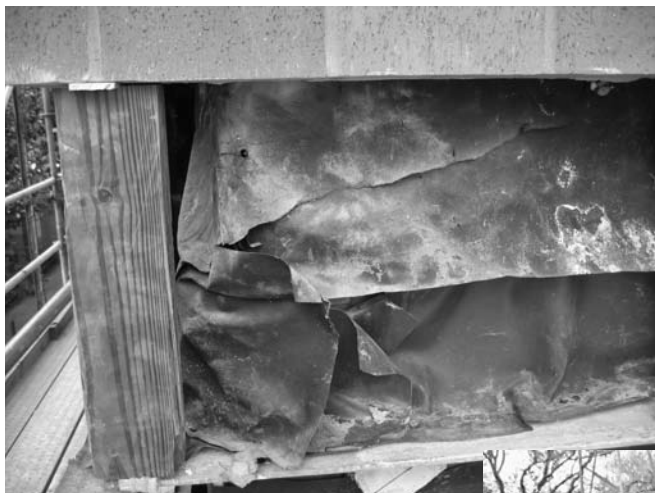
**Figure 10 – Improper weather-resistant barrier at corner.**

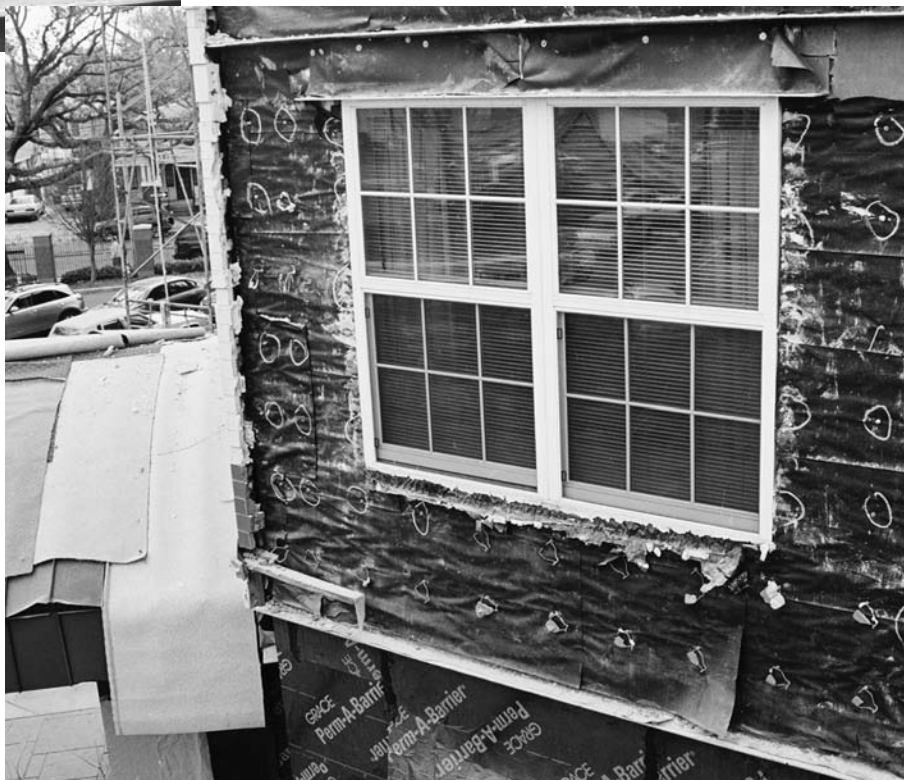
During the renovation demolition, we observed widespread periodic omission of specified wall ties or improper installation of wall ties. In certain locations, the original installation exhibits one or two missing wall ties of the six to eight anchor locations visible, while at other locations, the installation exhibits six missing wall ties of the 12 anchor locations visible. Accordingly, lateral support of the brick veneer in at least some wall areas is completely absent, and in other wall areas is questionable.

**Figure 11 – Missing wall ties at one section of wall.**

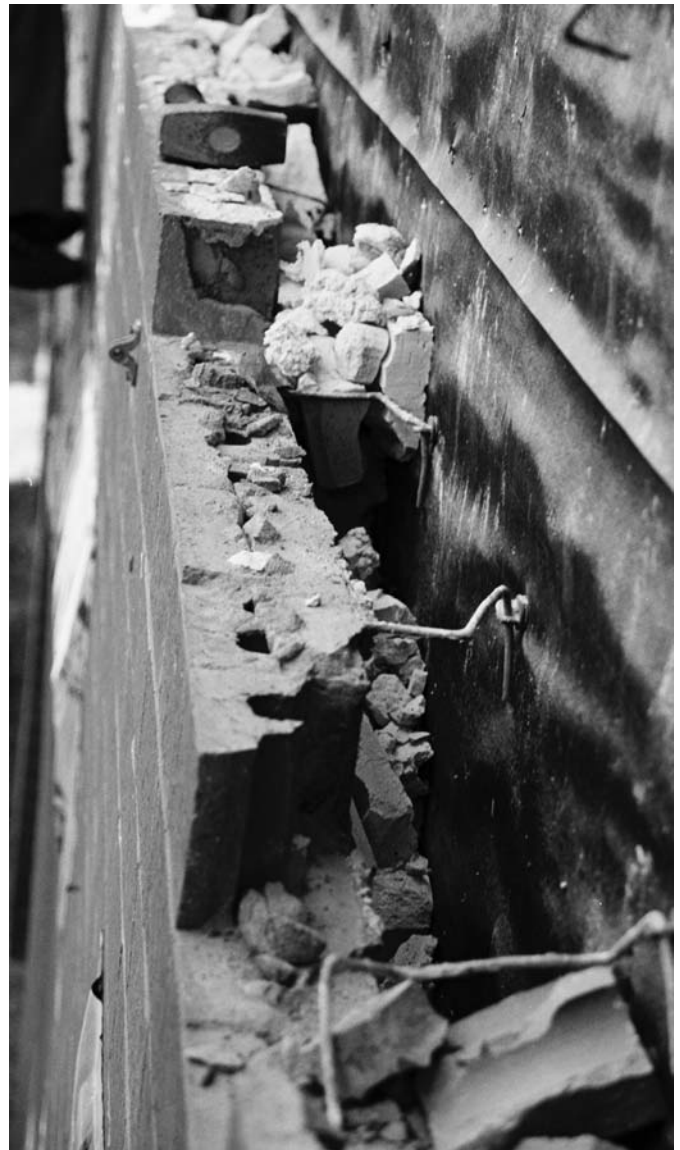
The most frequently observed improper tie/anchor assembly installed was a particular type of adjustable tie installed into a self-drilling screw anchor base (incompatible mating pieces). The adjustable wall tie product specified for use is designed for CMU or double-wythe masonry applications and utilizes a dual eyehook anchor to secure the tie. In most of the improperly installed locations, a single prong of the tie was inserted into the two-eyed anchor base, which does not provide adequate lateral support for the masonry.

**Figure 12 (above) – Wall ties improperly installed with one leg engaged.**

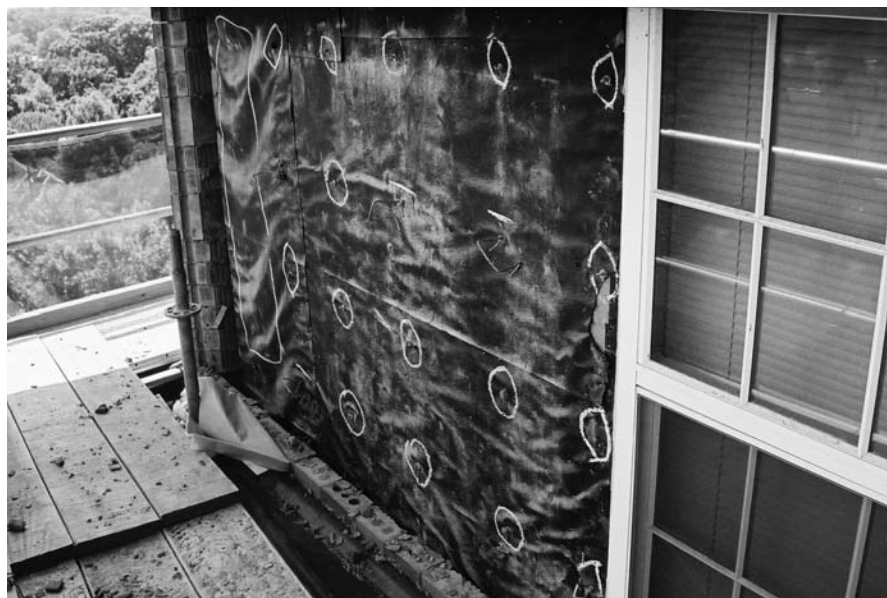
**Figure 13 – Missing wall ties at one section of wall.**

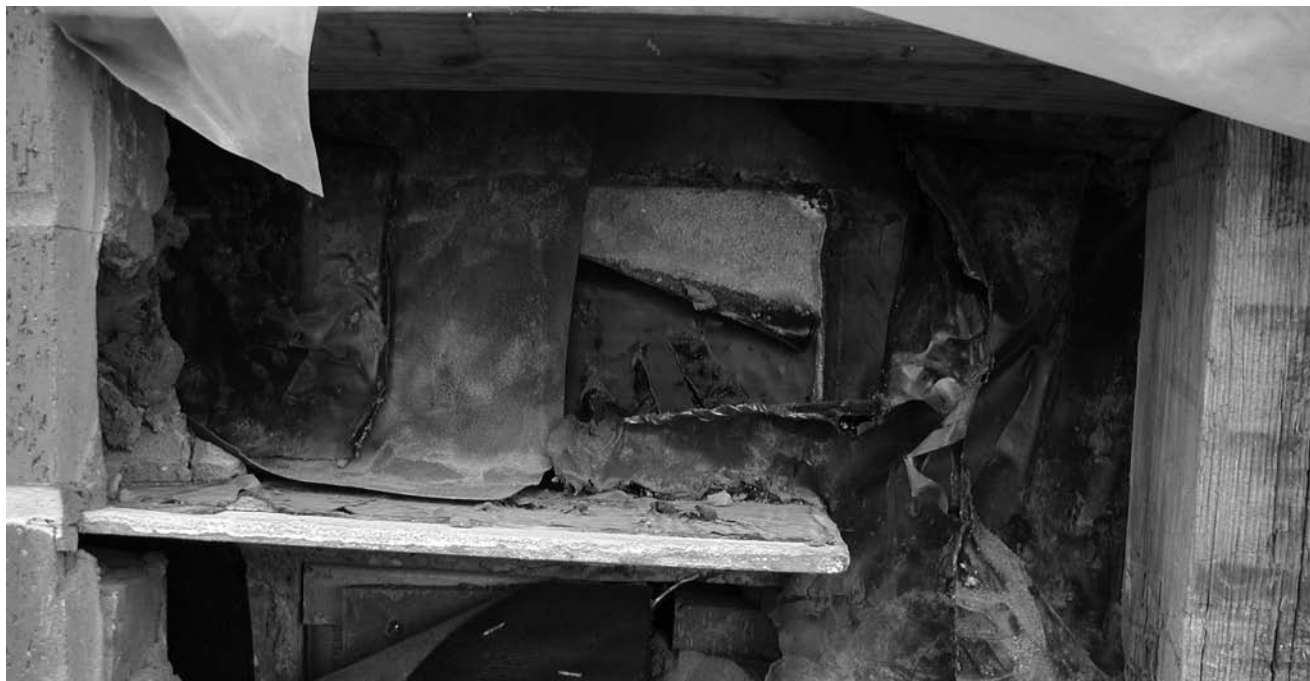
**Figure 15 – Shelf angle offset in elevation; no end dam at membrane flashing.**

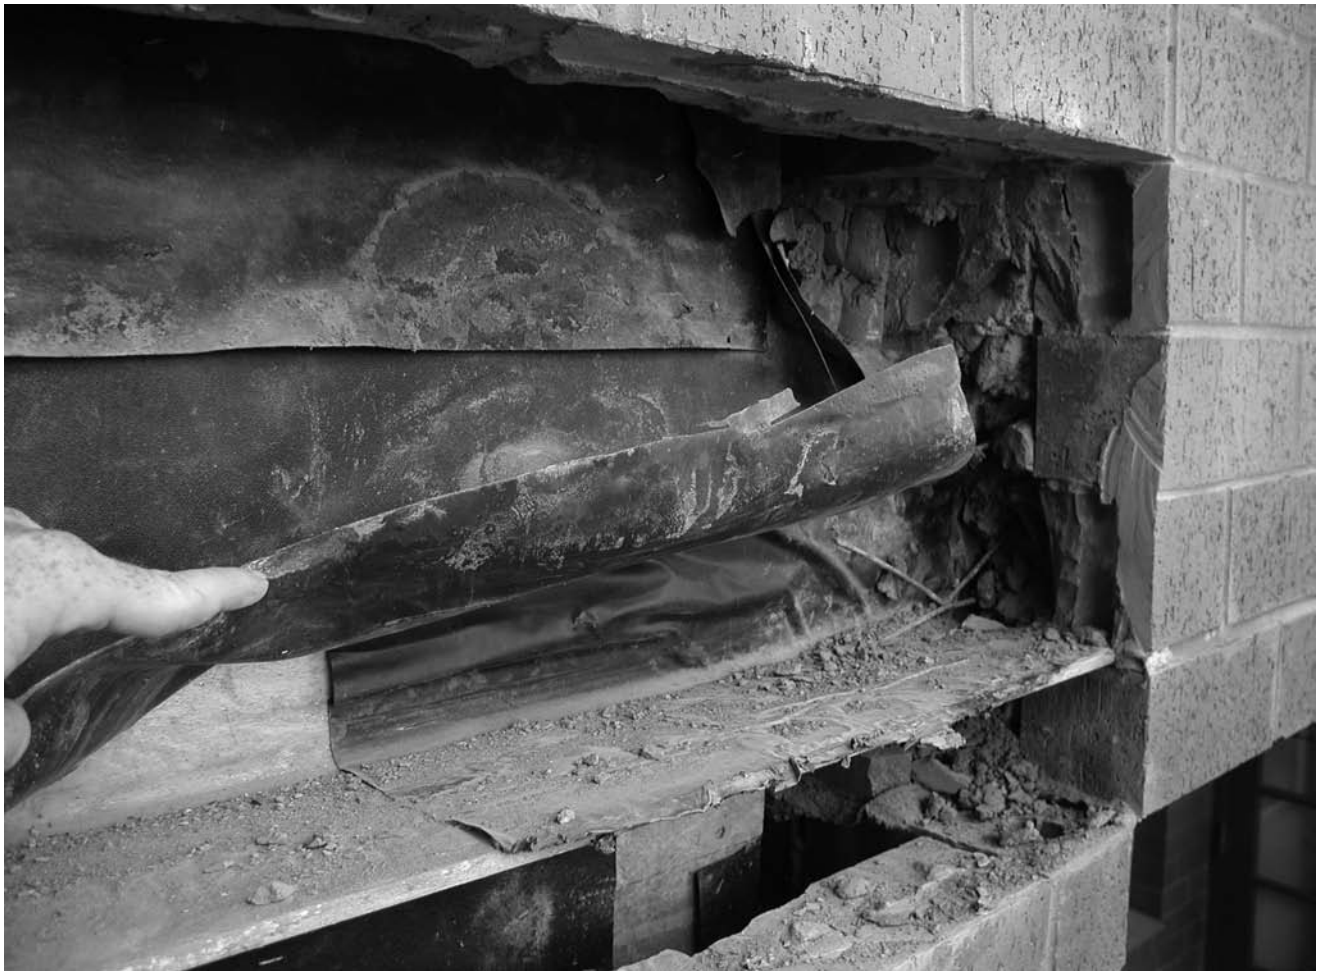
Selective demolition at the second floor terrace along the west elevation revealed that the PVC through-wall flashing material was dry set onto the steel shelf angle, the lap joints were not sealed with mastic, and the flashing did not extend to the outer plane of the brick veneer. In addition, the through-wall flashing was not integrated with the waterproofing membrane installed at the juncture between the concrete curb and the terrace deck. Mortar droppings were also measured to be eight inches high and plugging the plastic weeps.

**Figure 16 – PVC flashing lap set “dry.”**

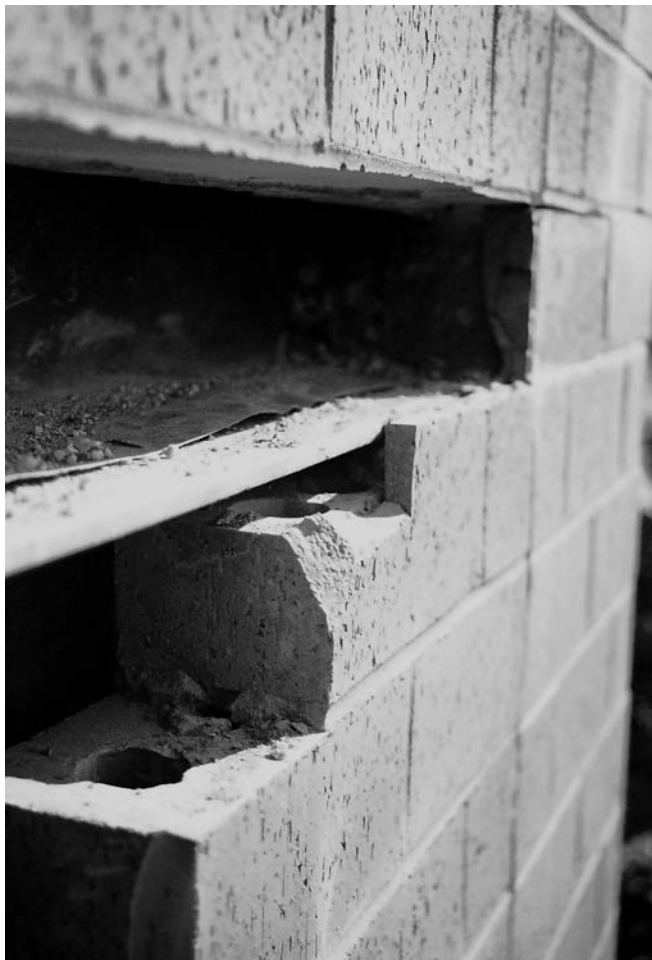
At a few areas, we observed that coursing of the brick veneer was not properly coordinated with installation of the steel shelf angle such that, rather than properly installing these cladding components, the masonry subcontractor simply saw-cut the back of each brick to allow the toe of the shelf angle to be let-in to the back of the veneer. However, since the shelf angle did not support the brick and there were hard mortar joints above and below this brick course, there was no proper relief of the brick expansion and contraction at these shelf angle locations.

**Figure 17 – Coordination error in shelf angle placement; back of brick saw-cut.**

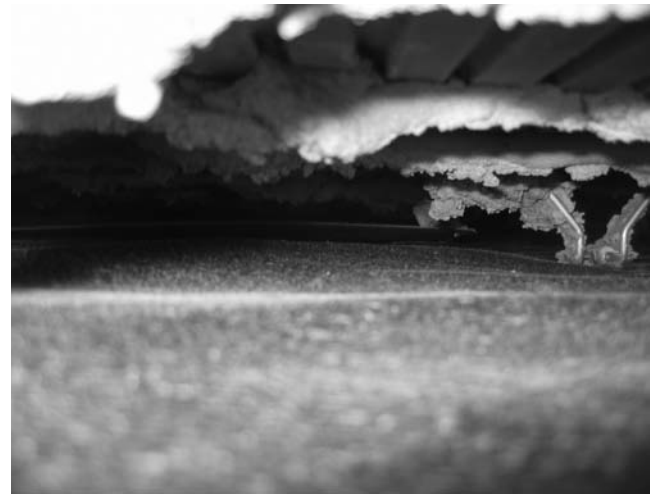
**Figure 19 – Mortar bridging at wall tie.**

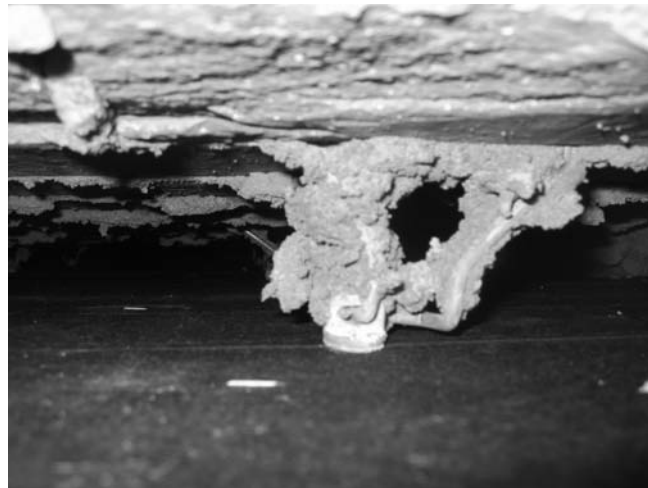
**Figure 20 – Mortar bridging at wall tie.**

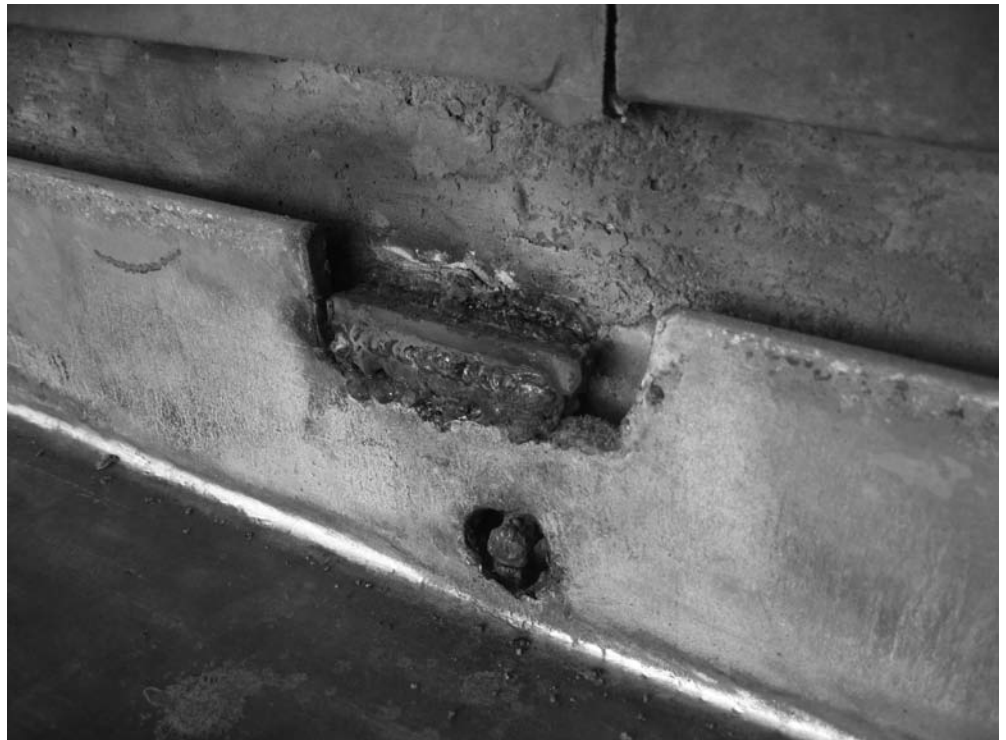
Our firm has observed numerous anomalies associated with the attachment and orientation of the steel shelf angles as originally installed at this project. The welding of the shelf angles was in poor condition considering the age of the building. A number of broken welds have been observed, as well as severely corroded welds and welds that projected more than one-half inch away from the slab.

**Figure 22 – Improper weld between shelf angle and embed.**
