# THE DAY AFTER:

## Documentation of Damage to Roofs from a Hailstorm and the Subsequent Restoration Efforts

By Karl A. Schaack, RRC, PE

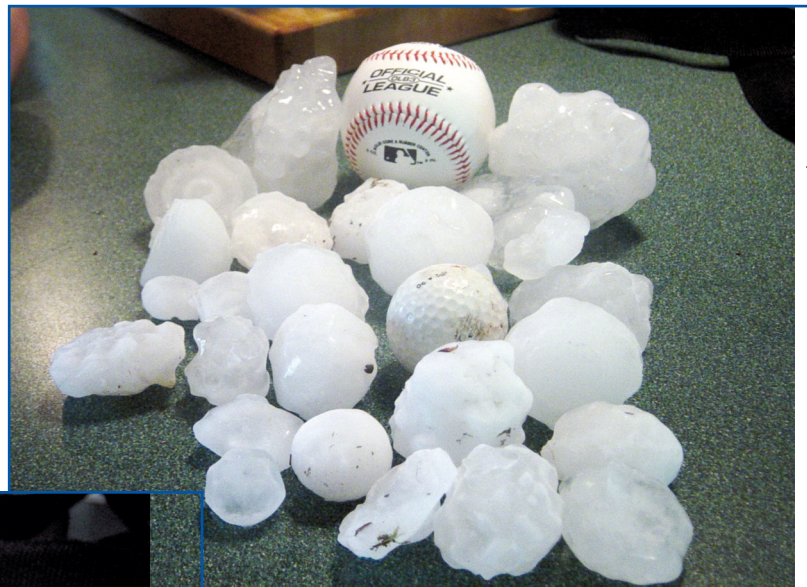
*Photo 2 – Hailstones collected by homeowner on May 4, 2006<sup>(4)</sup>.*

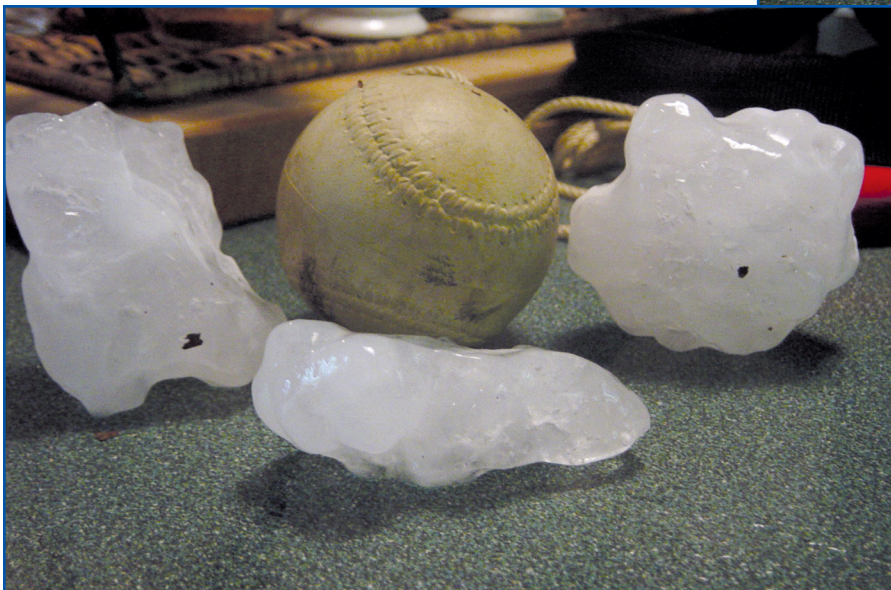
*Photo 1 – Hailstones collected by homeowner on May 4, 2006<sup>(4)</sup>.*

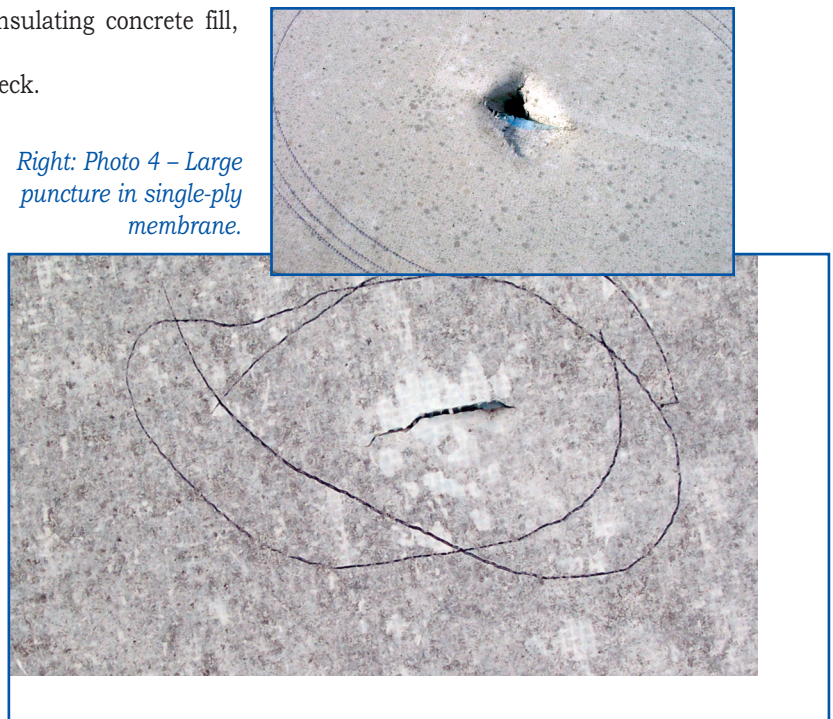
Right: Photo 4 – Large puncture in single-ply membrane.

Photo 3 – Large puncture in single-ply membrane.

3 and 4). This level of damage was widespread but sporadic, with no uniformity across the roofs. These punctures were found in approximately one to four locations within a 100-sq-ft area.

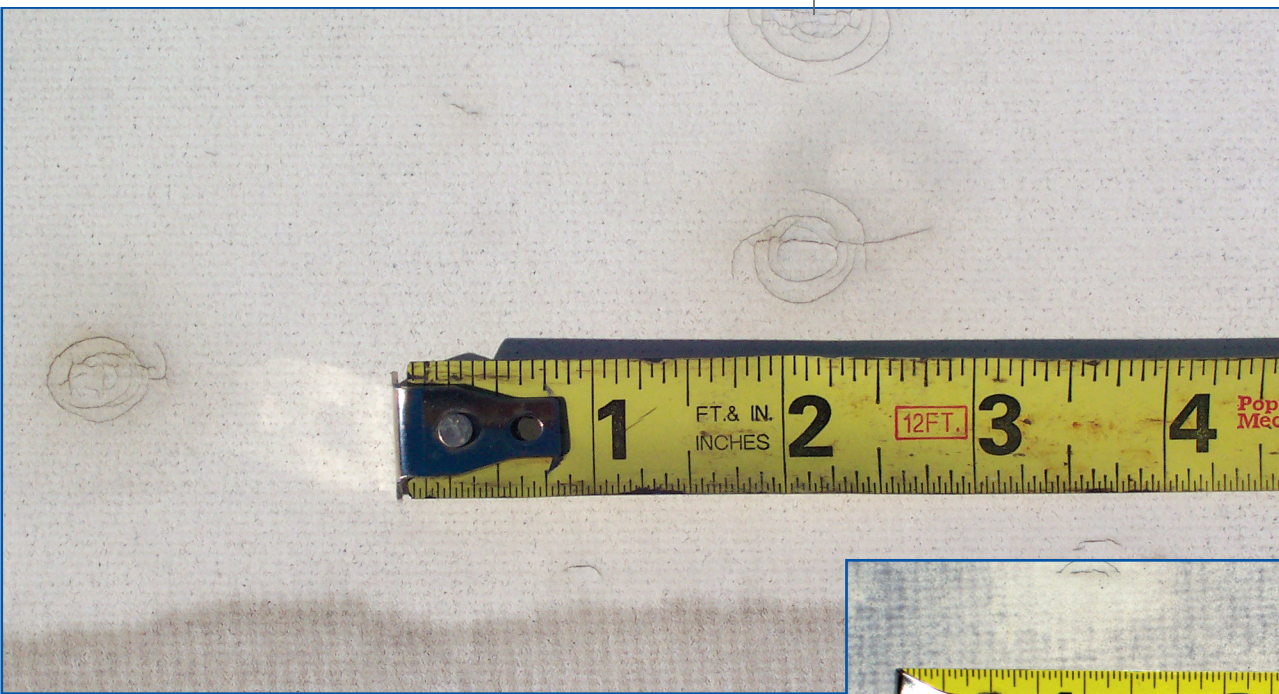
Photo 5 – Spiral fractures in single-ply membrane.

The more prominent damage that was observed on thermoplastic single-ply membranes consisted of numerous cylindrical or spiral-shaped fractures in the membrane (Photos 5 and 6). Other, less obvious damage consisted of small linear cracks in the membrane. This type of damage was consistent on the various types of PVC single-ply membranes that were installed over rigid insulation. (Note: Separator sheets were installed between the PVC membranes and EPS.) The single-ply membranes that appeared to perform better were installed directly over plywood sheathing. Cylindrical fractures were not as widespread and numerous on the CSPE and CPE sheets, even though these membranes may have been older than other PVC membranes.

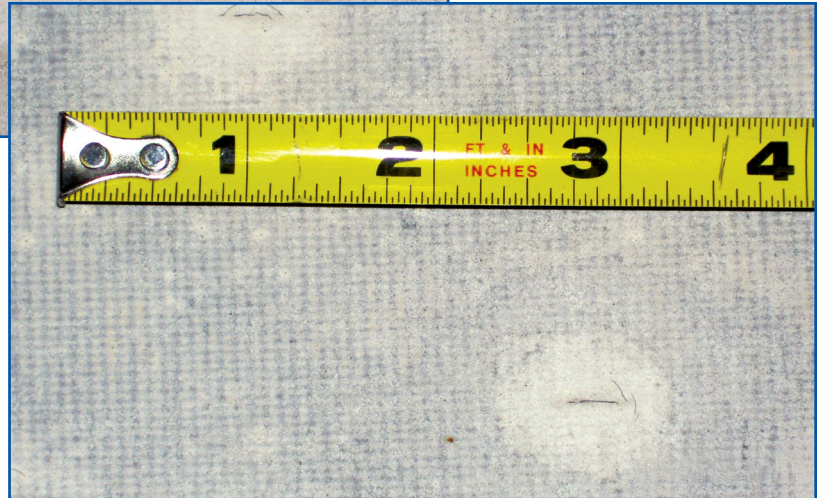
Below: Photo 6: – Spiral and linear fractures in single-ply membrane.

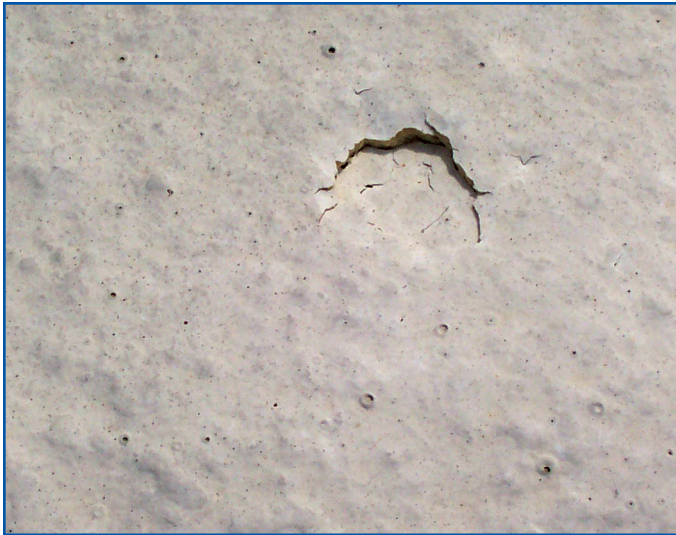
Similar damage was also observed on the spray-applied polyurethane foam roofs on the high school. This damage ranged from spiral-shaped cracks in the elastomeric coating to punctures through the coating, exposing the underlying foam core (Photos 7 and 8). The foam was more readily damaged in areas containing blisters. However, physical damage was also observed where the foam was sound and intact.

Photo 7 – Hail impact on SPUF.

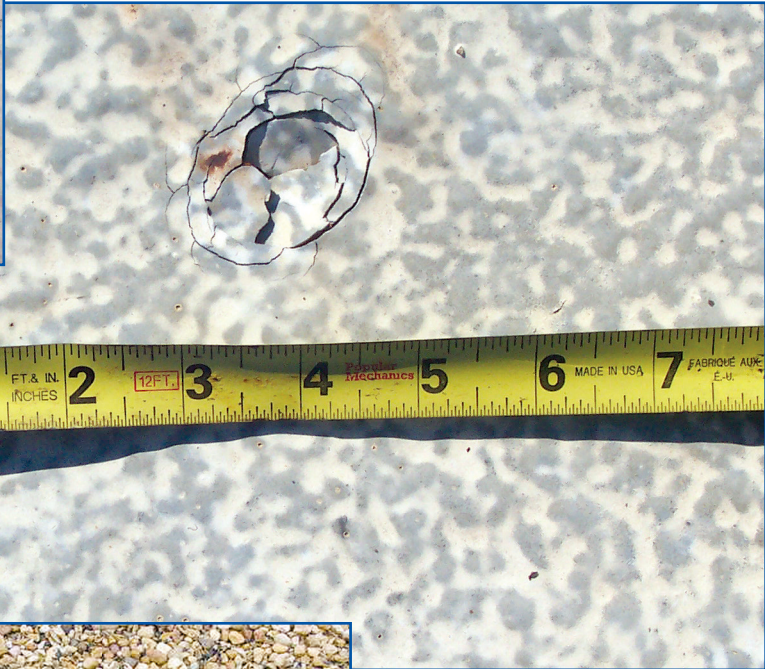
Photo 8 – Hail impact on SPUF.

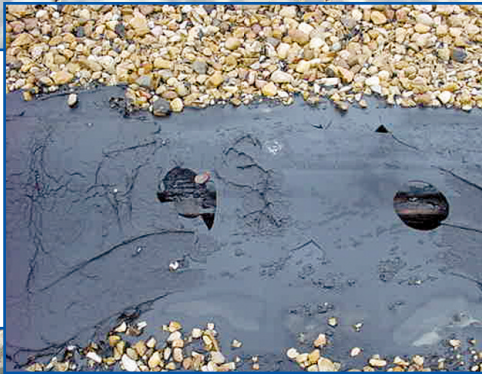
There was no obvious evidence of any physical damage on the gravel-surfaced, built-up roof membrane. Physical damage did occur to an elastomeric bellows expansion joint cover. Many large punctures (approximately 2 inches in diameter) were observed throughout the length of the bel-

lows (Photo 9), which was somewhat brittle and weathered.

Photo 9 – Punctures in weathered expansion joint.

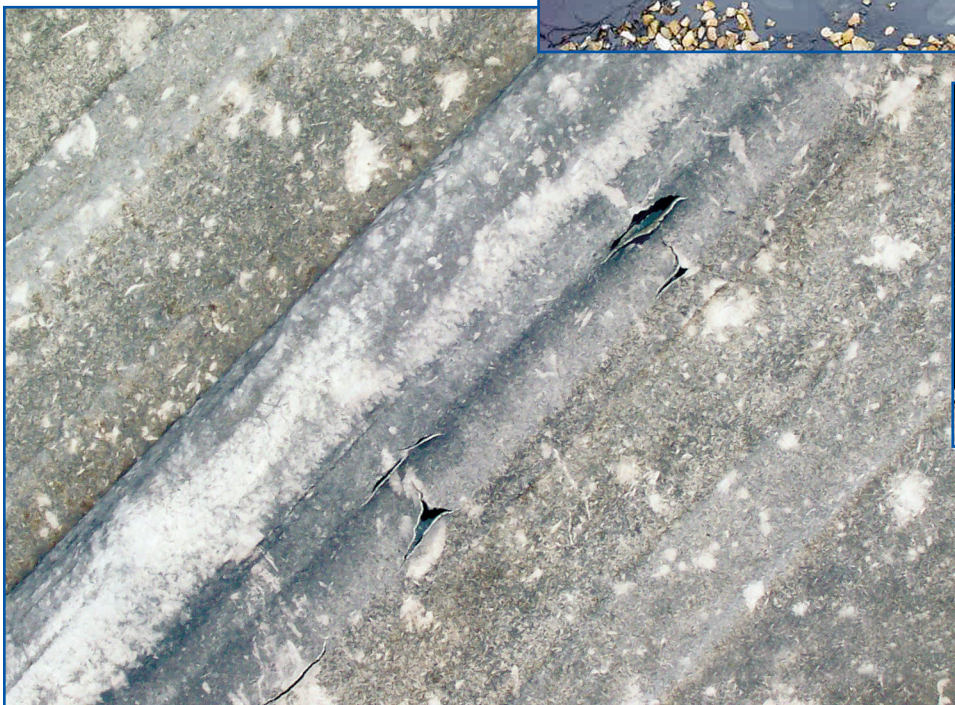
Observations of metal roofs indicated that damage was more cosmetic than damaging to the weatherproofing ability of the panel. Indentations were observed in prefinished metal panels, but the paint finish did not appear to have been affected. On the coated corrugated metal panels, chips were observed in the coating, which exposed the underlying metal core (Photo 10). Large indentations were observed in light-gauge corrugated metal panels that were installed over building entrances (Photo 11).

Photo 10 – Fractures in coating on metal roof.

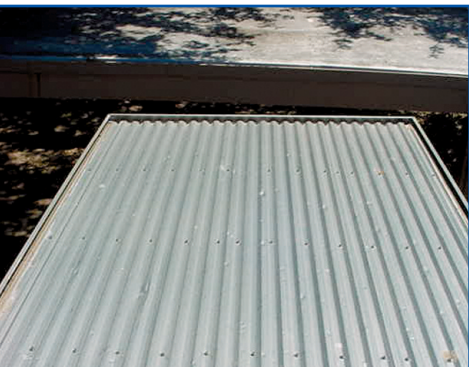
Photo 11 – Large dents in metal canopy.

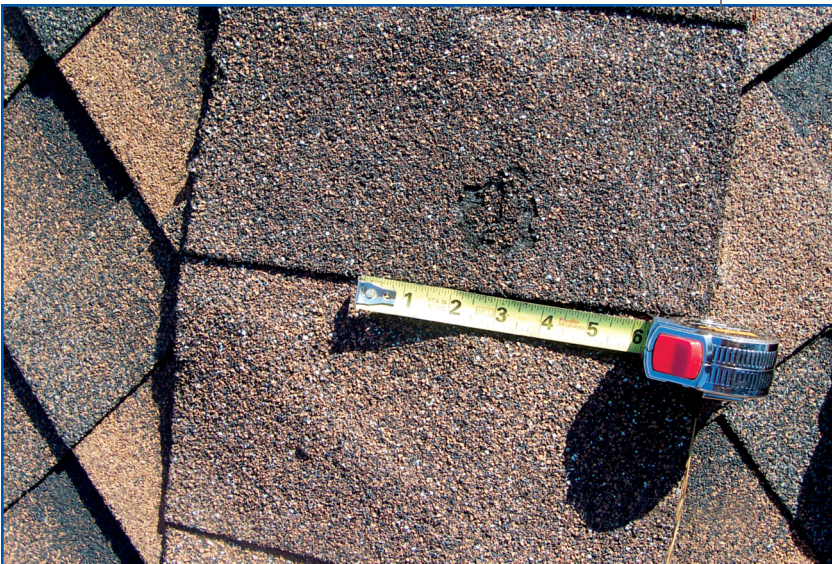
*Photo 13 – Damage to edges of ridge shingles.*

*Photo 12 – Large impact on ridge shingle.*

Damage observed on asphalt shingles varied from granule loss and breakage at unsupported ends and sides to large abrasions and indentations (*Photo 12*). Physical damage was more prevalent along the ridges (*Photo 13*).

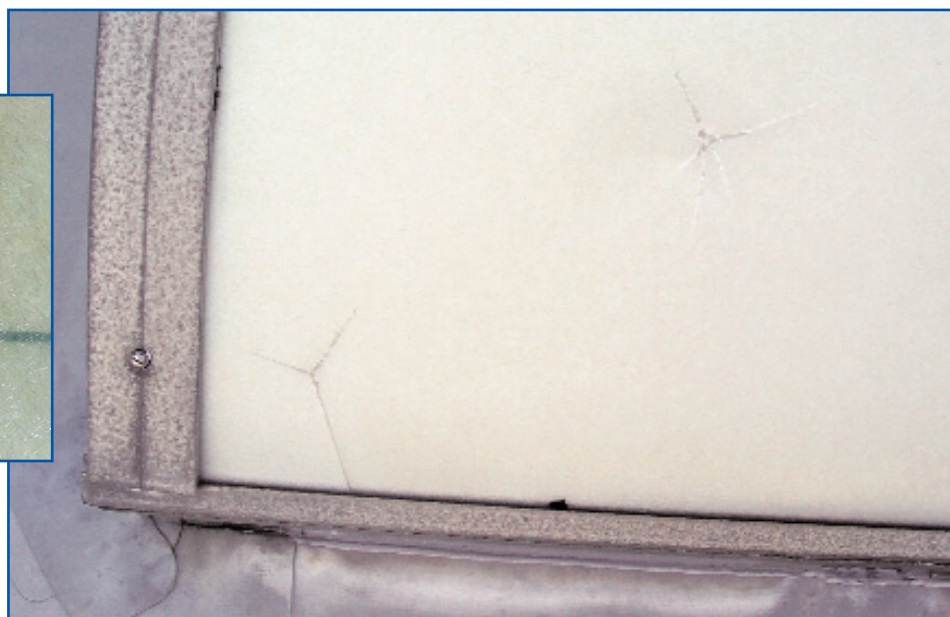
Damage to skylights included fracturing of glazing material (i.e., fiberglass and acrylic). See *Photos 14* and *15*. Large punctures and holes completely penetrated the glazing material (*Photos 16* and

*Photo 15 – Fracture in acrylic skylight.*

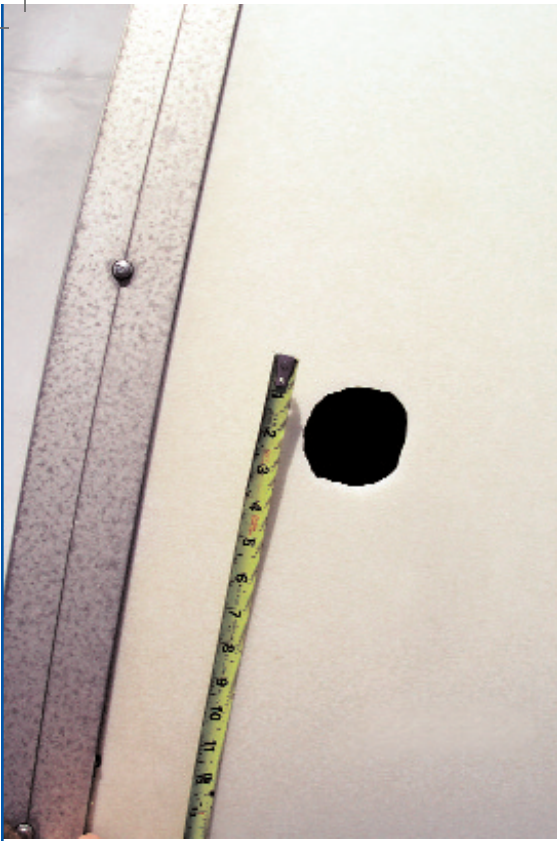
Photo 16 – Hole in barrel skylight.

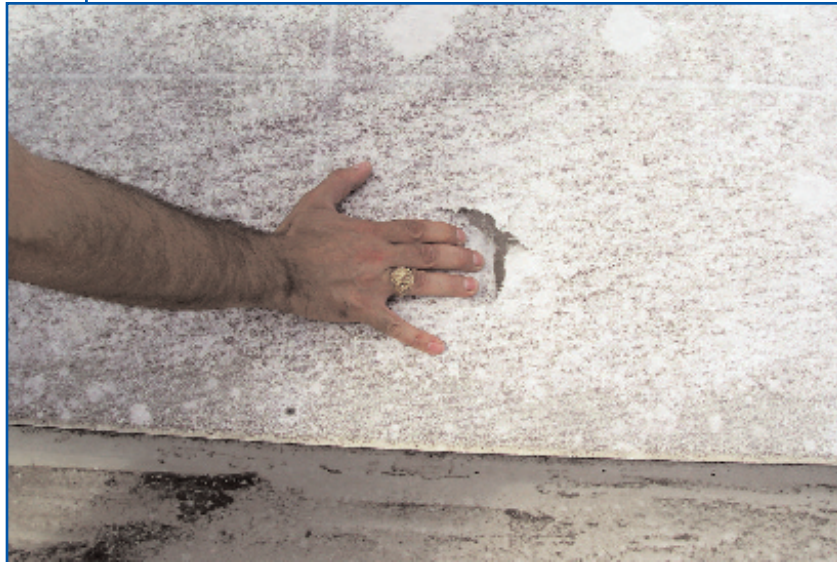
Photo 17 – Puncture in fabric skylight.

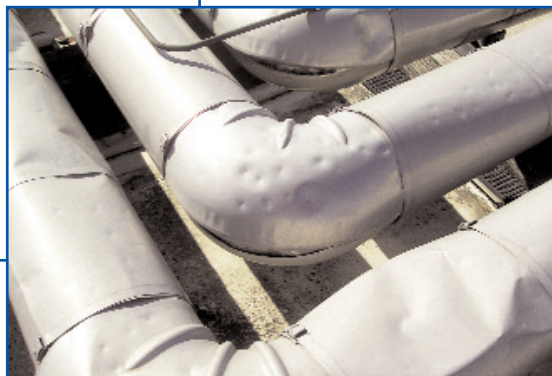
Indentations were observed on many light-gauge sheet-metal equipment hoods (Photo 18), as well as metal jackets on insulated water piping (Photo 19).

Photo 19: Dents in metal jacket on insulated piping.

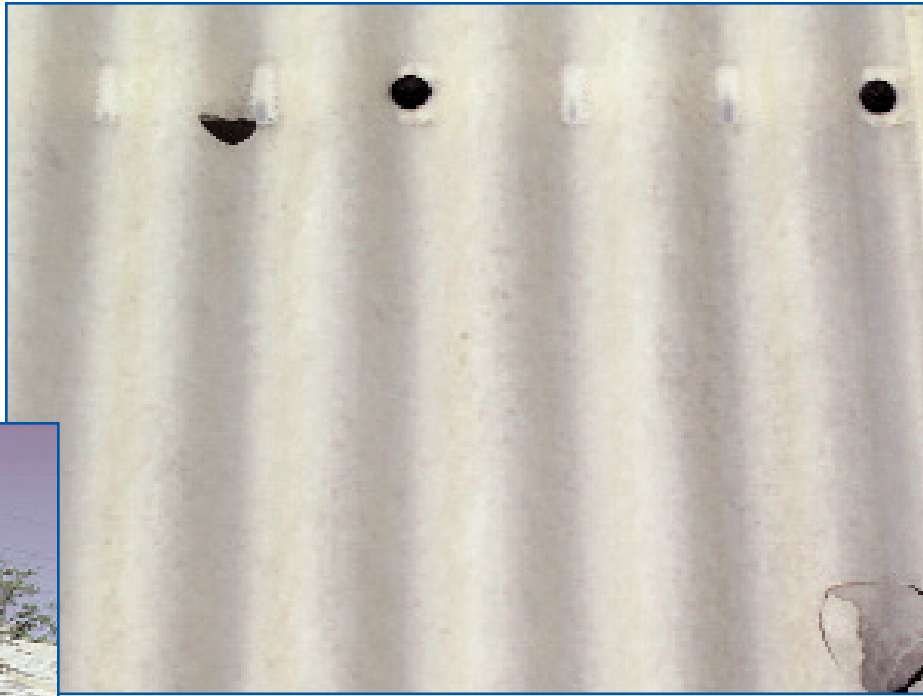
Both corrugated fiberglass-reinforced panels and flat-glass panels utilized as sloped glazing for greenhouses sustained damage. Punctures and isolated fractures were noted in fiberglass-reinforced panels (Photo 20). Glass panels sustained widespread breakage (Photo 21). Exterior insulated ductwork exhibited similar large punctures extending through the fabric covering and into the fiberglass insulation (Photos 22 and 23).

Photo 20 – Puncture in corrugated fiberglass panel.

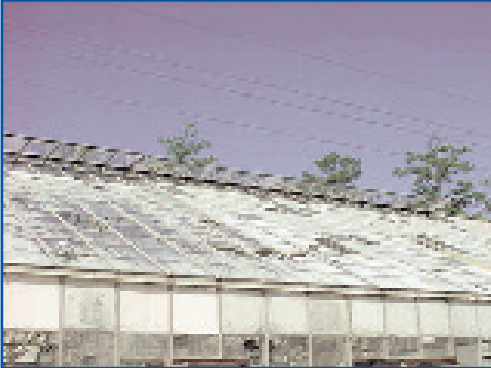
Photo 21 – Significant damage to glass panels.

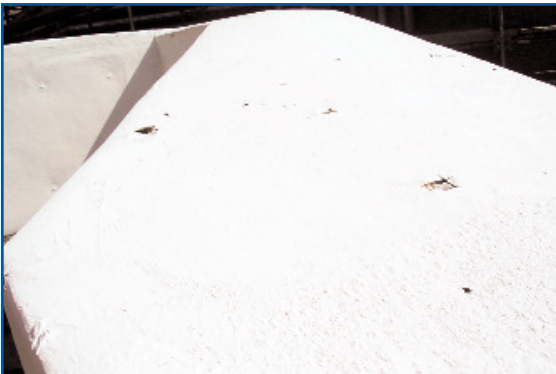
Photo 22 – Punctures in exterior insulated duct.

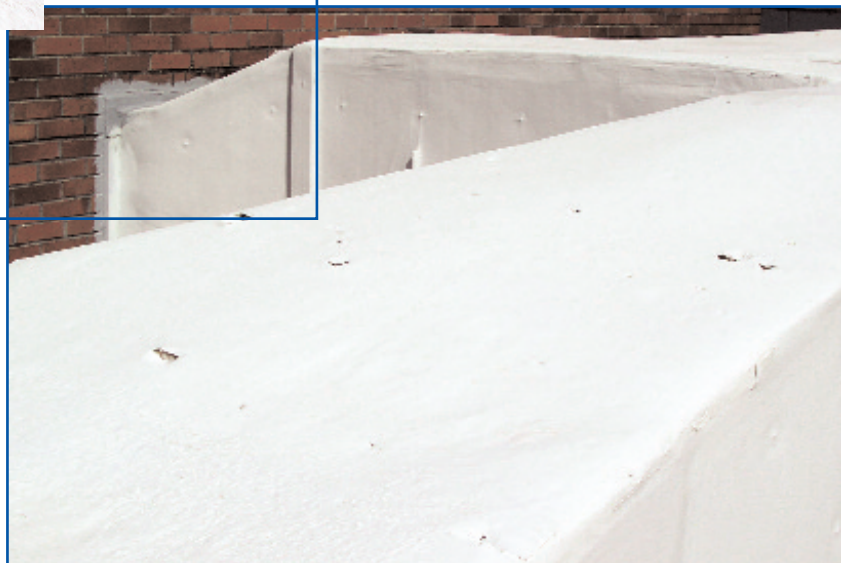
Photo 23 – Punctures in exterior insulated duct.

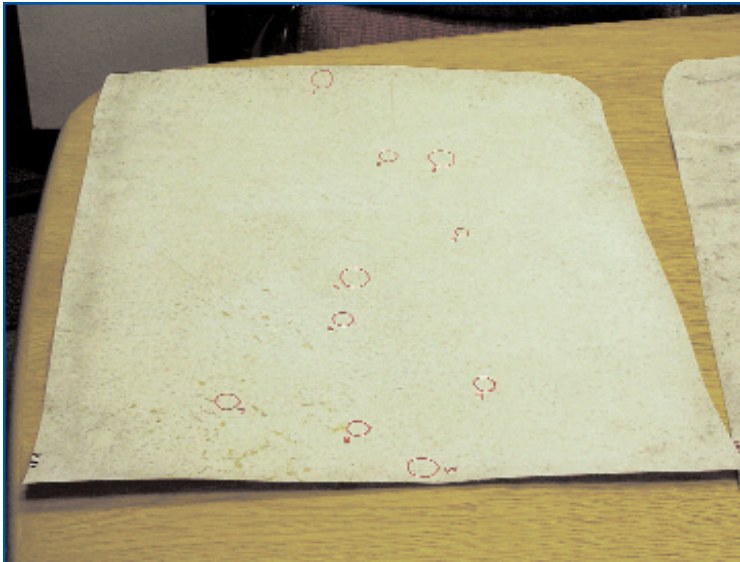
Upon initial review, physical damage was evident at approximately four to six random locations (Photos 26 and 27). However, after cleaning the top surface of

Photo 26 – Top view of typical sample.

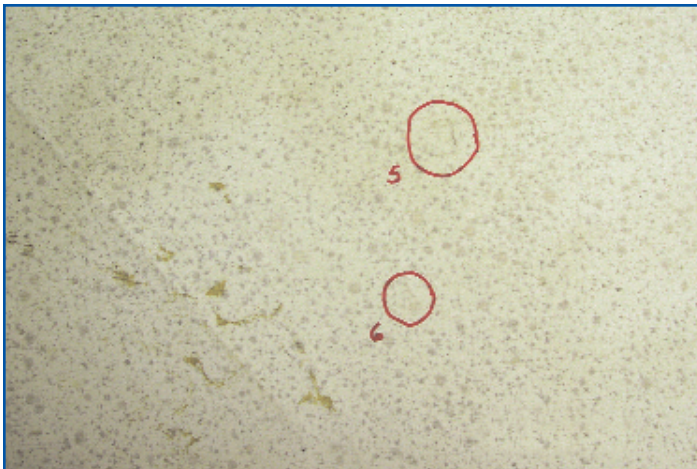
Photo 27 – Close-up view of typical damage on top side.

the membrane and upon closer visual inspection, physical damage was observed at three to four locations, which were considered to be relatively small, at 1/4 in to 1/2 in long. This extent of damage was not readily visible when walking the roof or handling the uncleaned sample at arm's length, due to the small size of the actual damage (1/8 inch to 1/4 inch in length) and to dirt accumulation on the membrane top surface.

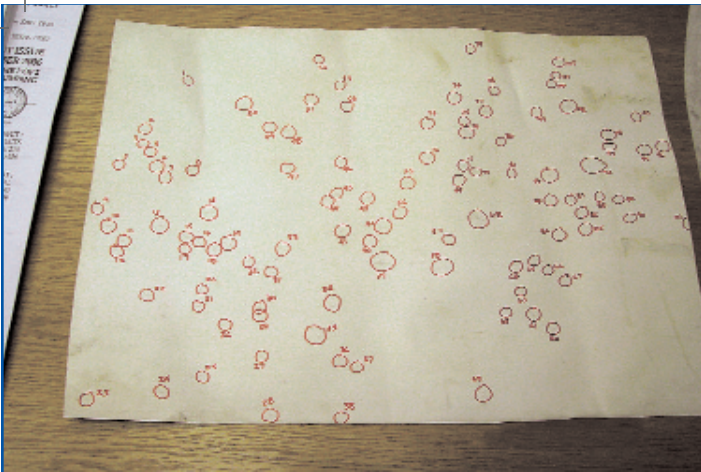
only at the locations corresponding to the top surface spots but also at additional problem locations throughout the samples (Photos 28 and 29). Since the underside of the membrane was relatively clean, the damage was readily evident.

Photo 28 – View of damage from bottom of sample.

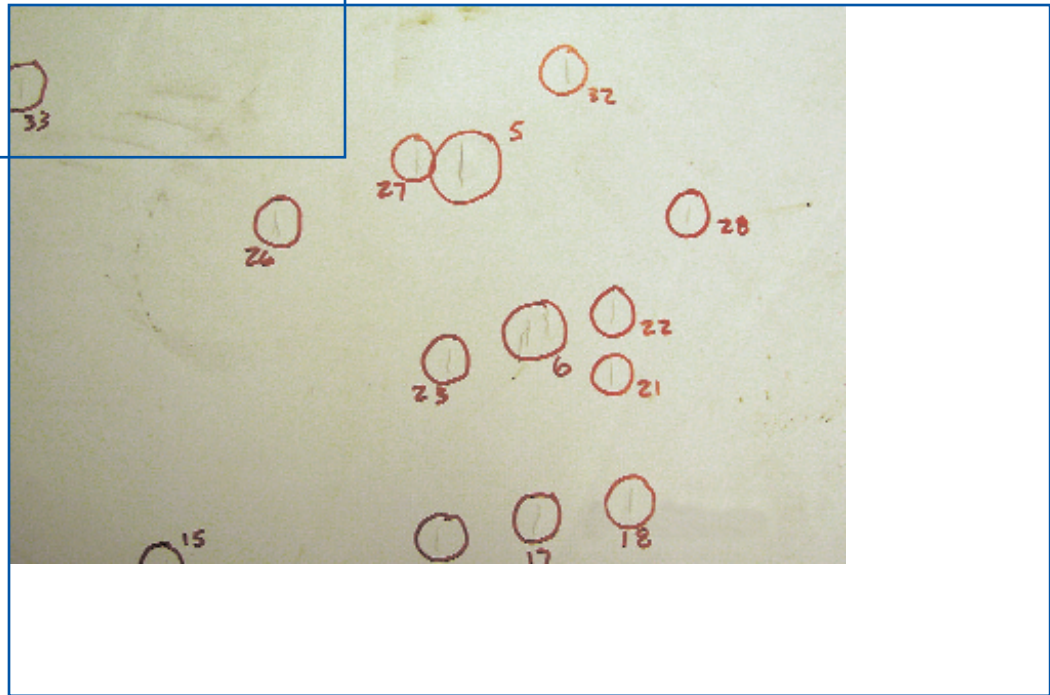
Photo 29 – Close-up view of damage on bottom side.

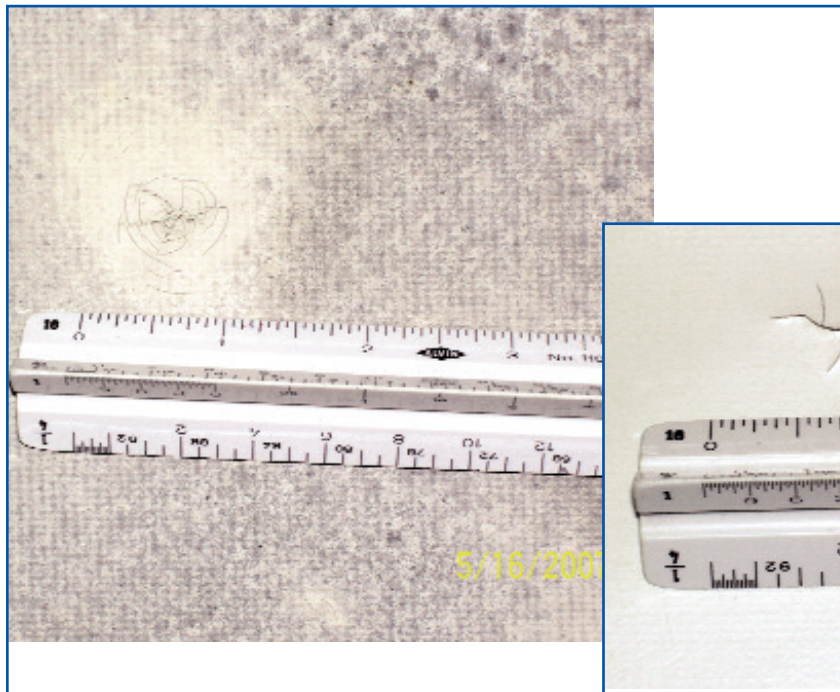
The damage, when viewed from the top surface (Photo 30), was circular- or spiral-shaped (or concentric rings). However, when viewed from the bottom, the damage typically appeared to be more “star-shaped,” or composed of linear cracks intersecting at midpoint or propagating from a central focal point (Photo 31).

Photo 30 – Typical fracture in top side of membrane.

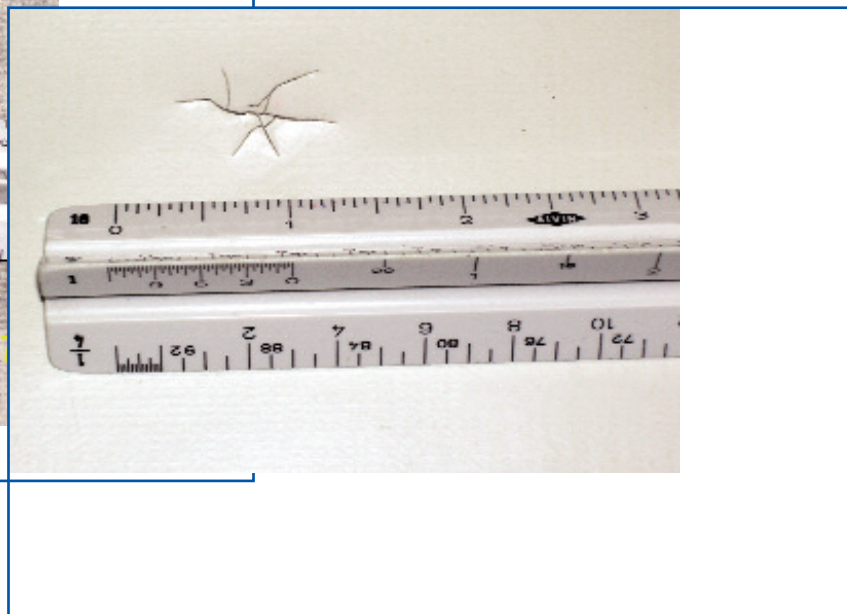
Photo 31 – Typical view of fracture from bottom of membrane.

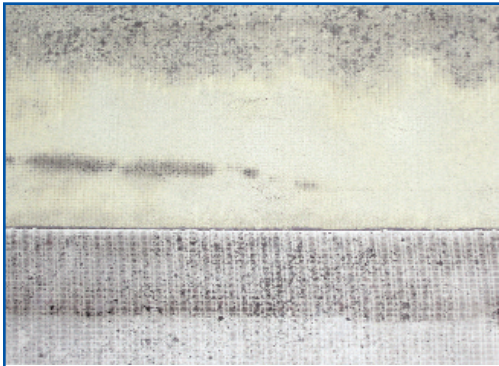
Photo 32 – View of top side of membrane (no damage visible).

mentioned manner. At one of these schools, similar conditions were revealed when the underside of the membrane was inspected in a closer manner (Photos 32 and 33). Based on this more

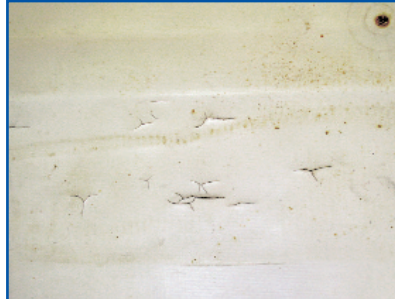
Photo 33 – View of damage on bottom of membrane.

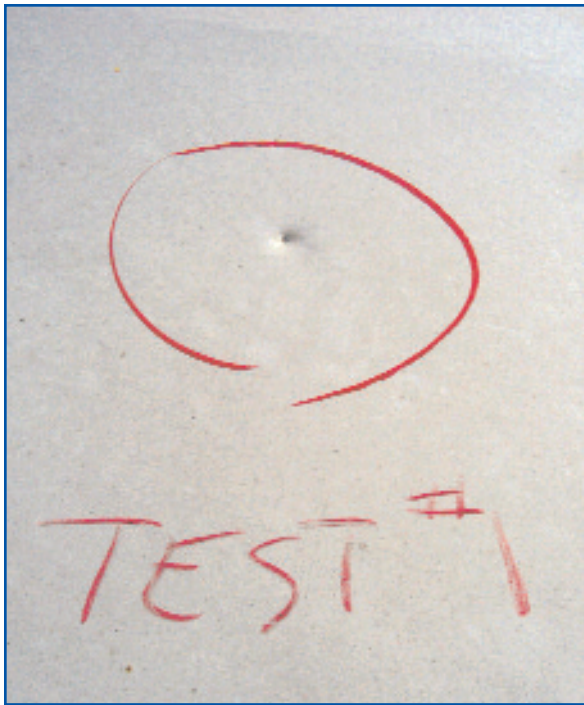
Photo 34 – Depression in membrane.

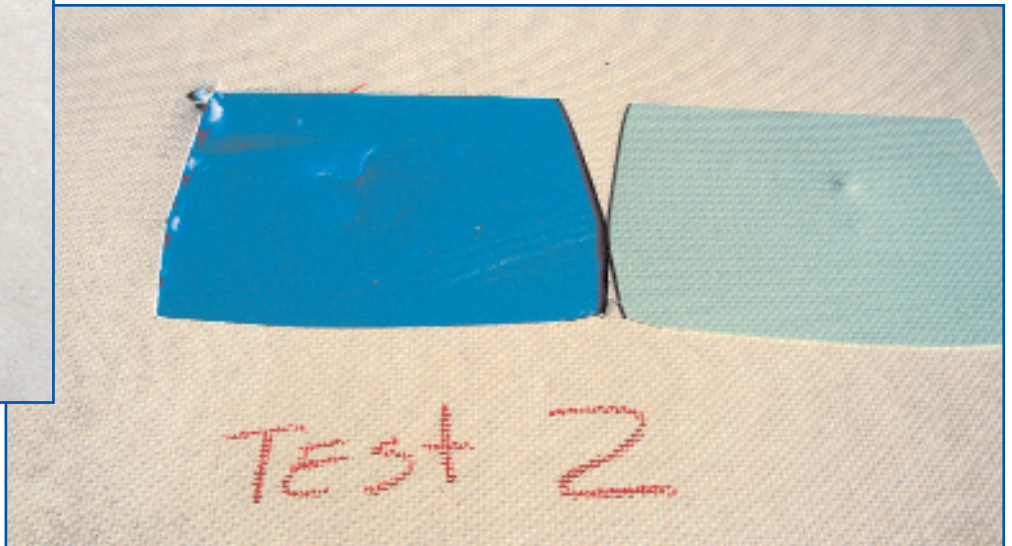
Photo 35 – Large depression in insulation board.

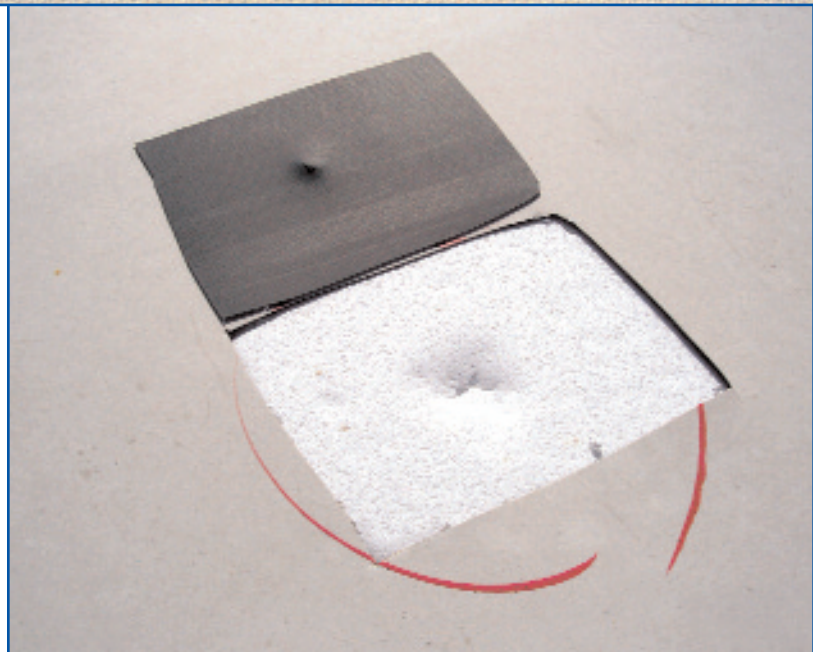
Photo 36 – Large depression in insulation board.

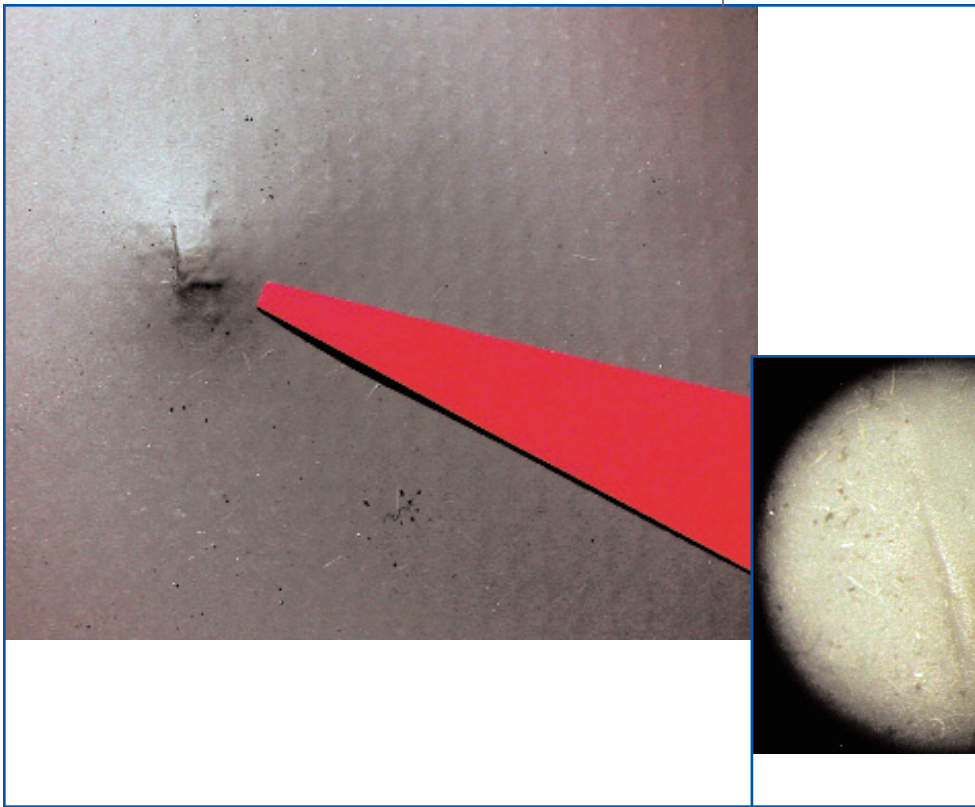
*Photo 37 – Close-up view of underside of membrane at depression.<sup>(9)</sup>*

The damage was small linear fractures in the membrane polymer coating, either on the top or bottom surface (*Photos 37 through 40*). Due to the isolated location and minimal frequency of this level of damage, the affected areas were repaired. This damage appears to have been caused by the larger-sized hailstones. These membranes also did not appear to have been affected by the smaller-sized hailstones.

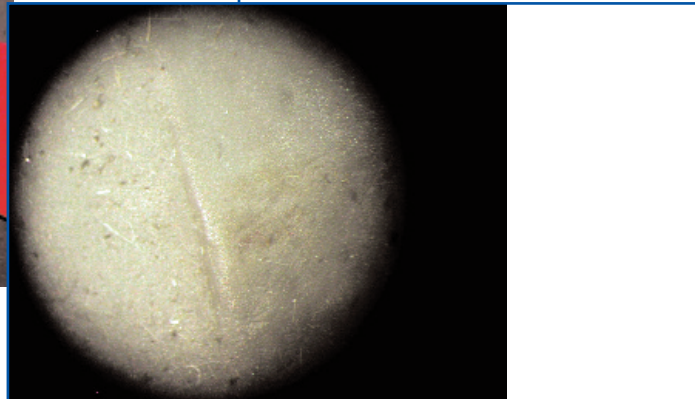
*Photo 38 – Magnified view (10x) of depression showing minor crease in membrane.<sup>(9)</sup>*

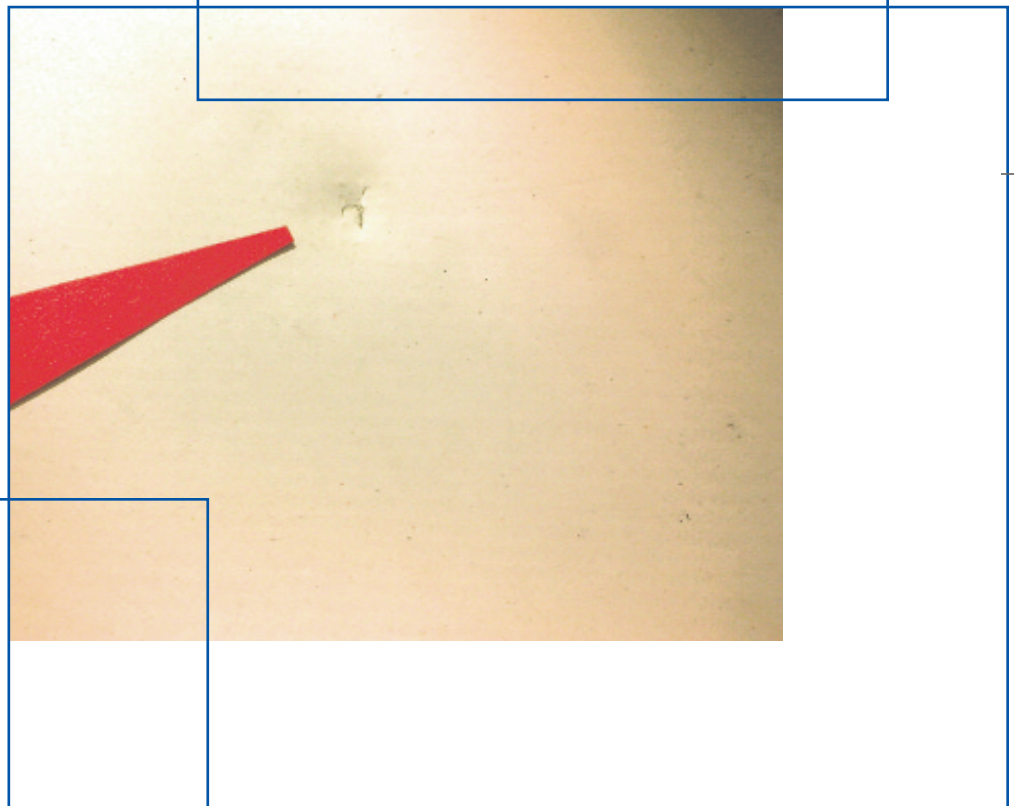
*Photo 39 – Close-up view of top side of depression.<sup>(9)</sup>*

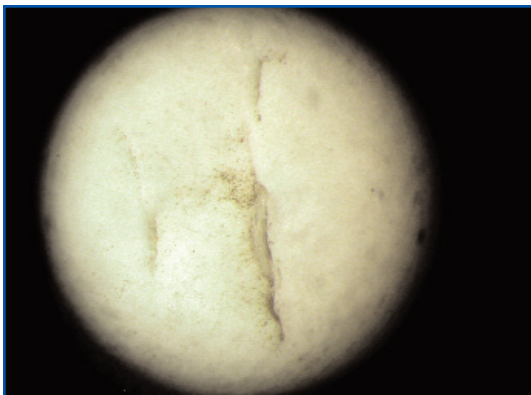
*Photo 40 – Magnified view (10x) of top side of depression showing minor crack in membrane coating.<sup>(9)</sup>*

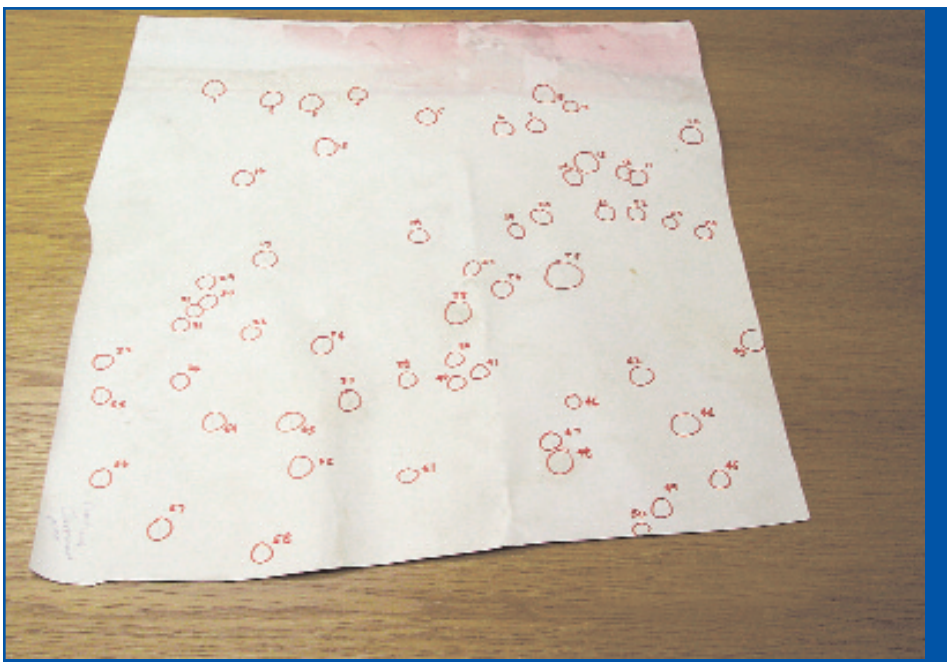
Photo 45 – View of underside of membrane showing numerous areas of damage.

through the numerous fractures in the single-ply membrane for a relatively effective time frame (six months) and, in the author’s opinion, could provide even longer service if needed (Photos 43 through 45).
