Multidisciplinary Historic Rehabilitation of Rockefeller Memorial Chapel

By Donald Kilpatrick and Barry O'Quinn

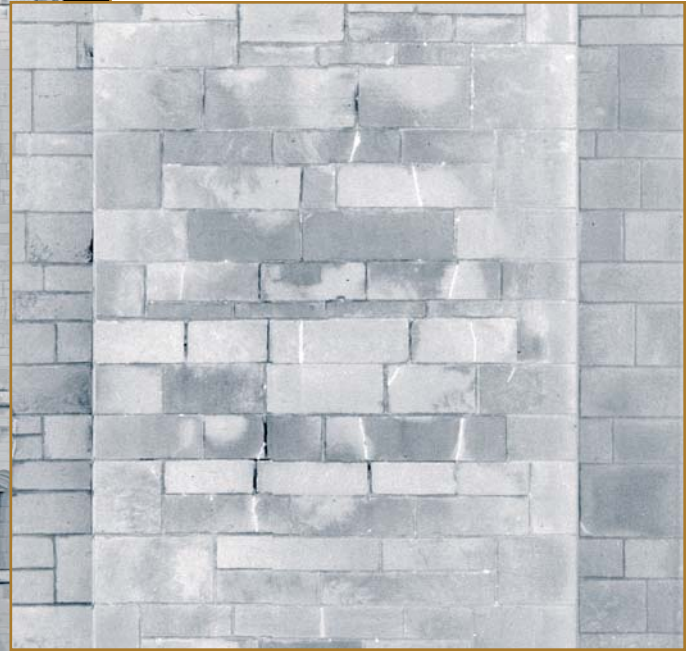
In 2002, subsequent to acceptance and review of the façade ordinance inspection specific to the bell tower, university facilities staff endorsed continued investigations that revealed significant distress on the remaining portions of the building. Basement flooding had become an all-too-common occurrence, and the stained glass windows were allowing the passage of water to the building interior. Damage to interior finishes and exterior cladding was occurring at random locations as a result of failed drain leaders.

Photo 7 – Enlarged area of localized distress below tower balcony roof with failed drain leader.

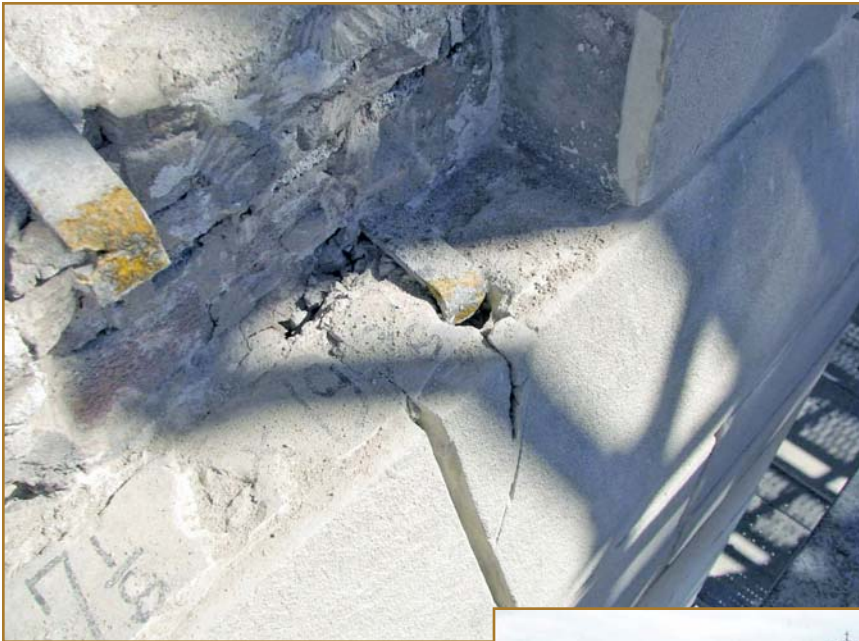
Photo 8 – Typical stone distress resulting from corroded steel strap and/or the open cell (receiver) in the stone subjected to freeze/thaw damages.

of the mild steel straps used as part of the original construction as a means to mechanically anchor the four-in ashlar stones to the brick backup. Typically, the straps extending from their set positions in the backup wall are engaged into pockets of the ashlar.

With corrodible metal within two inches of the outer wall, cyclical exposure to moisture had resulted in rusting, volumetric expansion of the steel, and cracking of the stone (Photo 8). At the stone mullions of the major window openings, similar conditions exist, with the corrosion causing cracking that radiates from the centrally located steel pins. All replacement anchors, pins, and straps required for setting and repairing stone are stainless steel. The tower turrets and pinnacle features above the nave roof

on the north and south ends of the building will be completely torn down and rebuilt using stainless steel pins with provisions for new, galvanized tension rings.

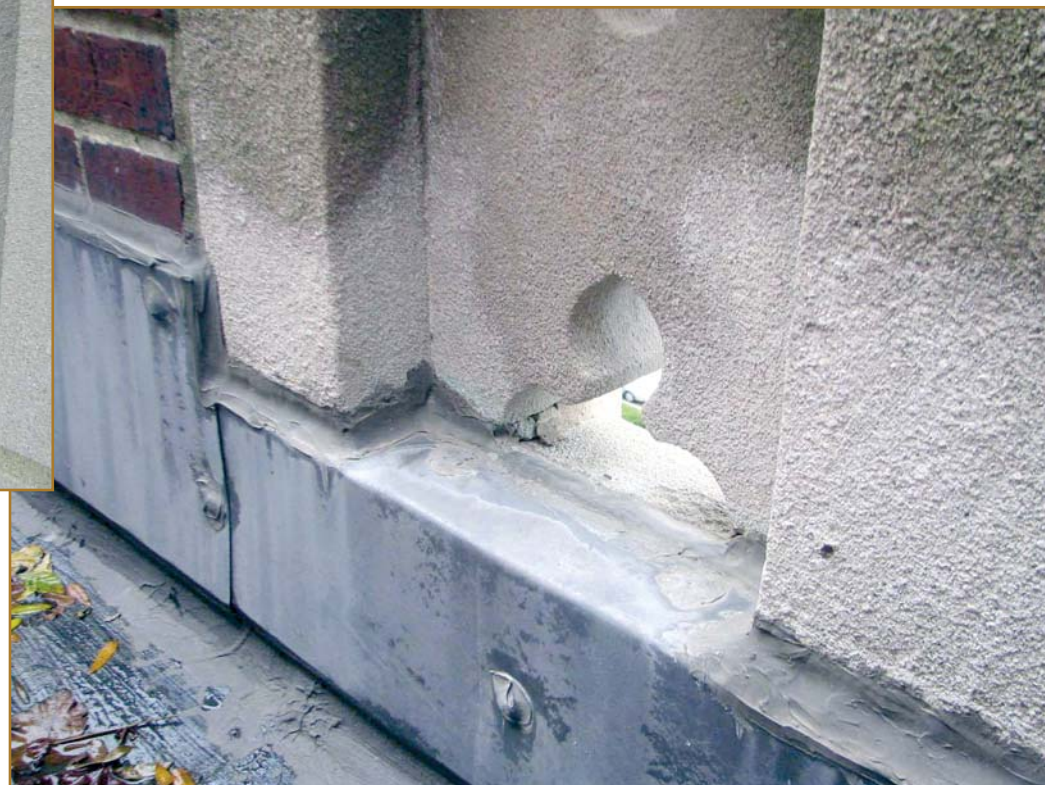
Photo 11 – Area of stone infill on roof side of parapet wall required to accommodate revised height of finished gallery roof.

In addition, the revised finished height and slope of the new integral gutter sections will invariably result in less-than-desirable flashing conditions at the portal openings in the parapet wall. To address these conditions, the original design included replacement of the three-stone set establishing the portal opening with a new single stone of matching ornamentation, less the opening through the wall-in section. Early dialogue with City of Chicago Landmarks, including mock-ups using limestone blanks to in-fill the openings from the building side of the parapet wall, was critical to approval of this minor change in building aesthetics that, when completed, will not be readily discernable from grade.

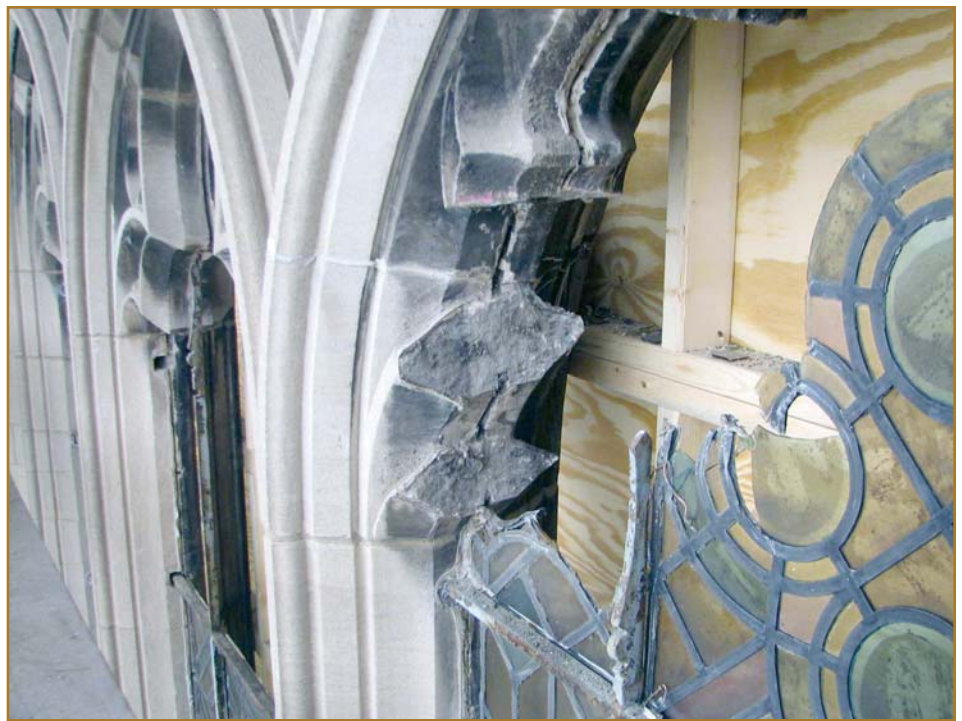
Widespread corrosion was noted on the exterior support bar framing, with section loss noted at the pockets where the steel

Photo 12 – At some locations, the stained glass and exterior support framing provided supplemental support to damaged stone tracery.

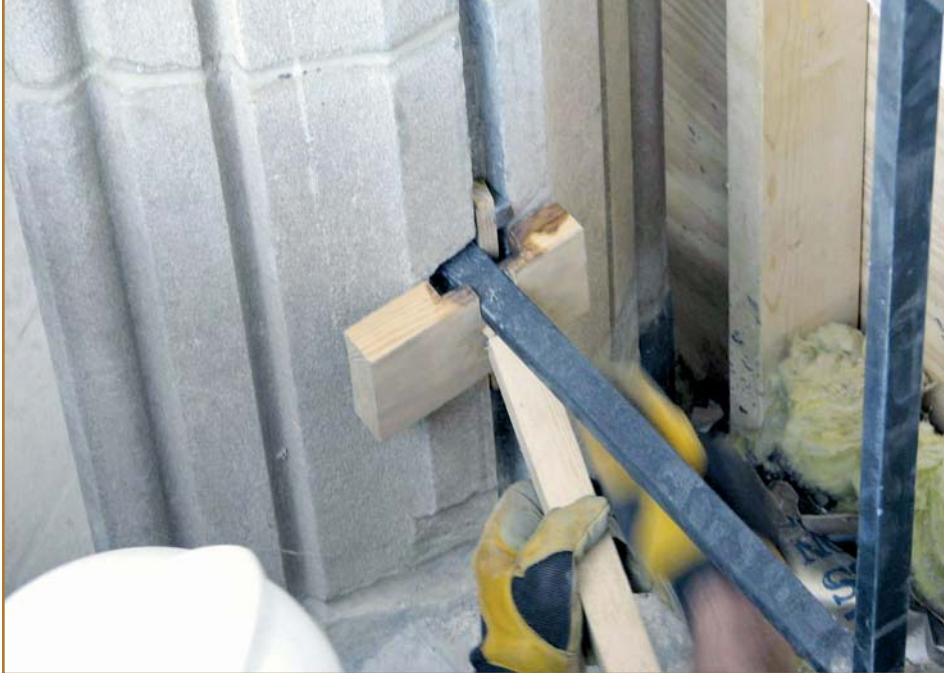
Photo 13 – Wood forms set in advance of pouring molten lead to fill the pocket in the stone surround.

Photo 14 – Finished interface of exterior support bar framing and stone surround.

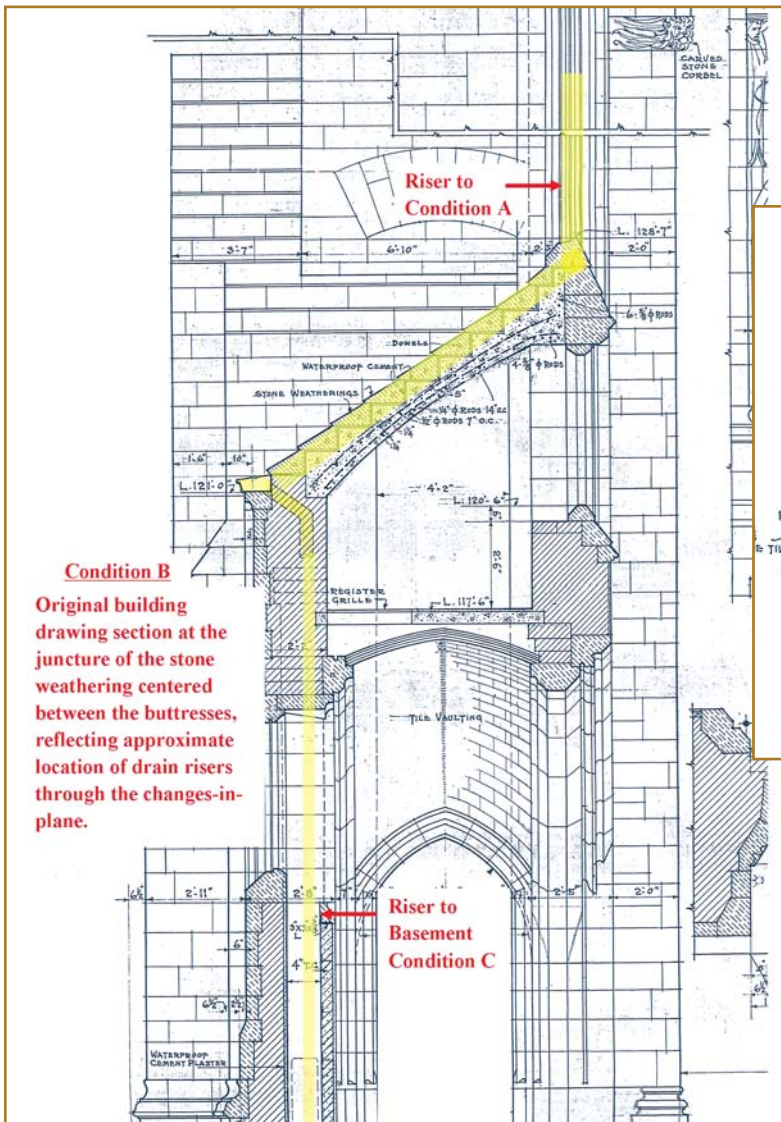
Condition B
Original building drawing section at the juncture of the stone weathering centered between the buttresses, reflecting approximate location of drain risers through the changes-in-plane.

Figure 1, Condition B – Original building drawing section at the juncture of the stone weathering centered between the buttresses, reflecting approximate location of drain risers through the changes in plane.

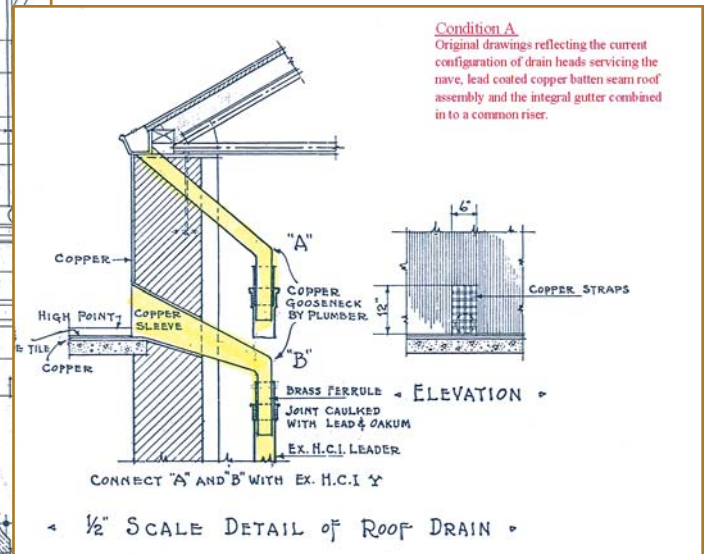
The typical risers in the buttresses service separate drain heads; one each servicing the gutter and leader of the lead-coated, batten-seam roof of the nave, with the other connected to the large integral gutter servicing the narrow band of roofing behind the

Condition A
Original drawings reflecting the current configuration of drain heads serving the nave, lead coated copper batten seam roof assembly and the integral gutter combined into a common riser.

Figure 1, Condition A – Original drawings reflecting the current configuration of drain heads serving the nave, lead-coated copper batten-seam roof assembly, and the integral gutter combined into a common riser.

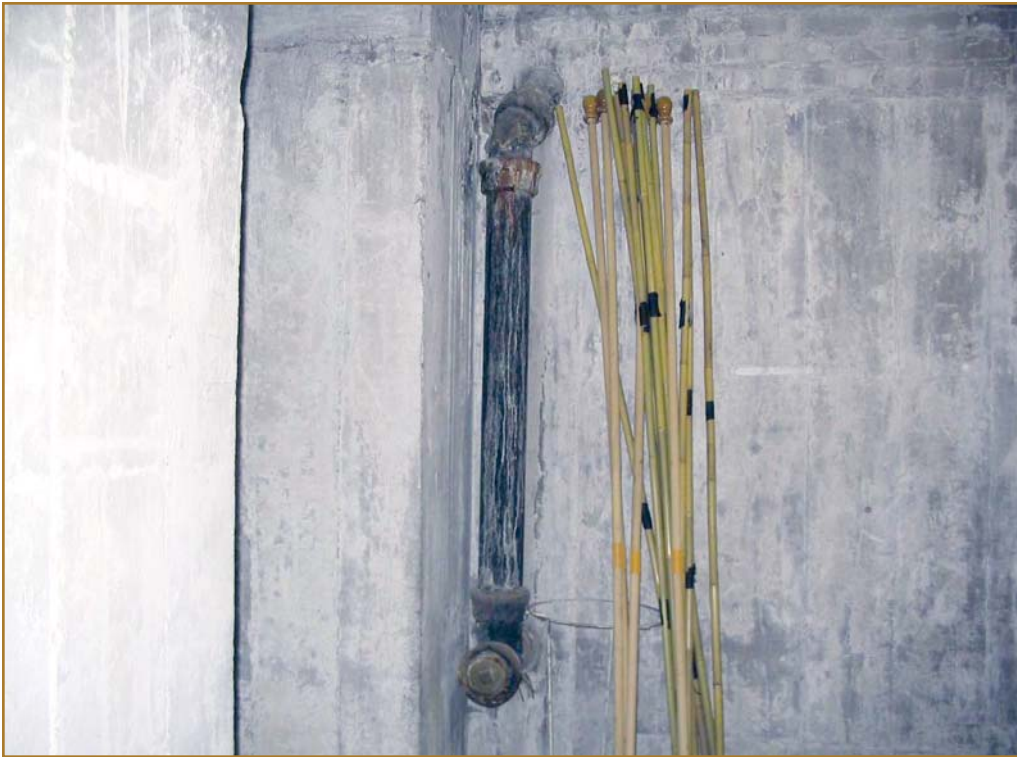
This condition left the assembly susceptible to moisture damage, most notably in the form of corrosion of the steel beams, resulting in volumetric expansion and loss of concrete cover (fire protection). (See *Photo 15*.) Additional distress specific to this condition was noted in the outside face of the limestone cladding at and below the roofline. The drains, as small triangular roofs, are completely restricted to the extent that water builds to level, exceeding the height of the membrane and accessory flashings. As a result, a significant volume of water has essentially been pumped into the high-mass walls, driving accelerated corrosion of mild steel straps anchoring the 4-in ashlar stones to the multiple-wythe masonry backup.

Figure 1, Condition C – Typical drain leader exiting the buttress as presented in the basement.

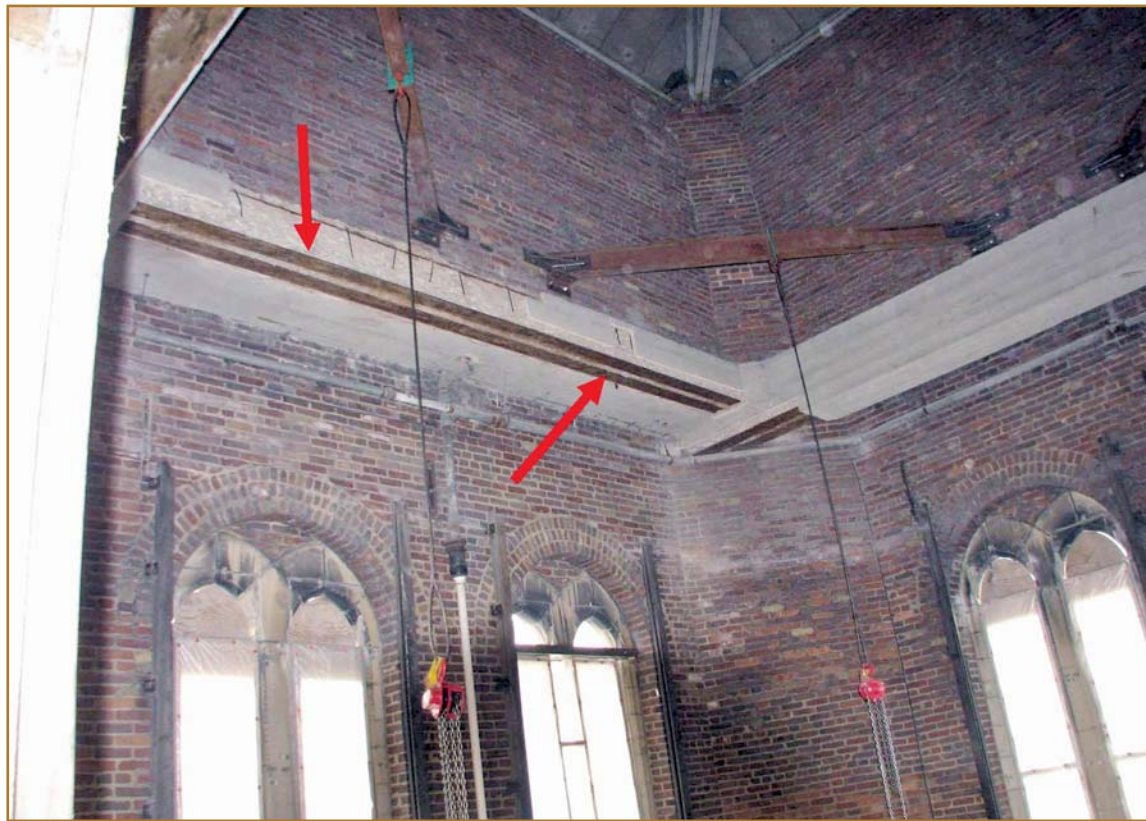
Photo 15 – Loss of concrete cover (fireproofing) at upper tower limits resulting from recurring water entry.

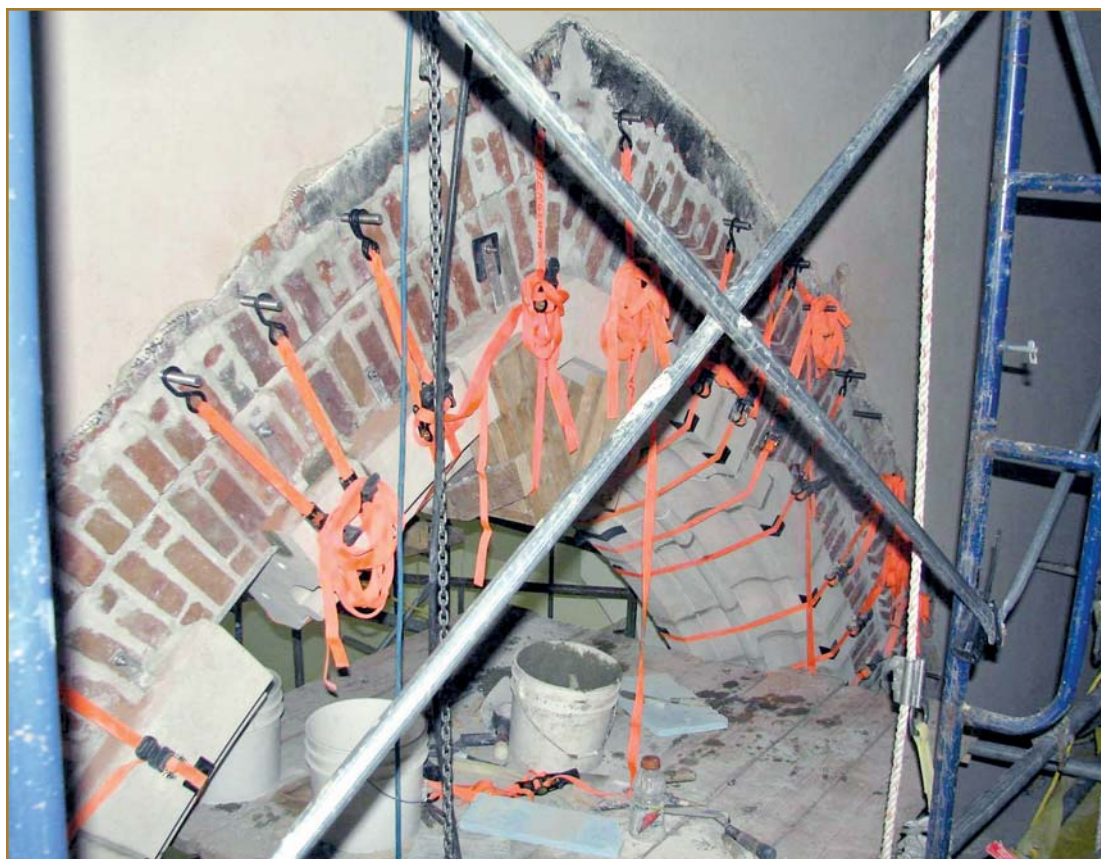
Photo 17 – Final setting of cut limestone surround in tonal opening.

month. A new structural steel arch was introduced to the rough opening after demolition of the 10-in-thick in-fill of brick and plaster finishes, followed by a cut limestone surround patterned after that found on the clerestory windows of the nave (Photo 17).

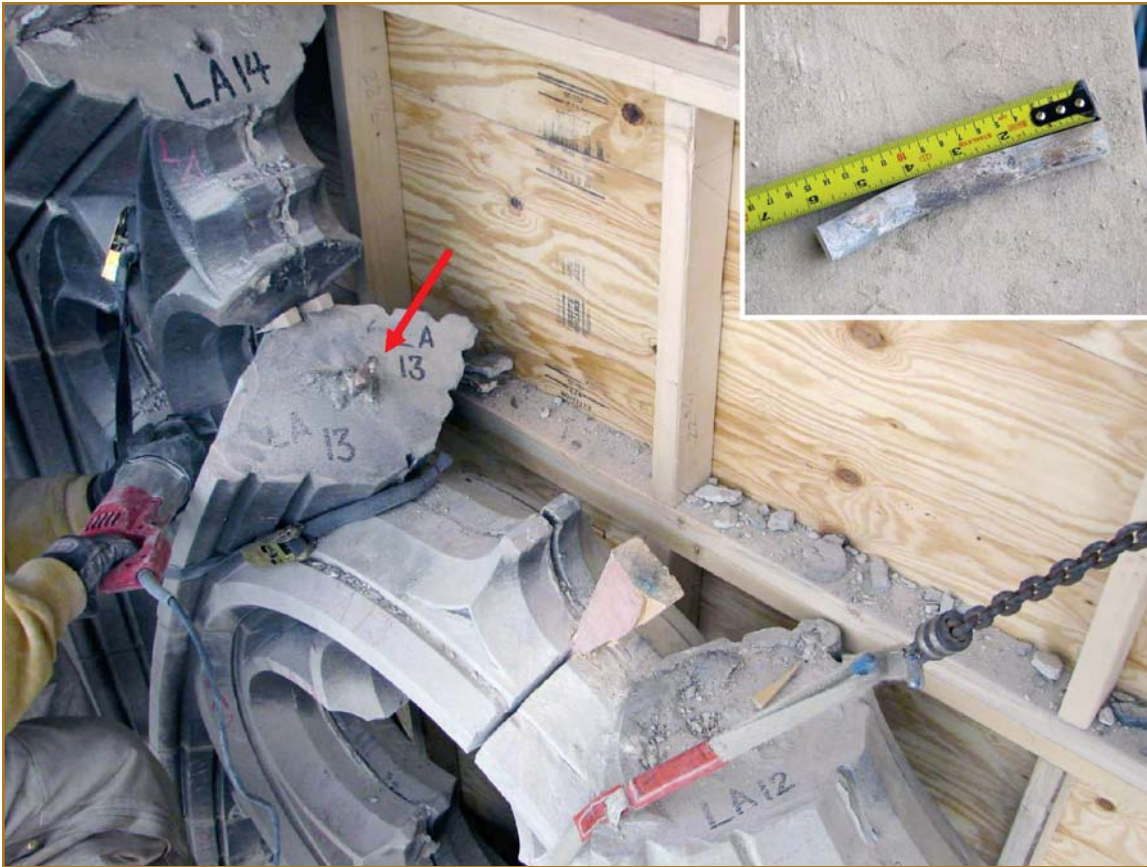
The findings were very instructional, and the integrity of steel pins at the stone joinery was determined to be satisfactory, which was useful in establishing work scopes for the balance of the major window openings (Photo 18). The single pin, centered in the 18-in-deep tracery stones, was exhibiting mild surface rusting, with no evidence to suggest that corrosion was contributing to stone distress. This work was in part considered a large-scale inspection opening, while at the same time it provided assurance that the restored Skinner organ would not be subjected to damage from leaking windows.

Photo 18 – Overall condition of steel pins at stone cusps from the organ loft window location.

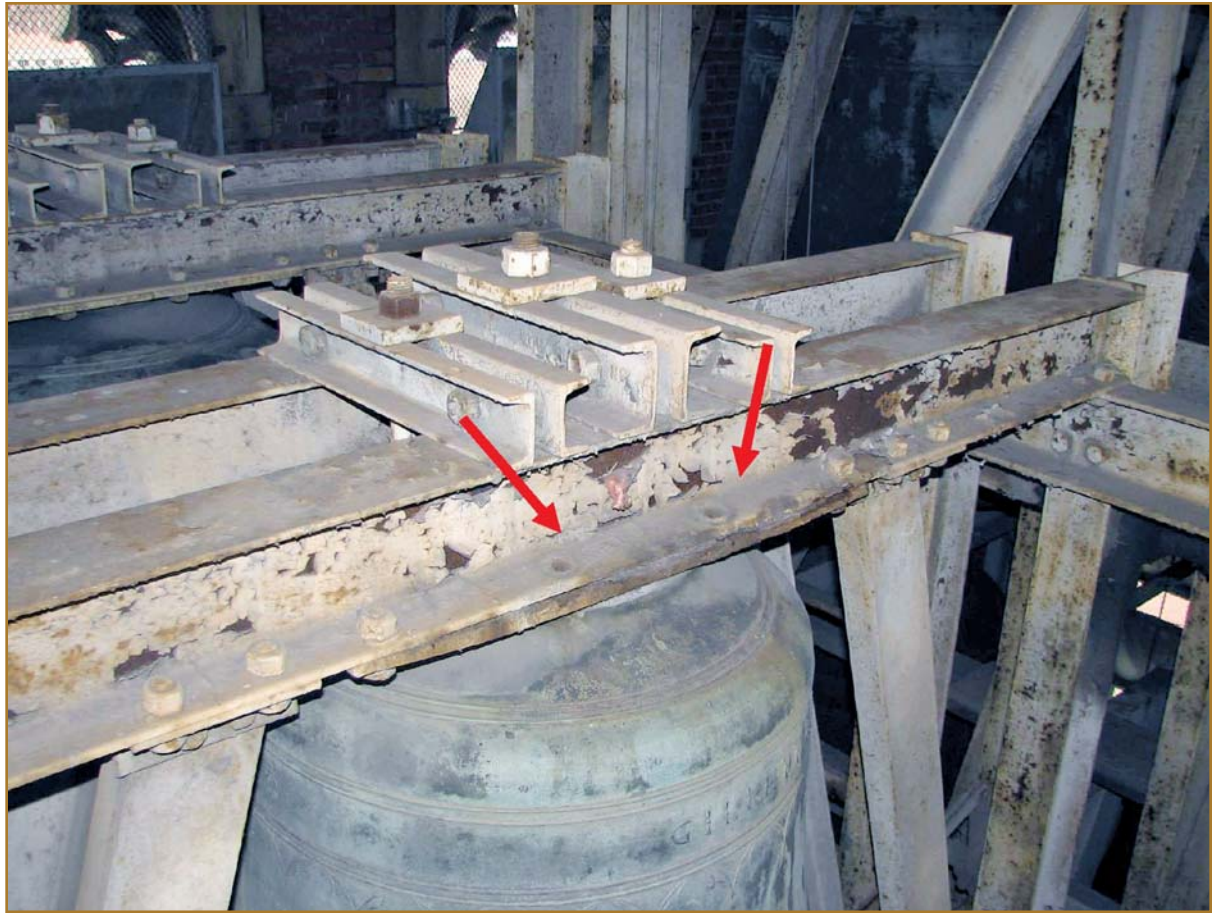
Photo 20 – Wind-driven rains entered the tower interior, resulting in heavy corrosion of steel plates and failure of bolted connections.

areas of localized corrosion and measurable deflection, most notably in the floor slab of the playing cabin. It was also noted that mounting plates of the upper bells below the cabin had been subjected to damage from corrosion, with significant deflection. In some instances, three or four bolts of an eight-bolt pattern had sheared due to the volumetric expansion of the plate steel (Photo 20). The cause of the corrosion was determined to be stone tracery at the upper limits of the large louver openings, admitting water during heavy, wind-driven rains. The revised louver design includes provisions for a custom louver assembly of minimal depth that will be installed behind the tracery to minimize the volume of wind-driven rain that enters the tower interior.
