Roof Restoration of Atlanta's Fox Theatre

By Kurt Sosinski, CDT, RRC; Jim Lohmann, CDT, RRO; and Tom Biller, CDT, RRO

EVALUATING & RESTORING THE FOX THEATRE ROOF SYSTEM

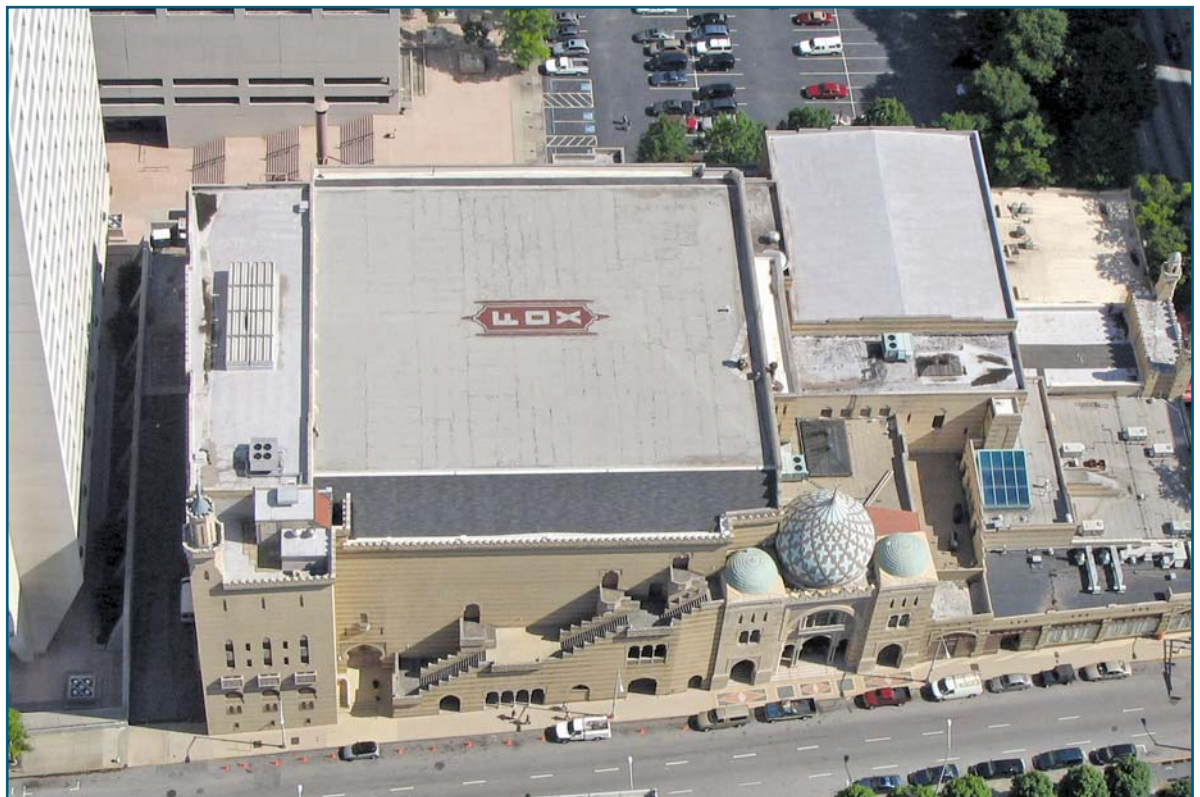
Overview of the historic Fox Theatre roof systems. This photo was taken prior to the restoration of the auditorium roof, which is the largest roof area of the structure, and sports the Fox logo.

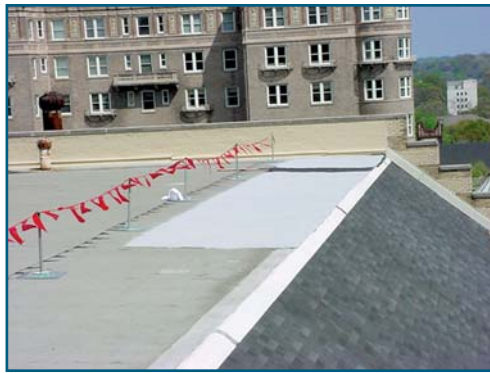
View of the mansard edge, which originally leaked due to differential movement from a buried I-beam at the perimeter.

The inspection began with a visual survey of the facility's roof and interior. It confirmed that the perimeter was the source of leakage. The edge detail along two perimeter walls consists of a metal I-beam that terminates the gypsum deck (instead of wood blocking) along the length of a shingled mansard roof. The I-beam presented two problems:

- The high movement of the metal I-beam caused high movement along the perimeter, eventually leading the flashing ply to tear open and leak.
- Conventional flashings could not be attached to the I-beam like they could be secured to a wood nailer.

This flashing issue was solved by the selection of a reinforced elastomeric membrane flashing that accommodates the movement and provides a long-term watertight performance. This flashing material, 45-mil-thick reinforced Hypalon, has the additional advantage of being compatible with the asphaltic roof system that it was stripped into.

The new flashing repairs were installed fairly quickly and permanently resolved the roof leaks at the Fox Theatre. The initial inspection revealed a roof system that, although almost 20 years old, was in remarkably good condition. This roof did not appear to be in need of replacement, and its owner were interested in keeping this roof in good shape to perform even longer. They committed to a roof evaluation program with the goal of determining if the roof was a restoration candidate.

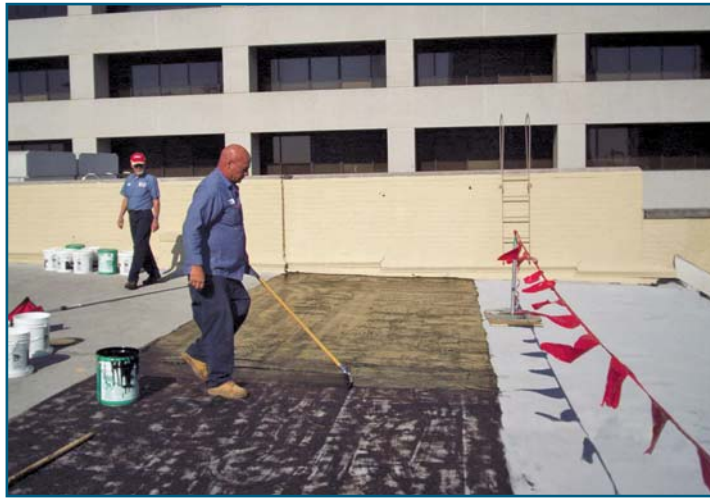
Application of cold-process surfacing adhesive over primed surface prior to granule application.

The Fox Theatre wanted to maintain the existing appearance of the Auditorium roof, so a ceramic granule surfacing was selected. The specified surfacing included 3.5 gallons/square of cold-process adhesive and 60 lbs/square of #11 ceramic granules. The perimeter was stripped in with a polyester/fiberglass-reinforced, asphalt-coated felt, fully adhered in asphalt mastic adhesive. The material manufacturer and contractor have issued a warranty against roof leaks.

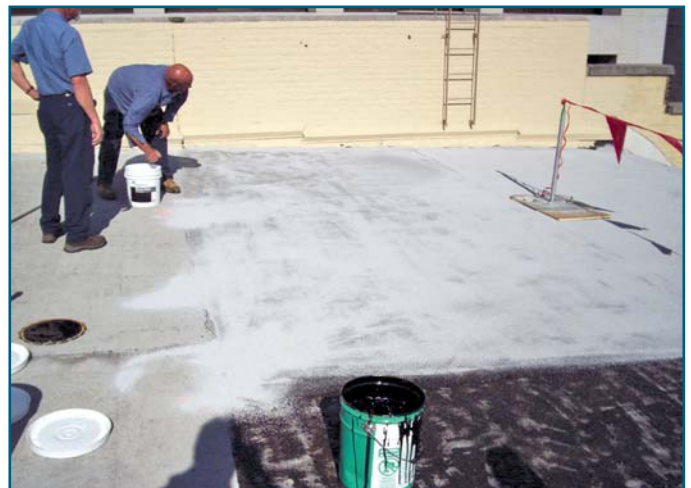
Broadcasting ceramic granule surfacing into cold-process adhesive.
