POST-9/11 RESTORATION OF THE EXTERIOR OF 90 WEST STREET, NYC

By Richard W. Lefever, PE, LEED AP and Mark Anderson, AIA

ABSTRACT

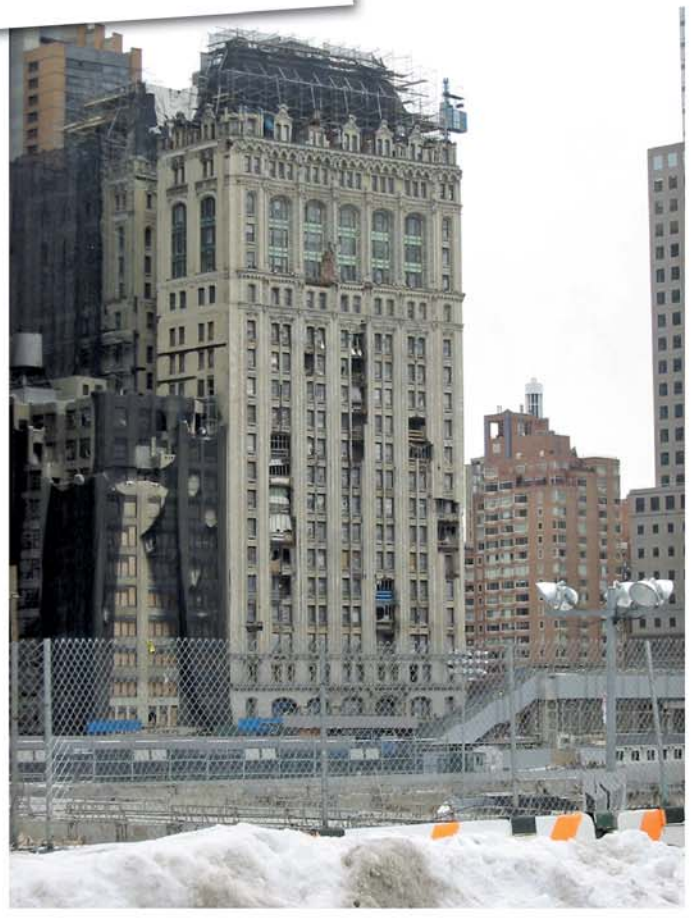
Figure 7 – North façade. Impact damage crushed terra cotta and bent and nearly sheared through a steel spandrel beam.

The majority of the façade is of ornamental, hand-pressed terra cotta with brick backup. The north elevations sustained the most severe deterioration from impact and fire. The façade was completely missing at several locations, due mostly to impact (Figure 7). Fire damage originated from both the interior and exterior at all elevations.

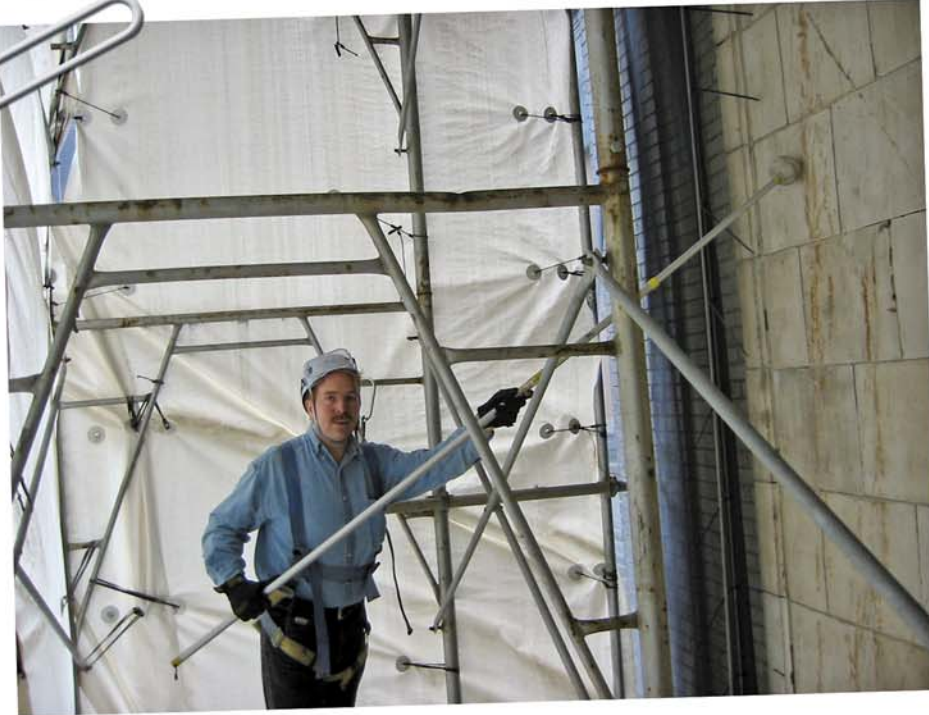
Figure 8 – Mark Anderson sounds terra cotta with a “sounding ball” at the north elevation.

“sounding ball” attached to a telescoping pole was designed and used by FMD to evaluate each stone (Figure 8).

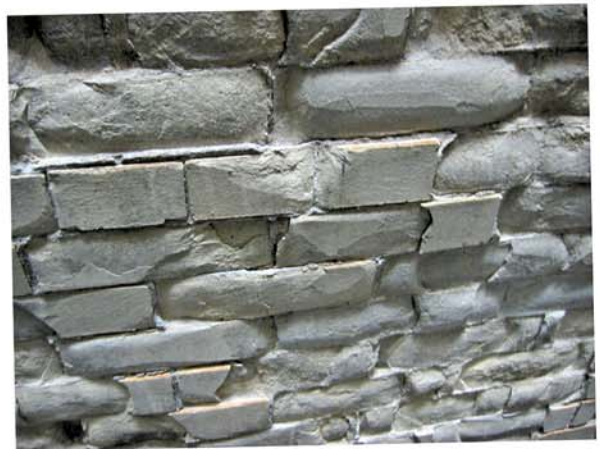
Figure 9D – Brick spalls due to heat of fire in the courtyard.

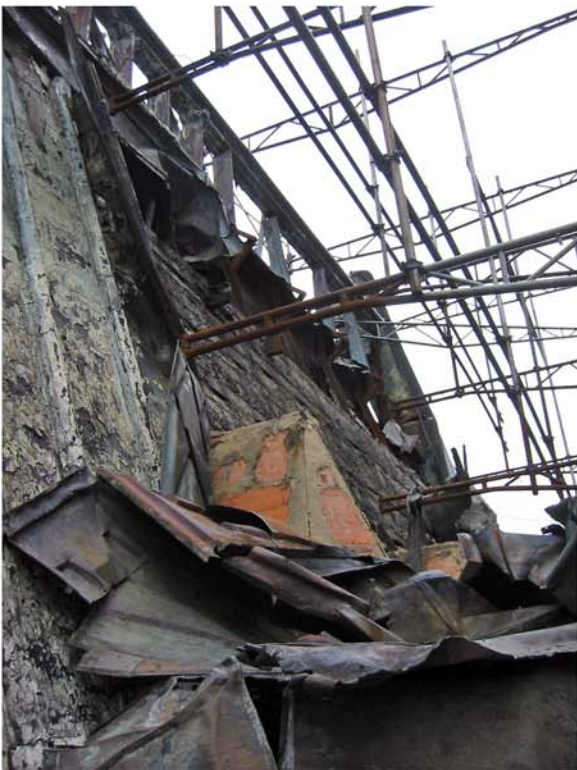
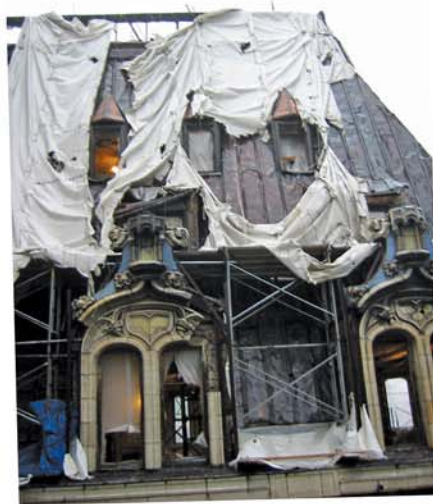
Figures 13A and 13B – Copper sheets on the mansard roof melted, and wood nailers burned from the fire on 9/11.

The original copper mansard roof and stamped copper balustrade had been repaired and coated with various sheet and liquid membranes numerous times prior to 9/11. Fire burned the coatings, deformed the copper, burned the underlying wood

nailers, and exposed previously unseen deterioration of the roof's attachment (Figures 13A, 13B, 16A, and 16B).

- The copper mansard was removed down to its cinder fill substrate, and new batten-seamed copper was laboriously installed by Eagle One Roofing to match the original roof (Figures 15A, 15B, 16A, and 16B).
- The entire balustrade was replaced with custom fiberglass panels by Seal Fiberglass (Figures 15A and 15B).
- The 23rd floor dormers were replaced with copper, while the 21st and 22nd floor dormers were repaired with copper wherever necessary.

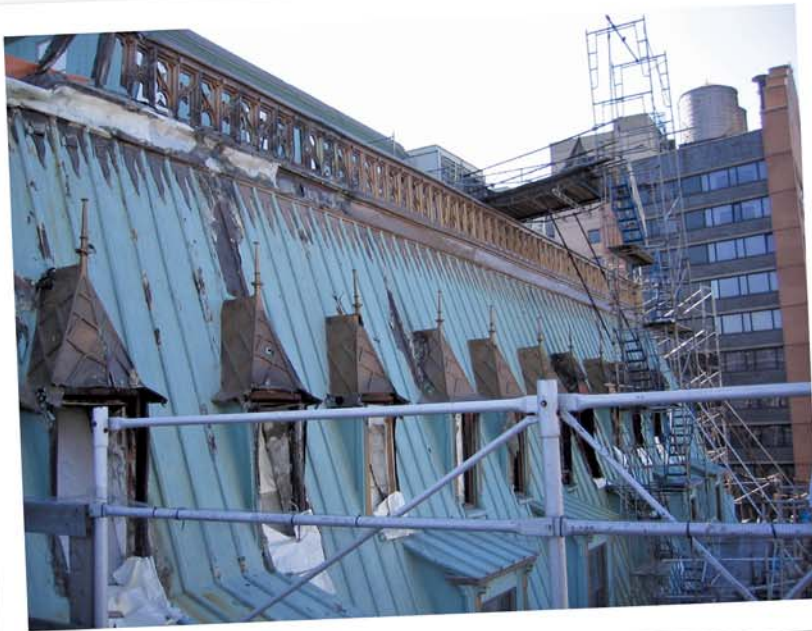
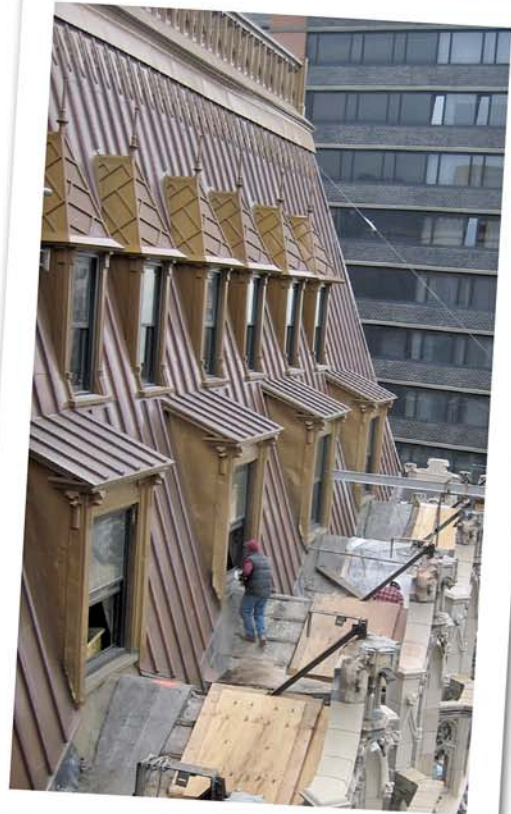
Figures 16A and 16B – West mansard roof before and after restoration.

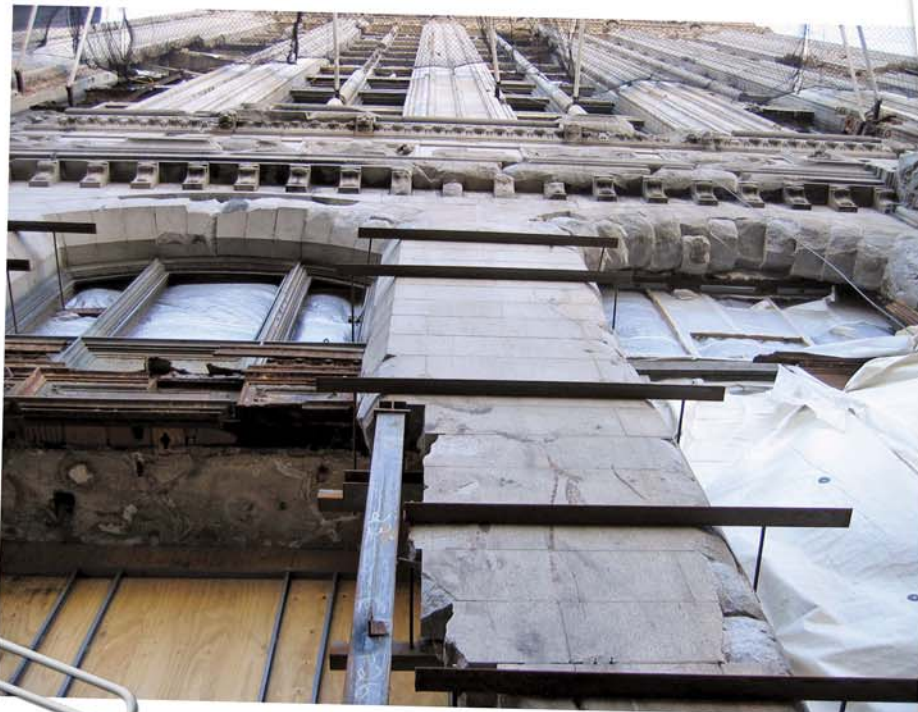
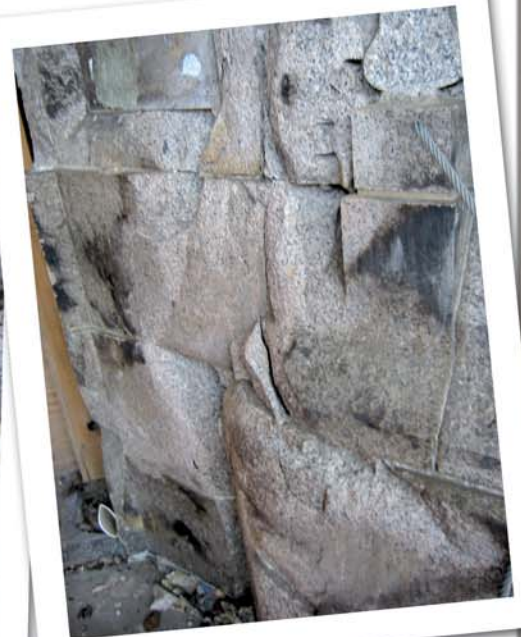
Figures 17A and 17B – Fire and impact damage rendered much of the north granite base unrestorable.

Eighty percent of the north elevation granite base needed to be removed due to excessive impact and fire damage (Figures 17A, 17B, 18, and 19). New ornamental stone was expertly cut and carved in Canada and Italy (Figure 20).

An innovative, steel-framed panel system was employed to replace the heavily damaged granite base at the north elevation. This panel system met aesthetic (Figure 22) requirements, as it provided the installation of both new and original stone, a first on such a large scale. A galvanized, welded steel tube skeleton

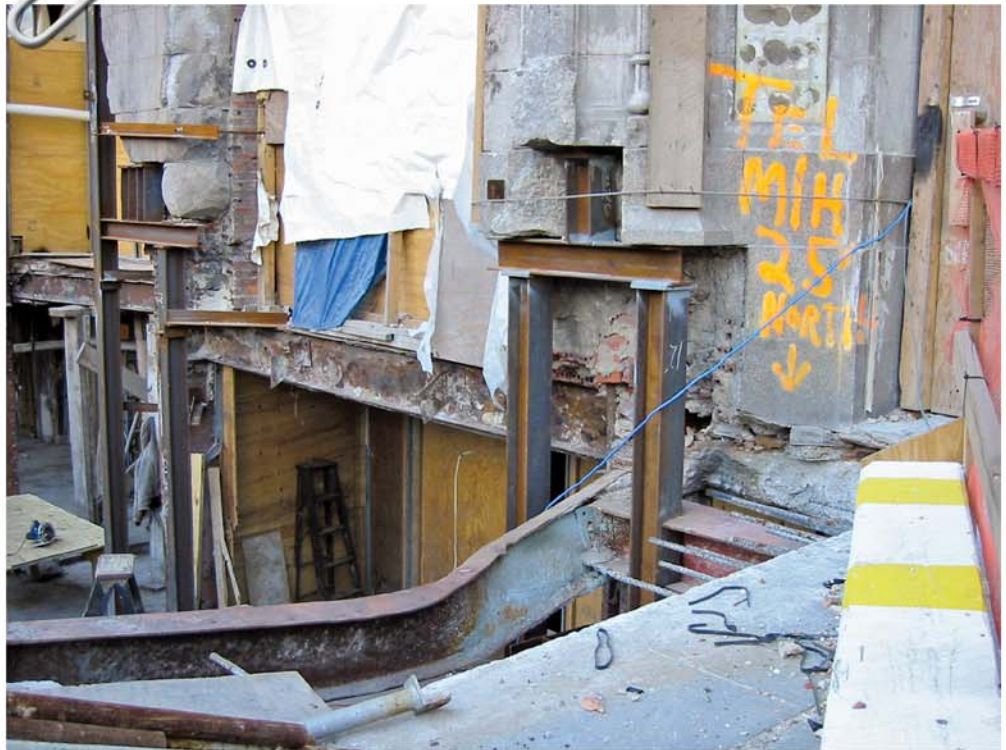
Figure 18 – Much of the north sidewalk, which supported the granite, was missing.

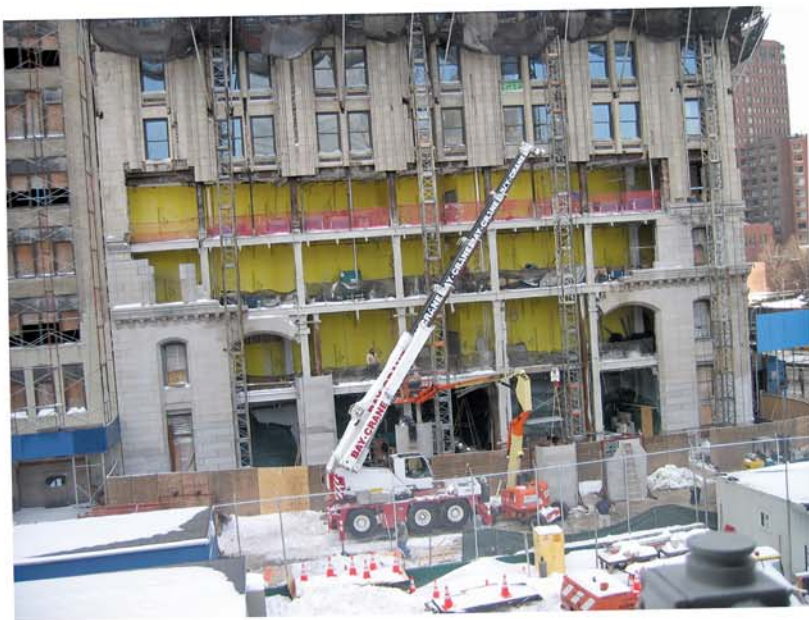
Figure 19 – Most of the north granite façade base was completely removed.
