Lessons Learned From Leakage Through a Subgrade Slab

Geotextile/Bentonite/Geotextile Composite Waterproofing Membrane

By Dr. Ian D. Peggs

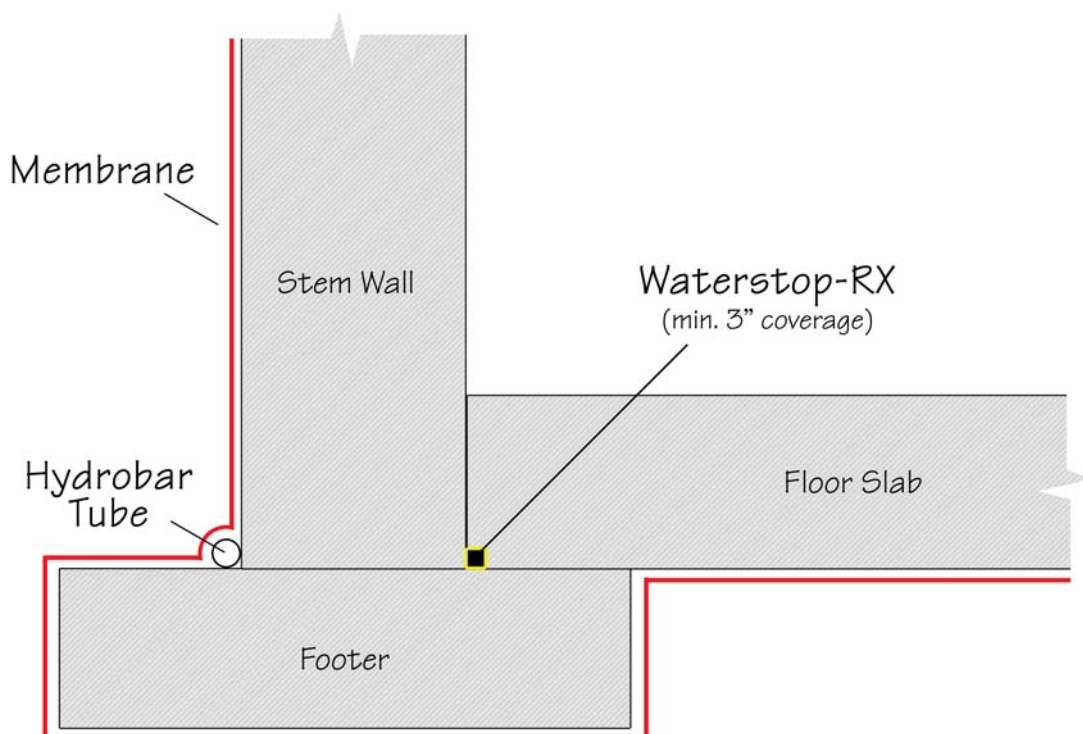
Figure 1 – Recommended cross section with hydrostatic head (CETCO).

In Figure 1, it should be noted that there is no expansion joint filler between the edge of the slab and the wall. More important, there is a waterstop at the triple point between slab, footing, and stem wall that prevents water from the outside and under the slab from rising between the stem wall and the edge of the floor slab. In the actual basement installation, the waterstop was

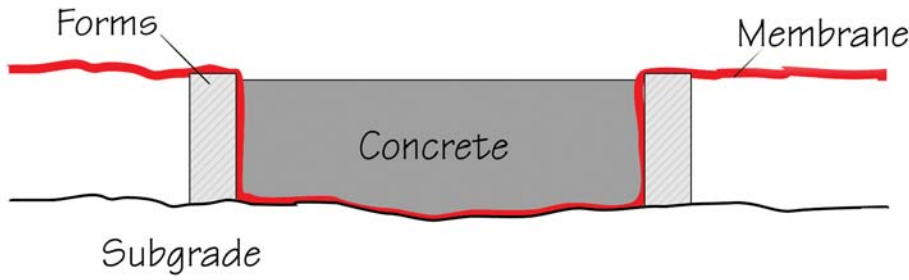
Figure 2 – Cross section of footing forms and membrane (red).

Typically, as shown in Figure 2, the forms are placed for the footing, and the membrane is placed inside the forms on subgrade and up the sides. There should be free flaps outside of the footing forms to overlap with the yet-to-be-placed membrane under the slab. Then, when the concrete is

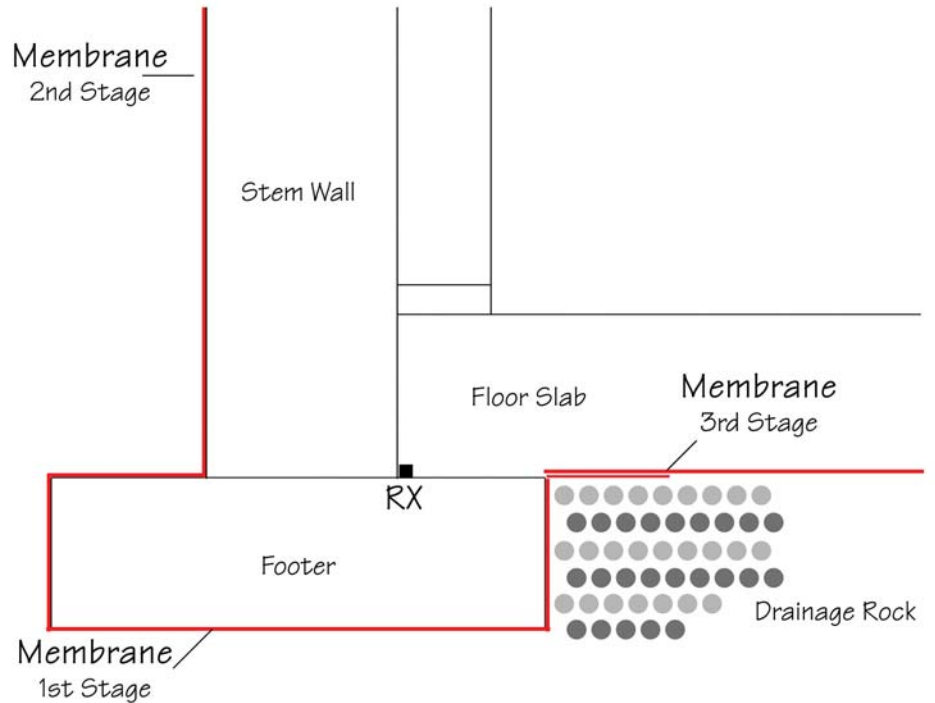
Figure 3 – Schematic of membrane location.

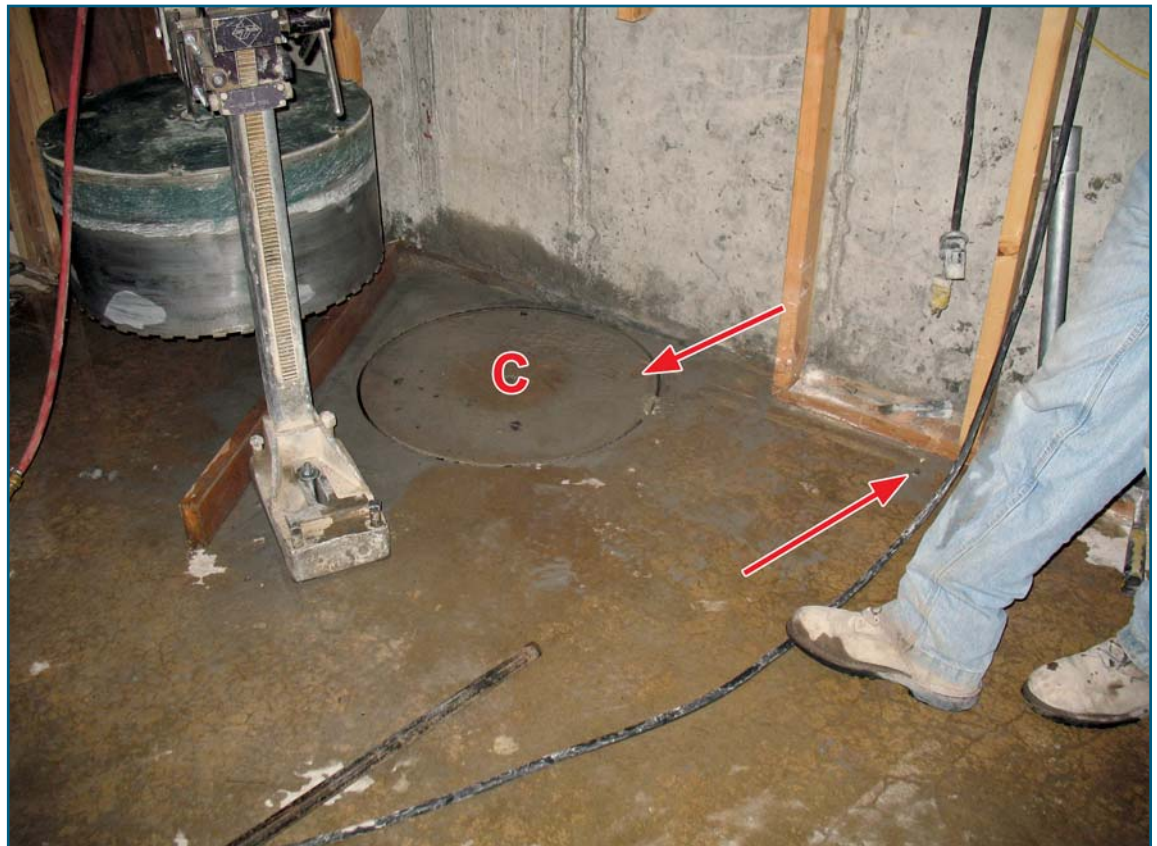
Figure 4 – Locations of core (C) and grout injection holes (at arrows).

A 24-in diameter core was removed from the floor slab as close to the stem wall as possible where studs had been removed (Figure 4) from the outside wall. The core included a hole drilled for grout injection during the second repair.

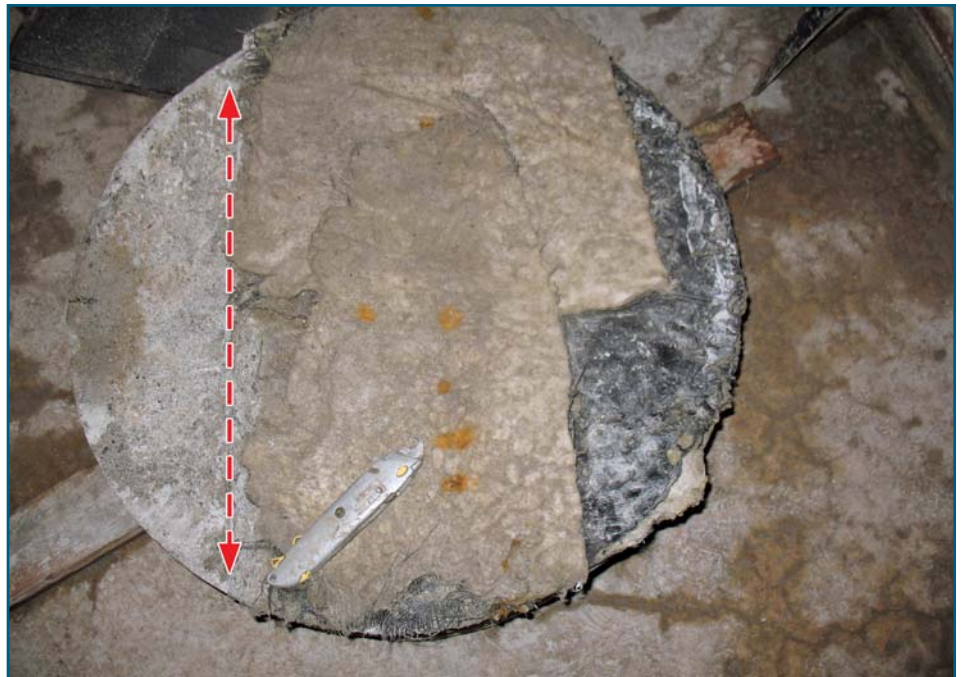
Figure 5 – Membrane layers on underside of core. Section on footing to left of dotted line.

When the core was removed, there were a few layers of membrane with various degrees of bonding attached to them (Figure 5). In the hole, the "smooth" top surface of the footing was obvious, but there was no evidence of repair grout on the top of the footing nor on the underside of the core above the footing, despite the fact that the injector hole went beyond the interface and into the footing (Figure 6). This hole was not filled with grout as it would have been had injection been successful.

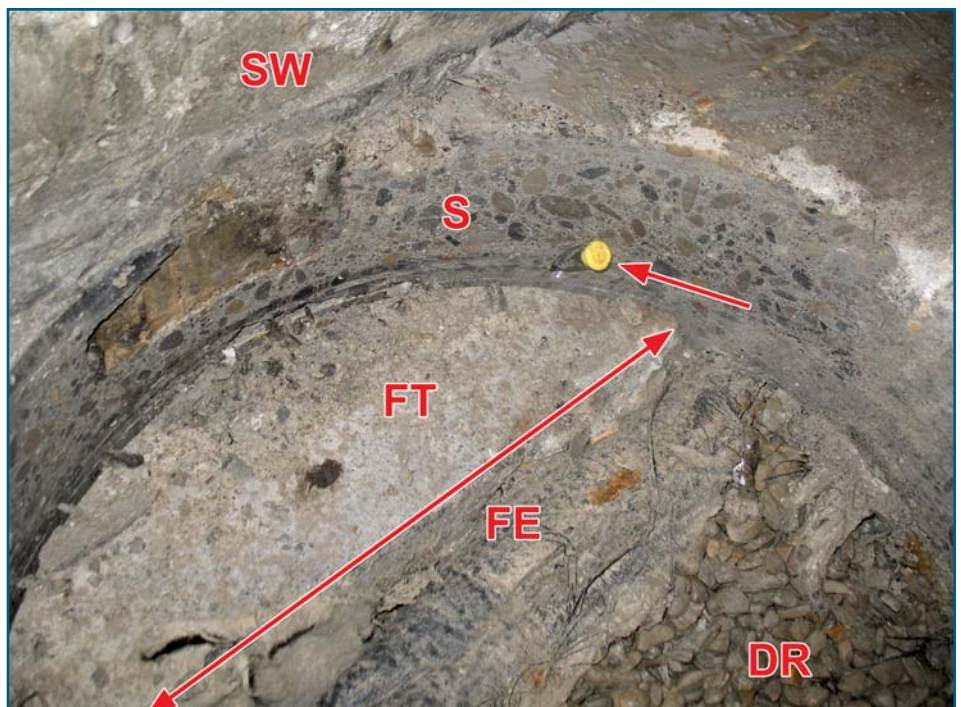
Figure 6 – Screwdriver (yellow top) in grout injection hole (arrowed). SW – stem wall; S – floor slab; FT – footing top; FE – footing edge; DR – drain rock.

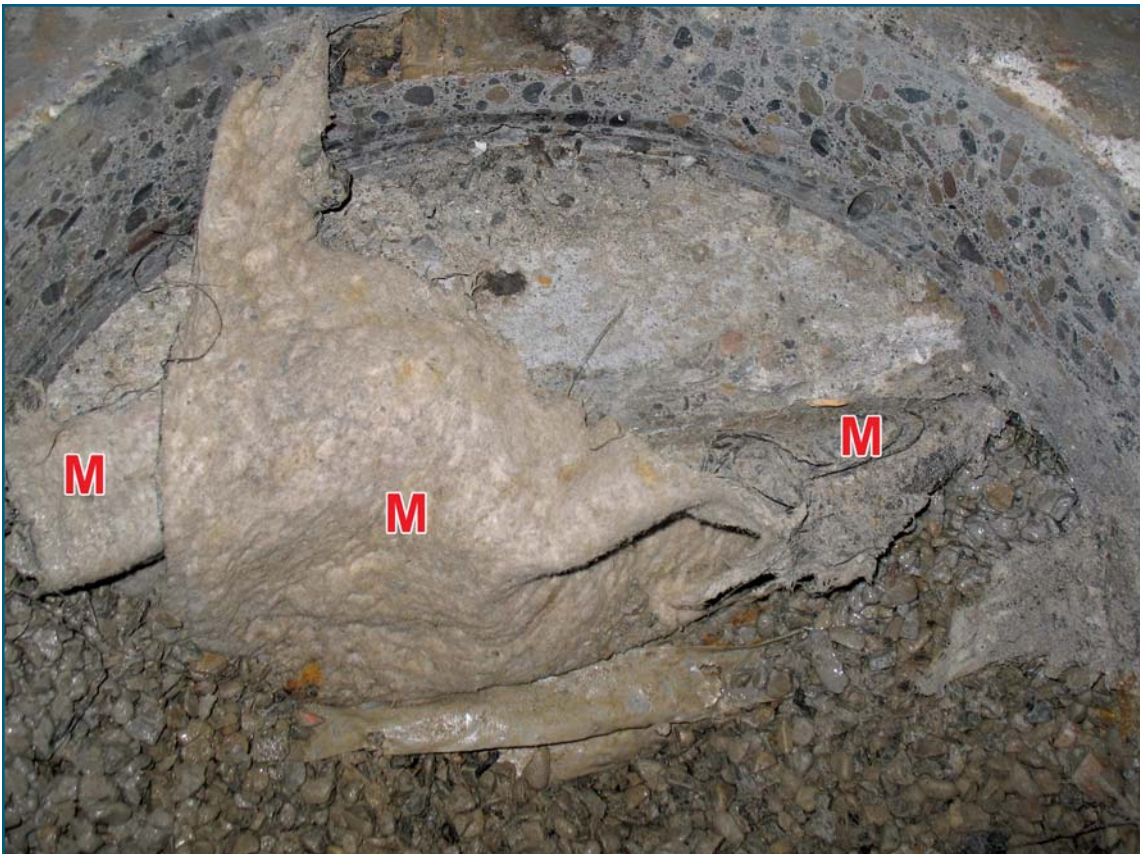
Figure 7 – Three layers of membrane (M) up the side of the footing.

There were several layers of membrane emerging from the vertical interface between gravel and footing (Figure 7). A rebar dowel between slab and stem wall had been cut. The rebar dowel was incorporated to help ensure the floor slab would not rise independently of the footing due to hydrostatic pressure.

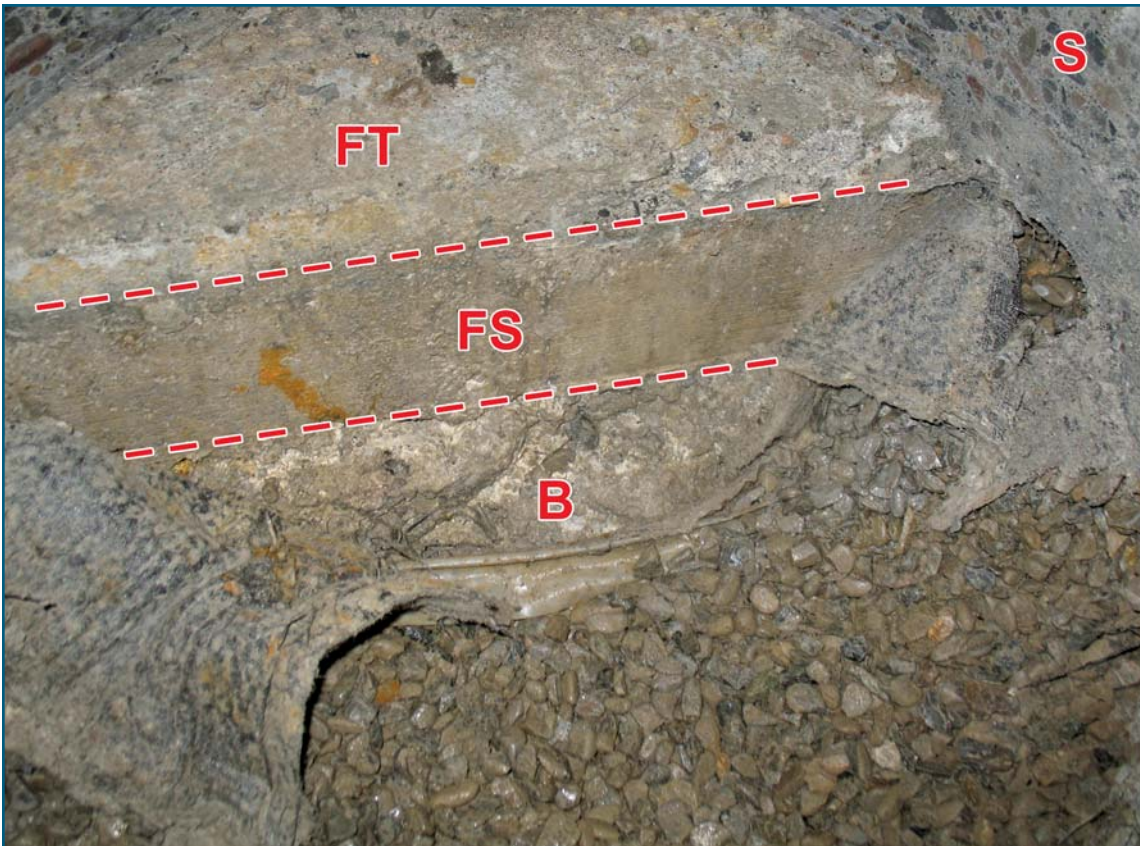
The gravel was removed, the membrane layers separated, and the side of the footing exposed. Figure 8 shows the smooth side of the footing; but below it, there was a large, rough mass of concrete bulging out under the floor slab. There was no membrane bonded to the side of the footing nor to this rough, bulging mass. There was an overhang/channel (Figure 9) between the bottom of the smooth part of the footing and the bulging mass that would preclude the application of a uniform confining pressure on the membrane at that location. The channel would also allow passage and dispersal of leaked water behind the membrane.

Figure 8 – Smooth side of footing (FS) with bulging concrete (B) below. Footing top – (FT); Slab – (S).

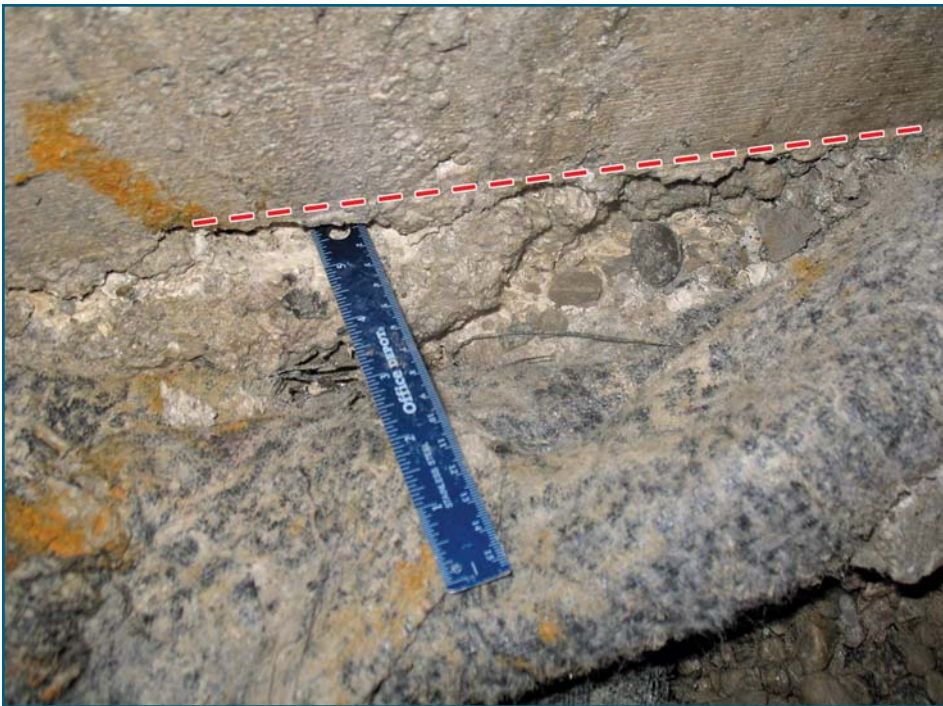
Figure 9 – Channel-like cavity in footing between smooth side (above dotted line) and bulge.

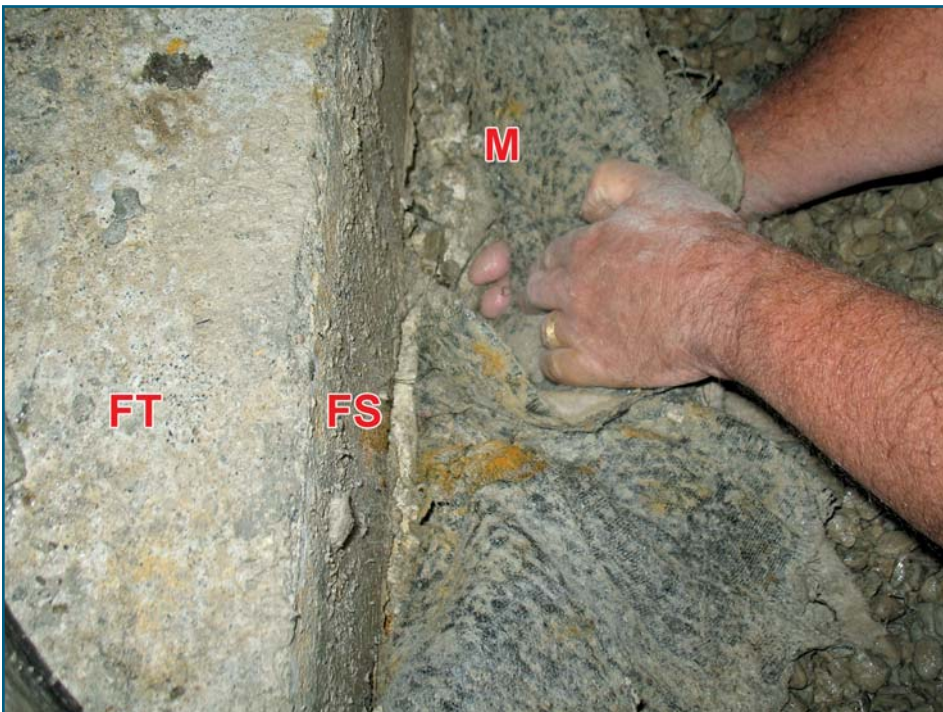
Attempts to sort out the layers of membrane revealed three or four layers. During separation of the membrane layers, there was one location where it was possible to put two fingers through a hole/gap from drain rock side to footing side (Figure 10). There had been a lump in the concrete bulge penetrating the liner at this location. This would have been a significant leak. It was also possible to reach well down the bulging concrete between concrete and membrane and to feel significant cavities in the concrete surface, even with the gravel in place. Thus, there had been inadequate and uneven confining pressure at these locations.

Figure 10 – Large hole through membrane layer (M). Footing side – (FS); Footing top – (FT).

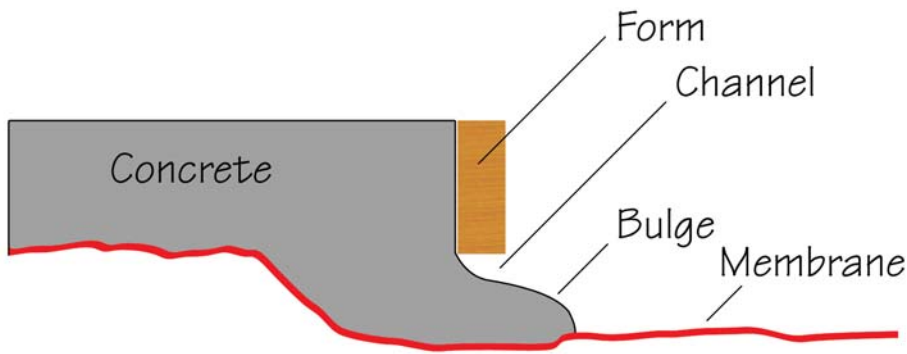
What appears to have happened is that the membrane was laid for the footing and the forms were placed not immediately on top of but above the membrane, as shown in Figure 11. The membrane was not placed up the inside of the footing forms but left on the subgrade outside the forms. The concrete was poured into the forms, but much of it slumped underneath and spread outside the forms to generate the large bulge. Thus, the membrane was not bonded to the sides of the footings.

Figure 11 – Cross section of poured footing on basement side.
