The Use of Closed-Cell Spray Polyurethane Foam (ccSPF) to Enhance the Structural Properties of Wall and Roof Assemblies

By Mason Knowles

This article discusses field observations and research that document the ability of closed-cell spray polyurethane foam (ccSPF)¹ to add structural strength to roof and wall assemblies.

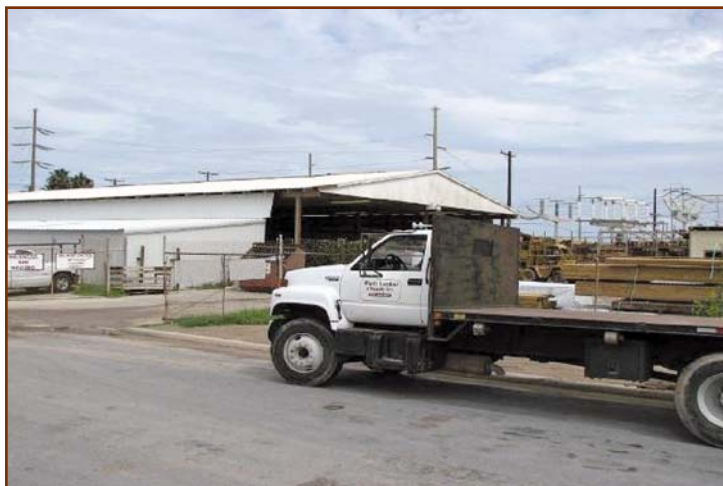
Figure 2 shows White's Lumber's open-end, post-frame-construction building. New metal was installed to half of the building (right side of the photo) in 2008, and the old metal originally installed in 1980 is on the left. For close to 30 years, there were no significant wind events in the area.

Figure 2 – The author installed the old metal roof on this building in 1980. A new metal roof was installed in 2008 on the right side of the building.

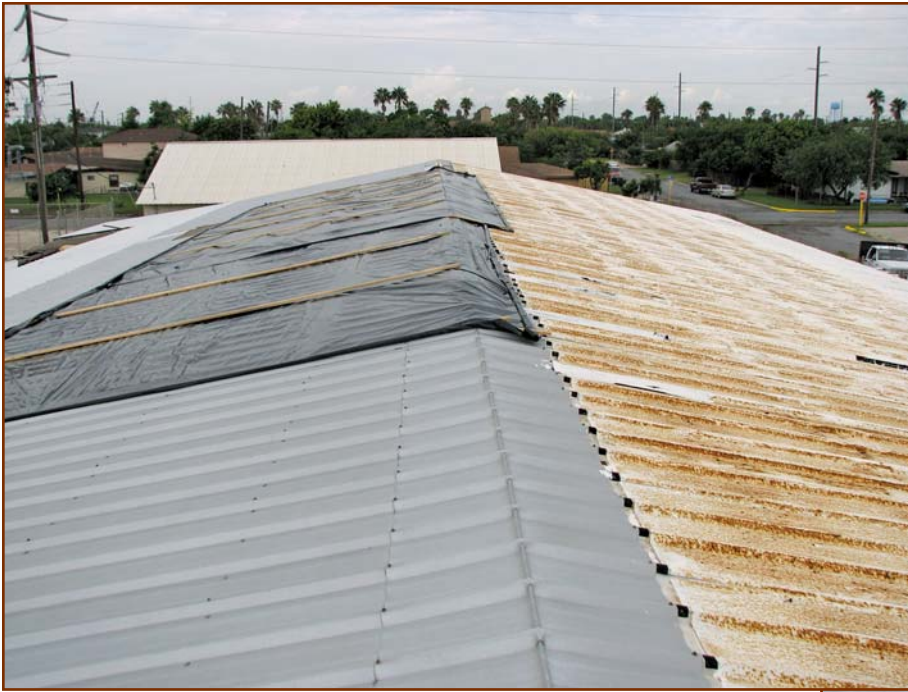
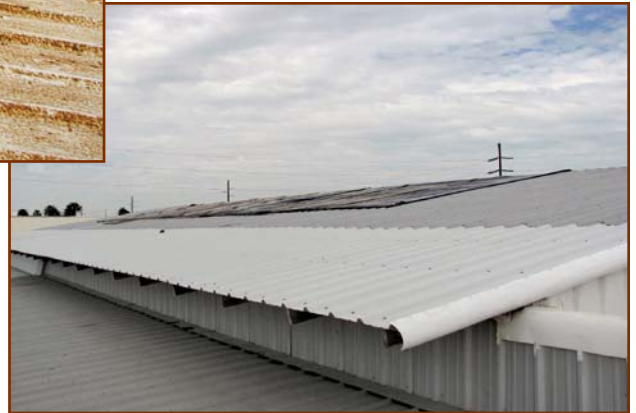
Figures 3 (left) and 4 (below) – Half of the roof blew off of White’s Lumber during Hurricane Dolly.

Lumber and Supply lost half of its roof, as shown in *Figures 3* and *4*. But something looks strange, doesn't it? The left side of the building has a new metal skin installed in 2008, while the right side has metal panels that are over 29 years old. As can be seen, the new metal blew off in the storm, while the old metal remained in place. Both are 29-gauge metal² with similar fasteners and fastening patterns (in fact, the new metal portion had a closer fastening pattern than the old section, and both are fastened to the same wood framing).

2. Since 29 gauge is a low-strength metal sheathing material, it is much more likely that fasteners will pull out of such metal, causing damage in a high-wind event. A thicker sheathing might have survived the storm without damage.

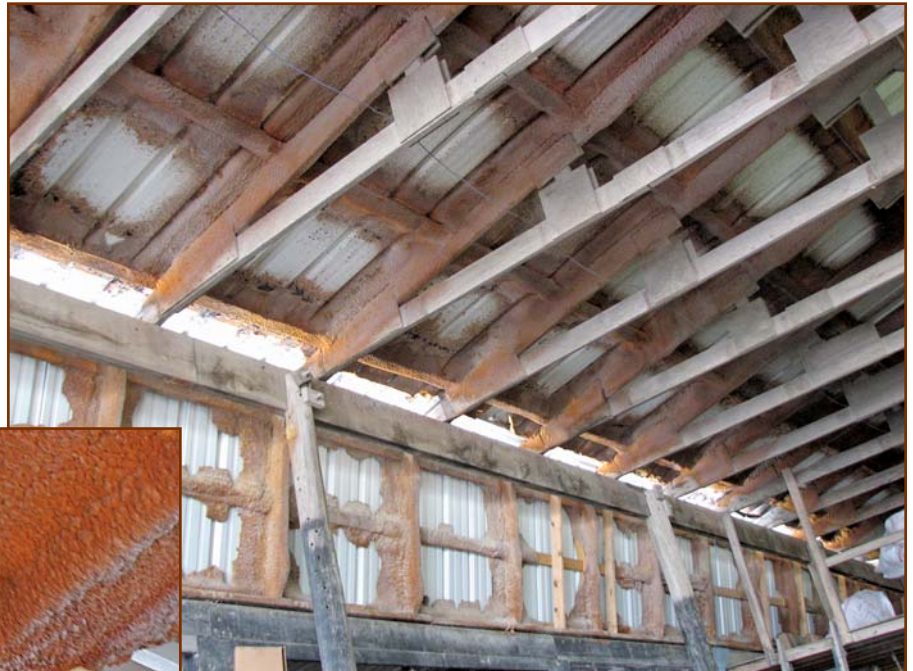
There is a simple explanation. When the metal was replaced in 1980, the owner contracted with the author to install a 2-lb, closed-cell spray foam in a “picture frame” pattern to help secure the metal panels to the wood trusses. Twenty-nine years later, this safety net proved invaluable (*Photo 5*). Unfortunately, when the owner replaced the metal on half of the building in 2008, he could not find an SPF applicator to replace the foam (*Photo 6*). Consequently, high winds blew off major portions of the new metal panels.

Figure 5 – Old metal secured with ccSPF.

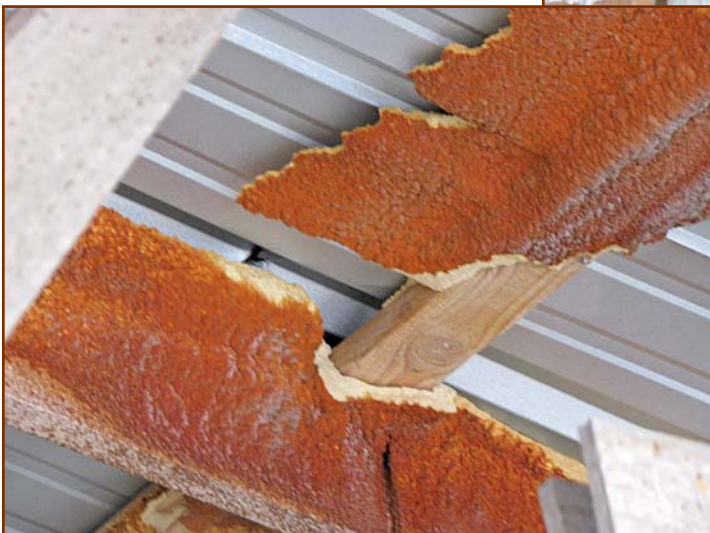
Figure 6 – The ccSPF was removed to install new metal.

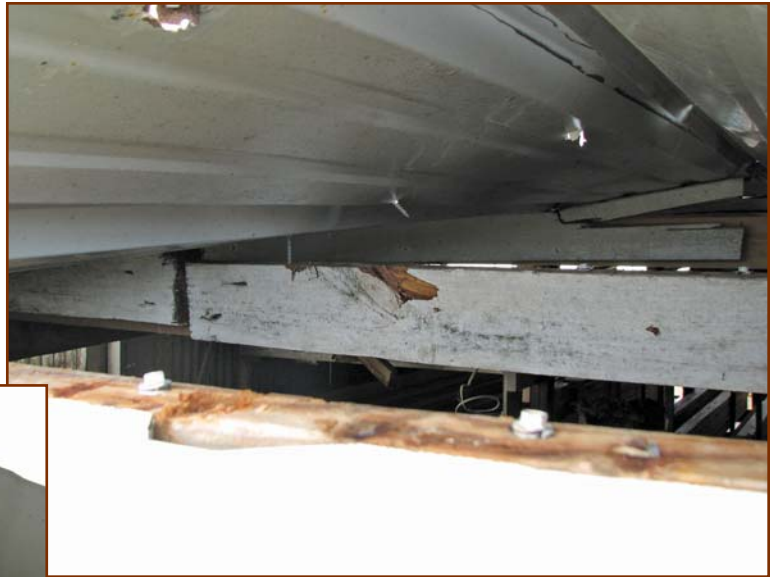
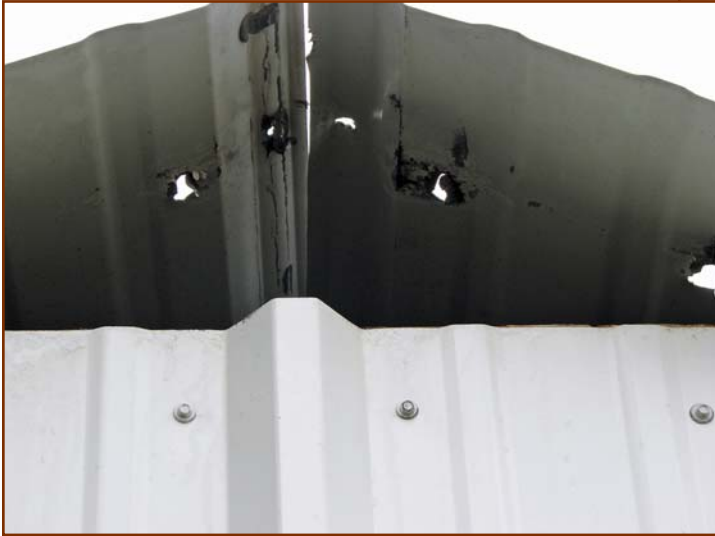
Figures 7 (right) and 8 (below) – Fasteners pulled through the new metal skin where there was no ccSPF to help secure the panels to the wood trusses.

As shown in Figures 7 and 8, the main cause of failure of the new metal skin was pulling of the fasteners through the metal.

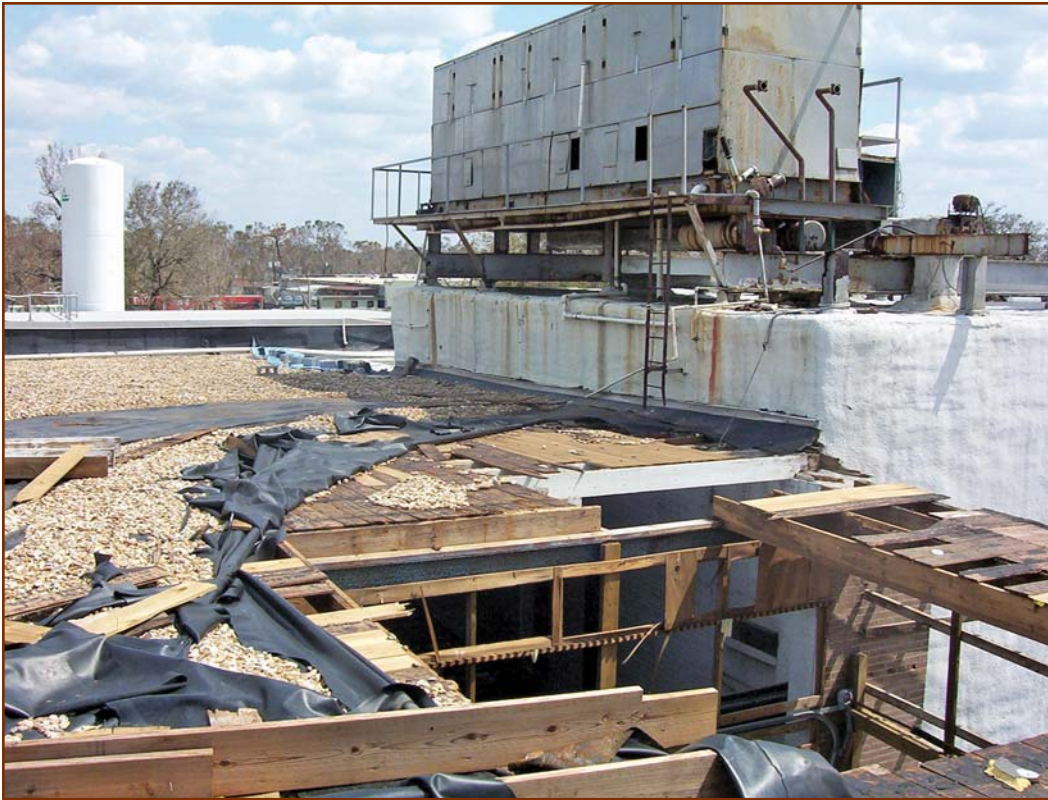
As shown in Photo 9, internal pressurization destroyed the tongue-and-groove roof deck of this ice plant during Hurricane Katrina. However, the metal building section (depicted in Photo 10) that was insulated with ccSPF and connected to the same structure, survived with no damage.

Figure 9 – Internal pressurization during Hurricane Katrina destroyed a tongue-and-groove wood deck at this ice plant.

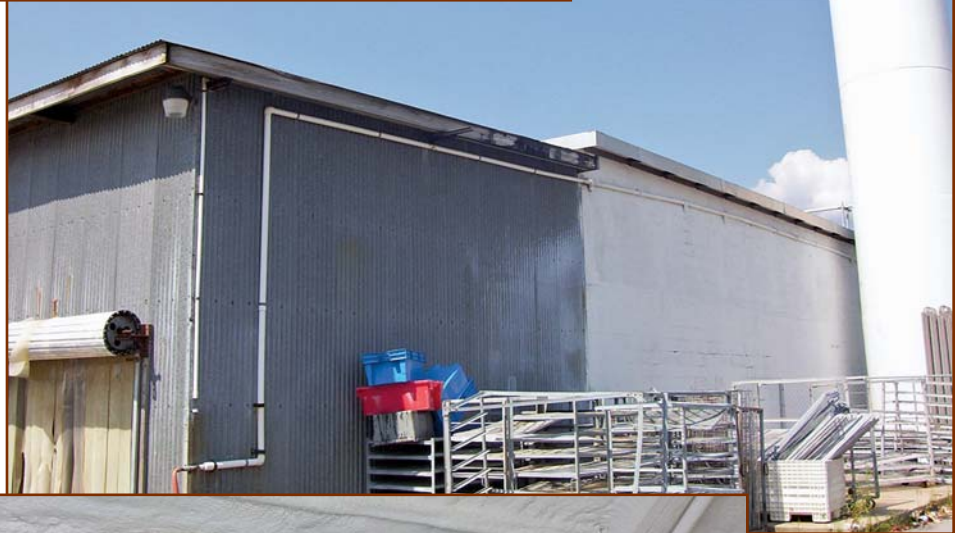
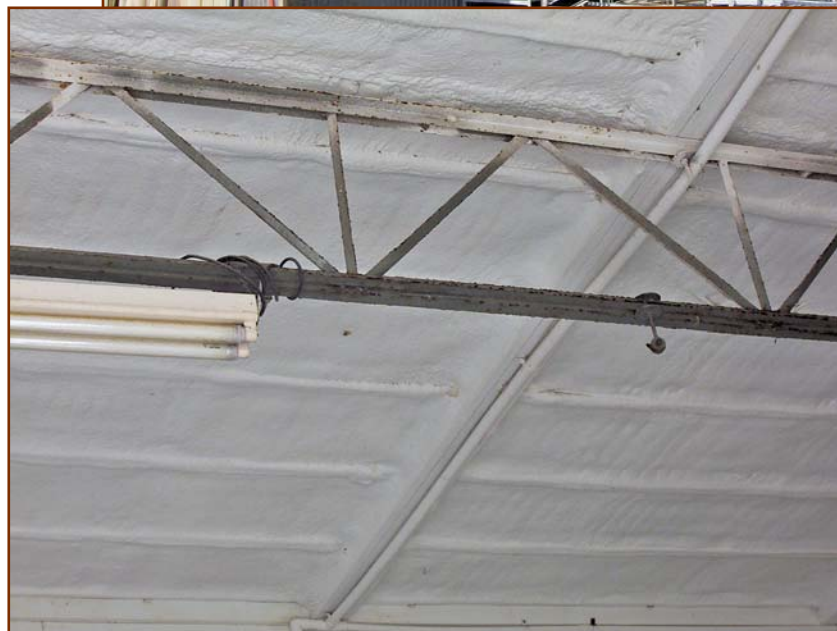
Figure 10 – The metal building below was connected to the structure shown in Figure 9 and was insulated with ccSPF. It received no damage during Hurricane Katrina.

None of the areas insulated with ccSPF sustained any damage. An interesting observation is that many of the ccSPF-insulated portions of the building were areas that would be considered less structurally sound than other areas (if they were not structurally reinforced with ccSPF). Figure 11 shows the foam sprayed against metal roof decking and corrugated metal wall panels.

Figure 11 – Foam sprayed against metal roof decking and corrugated metal wall panels.

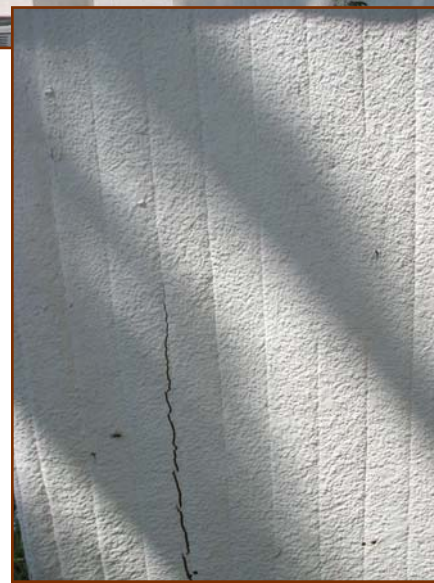
In 2009, the building was in the direct path of Hurricane Dolly, with up to 110 mph winds. Again, the building survived with no damage except for a small crack (see Photo 15) and no water intrusion.

Figure 15 – Only damage after two hurricanes and 30 years of service.

3. Wind-driven debris will typically cause dents, cracks, and gouges to exterior applications of ccSPF. A sealant compatible with the coating can repair small (less than 4 in) mechanical damage. Larger areas of damage can be repaired by removing the damaged foam and replacing it with new foam using high-density foam kits or standard SPF proportioning equipment. Recoating may be required if the damage covers large areas of the structure.

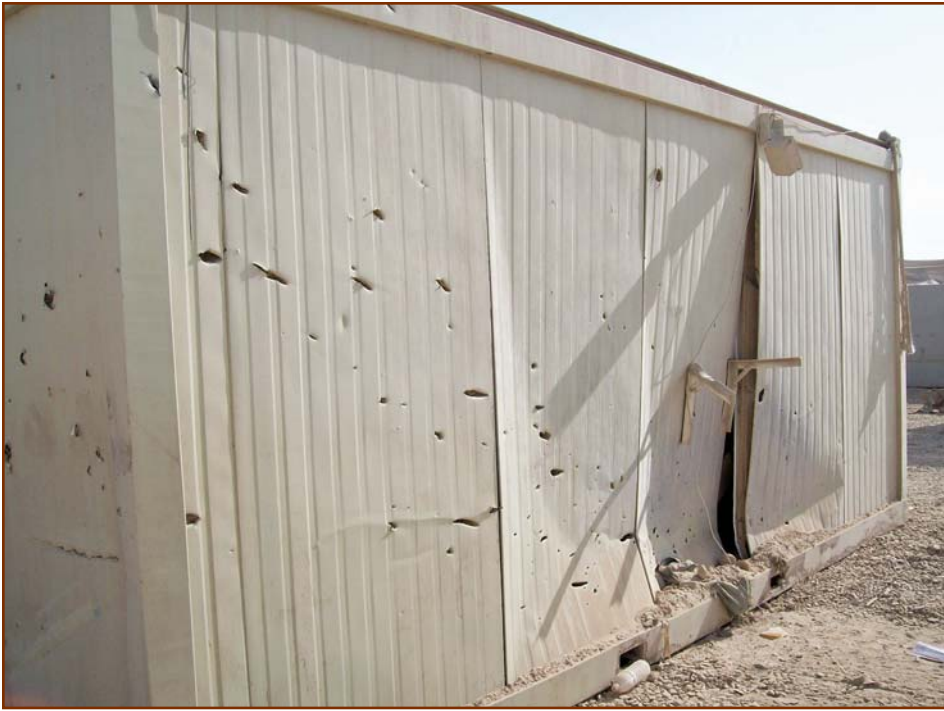
Figure 18 – This metal building was approximately 50 yards from the mortar shell's impact.

But a recent incident may be prompting the military to look seriously at using ccSPF to protect structures against damage from mortars or improvised explosive devices (IEDs). On October 17, 2008, Mearl “Skip” Kline was working with a crew from West Roofing that was insulating tents with ccSPF at a military base just outside the city of Baqubah, Iraq. According to Kline, “The base was attacked by what Army personnel assumed to be 107mm rockets. We hit the ground when we heard the shells coming into the camp. The shells impacted approximately 40 yards from us and 80 to 100 yards away from the ccSPF tents. We were told this type of ordnance has a kill radius of approximately 30 yards. The tents [that were insulated with ccSPF] absorbed shrapnel from the shells without [the shrapnel] penetrating the structures. After the attack, Army personnel were impressed by the

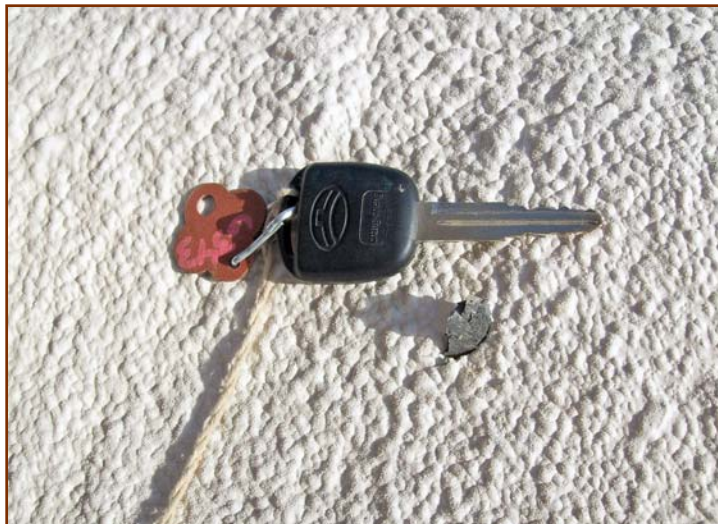
foam’s ability to absorb the shock of the shrapnel hits. Many expressed a desire to use the foam to increase the impact resistance from enemy shells.” (See Photos 18 and 19.)

Figure 19 – Shell fragments still capable of severely wounding personnel were embedded in the foam of the structures, 80 to 100 yards away from impact.
