# BUILDING ENVELOPE TECHNOLOGY SYMPOSIUM

## ADDRESSING ROOF LEAKS BY FIXING A WALL PROBLEM

# ADDRESSING ROOF LEAKS BY FIXING A WALL PROBLEM

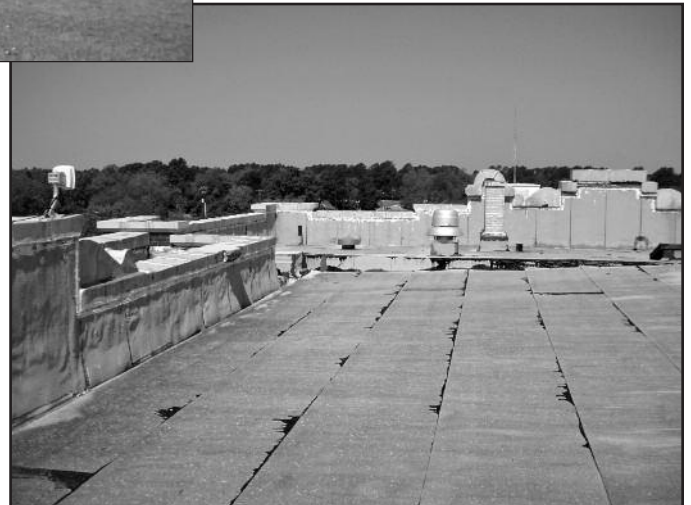
The existing roof system at the property consisted of a two-ply modified bitumen roof set in hot asphalt over a 1-in-thick layer of polyisocyanurate insulation (*Photo 2*). The insulation was set in hot asphalt over the wood plank deck. The roof structural system consisted of sloped wood rafters supported by the exterior load-bearing masonry walls and internal concrete beams at the long span over the main courtroom. The wood rafters were rotted at locations of bearing pockets in the masonry wall system. An interstitial attic space existed between the wood deck and the concrete ceiling system. The attic was only partially ventilated. Roof debris from the previous roof projects was found inside the attic space, apparently discarded there rather than being properly disposed of by the previous contractors. The roof was primarily drained by perimeter built-in sheet-metal gutters stripped into the roof system. The

*Photo 2 – Overview of existing roof systems. Note vertical wall flashings at back side of parapet.*

The vertical flashings of the roof system extended to the top of the parapet wall in most locations, with no cant at the base of the wall, some of which were over 6 ft in height. The flashings and the top of the parapet coping had been coated with an aluminized coating. The vertical flashings were delaminated from the masonry substrate.

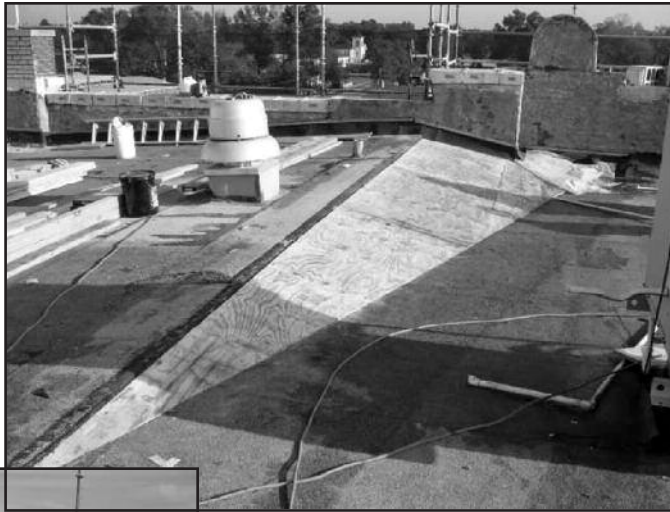
*Photo 3 – Steep-slope cricket at existing transition in roof slope.*

The engineer designed a replacement roof system that incorporated a cold-adhesive-applied modified bitumen membrane; mechanically fastened polyisocyanurate insulation; steep-sloped, wood-framed crickets (*Photos 3 and 4*); cants; and sumped drains. The design eliminated the stripped-in sheet-metal gutter, a chronic leak issue, and directed water to the drains,

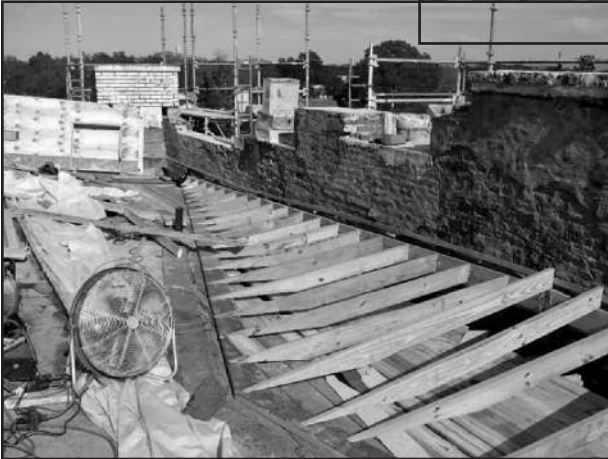
*Photo 4 – Steep-slope cricket at parapet wall.*

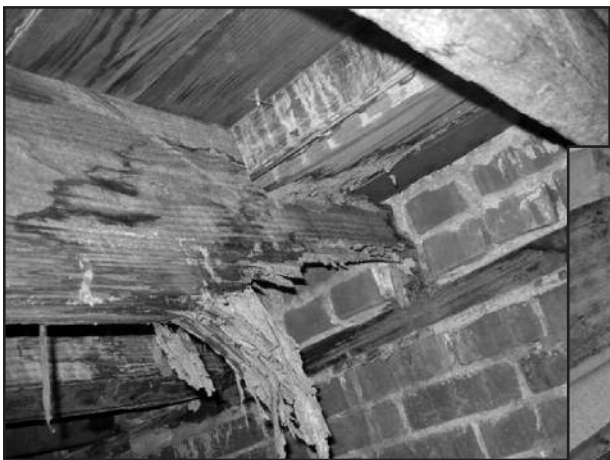
*Photo 5 – Rotted wood rafter at bearing end, note box out for gutter.*

As part of the repair project, nearly all of the roof rafters were addressed at the bearing pockets where the wood was in contact with the masonry wall. Many of the rafters were already rotted beyond salvaging (Photo 5), while others were repaired with a pressure-treated sistered member to provide a measure of protection against future rot. Pressure-treated lumber was used at the repairs, and both sistering (attaching new members to

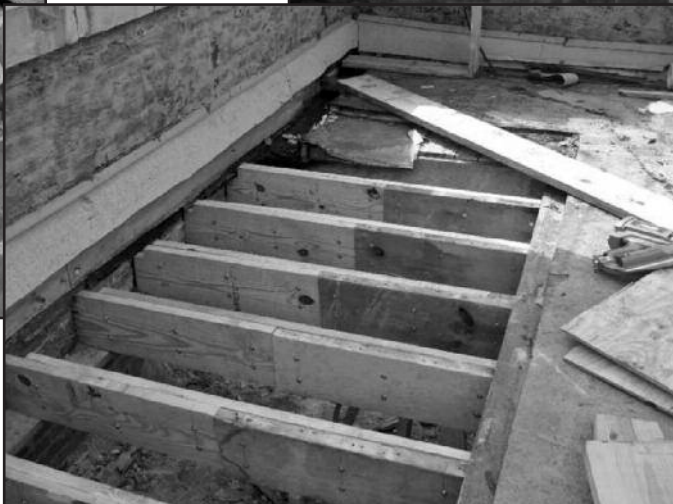
*Photo 6 – View of sistered rafters from above prior to deck reinstallation.*

the face of existing remaining members) as well as full replacement were performed (Photo 6). Many of the primary rafters had been decreased in cross section at the bearing points due to a boxed-out frame for the built-in gutter. These were replaced as part of the wood structural repairs with full-depth members. At some locations, construction of a secondary masonry knee wall approximately five courses high was necessary within the attic space to support the repaired rafters (Photo 7). This approach was selected by the contractor to minimize the unknown com-

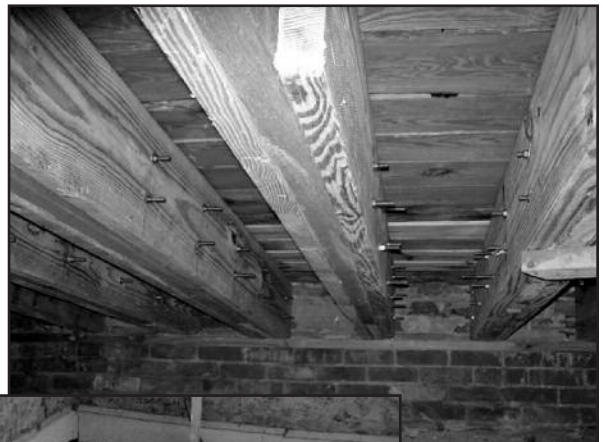
*Photo 7 – View of sistered rafters from beneath after deck reinstallation. Note masonry knee wall.*

ponent chipping into the existing remaining masonry to create bearing pockets. By constructing this knee wall within 3 to 4 in of the face of the existing wall, load transfer to the existing bearing points was accomplished within the concrete slab cross section.

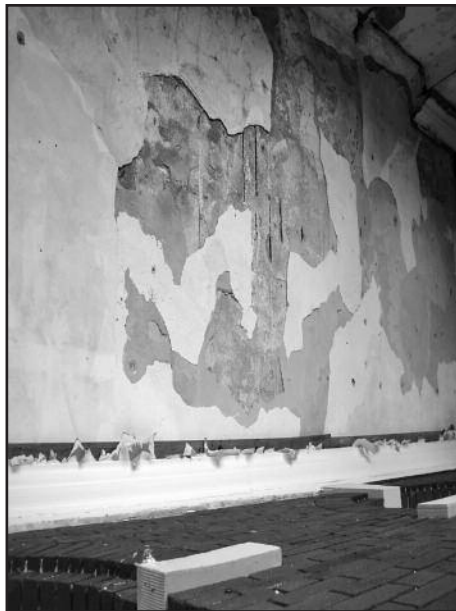
In addition to wood structural repairs, concrete slab replacement was also necessary at the ceiling over the main entrance portico. This entrance had originally included a plaster suspended ceiling that had deteriorated and been removed as a safety concern years before. The unprotected and exposed concrete ceiling had deteriorated to the point of spalling; and exposed, corroded reinforcing was observed at the start of the project (Photo 8).

**Photo 8 – Underside of portico ceiling at start of project.**

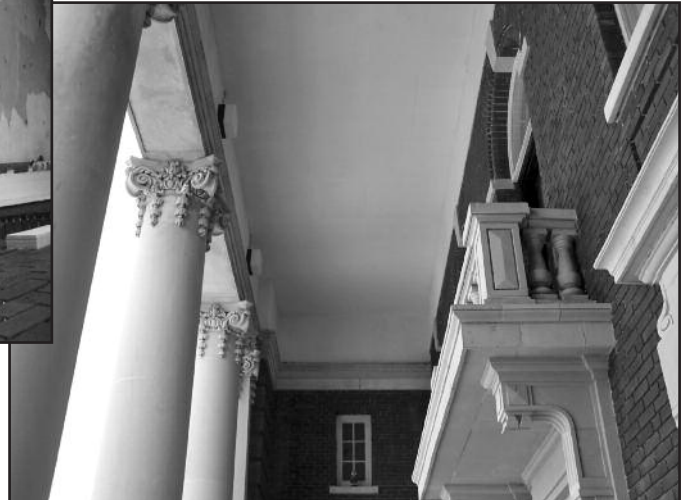
**Photo 9 – New portico ceiling slab.**

The portico ceiling was replaced with a cast-in-place concrete slab, similar to the original construction (Photo 9).

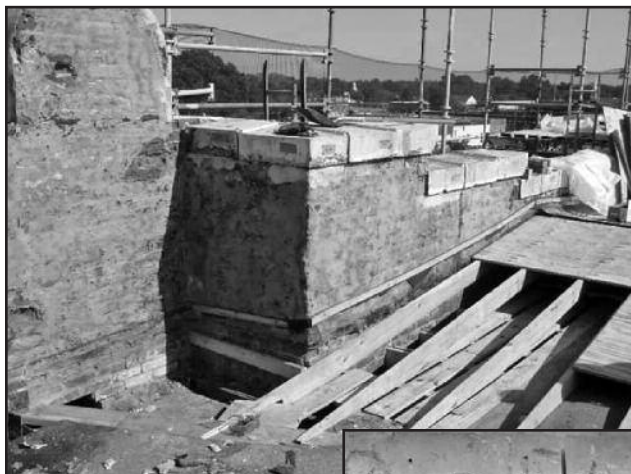
parapet had been saturated with moisture due to the flashings preventing drying. The uncovered masonry was found to be previously painted and parged as well, which may have also contributed to additional moisture retention in the masonry. Once the walls were uncovered (Photo 10), they were allowed to dry, and the masonry was verified to be sound.

**Photo 10 – Backside of exposed brick masonry parapet.**

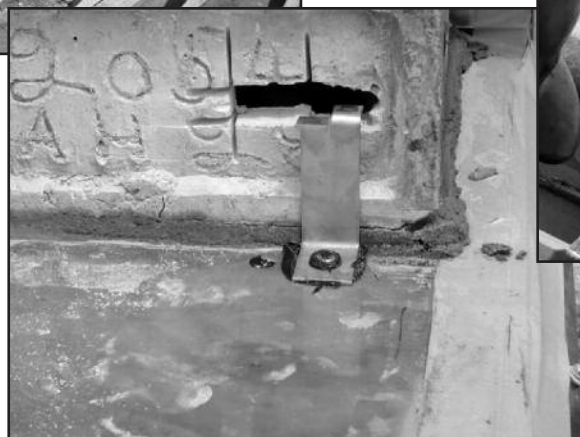
**Photo 11 – Stainless-steel cleat at terra-cotta attachment.**

The terra-cotta coping was removed from the entire perimeter of the building, and a new continuous copper through-wall flashing was installed beneath the terra-cotta. Each section of terra-cotta was numbered, stored, cleaned, and then reinstalled over the new flashings. New stainless-steel cleats (Photo 11) were

installed by using traditional dovetail stone anchors in a horizontal application. Openings were made in the sides of the terra-cotta sections to install the cleats. The installation of the cleats was necessary to prevent sliding of the terra-cotta on the flashings.

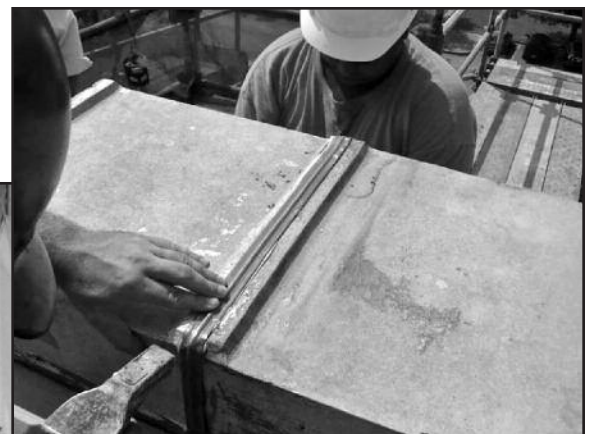
**Photo 12 – Installation of lead cap at terra-cotta sealant joints.**

Once the terra-cotta was reset, the skyward-facing joints were sealed with caulking over backer rod. The sealant joints were protected with an embedded lead cap (Photo 12).

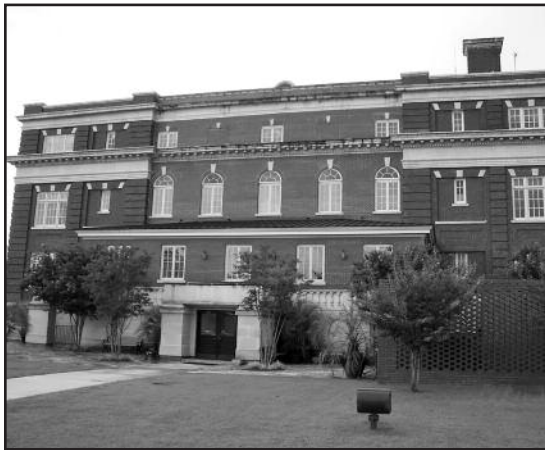
**Photo 13 – Rear elevation of addition before restoration of parapet.**

tion, in turn obscuring it from view (Photo 13). As part of the parapet wall work, this ornamental detail was relocated to the exterior wall of the addition (Photo 14) to allow for the parapet to appear continuous from the exterior and the roof level. This additional step not only was an aesthetic improvement but also allowed for improved waterproofing details at the transition from the addition to the original building at the parapet level.

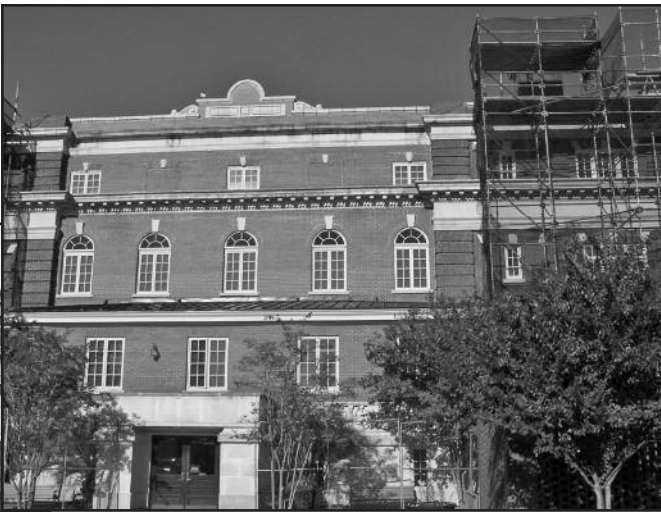
**Photo 14—Rear elevation of addition after restoration of parapet.**

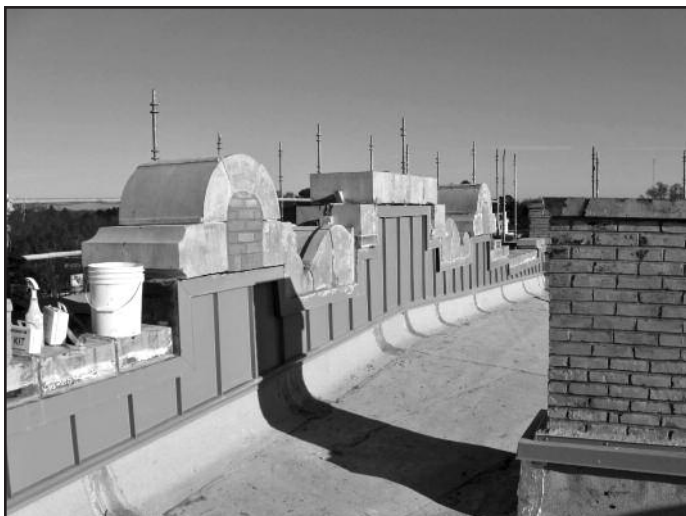
**Photo 15 – Installed rainscreen at back side of parapet wall.**

for the masonry, a metal rainscreen was installed on the back side of the parapet (Photo 15).

was installed over the wall as a drainage plane behind the metal panels. Then steel hat channels were attached to the masonry using nail-in expansion anchors. The metal panels were secured to the hat channels using standing-seam metal roof system clips. The installation of the rainscreen allowed the parapet to dry out while keeping the driving rain from saturating the masonry. Because of the intricate nature of the parapet wall, numerous transitions and various panel sizes were necessary. A patina green copper finish was chosen to maintain an historic appearance consistent with this building's age. Once the rainscreen was

installed, the new through-wall flashing beneath the terra-cotta coping was used as a counter-flashing for the top of the rainscreen, capping off the system.

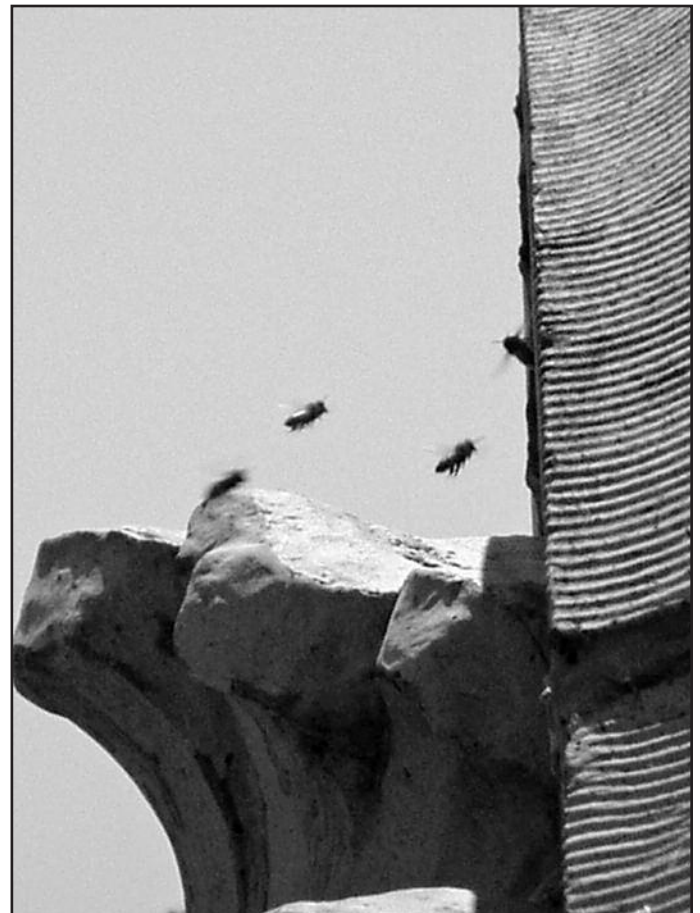
During the assessment of the property, it was noted that there were many honeybees present at the ornamental stone carvings and terra-cotta at the parapet level (*Photo 17*). Although it was expected that the bees would affect construction, it was not expected that a complete hive structure, including honeycomb, would be found within the terra-cotta coping (*Photos 18 and 19*).

**Photo 17 – Honey bees at stone ornament prior to construction.**

The contractor contacted a local apiarist to remove the bees safely and humanely.

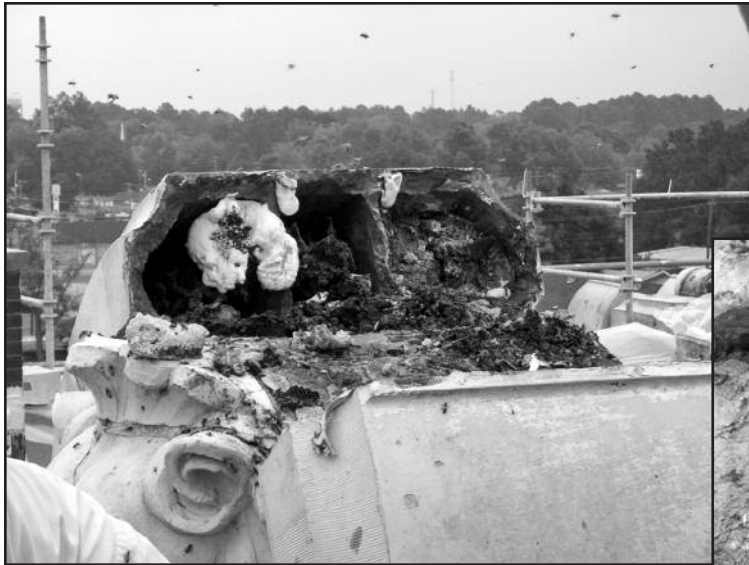
*Photo 18 – Honeybees swarming as terra cotta is removed.*

The bees and their honeycomb were extracted from the terra-cotta, which was then cleaned and reinstalled as planned. This process added a few days to construction but successfully preserved the hive structure of a large honeybee colony.

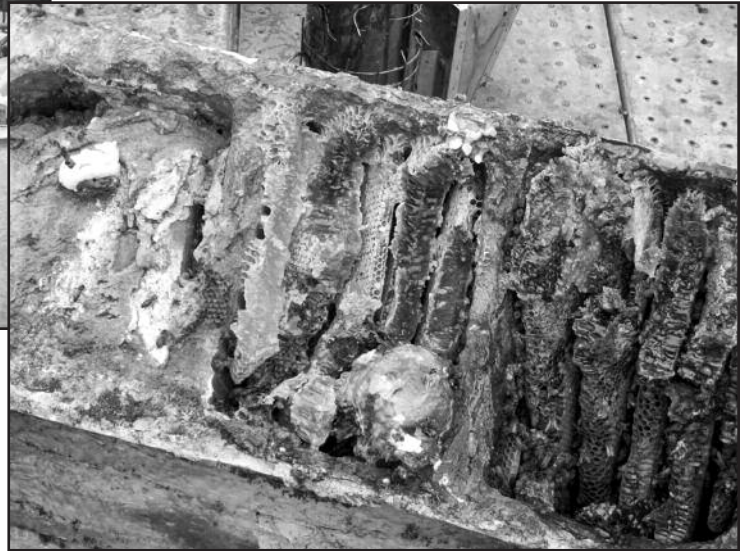
*Photo 19 – Terra cotta void filled with honeycomb.*
