# BUILDING ENVELOPE TECHNOLOGY SYMPOSIUM

## RAPID BUILDING FAILURE

# RAPID BUILDING FAILURE

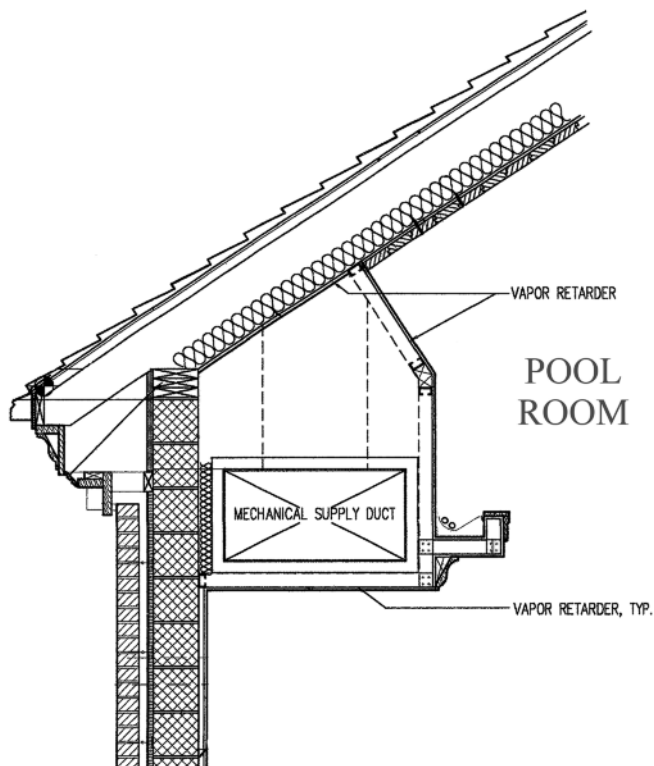
**Figure 6 – Original pool room roof/wall intersection and vapor barrier locations.**

- There was a large disconnect around the entire perimeter of the interface between the ceiling and the walls where the polyethylene vapor barrier stopped at the 2-in x 4-in furring strips. The air/vapor barrier was by no means continuous (Figure 8).
- On the walls, a 6-mil polyethylene vapor barrier was behind the gypsum wall board; however, the polyethylene sheets were lapped but not sealed or taped (Figure 9).
- Penetrations in the polyethylene vapor barrier around outlets, piping conduits, and lighting fixtures were not treated with any particular attention to detailing or sealing.
- A massive amount of airflow and condensation was occurring in the compact roof assembly above the pool room.
- A massive amount of air flow and condensation was occurring in the attic between the pool room and the adjacent portions of the building.

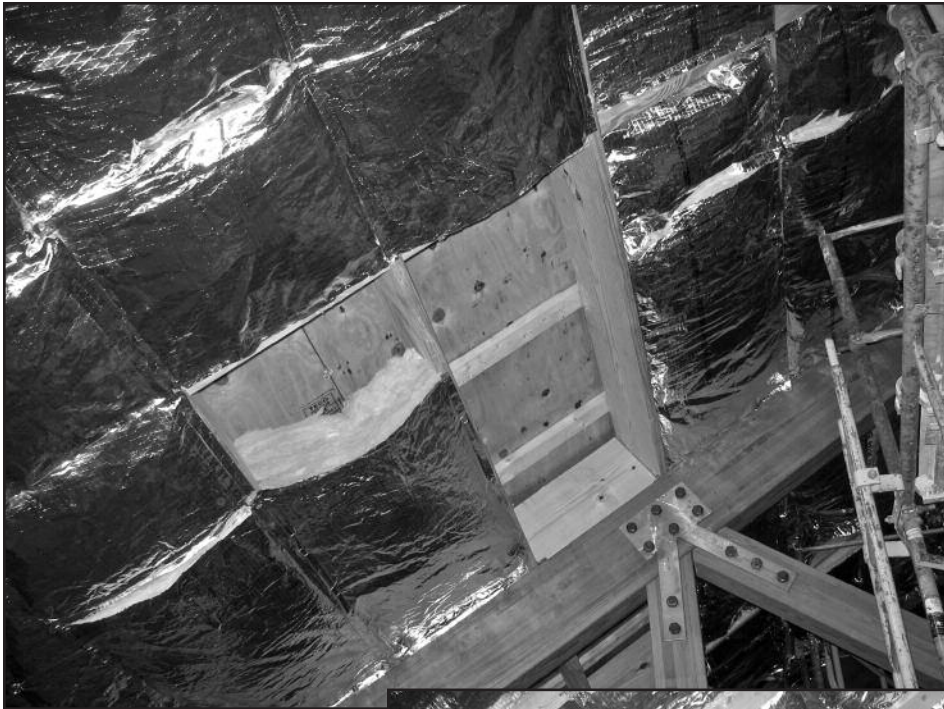
*Figure 7 – Installation of the original roof insulation and FSK “vapor barrier.”*

further clarification through the RFI (request for information) process, and the architect's representative clarified and wrote, "The foil side of the FSK insulation, if properly taped and sealed, will act as the required vapor barrier." (See Figures 7 and 8).

To expect an air- and vaportight assembly from an FSK product in this application is almost an impossible task. The less-than-robust original design was rendered less so with the approved change request. When the owner's representative questioned the installation, he was assured by the construction manager that the contractor and architect were "on the same page" and the work would be installed properly.

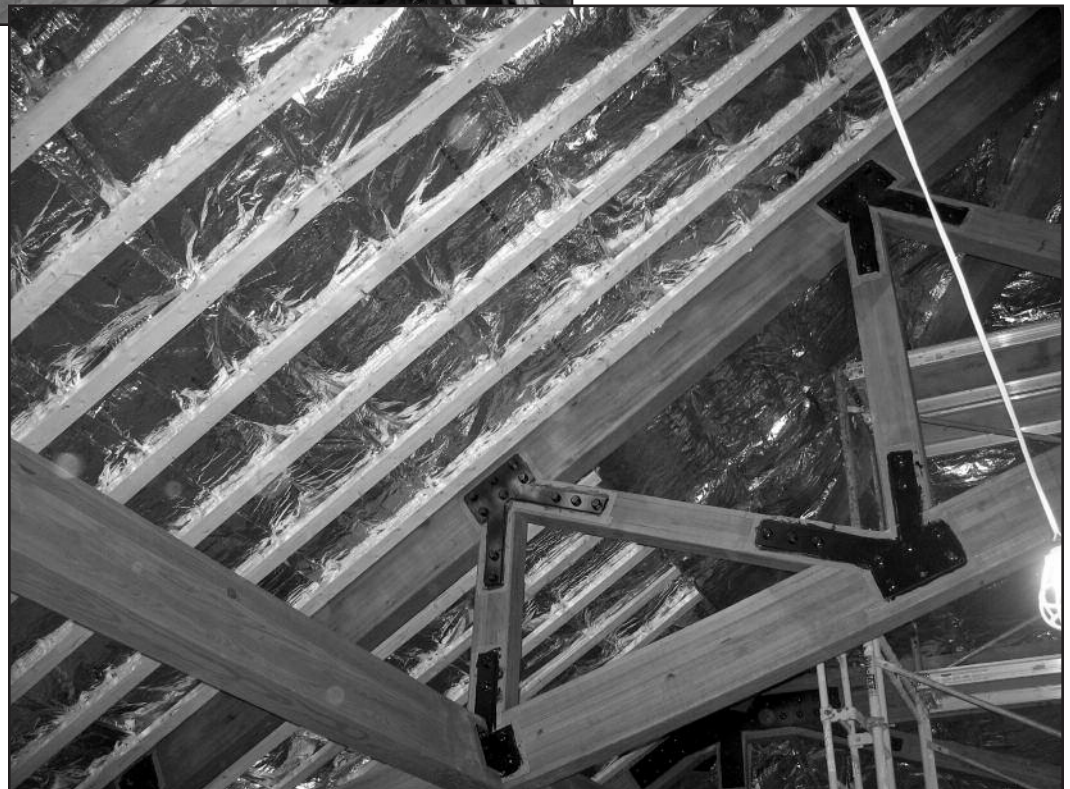
*Figure 8 – Roof assembly under construction with Glu-Lam trusses and ceiling furring strips shown over FSK “vapor barrier.”*

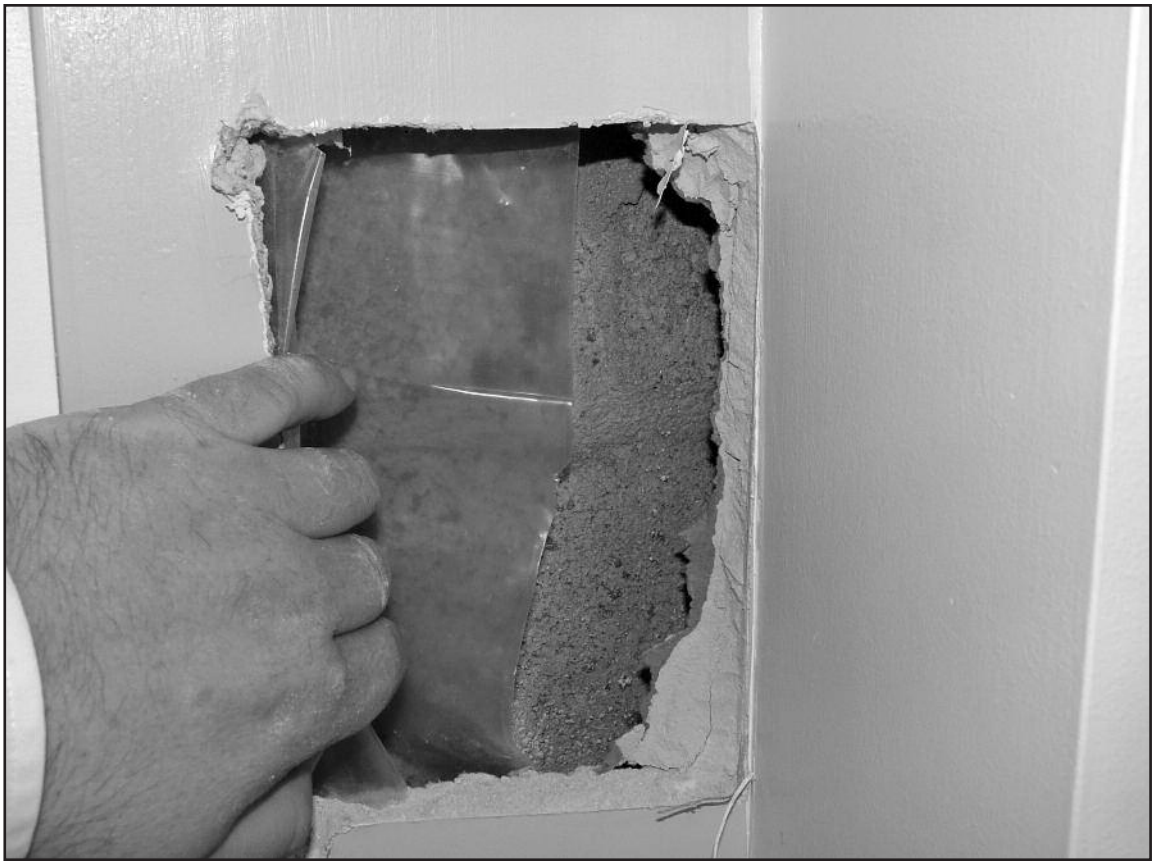
During the installation, the laps in the polyethylene wall sheeting were not taped or sealed (Figure 9), nor was the polyethylene sealed to the foil-faced insulation at the ceiling level. In fact, the polyethylene vapor barrier was held back 1½ in (the thickness of the 2-in x 4-in furring strips), leaving ample opportunity for an airflow shortcut to exist in the vapor barrier, exposing the uncovered portion of the CMU exterior walls and permitting direct air access to the adjoining large attic areas through openings in the taped FSK and directly through the

**Figure 9** – In the walls, the polyethylene vapor barrier was not taped and sealed at all joints and laps.

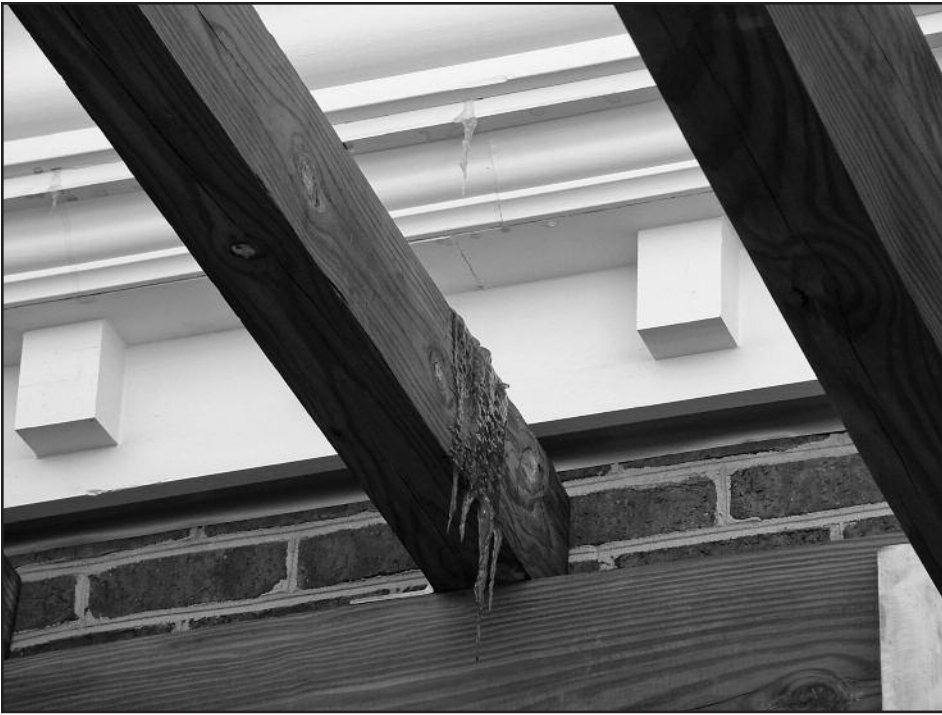
**Figure 10 – Icicle formations where condensation was dripping from the pool-room eave.**

- Condensation was dripping from the eaves and forming icicles at night along the perimeter of the building (Figure 10).
- Large-scale wetting, warping, delamination, and buckling of the plywood roof panels above the pool room and adjacent attic space were observed.
- Widespread mold infestation in the locker room attics was noticeable in the portion of the adjacent attic areas close to the pool room (Figures 11 and 12).
- Condensation in the locker room

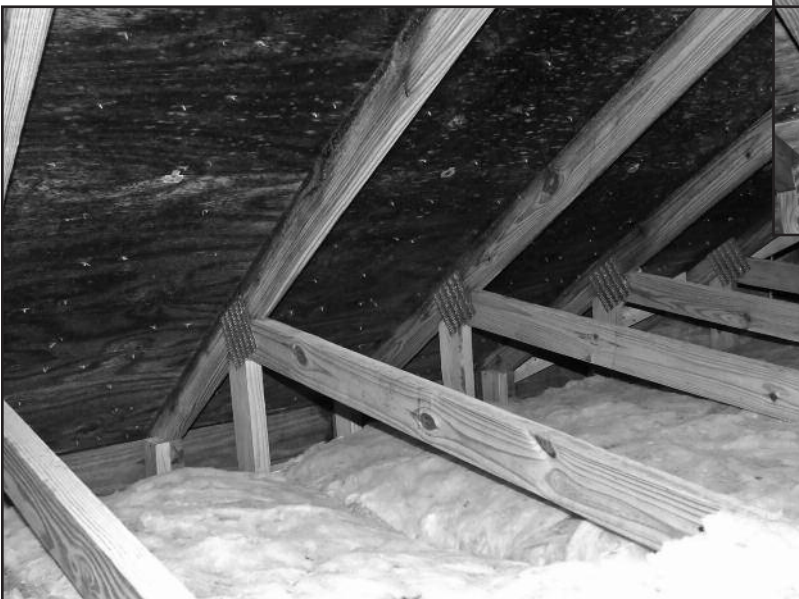
**Figure 11 – Biological growth on sheathing in attic space above equipment room prior to occupancy.**

Both options required removing all of the damaged and most of the moldy roof sheathing on the adjacent attic roof over the locker rooms and offices, as well as air sealing and better insulating the common wall and sloped roof between the pool room and adjacent attic spaces and applying a vapor barrier coating on the walls and ceilings of the office and storage room to tie those spaces to the adjacent pool room and separate those gypsum wall assemblies from the rest of the building.

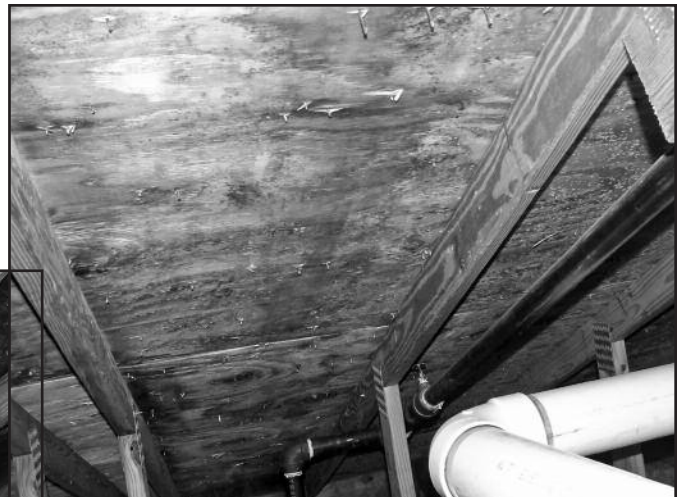
**Figure 12 – Biological growth and buckled sheathing at the attic space above the aquatics office.**

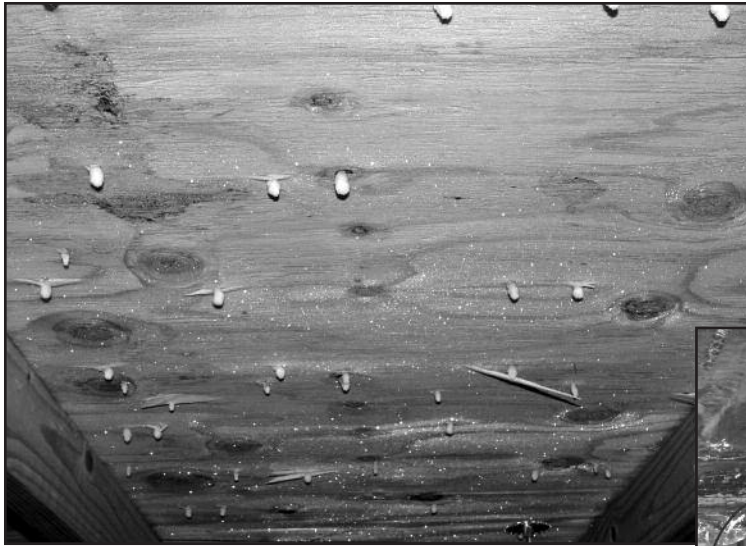
attic was occurring on the underside of the roof sheathing and freezing (Figure 13).

*Figure 13 – View of condensation ice formation on the underside of the locker room attic roof sheathing.*

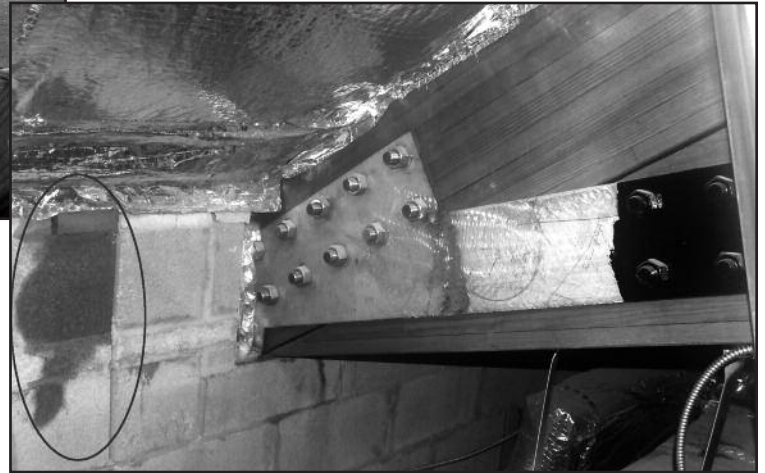
practical). However, it was apparent that there were many opportunities for air transfer through small openings in the FSK taped edges (Figure 14).

*Figure 14 – View of condensation dripping from behind the FSK facing. It is not practical to tape FSK to CMU.*

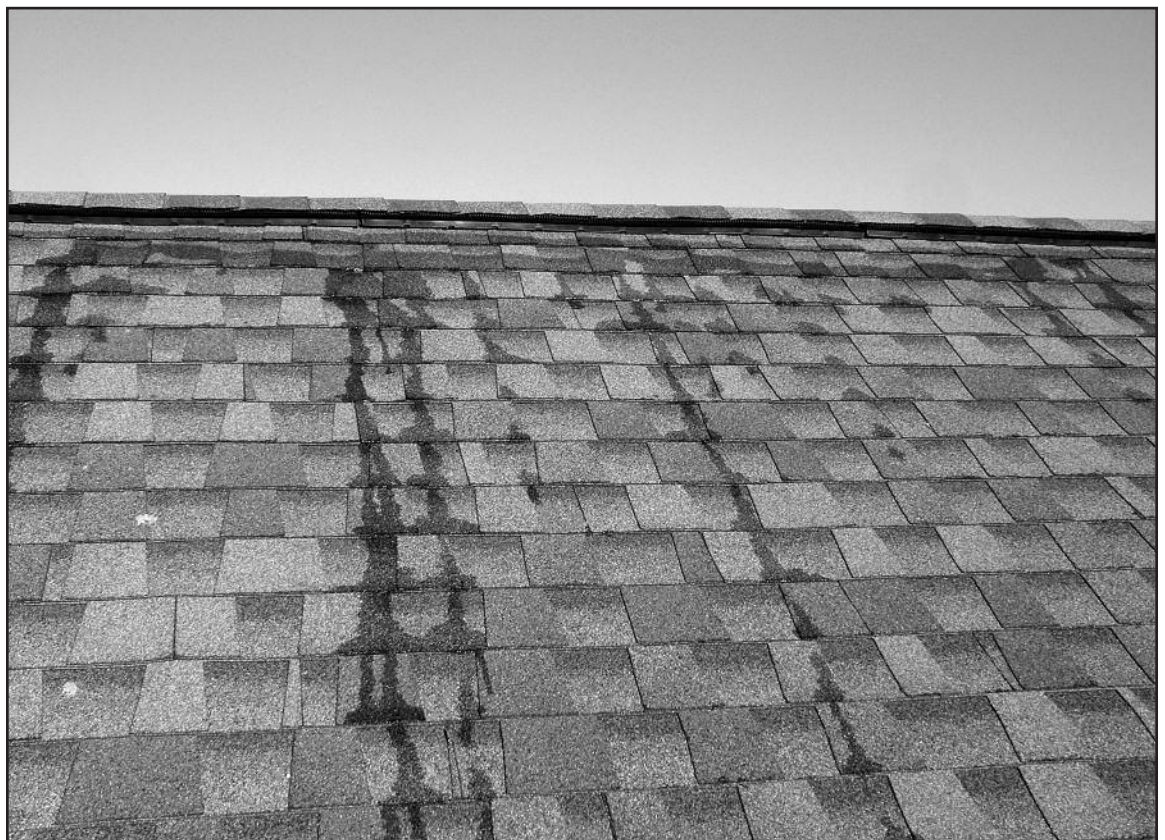
- Moisture at the roof ridge vent was condensing to liquid water, then into ice along the length of the ridge. On a 25°F January morning, the air measured at the ridge of the roof was 68°F and 97% relative humidity (Figure 15).
- The design had called for the installation of two attic access hatches in the ceilings of the pool equipment room and aquatics office. These hatches were allowing rapid air infiltration from the pool space directly into the adjacent nonpool room attic spaces.
- Saturated fiberglass roof insulation above the pool room ceiling was observed.
- The HVAC system appeared to be working properly and was not contributing to the problems.

*Figure 15 – View of condensation dripping from roof ridge vent.*
